**Landslide Hazard and Risk  
Assessment**

Final Report

December 13, 2021  
File: 121624058

DCR/Phoenix Group of Companies  
Ottawa, ON

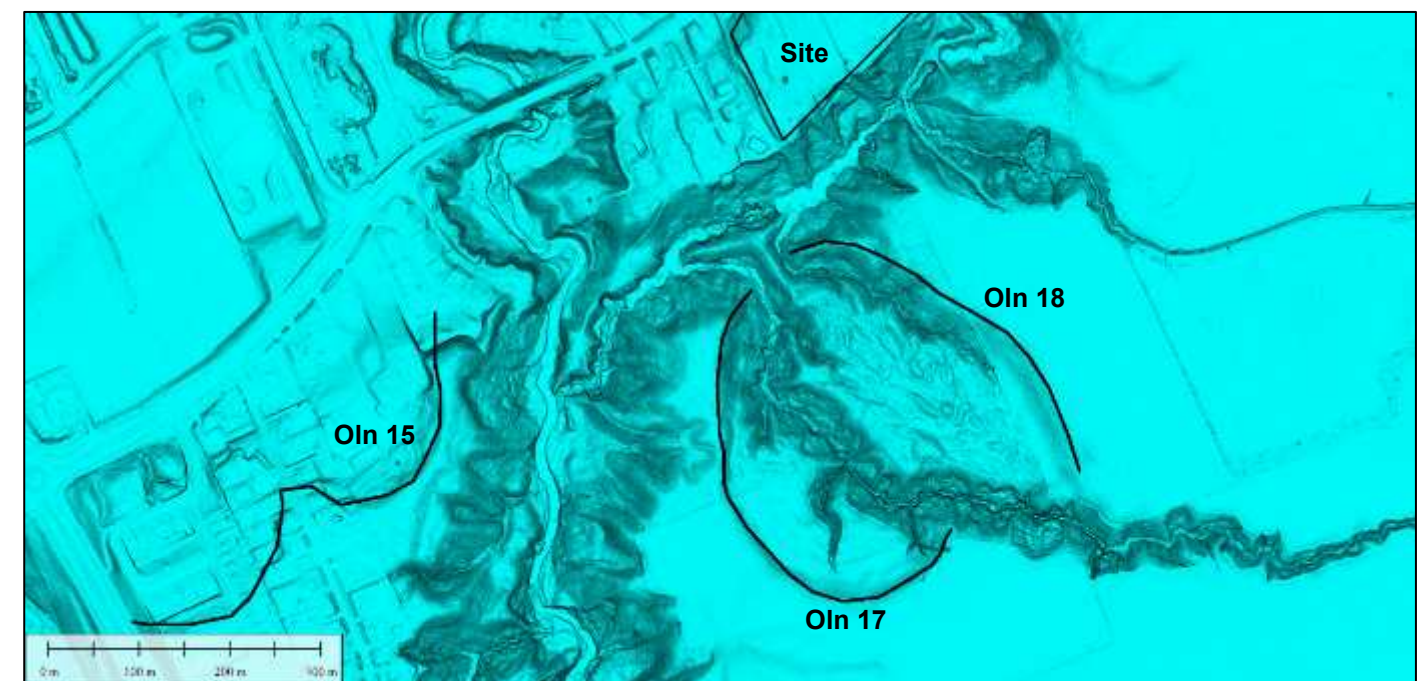
Figure 2-7 2019 bare-earth LiDAR of landslide units OLn 16, 17 and 18

Information relevant to the current assessment is the recent landslide inventory map and database produced for the Ottawa region (Brooks 2019), where at four distinct retrogressive landslides are present within a one-kilometer distance from the Site (two within 400 m). Refer to Table 2-2, and Figure 2-6 and 2-7 for a subset of the database information compiled by Brooks.

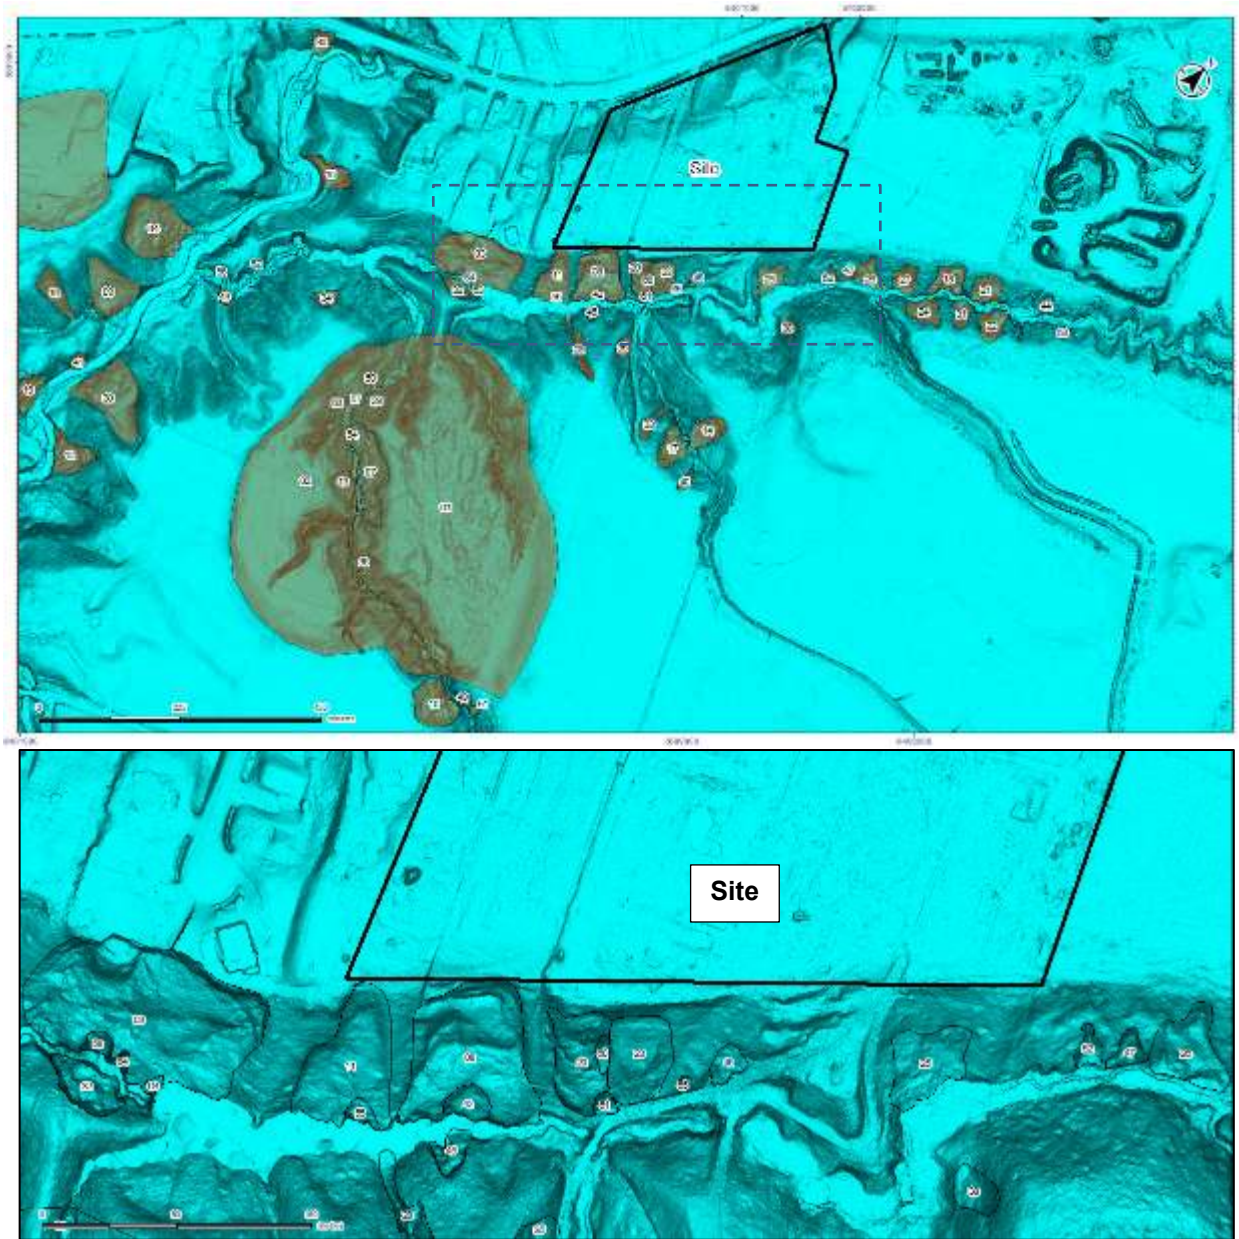
Figure 3-1 Old Montreal Road Landslide Inventory

Reviewing available data suggest the gully system located south of the Site has developed by basal incision and headward erosion, with contribution of relatively small landslides features (generally under 5,000 m<sup>2</sup> in size) that have developed in gully headwalls, side slopes and/or along the edges of the creek and tributary gullies over time.

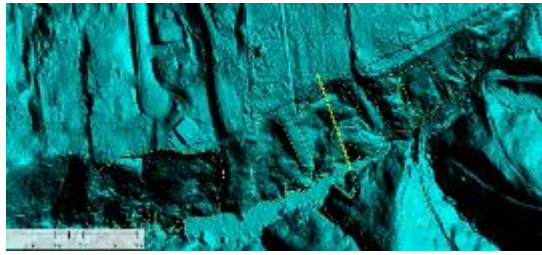
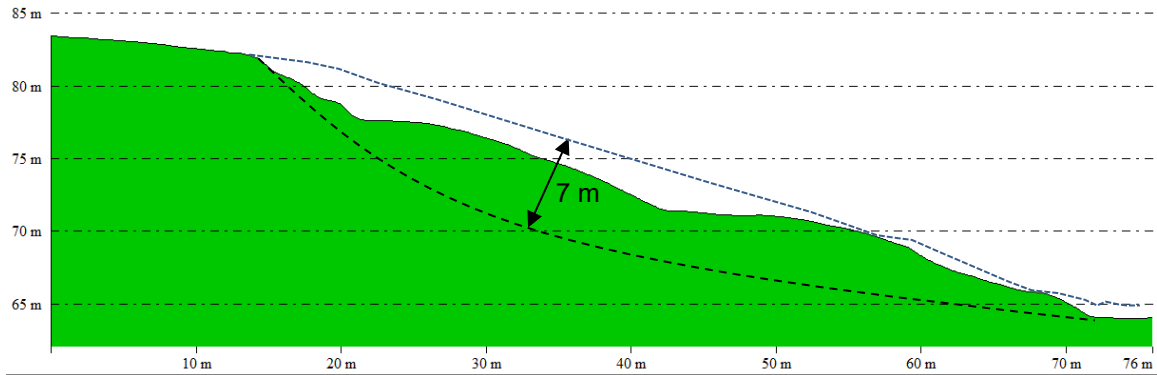
**Figure 3-2** Topographic cross section across rotational landslide south of the Site

- Longitudinal cross sections through mapped landslides units (i.e., from the head scarp to the toe bulge position) suggest overall displacement depth in the order of 1 to 5 m (example on Figure 3-2). Cross sections across the retrogressive landslides south of the Site (example on Figure 3-3) suggest spread-type failures may have reached a minimum depth of approximately 10 m.

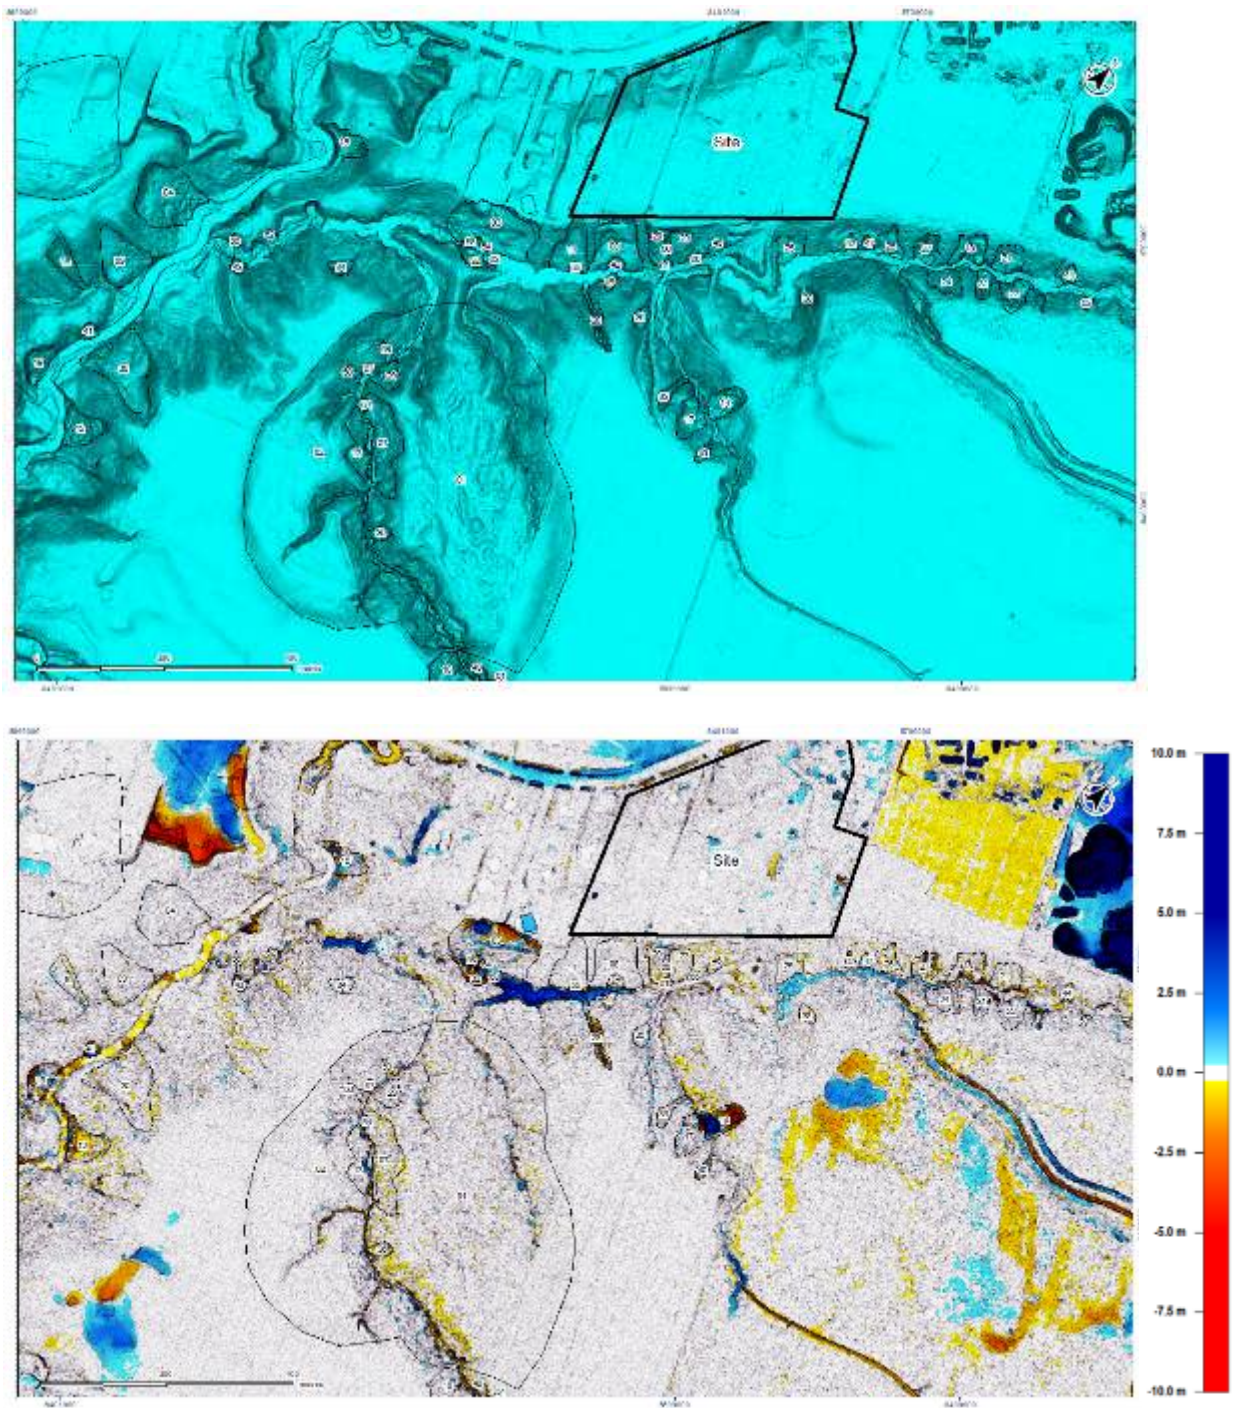
Figure 3-4 Overview of 2006-2019 LiDAR Change Detection

The availability of three distinct LiDAR dataset allowed for the identification of topographic changes within the Project Area. Visual representations of the DoD produced from comparing the 2006, 2014 and 2019 LiDAR DEMs are presented in Figure 3-4 to 3-6. On these figures, areas of positive elevation changes are shown in shades of blue, and areas of negative elevation changes are shown in shades of red and yellow.

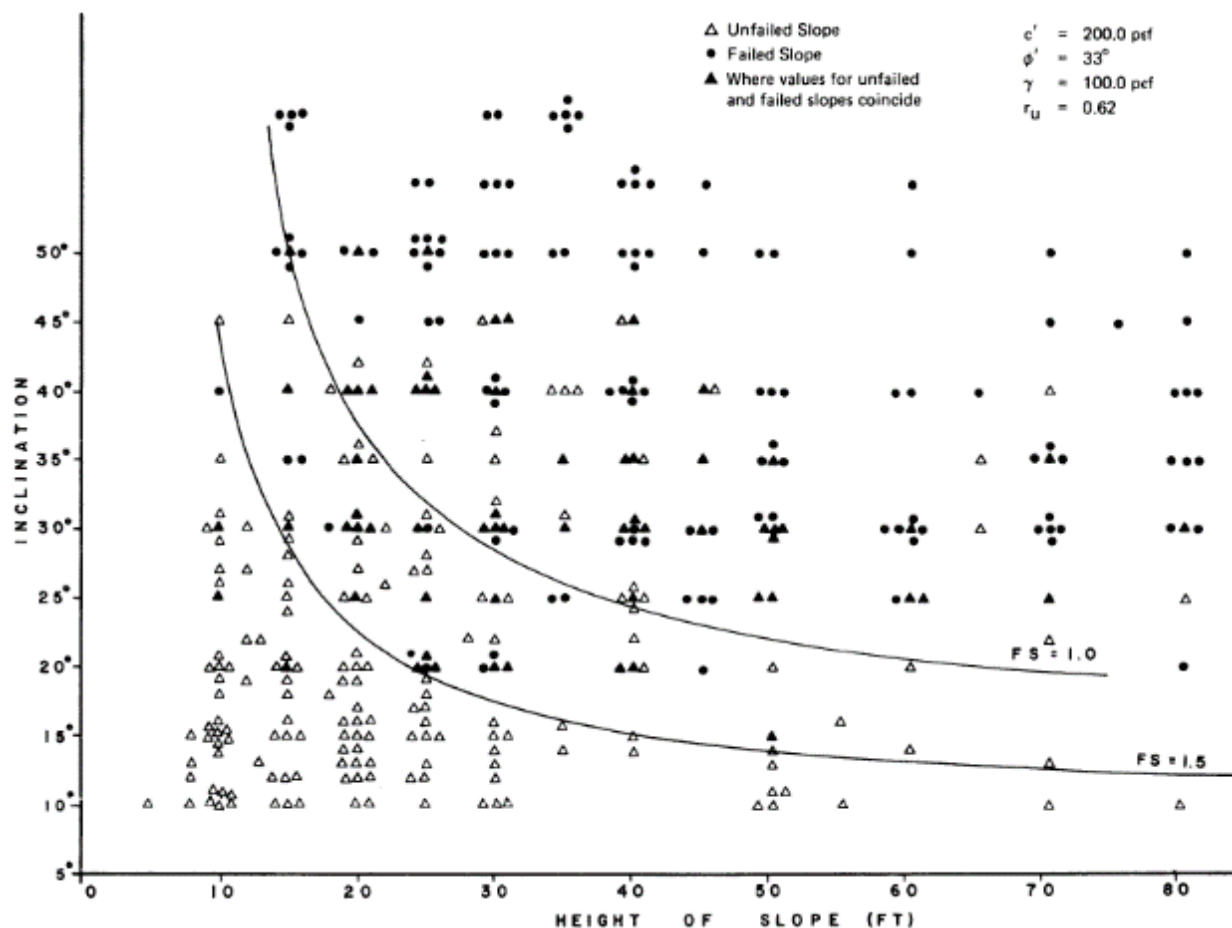
Figure 5-12 presents the unfailed versus failed slopes of 419 survey slopes in the field with calculated slope factor of safety. The factor of safety obtained from our effective stress analysis is within the reasonable range presented in this figure.

**Figure 5-12 Calculated FOS and 419 Survey Slopes in the Field (from Klugan and Chung 1976)**

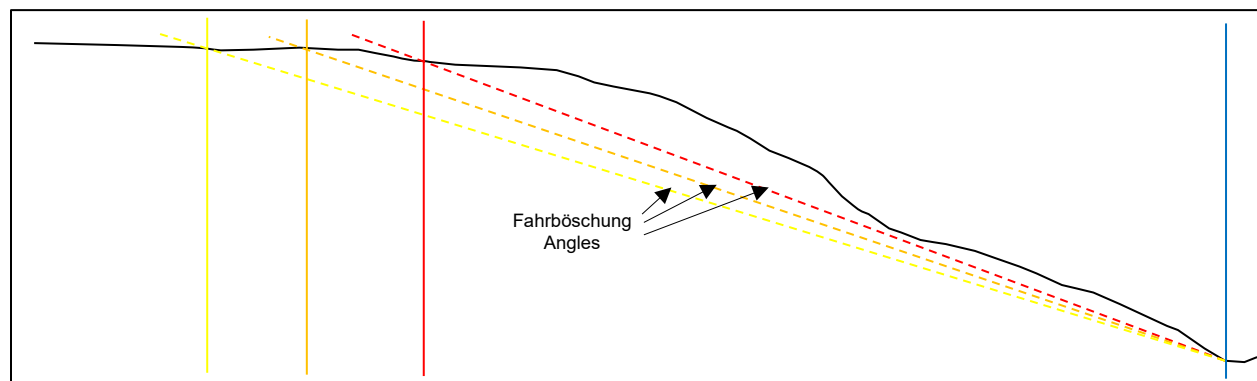
The Fahrböschung angle was calculated along 30 different cross sections, each separated from the others by a 100 m and established along the south-facing slope in a manner that accounted for topographic variation. A cross plane was then projected through each cross-section using the average calculated Fahrböschung angle of mapped landslides, from the toe to the crest of the slopes, along each cross sections. The locations were the projected plane daylighted on the upslope portion of the cross sections was used to delineate setback limits corresponding to different landslide return period. Refer to Figure 6-1 and Figure 6-2 for diagrams illustrating Fahrböschung angles calculated for the assessment.

**Figure 6-1** Fahrböschung angle of mapped landslides. Solid black line is the existing ground surface, vertical blue line is the toe of the slope, and the red, orange and yellow lines represent different Fahrböschung angles.

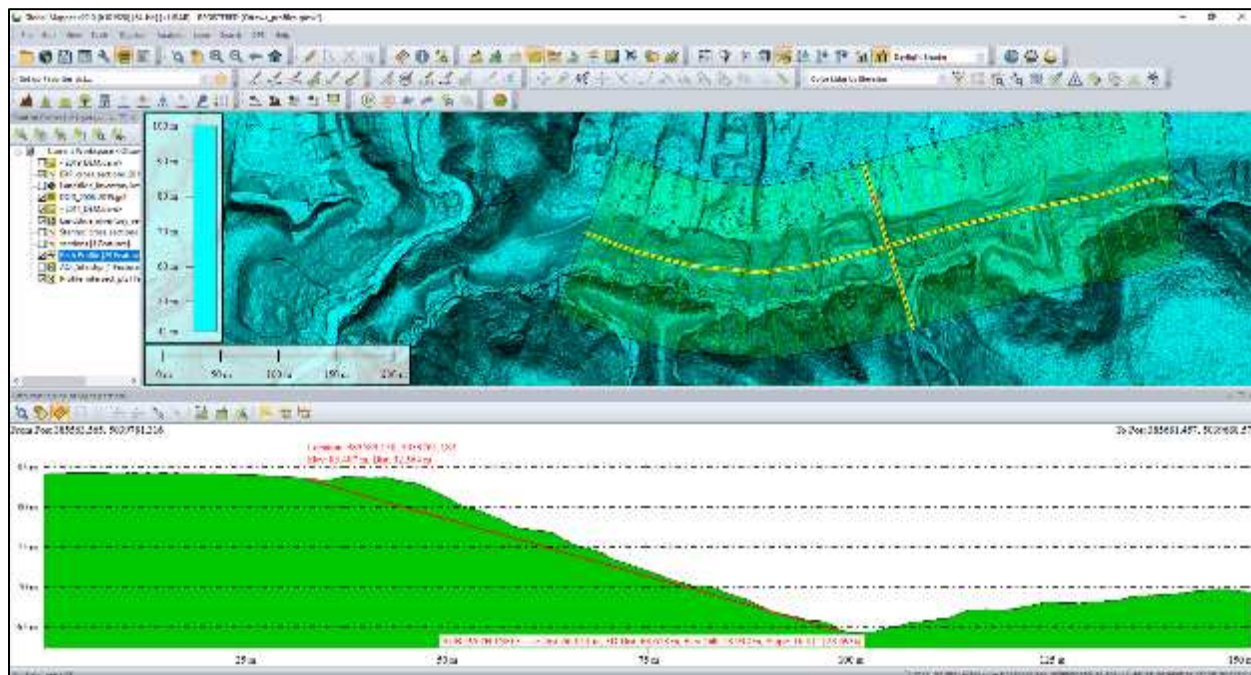
Figure 6-2 Cross Sections and Example of Setback Calculation

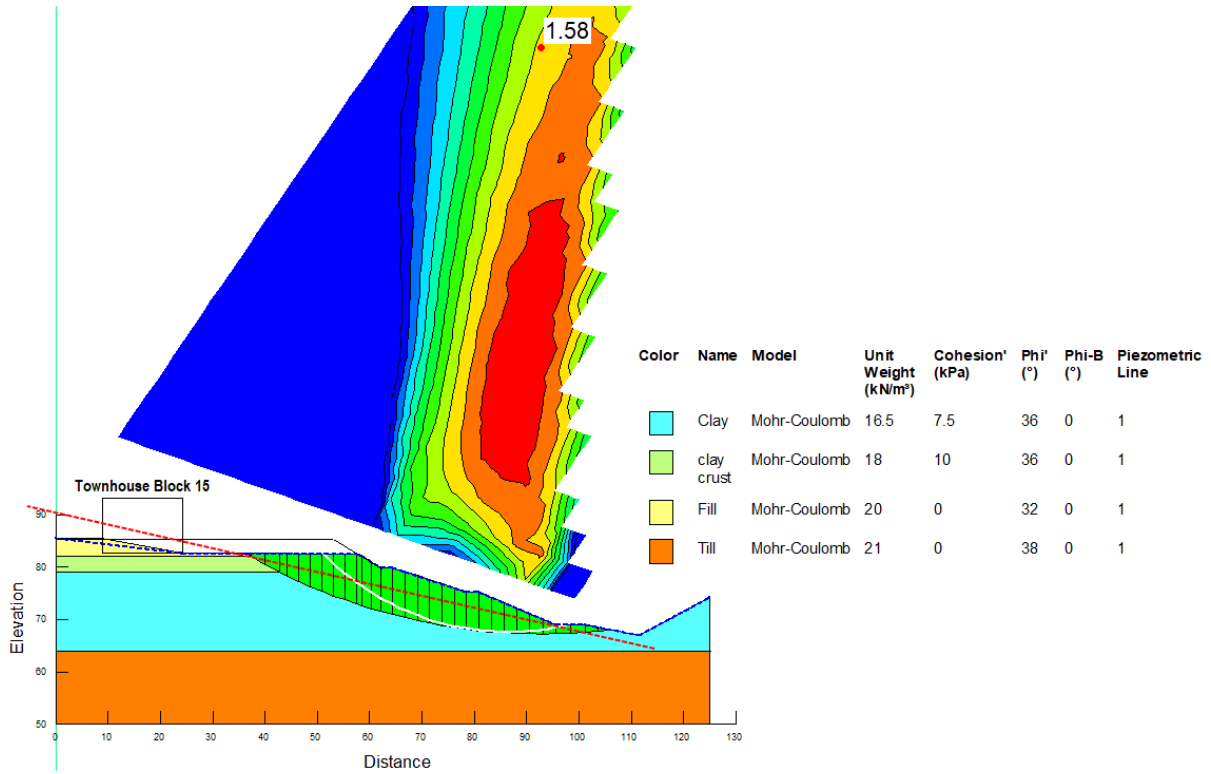
**Figure 6-5 Fahrböschung (13°) of the 1:10,000 return period event (FoS ~1.58)-Slope Profile 17 After 2.5 m Grade Lowering**

Due to the hazard zone impact to the development plan, the existing slope crest at planned townhouse blocks 15, 16 and 17 are proposed to be lowered by about 2.5 m (see conceptual macro grading plan in Appendix B). Based on the Fahrböschung line at 13° shown on the Figure 6-5, with the proposed grade lowering, the development plan may remain unchanged.

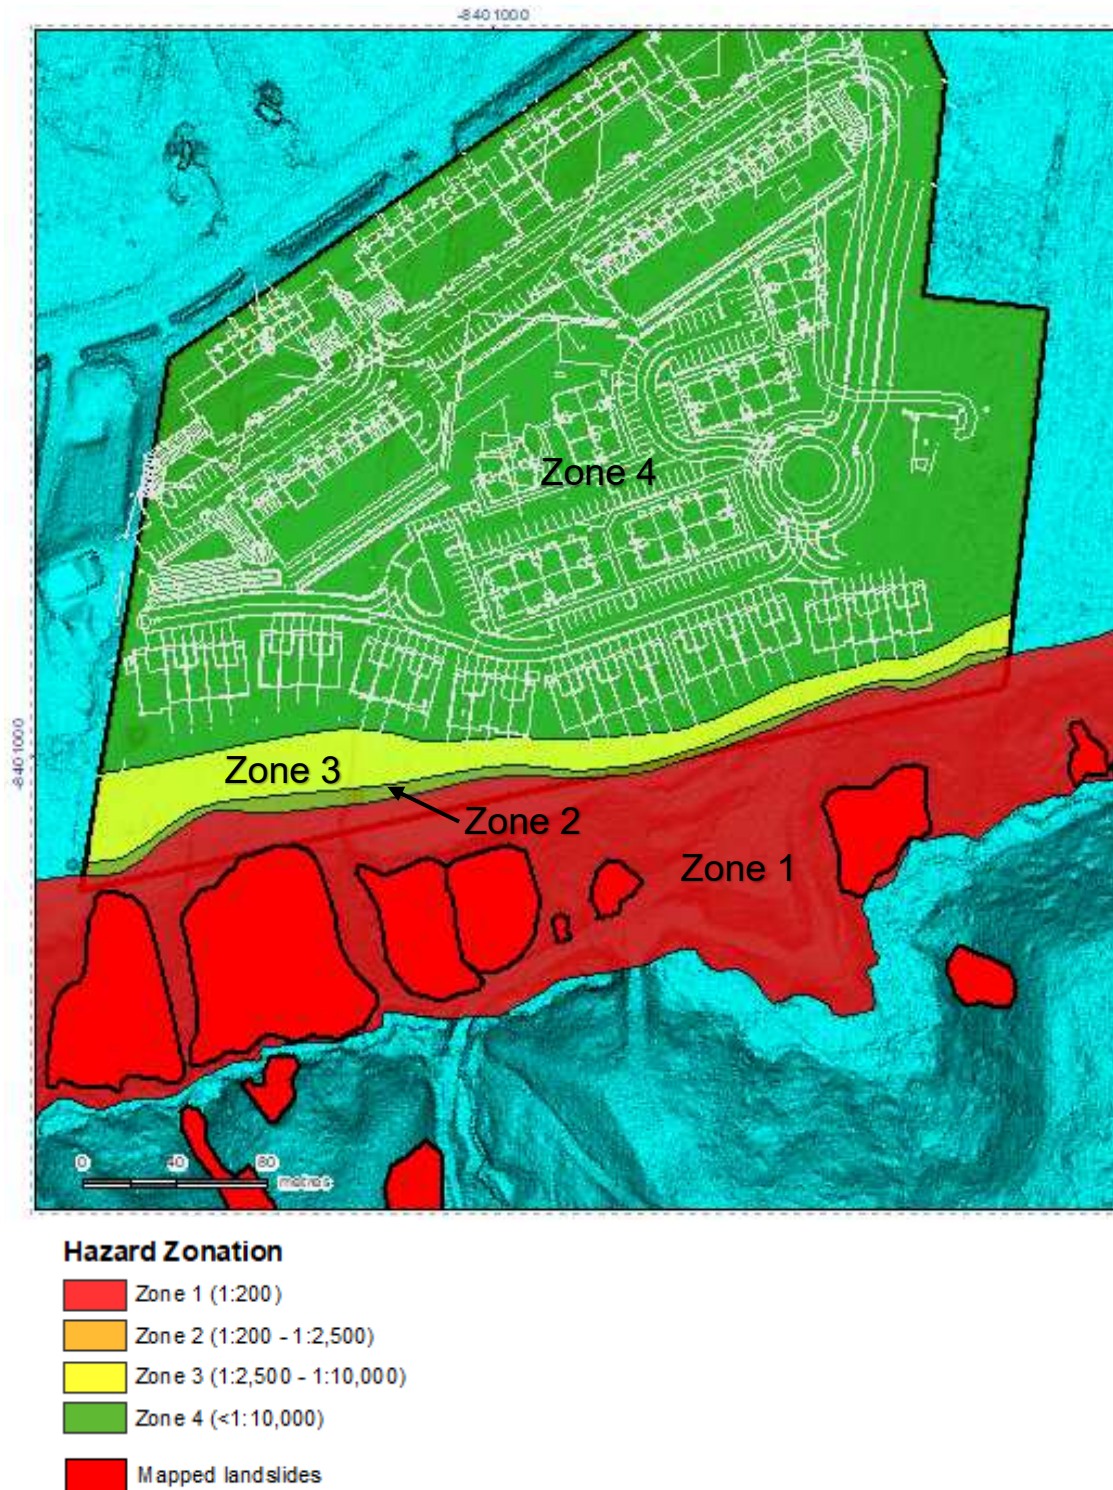
Figure 6-6 shows results of the hazards zonation overlain on the proposed development site plan.

Figure 6-6 Hazard Zonation
