3194 Jockvale Road Development Tree Conservation Report

December 2018
Prepared for Richcraft Homes Inc.

RE: Tree Conservation Report for the 3194 Jockvale Road Development

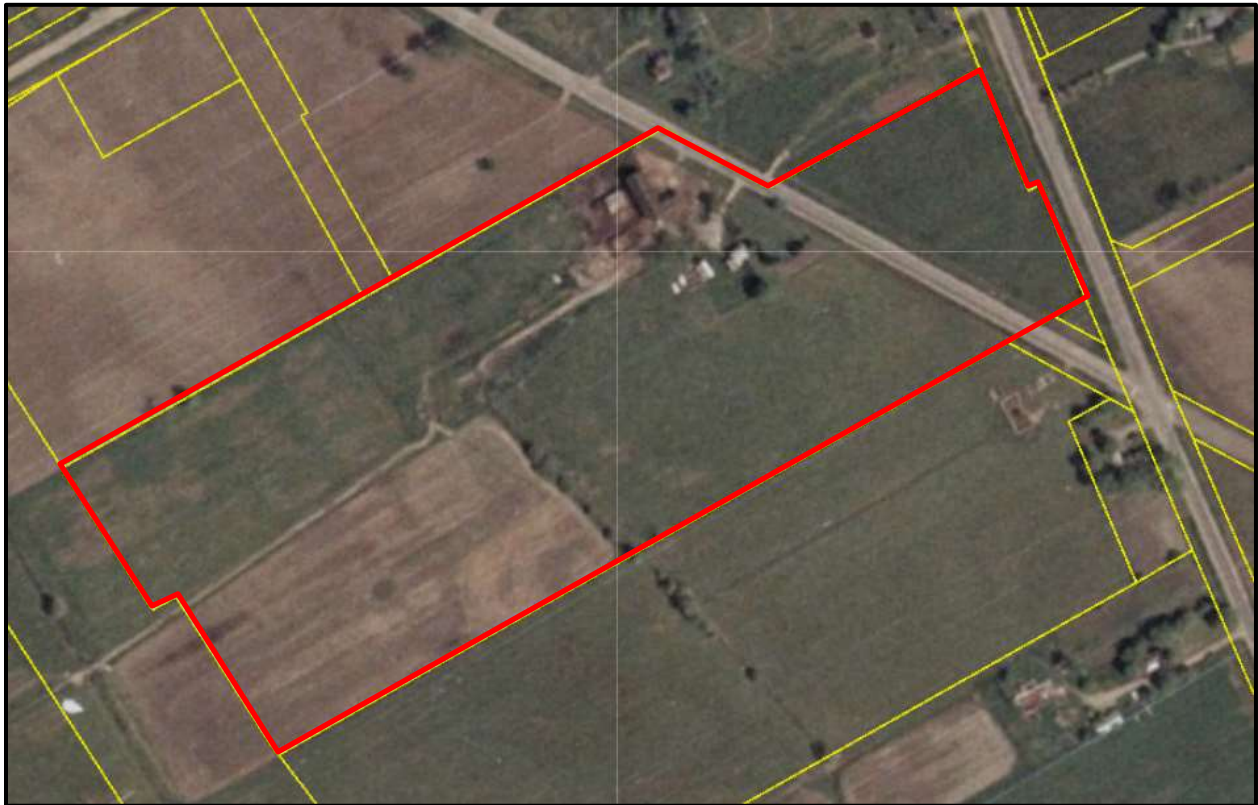
Historic Air Photograph 1: Historic Air Photo from 1976 (Site limits shown in red). Note the Site appears to be farmed. In 1976, there appears to be very little tree cover within the Site, with only a few young trees present in the southern part of the Site (Tree Stand M) and around the historic farmhouse (Photos from City of Ottawa 2018).

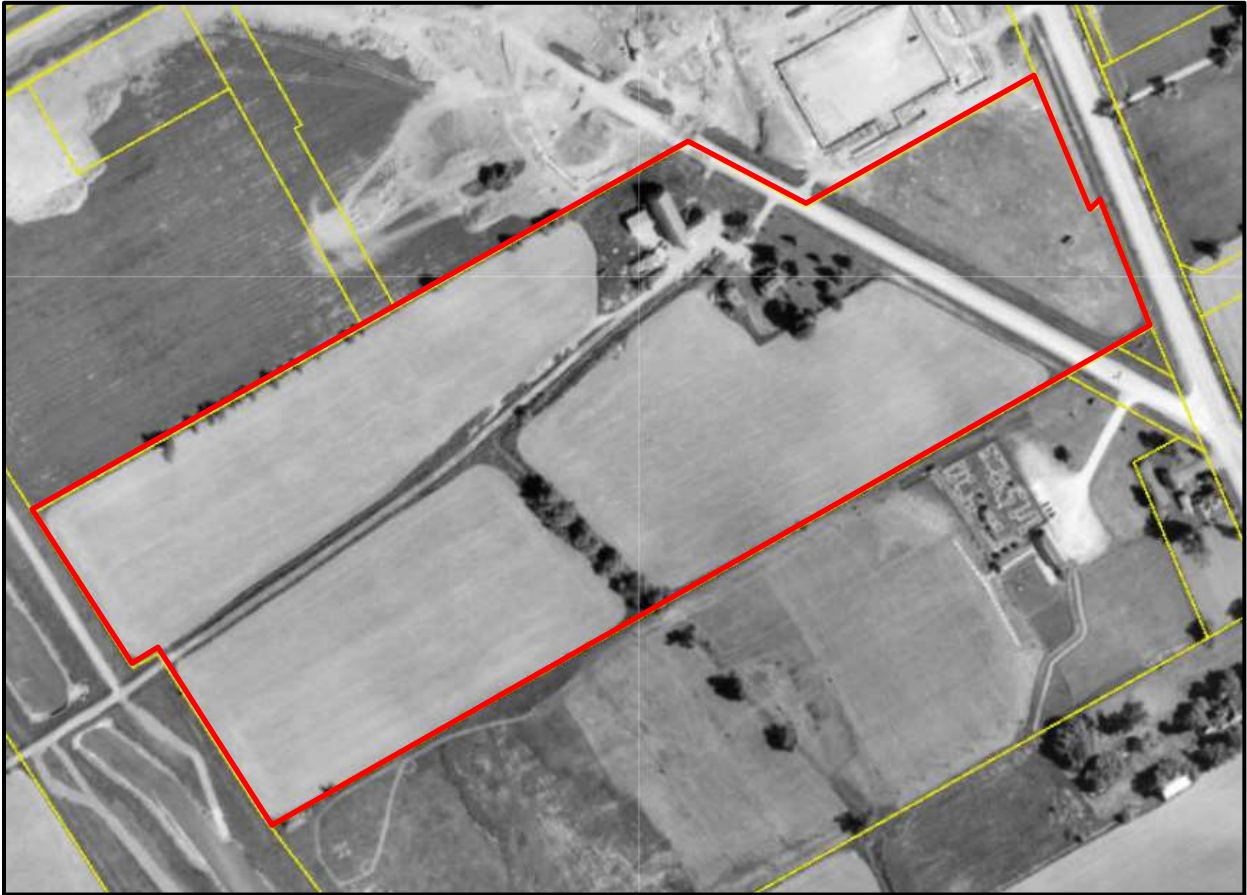
Historic Air Photograph 2: Historic Air Photo from 1991 (Site limits shown in red). Note the Site appears to be farmed in 1991. By 1991, trees found within the southern part of the Site (Tree Stand M) appear more mature, and additional stems are visible around the farmhouse (Photos from City of Ottawa 2018).

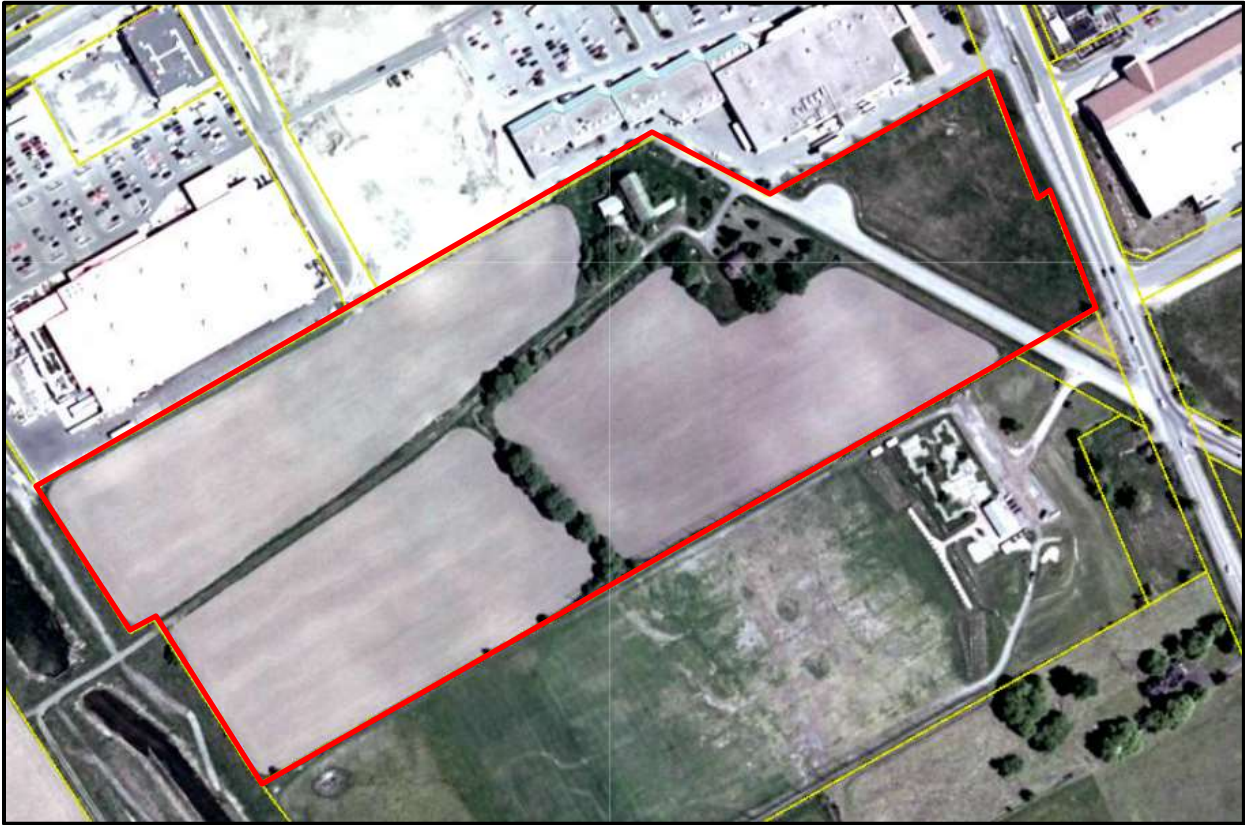
Historic Air Photograph 3: Historic Air Photo from 2005 (Site limits shown in red). Note the Site appears to be farmed in 2005. By 2005, the Deciduous Hedgerows (Tree Stand M) and the tree coverage surrounding the farmhouse have expanded. The farmhouse, barn, and other agricultural buildings that are visible within the historic air photos were demolished sometime after 2005 (Photos from City of Ottawa 2018).
