# Marlborough Creek Meander Belt Width Delineation

**6038 Ottawa Street**  
City of Ottawa (Richmond), Ontario

March 10, 2025

GEO Morphix Project No. 25011

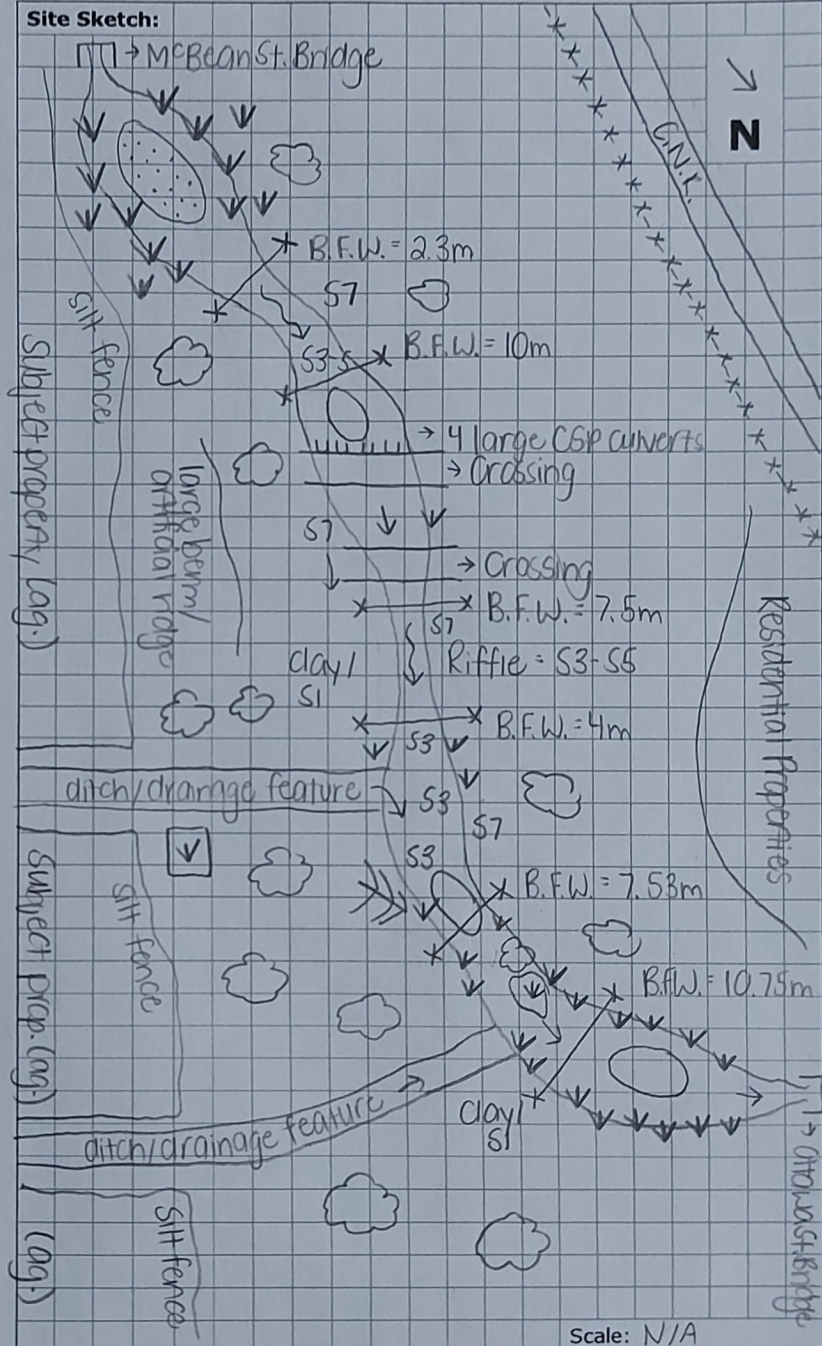
## Site Sketch:

Additional Notes:  $\rightarrow$  [v] = Stand of dominant wild parsnip/hogweed $\rightarrow$  Several large boulders within channel, along banks, and within the floodplain $\rightarrow$  Good connectivity between channel + floodplain
