Fluvial Geomorphological and Erosion Threshold Assessment, Tributary of Cardinal Creek

1296 and 1400 Old Montreal Road
City of Ottawa, Ontario

Submitted:
November 11, 2024

GEO Morphix Project No. 23076

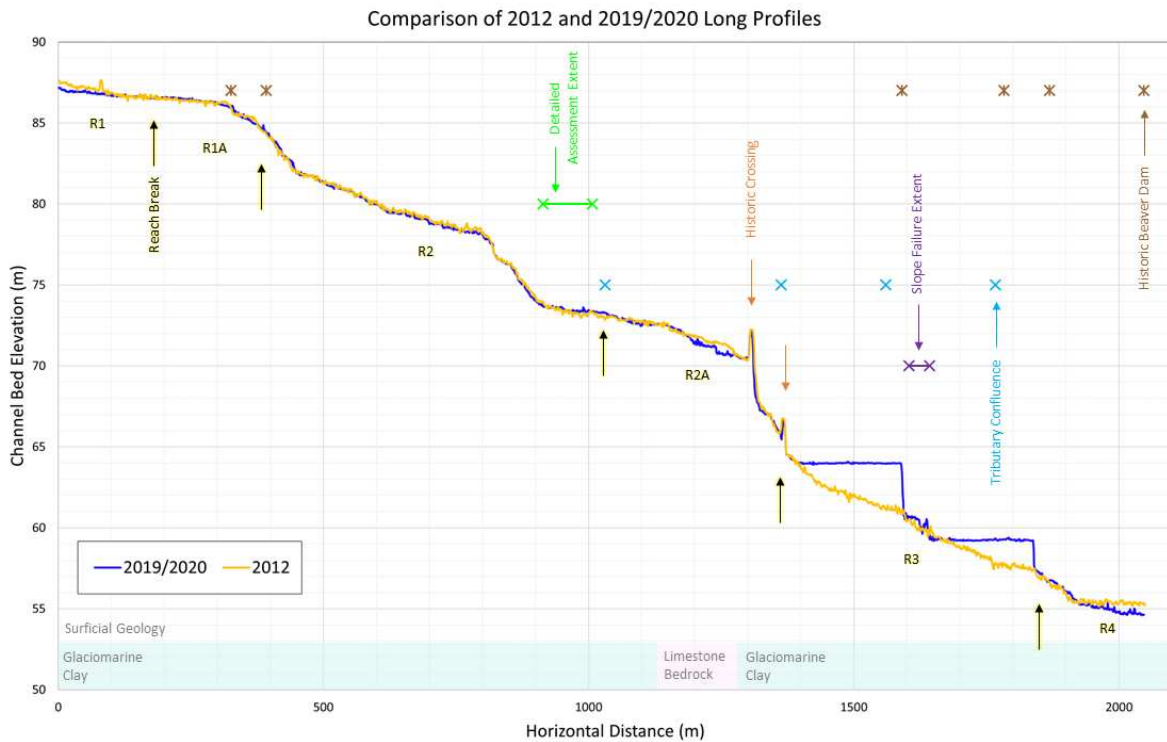
Figure 1: Comparison of 2012 and 2019/2020 South Tributary Long Profiles

The comparison of longitudinal profiles from 2012 (yellow) and 2019/2020 (blue) in **Figure 1** below reveals several changes in channel bed gradient and profile during the intervening period. The locations of reach breaks, surficial geology, detailed assessment, tributary confluences, historical crossings and beaver dams, and the extent of the recent slope failure are also overlaid on the long profiles. Along the length of the subject lands, the elevation of the South tributary drops approximately 32 m over a distance of approximately 2000 m (average channel gradient 1.6%). The long profile for the South Tributary is punctuated by several prominent slope breaks with localized sub-reach scale channel gradients of up to 4%. The longitudinal profiles are generally consistent between the 2012 and 2019/2020 elevation data, with the exception of the significant (2-3m) elevation increases observed at the location of the beaver dams. Surficial geology along the watercourse is largely dominated by glaciomarine clay, with a short section of limestone bedrock outcropping at the downstream end of Reach R2A near the first historic channel crossing. The long profiles are described below reach by reach.

Reach R4 begins downstream of a beaver dam. There is a slope break around 1900 m, after which the gradient decreases in both the 2012 and 2019/2020 profiles. The 2012 profile shows a backwatered section upstream of the confluence with Cardinal Creek.

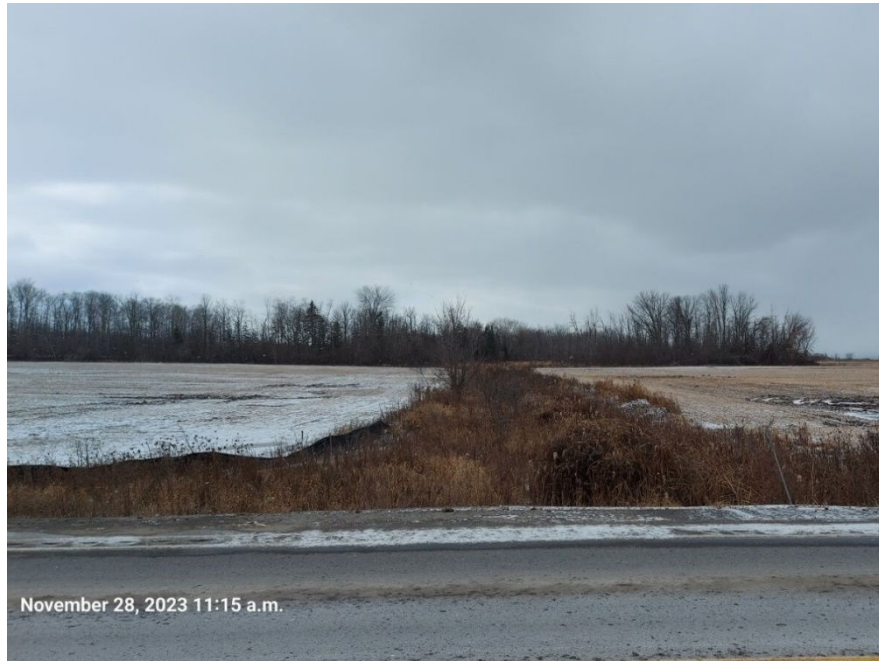
Photo 1
Tributary of Cardinal Creek
Reach: R1

Photograph taken facing downstream at the most upstream extent of **R1**. The straightened channel flows through an active agricultural field.

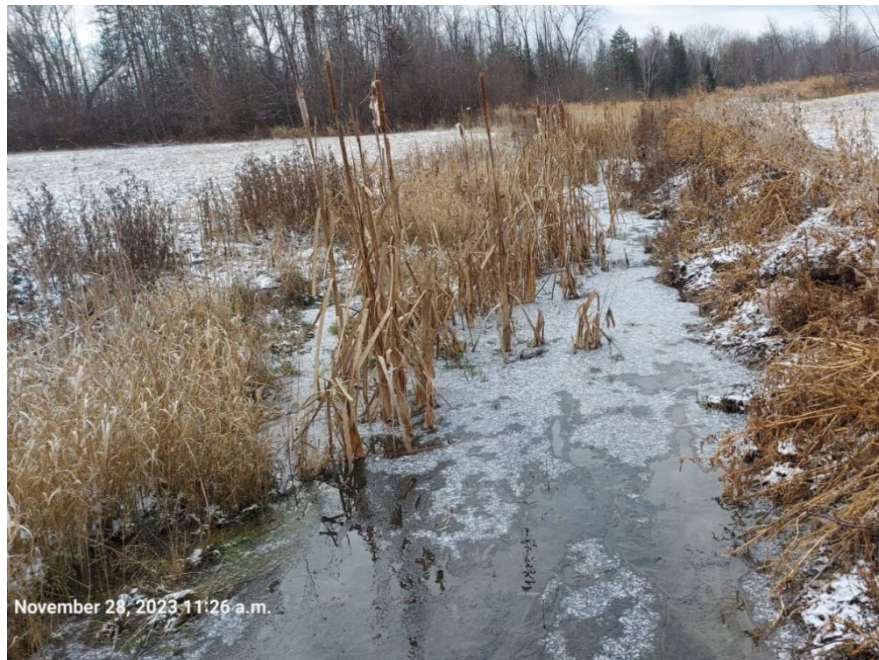
Photo 2
Tributary of Cardinal Creek
Reach: R1

Photograph taken facing downstream along **R1**. The riparian buffer between the fields and the channel was narrow and composed of grasses and herbaceous vegetation. Vegetation encroachment was major.

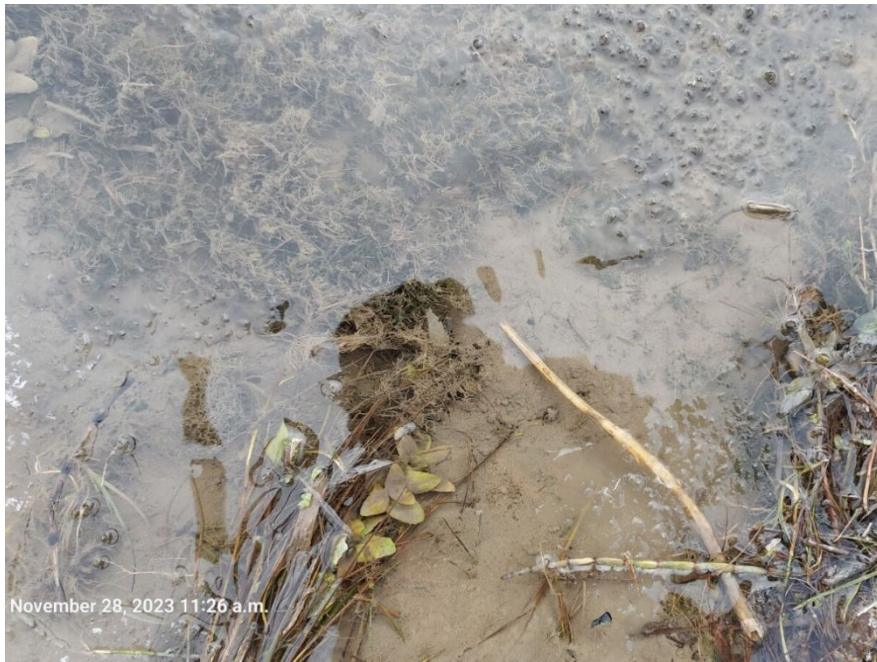
Photo 3
Tributary of Cardinal Creek
Reach: R1

Photograph taken facing the channel bed at **R1**. The bed and banks were composed of compact silt. Instream vegetation covered approximately 60-80% of the reach.

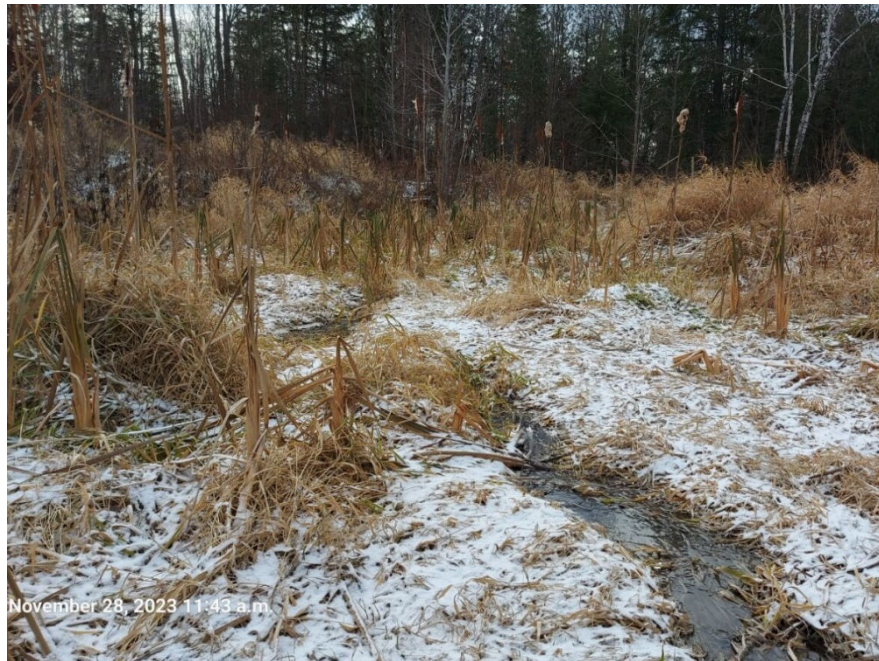
Photo 6
Tributary of Cardinal Creek
Reach: R1A

Photograph taken facing downstream along **R1A**. Along the downstream extent, the channel gains definition. The riparian vegetation was predominantly grasses and trees along the border of the floodplain.

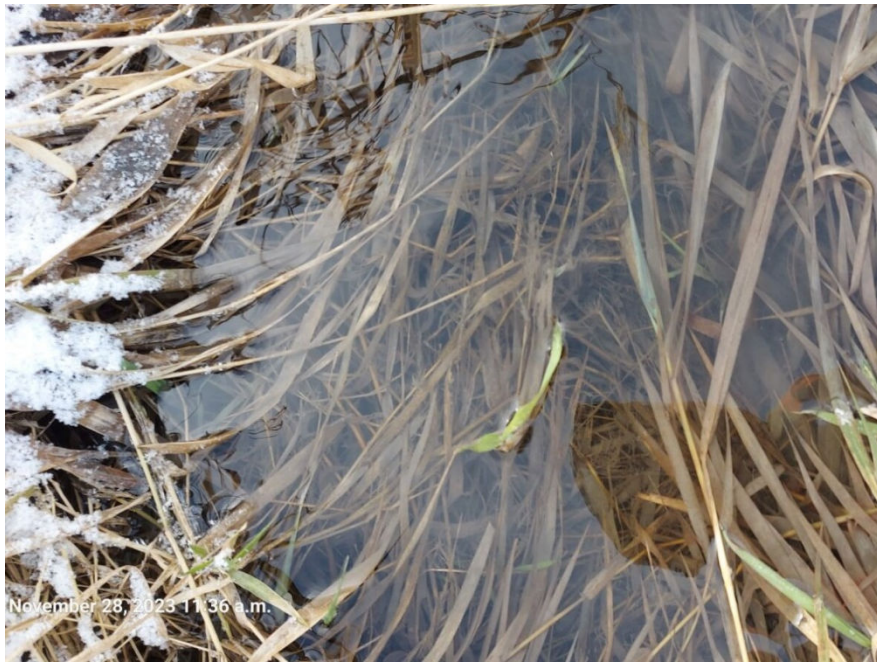
Photo 7
Tributary of Cardinal Creek
Reach: R1A

Photograph taken facing the channel bed along reach **R1A**. The channel was heavily encroached throughout the reach. Bed substrates were composed of compact silt.

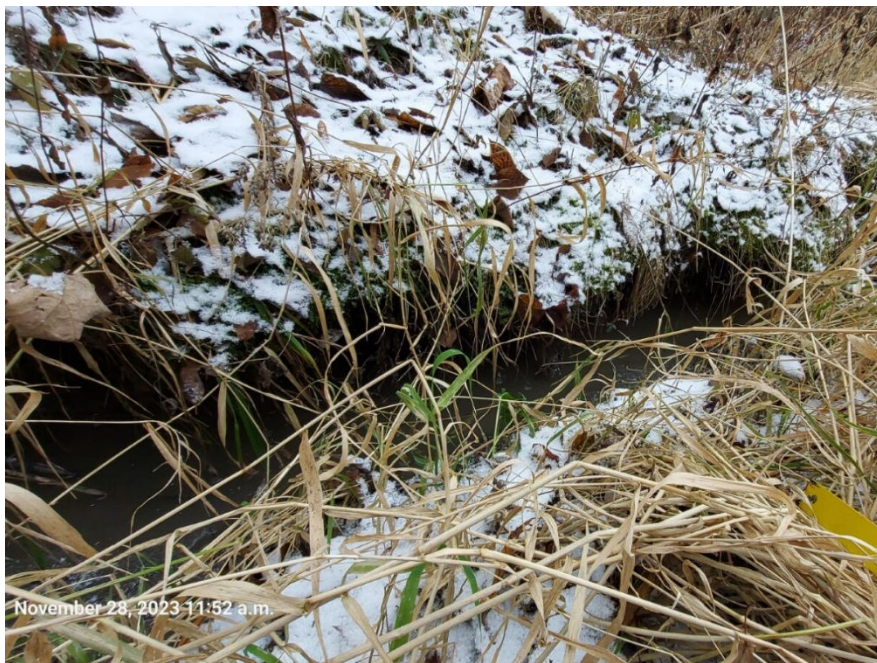
Photo 8
Tributary of Cardinal Creek
Reach: R1A

Photograph taken at the downstream extent of **R1A**. An old historic beaver dam was identified on the left bank and was undercut (0.55m).

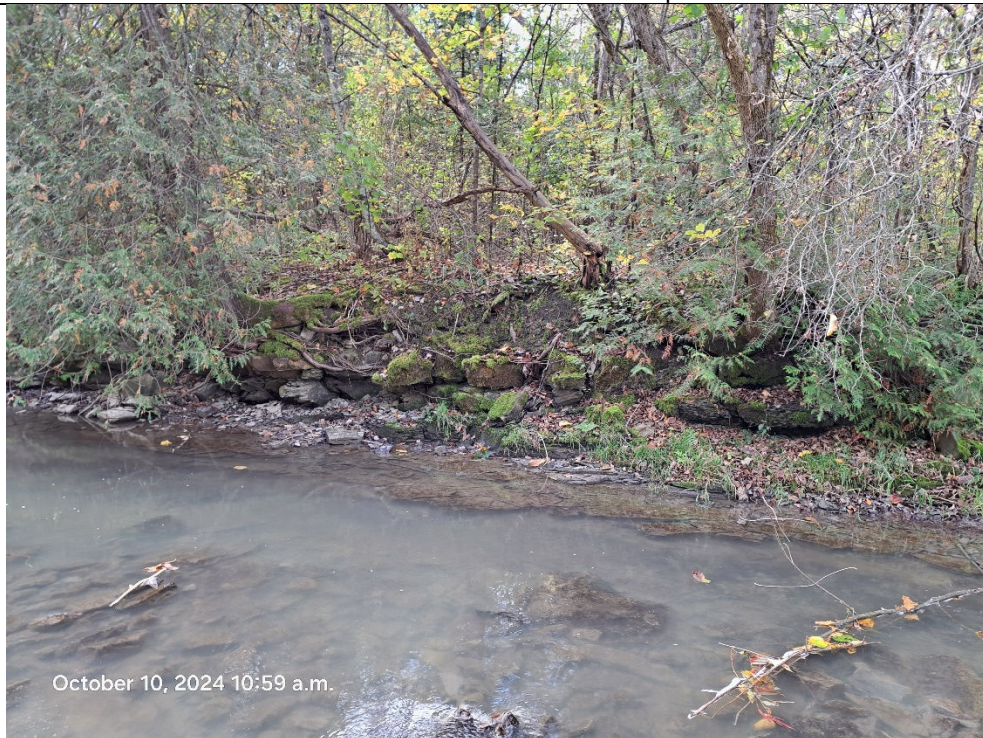
Photo 42
Tributary of Cardinal Creek
Reach: C10

Photograph taken facing the left bank near cross-section 6. Bank materials consisted of clayey and sandy soils containing gravel deposits, with exposed local calciferous bedrock.

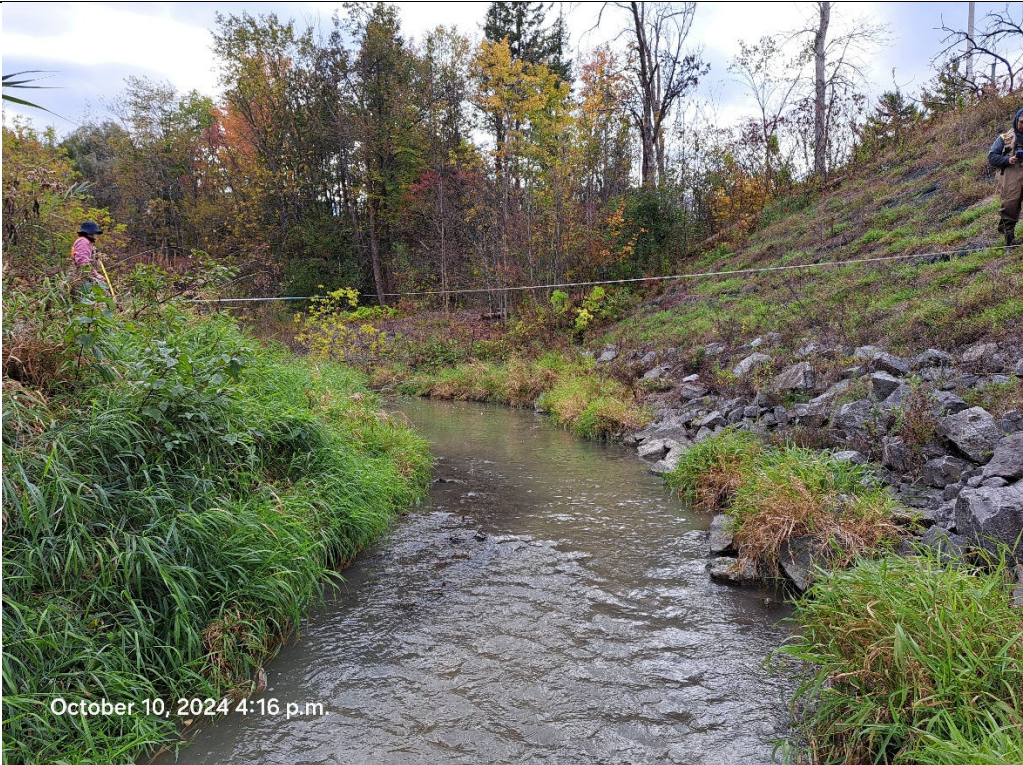
<p>Photograph taken facing upstream at cross-section 10. Slope stabilization works are evident along the left bank, which comprised the embankment of Old Montreal Road.</p>

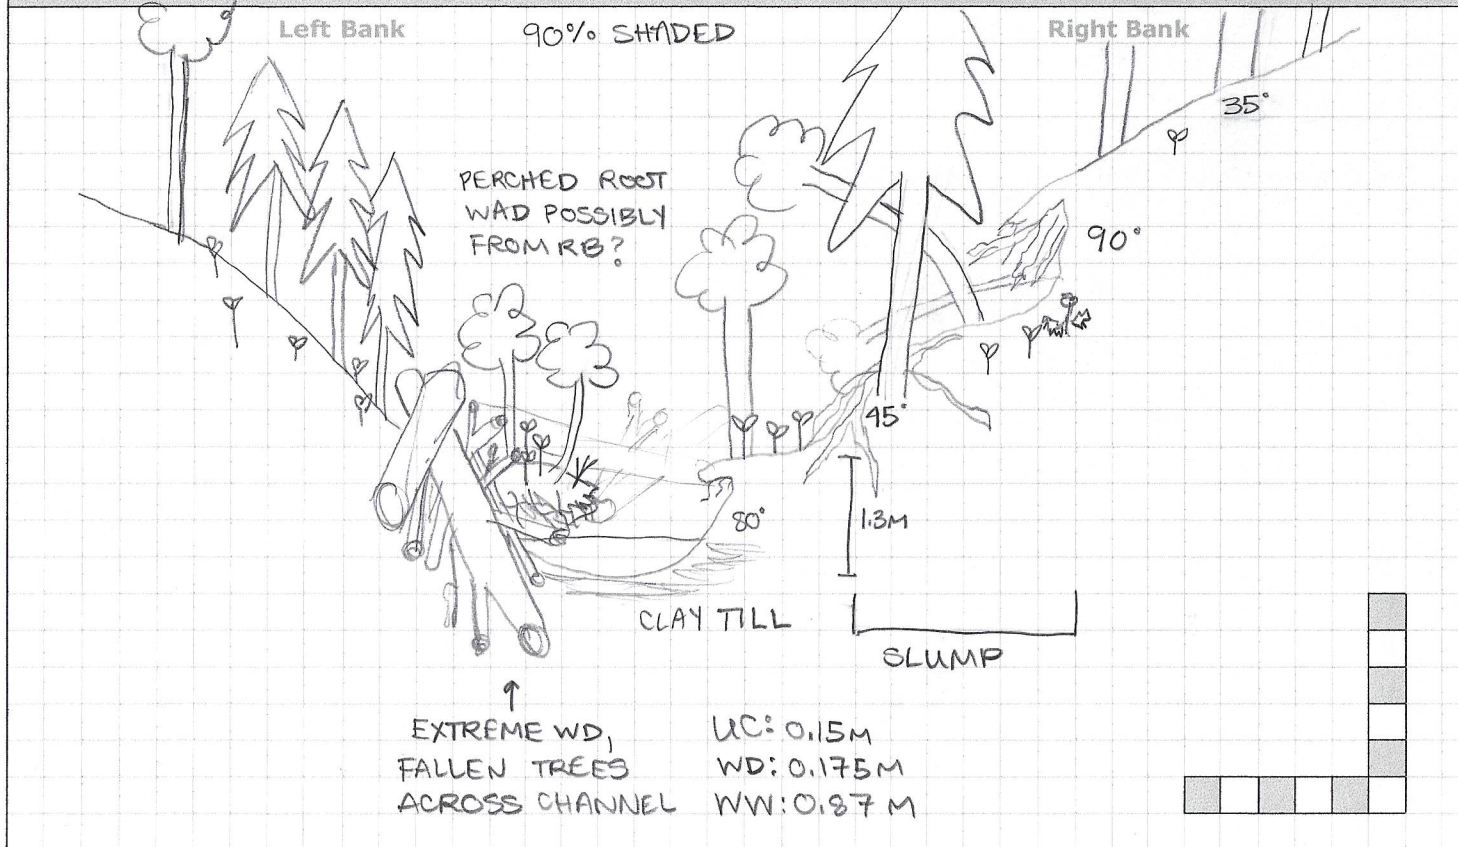
Geomorphic Unit (Table 22)
<input type="checkbox"/> Riffle <input type="checkbox"/> Run <input checked="" type="checkbox"/> Pool <input type="checkbox"/> None
Type of Bank Failure (Table 14)
<input type="checkbox"/> Fluvial entrainment <input type="checkbox"/> Fall/slough <input type="checkbox"/> Undercutting <input type="checkbox"/> Parallel slide <input type="checkbox"/> Slab failure <input checked="" type="checkbox"/> Rotation slip and slump
Adjacent Infrastructure
<input type="checkbox"/> Utilities <input type="checkbox"/> Parking lot <input checked="" type="checkbox"/> Building <input type="checkbox"/> Pathway <input type="checkbox"/> Road <input type="checkbox"/> Bridge footing <input type="checkbox"/> Other: _____
Distance from TOB (m): _____
Notes: HOUSE ON TABLE LAND ADJACENT TO RB VALLEY WALL NO ALLUVIAL STRATA OBS. BED CLAY TILL TILL CLAY BANK BASE CLAY TILL MANY EXPOSED ROOTS, FALLEN + LEANING TREES

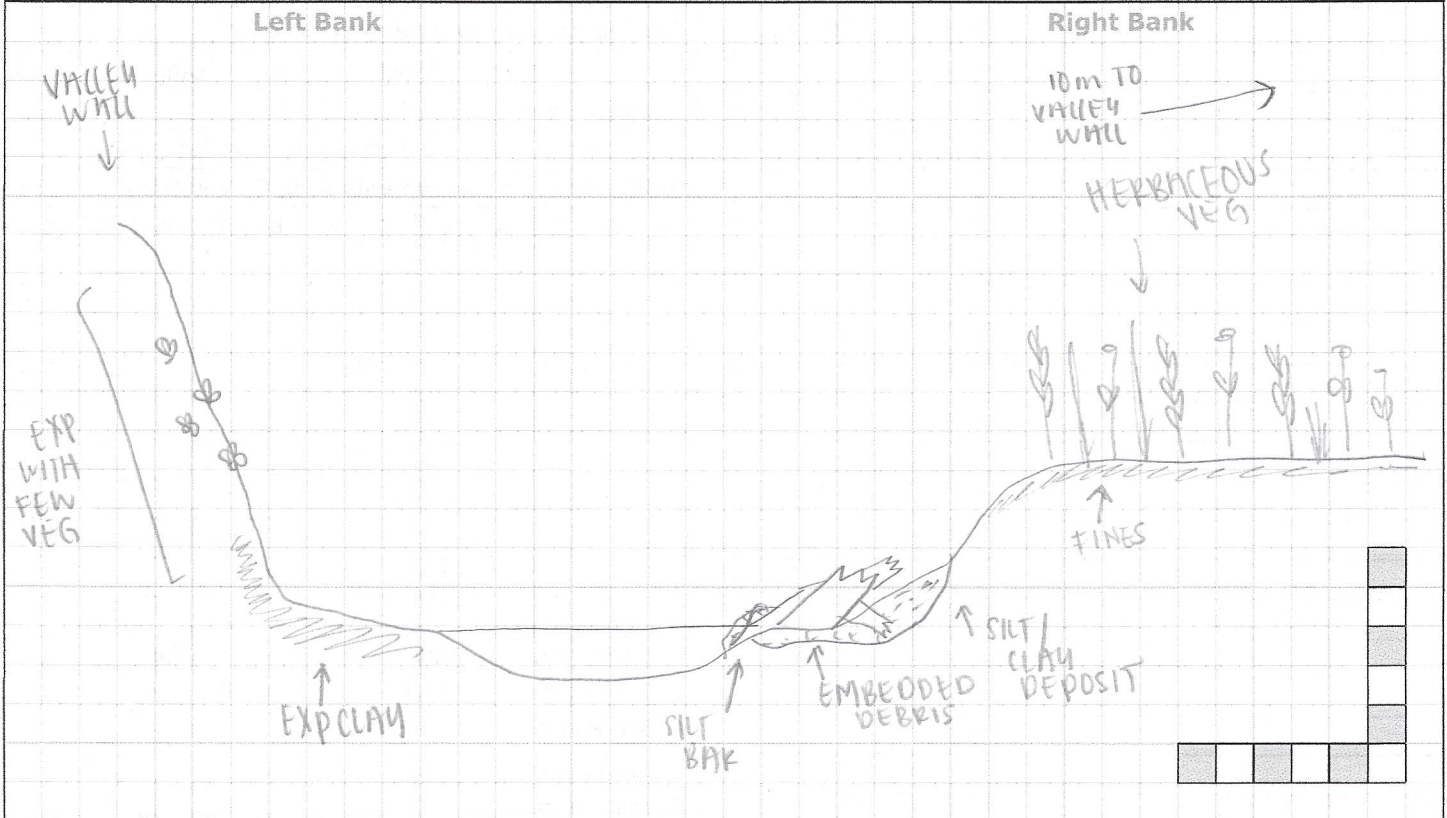
Date:	2024-08-06	Cross-section:	X51
Time:	11:13am	Reach:	R3
Weather:	SUN 25°C	Location:	ORLEANS
Field Staff:	KM HM	Watershed/Subwatershed:	CARDINAL CREEK

Left Bank Materials		Features		Right Bank Materials	
<input type="checkbox"/> Bedrock	<input type="checkbox"/> Gravel	<input checked="" type="checkbox"/> Station location	<input type="checkbox"/> Bedrock	<input type="checkbox"/> Gravel	<input type="checkbox"/> Bedrock
<input type="checkbox"/> Till	<input type="checkbox"/> Small Cobble	<input type="checkbox"/> Monumented XS	<input type="checkbox"/> Till	<input type="checkbox"/> Small Cobble	<input type="checkbox"/> Till
<input checked="" type="checkbox"/> Clay	<input type="checkbox"/> Large Cobble	<input checked="" type="checkbox"/> Monumented photo	<input checked="" type="checkbox"/> Clay	<input type="checkbox"/> Large Cobble	<input checked="" type="checkbox"/> Clay
<input checked="" type="checkbox"/> Silt	<input type="checkbox"/> Small Boulder	<input type="checkbox"/> Undercut bank	<input checked="" type="checkbox"/> Silt	<input type="checkbox"/> Small Boulder	<input checked="" type="checkbox"/> Silt

<input type="checkbox"/> Sand	<input type="checkbox"/> Large Boulder	<input type="checkbox"/> Eroded bank/slope	<input type="checkbox"/> Sand	<input type="checkbox"/> Large Boulder	<input type="checkbox"/> Sand
Bank Height: <u>0.85</u> m		<input checked="" type="checkbox"/> Bank stabilization	Bank Height: <u>0.55</u> m		
Bank Angle: <u>30</u> °		<input type="checkbox"/> Fence	Bank Angle: <u>40</u> °		
Root Depth: <u>0.16</u> m		<input checked="" type="checkbox"/> Grasses	Root Depth: <u>0.07</u> m		
Root Density: <u>S</u> %		<input checked="" type="checkbox"/> Leaning tree	Root Density: <u>NO</u> %		
Undercut: <u>NO</u> m		<input type="checkbox"/> Tree	Undercut: <u>NO</u> m		
Erosion Pin: <u>N/A</u> m		<input checked="" type="checkbox"/> Woody Debris	Erosion Pin: <u>N/A</u> m		
Torvane: <u>1.5</u> kg/cm ²		<input type="checkbox"/> Sediment sample	Torvane: <u>0.5</u> kg/cm ²		
Penetrometer: <u>1.5</u> kg/cm ²		<input type="checkbox"/> Erosion pin	Penetrometer: <u>0.75</u> kg/cm ²

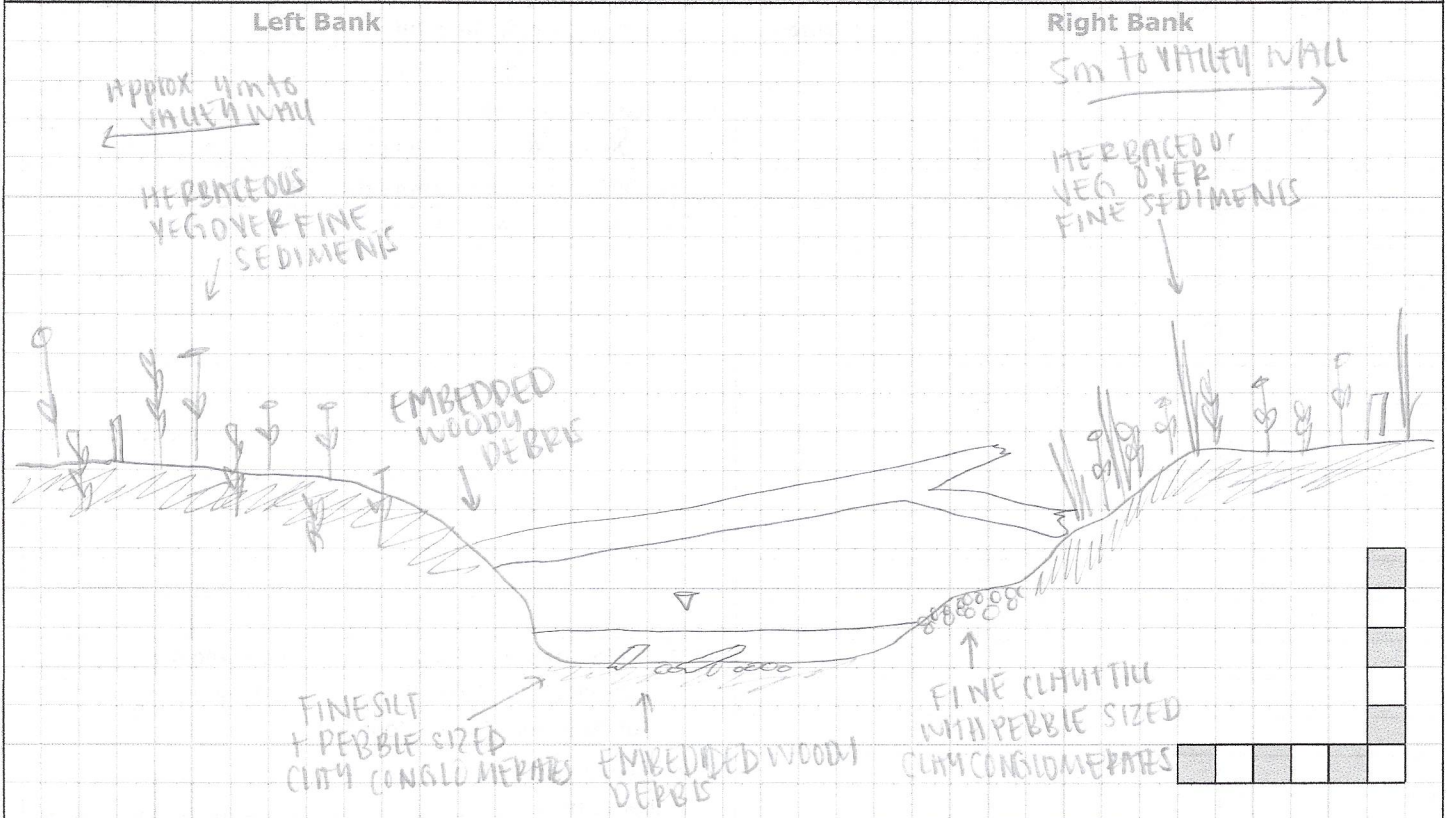
Date:	<u>2024-08-06</u>	Cross-section:	<u>XS2</u>
Time:	<u>11:35am</u>	Reach:	<u>R3</u>
Weather:	<u>SUN 25°C</u>	Location:	<u>ORLEANS</u>
Field Staff:	<u>KM HM</u>	Watershed/Subwatershed:	<u>CARDINAL CREEK</u>

Left Bank Materials		Features		Right Bank Materials	
<input type="checkbox"/> Bedrock	<input type="checkbox"/> Gravel	<input checked="" type="checkbox"/> Station location		<input type="checkbox"/> Bedrock	<input type="checkbox"/> Gravel
<input type="checkbox"/> Till	<input type="checkbox"/> Small Cobble	<input type="checkbox"/> Monumented XS		<input type="checkbox"/> Till	<input type="checkbox"/> Small Cobble
<input checked="" type="checkbox"/> Clay	<input type="checkbox"/> Large Cobble	<input checked="" type="checkbox"/> Monumented photo		<input checked="" type="checkbox"/> Clay	<input type="checkbox"/> Large Cobble
<input checked="" type="checkbox"/> Silt	<input type="checkbox"/> Small Boulder	-----	Undercut bank	<input checked="" type="checkbox"/> Silt	<input type="checkbox"/> Small Boulder
<input type="checkbox"/> Sand	<input type="checkbox"/> Large Boulder	#####	Eroded bank/slope	<input type="checkbox"/> Sand	<input type="checkbox"/> Large Boulder

Bank Height: <u>0.70</u> m		XXXXX	Bank stabilization	Bank Height: <u>0.45</u> m	
Bank Angle: <u>45</u> °		x--x-x	Fence	Bank Angle: <u>25</u> °	
Root Depth: <u>0.11</u> m		VVVV	Grasses	Root Depth: <u>0.10</u> m	
Root Density: <u>35</u> %		↘↘↘	Leaning tree	Root Density: <u>15</u> %	
Undercut: <u>0.05</u> m		☁	Tree	Undercut: <u>NO</u> m	
Erosion Pin: <u>NO</u> m		* * *	Woody Debris	Erosion Pin: <u>N/A</u> m	
Torvane: <u>0.150</u> kg/cm ²		☐	Sediment sample	Torvane: <u>10</u> kg/cm ²	
Penetrometer: <u>0.50</u> kg/cm ²			Erosion pin	Penetrometer: <u>10</u> kg/cm ²	
Foot Used: <input type="checkbox"/> Yes <input checked="" type="checkbox"/> No		0	Scour/bed chain	Foot Used: <input type="checkbox"/> Yes <input checked="" type="checkbox"/> No

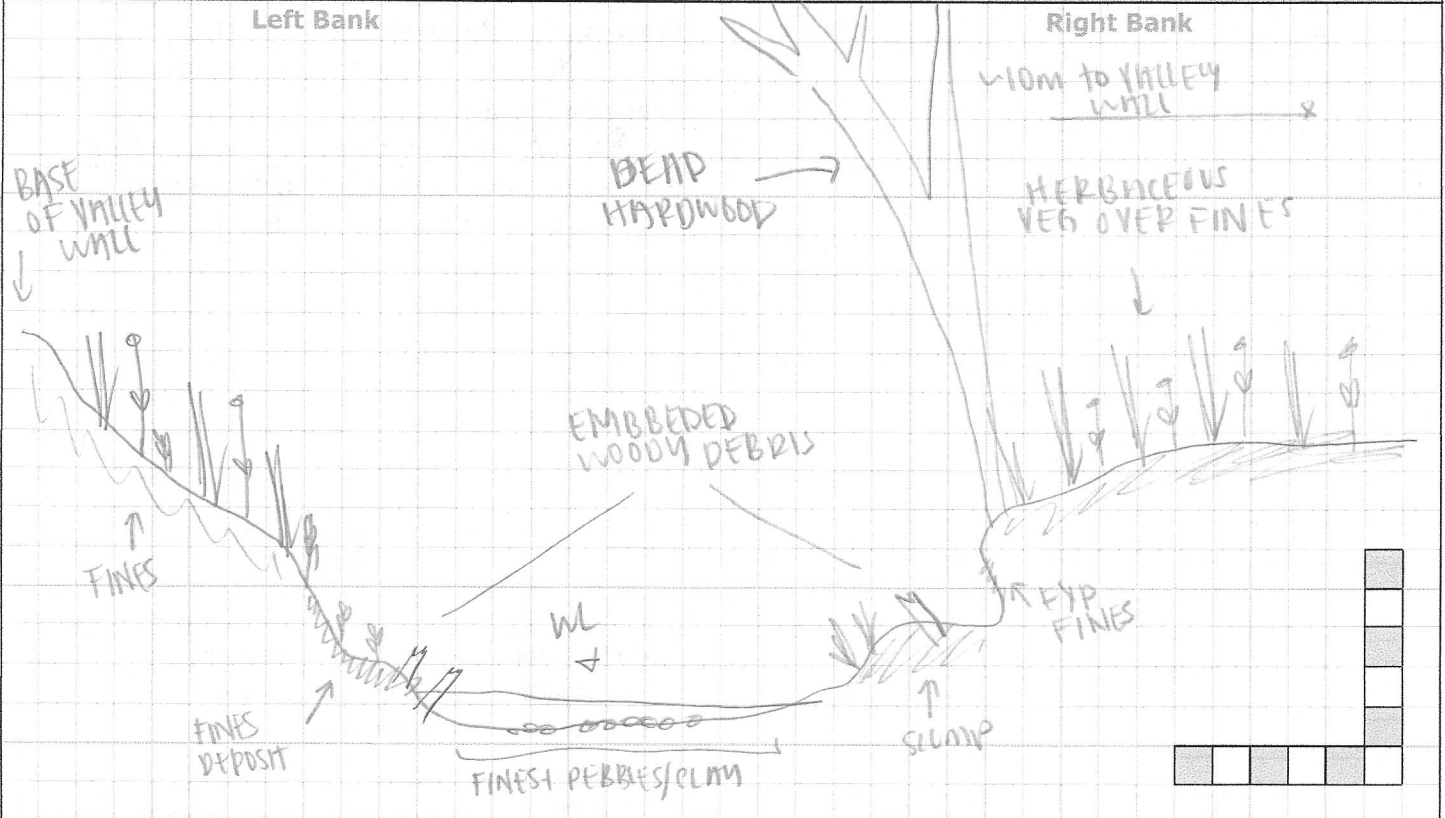
Date:	<u>2024-08-06</u>	Cross-section:	<u>XS3</u>
Time:	<u>11:46am</u>	Reach:	<u>R3</u>
Weather:	<u>SUN 25°C</u>	Location:	<u>ORLEANS</u>
Field Staff:	<u>KM HM</u>	Watershed/Subwatershed:	<u>CARDINAL CREEK</u>

Left Bank Materials		Features		Right Bank Materials	
<input type="checkbox"/> Bedrock	<input type="checkbox"/> Gravel	<input checked="" type="checkbox"/> Station location	<input type="checkbox"/> Bedrock	<input type="checkbox"/> Gravel	
<input type="checkbox"/> Till	<input type="checkbox"/> Small Cobble	<input type="checkbox"/> Monumented XS	<input type="checkbox"/> Till	<input type="checkbox"/> Small Cobble	
<input checked="" type="checkbox"/> Clay	<input type="checkbox"/> Large Cobble	<input type="checkbox"/> Monumented photo	<input type="checkbox"/> Clay	<input type="checkbox"/> Large Cobble	
<input type="checkbox"/> Silt	<input type="checkbox"/> Small Boulder	<input type="checkbox"/> Undercut bank	<input type="checkbox"/> Silt	<input type="checkbox"/> Small Boulder	
<input type="checkbox"/> Sand	<input type="checkbox"/> Large Boulder	<input type="checkbox"/> Eroded bank/slope	<input type="checkbox"/> Sand	<input type="checkbox"/> Large Boulder

Bank Height: <u>0.85</u> m		<input checked="" type="checkbox"/> Bank stabilization	Bank Height: <u>0.55</u> m		
Bank Angle: <u>30</u> °		<input type="checkbox"/> Fence	Bank Angle: <u>25</u> °		
Root Depth: <u>0.07</u> m		<input type="checkbox"/> Grasses	Root Depth: <u>0.11</u> m		
Root Density: <u>10</u> %		<input type="checkbox"/> Leaning tree	Root Density: <u>30</u> %		
Undercut: <u>NO</u> m		<input type="checkbox"/> Tree	Undercut: <u>0.28</u> m		
Erosion Pin: <u>N/A</u> m		<input type="checkbox"/> Woody Debris	Erosion Pin: <u>N/A</u> m		
Torvane: <u>0.50</u> kg/cm ²		<input type="checkbox"/> Sediment sample	Torvane: <u>0</u> kg/cm ²		
Penetrometer: <u>0.75</u> kg/cm ²		<input type="checkbox"/> Erosion pin	Penetrometer: _____ kg/cm ²		
Foot Used: <input type="checkbox"/> Yes <input checked="" type="checkbox"/> No		<input type="checkbox"/> Scour/bed chain	Foot Used: <input type="checkbox"/> Yes <input type="checkbox"/> No

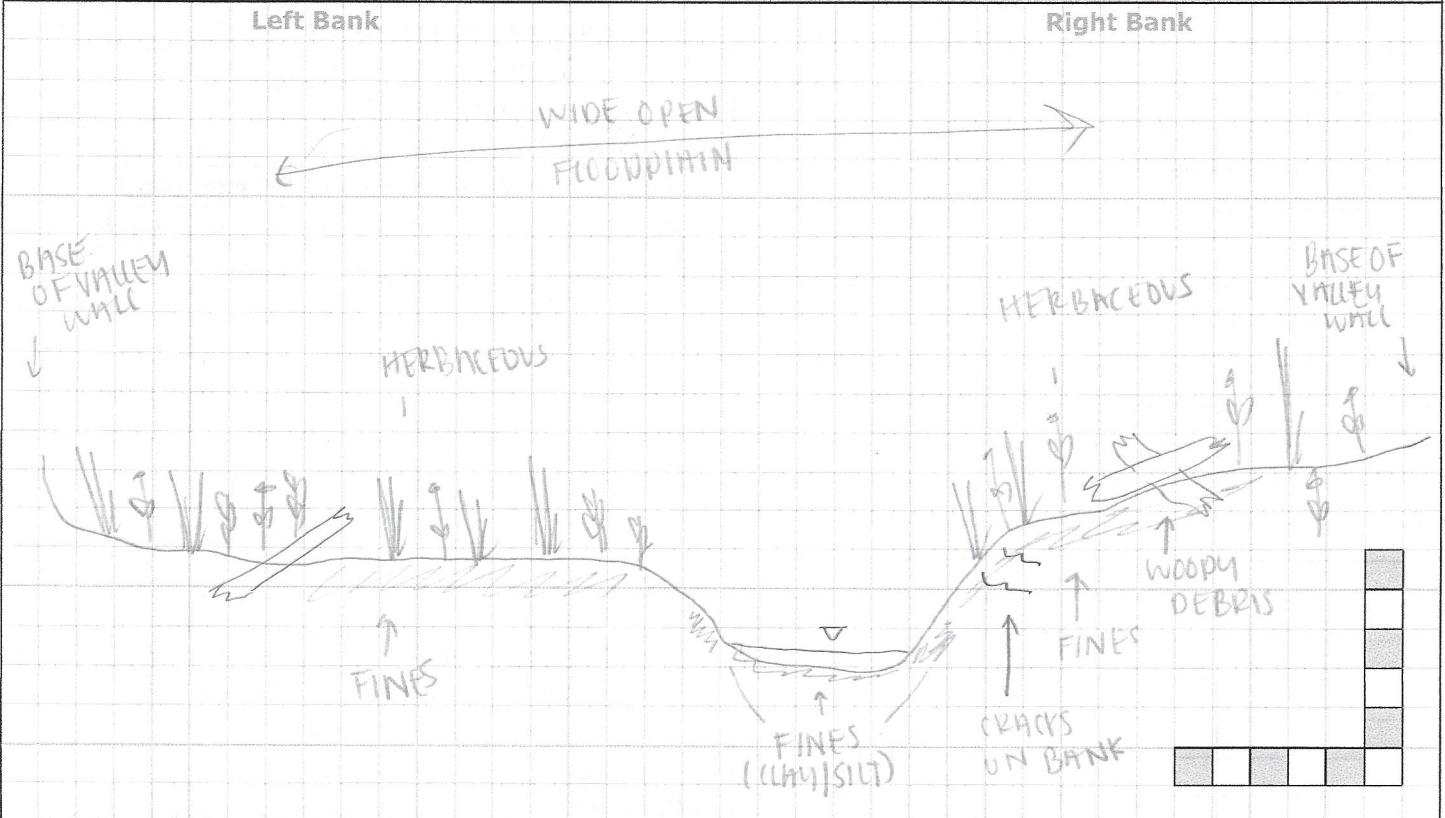
Date:	<u>2024-08-06</u>	Cross-section:	<u>XS4</u>
Time:	<u>12:01pm</u>	Reach:	<u>R3</u>
Weather:	<u>SUN 25°C</u>	Location:	<u>ORLEANS</u>
Field Staff:	<u>KM HM</u>	Watershed/Subwatershed:	<u>CARDINAL CREEK</u>

Left Bank Materials		Features	Right Bank Materials	
<input type="checkbox"/> Bedrock	<input type="checkbox"/> Gravel		<input checked="" type="checkbox"/> Station location	<input type="checkbox"/> Bedrock
<input type="checkbox"/> Till	<input type="checkbox"/> Small Cobble	<input type="checkbox"/> Monumented XS	<input type="checkbox"/> Till	<input type="checkbox"/> Small Cobble
<input checked="" type="checkbox"/> Clay	<input type="checkbox"/> Large Cobble	<input checked="" type="checkbox"/> Monumented photo	<input checked="" type="checkbox"/> Clay	<input type="checkbox"/> Large Cobble
<input checked="" type="checkbox"/> Silt	<input type="checkbox"/> Small Boulder	----- Undercut bank	<input checked="" type="checkbox"/> Silt	<input type="checkbox"/> Small Boulder
<input type="checkbox"/> Sand	<input type="checkbox"/> Large Boulder	##### Eroded bank/slope	<input type="checkbox"/> Sand	<input type="checkbox"/> Large Boulder

Bank Height: <u>0.55</u> m		XXXXX Bank stabilization	Bank Height: <u>0.50</u> m	
Bank Angle: <u>85</u> °		x-x-x-x Fence	Bank Angle: <u>45</u> °	
Root Depth: <u>0.12</u> m		VVVV Grasses	Root Depth: <u>0.06</u> m	
Root Density: <u>10</u> %		→ Leaning tree	Root Density: <u>30</u> %	
Undercut: <u>0.05</u> m		☁ Tree	Undercut: <u>0.07</u> m	
Erosion Pin: <u>N/A</u> m		* * * Woody Debris	Erosion Pin: <u>NO</u> m	
Torvane: <u>0.5</u> kg/cm ²		☐ Sediment sample	Torvane: <u>1.0</u> kg/cm ²	
Penetrometer: <u>0.5</u> kg/cm ²		▬ Erosion pin	Penetrometer: <u>0.25</u> kg/cm ²	
Foot Used: <input type="checkbox"/> Yes <input type="checkbox"/> No		○ Scour/bed chain	Foot Used: <input type="checkbox"/> Yes <input checked="" type="checkbox"/> No

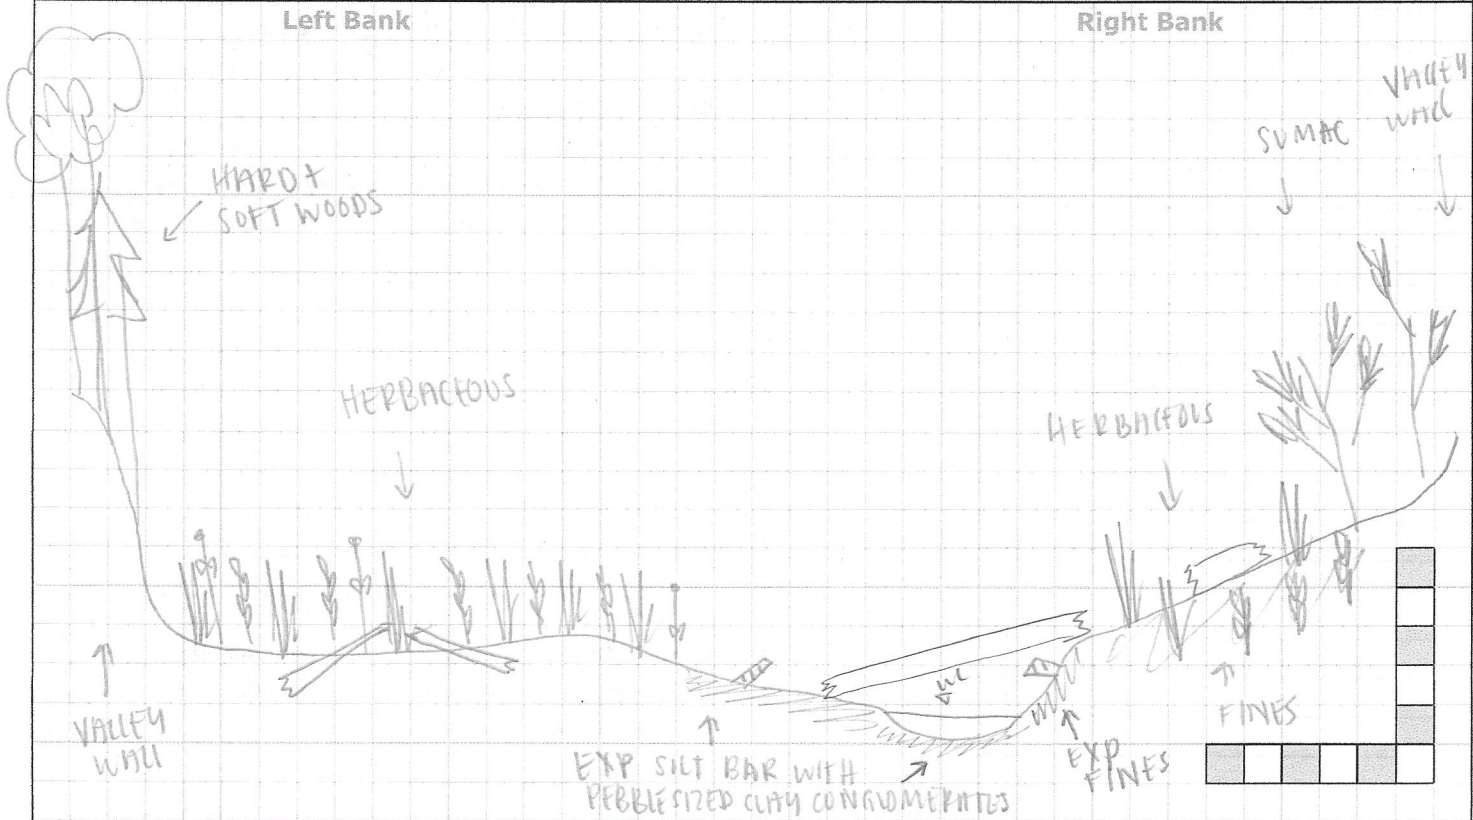
Date:	2024-08-06	Cross-section:	XSS-M
Time:	12:09 pm	Reach:	R3
Weather:	SUN 25°C	Location:	DREANS
Field Staff:	KM HM	Watershed/Subwatershed:	CARDINAL CREEK

Left Bank Materials			Features		Right Bank Materials		
<input type="checkbox"/> Bedrock	<input type="checkbox"/> Gravel			Station location	<input type="checkbox"/> Bedrock	<input type="checkbox"/> Gravel	
<input type="checkbox"/> Till	<input type="checkbox"/> Small Cobble			Monumented XS	<input type="checkbox"/> Till	<input type="checkbox"/> Small Cobble	
<input checked="" type="checkbox"/> Clay	<input type="checkbox"/> Large Cobble			Monumented photo	<input checked="" type="checkbox"/> Clay	<input type="checkbox"/> Large Cobble	
<input checked="" type="checkbox"/> Silt	<input type="checkbox"/> Small Boulder			Undercut bank	<input checked="" type="checkbox"/> Silt	<input type="checkbox"/> Small Boulder	
<input type="checkbox"/> Sand	<input type="checkbox"/> Large Boulder			Eroded bank/slope	<input type="checkbox"/> Sand	<input type="checkbox"/> Large Boulder	
Bank Height: <u>0.162</u> m				Bank stabilization	Bank Height: <u>0.52</u> m

Bank Angle: <u>15</u> °				Fence	Bank Angle: <u>40</u> °		
Root Depth: <u>0.06</u> m				Grasses	Root Depth: <u>0.16</u> m		
Root Density: <u>20</u> %				Leaning tree	Root Density: <u>20</u> %		
Undercut: <u>0.03</u> m				Tree	Undercut: <u>0.13</u> m		
Erosion Pin: <u>0.28</u> m				Woody Debris	Erosion Pin: <u>0.26</u> m		
Torvane: <u>0.75</u> kg/cm ²				Sediment sample	Torvane: <u>0.75</u> kg/cm ²		
Penetrometer: <u>0.50</u> kg/cm ²				Erosion pin	Penetrometer: <u>0.50</u> kg/cm ²		
Foot Used: <input type="checkbox"/> Yes <input checked="" type="checkbox"/> No				Scour/bed chain	Foot Used: <input type="checkbox"/> Yes <input checked="" type="checkbox"/> No

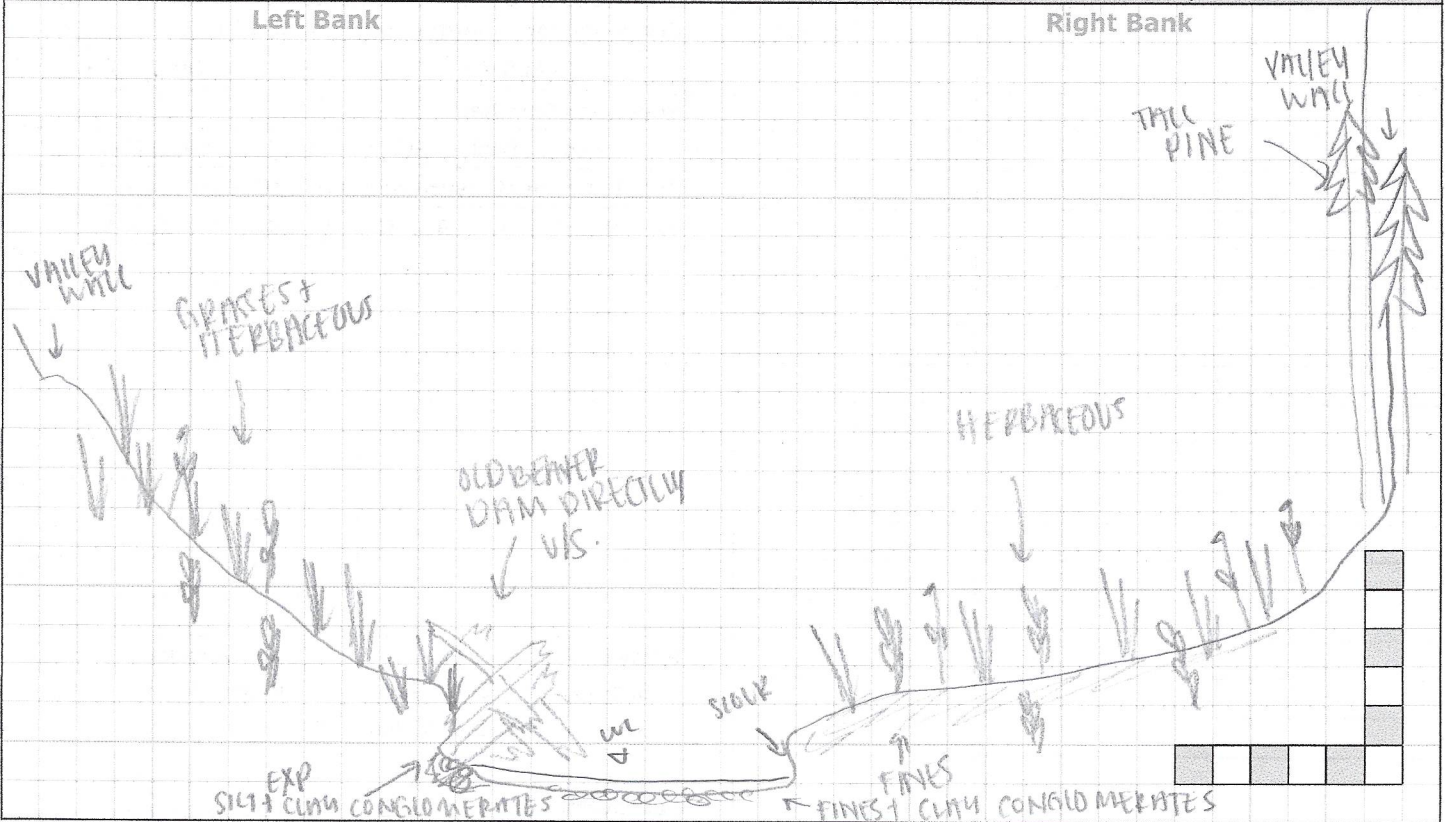
Date:	2024-08-06	Cross-section:	XS10
Time:	12:25pm	Reach:	R3
Weather:	SUN 25°C	Location:	ORLEANS
Field Staff:	KM HM	Watershed/Subwatershed:	CARDINAL CREEK

Left Bank Materials		Features		Right Bank Materials	
<input type="checkbox"/> Bedrock	<input type="checkbox"/> Gravel		Station location	<input type="checkbox"/> Bedrock	<input type="checkbox"/> Gravel
<input type="checkbox"/> Till	<input type="checkbox"/> Small Cobble		Monumented XS	<input type="checkbox"/> Till	<input type="checkbox"/> Small Cobble
<input checked="" type="checkbox"/> Clay	<input type="checkbox"/> Large Cobble		Monumented photo	<input checked="" type="checkbox"/> Clay	<input type="checkbox"/> Large Cobble
<input checked="" type="checkbox"/> Silt	<input type="checkbox"/> Small Boulder		Undercut bank	<input type="checkbox"/> Silt	<input type="checkbox"/> Small Boulder
<input type="checkbox"/> Sand	<input type="checkbox"/> Large Boulder		Eroded bank/slope	<input type="checkbox"/> Sand	<input type="checkbox"/> Large Boulder
Bank Height: <u>0.60</u> m			Bank stabilization	Bank Height: <u>0.50</u> m

Bank Angle: <u>50</u> °			Fence	Bank Angle: <u>45</u> °	
Root Depth: <u>0.09</u> m			Grasses	Root Depth: <u>0.13</u> m	
Root Density: <u>10</u> %			Leaning tree	Root Density: <u>10</u> %	
Undercut: <u>0.05</u> m			Tree	Undercut: <u>0.02</u> m	
Erosion Pin: <u>N/A</u> m			Woody Debris	Erosion Pin: <u>N/A</u> m	
Torvane: <u>0</u> kg/cm ²			Sediment sample	Torvane: <u>1.00</u> kg/cm ²	
Penetrometer: <u>0.50</u> kg/cm ²			Erosion pin	Penetrometer: <u>0.50</u> kg/cm ²	
Foot Used: <input type="checkbox"/> Yes <input checked="" type="checkbox"/> No			Scour/bed chain	Foot Used: <input type="checkbox"/> Yes <input checked="" type="checkbox"/> No

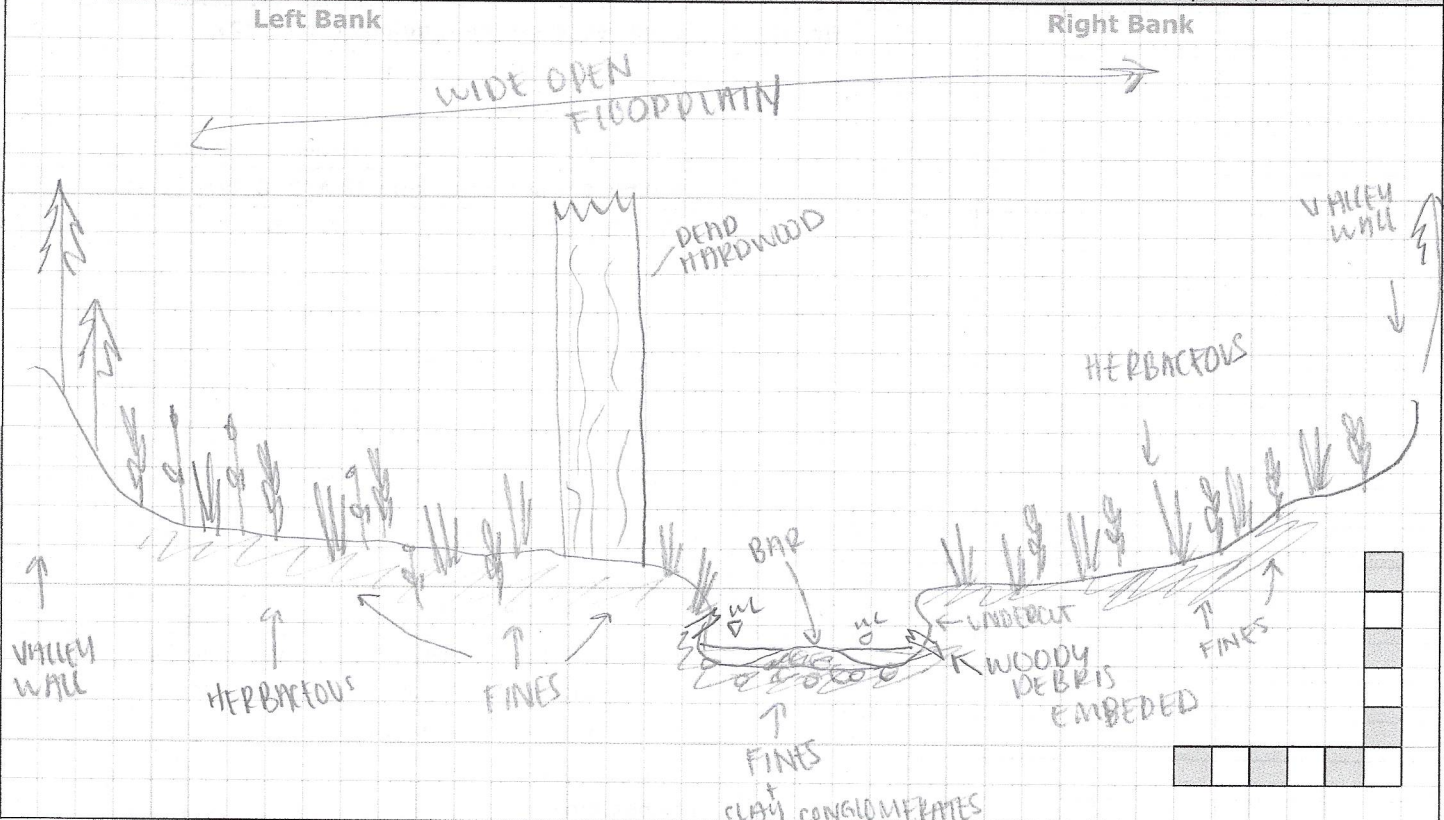
Date:	2024-08-06	Cross-section:	XS 7
Time:	12:41pm	Reach:	R3
Weather:	SUN 25°C	Location:	ORLEANS
Field Staff:	KM HM	Watershed/Subwatershed:	CARDINAL CREEK

Left Bank Materials		Features		Right Bank Materials	
<input type="checkbox"/> Bedrock	<input type="checkbox"/> Gravel	<input checked="" type="checkbox"/> Station location	<input type="checkbox"/> Bedrock	<input type="checkbox"/> Bedrock	<input type="checkbox"/> Gravel
<input type="checkbox"/> Till	<input type="checkbox"/> Small Cobble	<input type="checkbox"/> Monumented XS	<input type="checkbox"/> Till	<input type="checkbox"/> Till	<input type="checkbox"/> Small Cobble
<input checked="" type="checkbox"/> Clay	<input type="checkbox"/> Large Cobble	<input checked="" type="checkbox"/> Monumented photo	<input checked="" type="checkbox"/> Clay	<input checked="" type="checkbox"/> Clay	<input type="checkbox"/> Large Cobble
<input checked="" type="checkbox"/> Silt	<input type="checkbox"/> Small Boulder	----- Undercut bank	<input checked="" type="checkbox"/> Silt	<input checked="" type="checkbox"/> Silt	<input type="checkbox"/> Small Boulder

<input type="checkbox"/> Sand	<input type="checkbox"/> Large Boulder	#### Eroded bank/slope	<input type="checkbox"/> Sand	<input type="checkbox"/> Sand	<input type="checkbox"/> Large Boulder
Bank Height: 0.180 m		XXXXX Bank stabilization	Bank Height: 0.55 m		
Bank Angle: 25 °		*-*-* Fence	Bank Angle: 90 °		
Root Depth: 0.10 m		VVVV Grasses	Root Depth: 0.15 m		
Root Density: 15 %		Leaning tree	Root Density: 30 %		
Undercut: NO m		Tree	Undercut: 0.29 m		
Erosion Pin: N/A m		* * * Woody Debris	Erosion Pin: N/A m		
Torvane: 0.50 kg/cm²		☐ Sediment sample	Torvane: 1.00 kg/cm²		
Penetrometer: 0.50 kg/cm²		☐☐☐☐ Erosion pin	Penetrometer: 0.55 kg/cm²		
Foot Used: <input type="checkbox"/> Yes <input type="checkbox"/> No		○ Scour/bed chain	Foot Used: <input type="checkbox"/> Yes <input checked="" type="checkbox"/> No

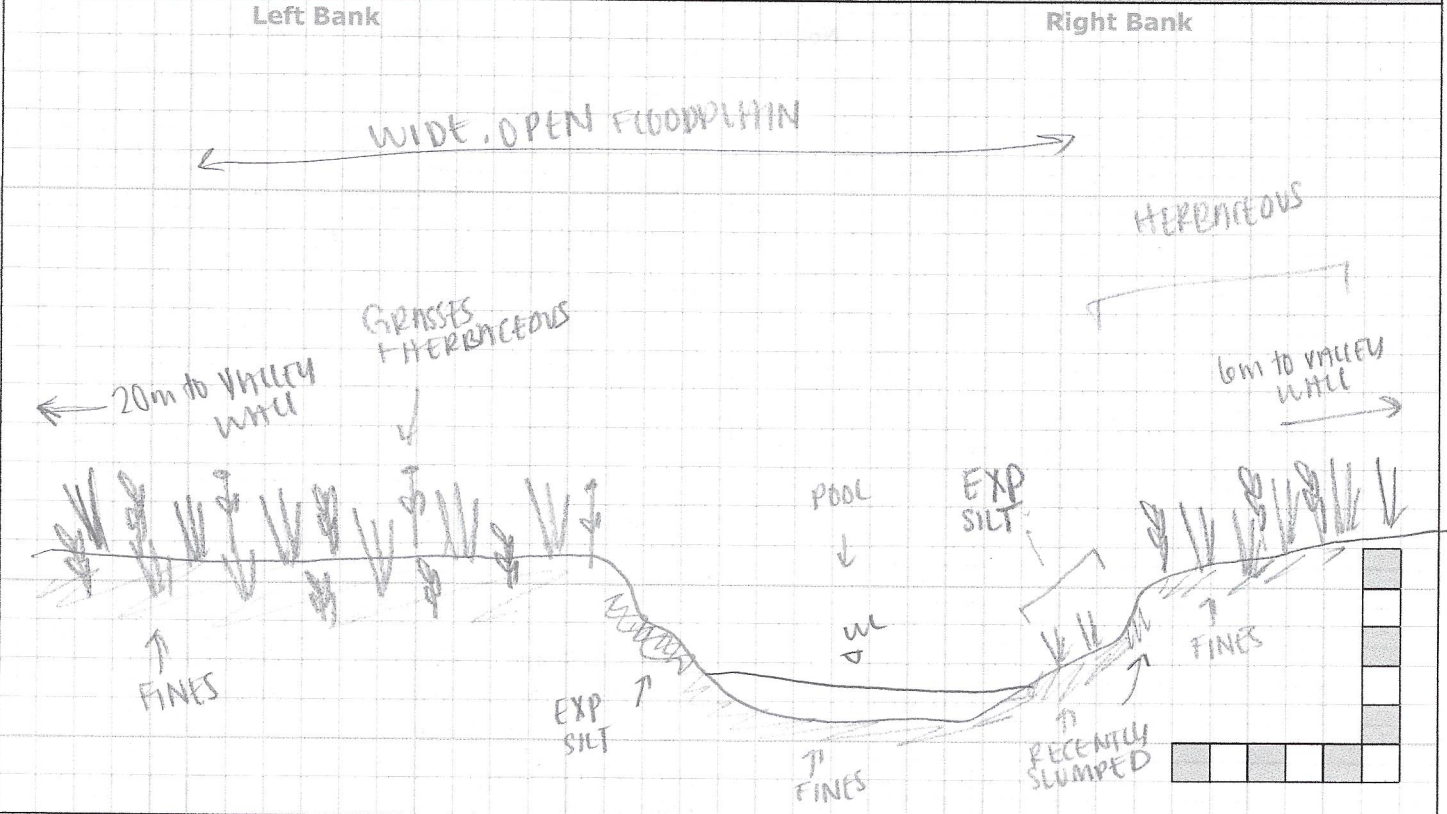
Date:	2024-08-06	Cross-section:	XS 8
Time:	12:49pm	Reach:	R3
Weather:	SUN 25°C	Location:	ORLEANS
Field Staff:	KM HM	Watershed/Subwatershed:	CARDINAL CREEK

Left Bank Materials		Features		Right Bank Materials	
<input type="checkbox"/> Bedrock	<input type="checkbox"/> Gravel		Station location	<input type="checkbox"/> Bedrock	<input type="checkbox"/> Gravel
<input type="checkbox"/> Till	<input type="checkbox"/> Small Cobble		Monumented XS	<input type="checkbox"/> Till	<input type="checkbox"/> Small Cobble
<input checked="" type="checkbox"/> Clay	<input type="checkbox"/> Large Cobble		Monumented photo	<input checked="" type="checkbox"/> Clay	<input type="checkbox"/> Large Cobble
<input checked="" type="checkbox"/> Silt	<input type="checkbox"/> Small Boulder		Undercut bank	<input checked="" type="checkbox"/> Silt	<input type="checkbox"/> Small Boulder
<input type="checkbox"/> Sand	<input type="checkbox"/> Large Boulder		Eroded bank/slope	<input type="checkbox"/> Sand	<input type="checkbox"/> Large Boulder
Bank Height: <u>0.70</u> m			Bank stabilization	Bank Height: <u>0.60</u> m

Bank Angle: <u>45</u> °			Fence	Bank Angle: <u>35</u> °	
Root Depth: <u>0.05</u> m			Grasses	Root Depth: <u>0.08</u> m	
Root Density: <u>20</u> %			Leaning tree	Root Density: <u>20</u> %	
Undercut: <u>0.02</u> m			Tree	Undercut: <u>0.12 (from slump)</u> m	
Erosion Pin: <u>N/A</u> m			Woody Debris	Erosion Pin: <u>N/A</u> m	
Torvane: <u>1.25</u> kg/cm ²			Sediment sample	Torvane: <u>1.00</u> kg/cm ²	
Penetrometer: <u>100</u> kg/cm ²			Erosion pin	Penetrometer: <u>1.50</u> kg/cm ²	
Foot Used: <input type="checkbox"/> Yes <input checked="" type="checkbox"/> No			Scour/bed chain	Foot Used: <input type="checkbox"/> Yes <input checked="" type="checkbox"/> No
