Fluvial Geomorphological and Erosion Threshold Assessment, Tributary of Cardinal Creek

1296 and 1400 Old Montreal Road
City of Ottawa, Ontario

Submitted:
November 11, 2024

GEO Morphix Project No. 23076

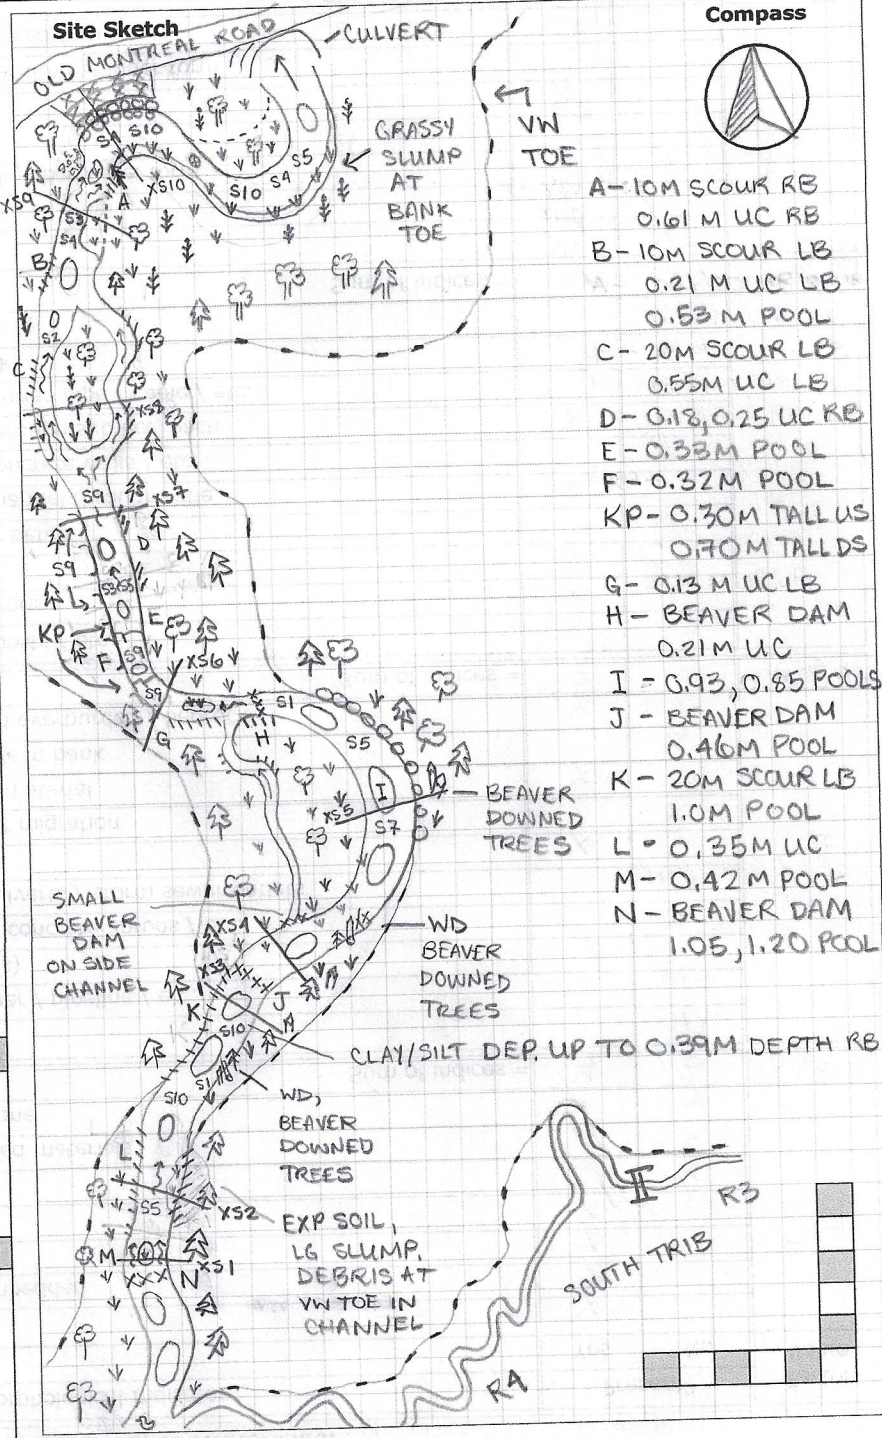
Notes: ISLANDS W/ TREES IN 2 LOCATIONS, ISLANDS / MATURE BARS W/ GRASS THROUGHOUT REACH, 3 BEAVER DAMS ACROSS MAIN CHANNEL W/IN US EXTENT OF REACH

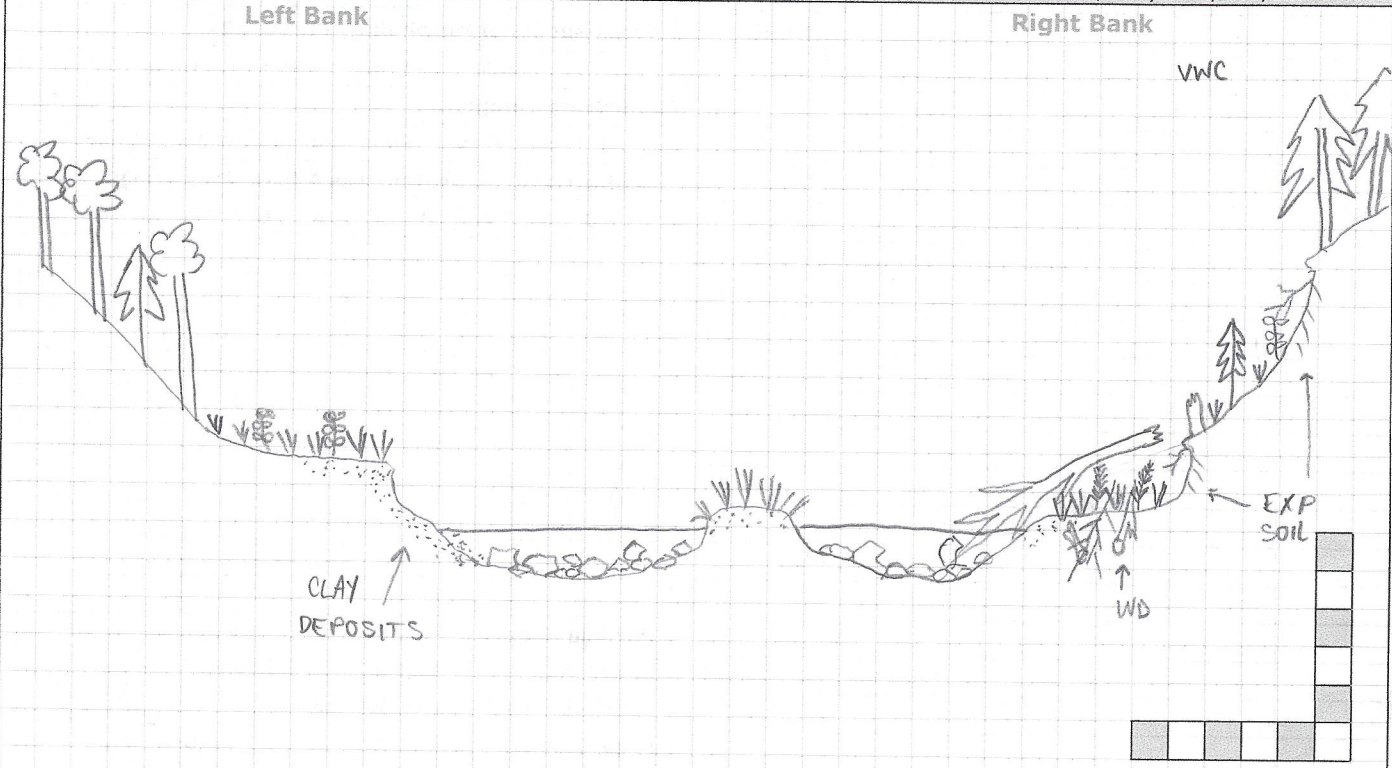
Date:	10-10-24	Cross-section:	XSI
Time:	12:00	Reach:	C10
Weather:	10°C SUN/CLOUD	Location:	CARDINAL CREEK
Field Staff:	KS CM MK	Watershed/Subwatershed:	OTTAWA RIVER

Left Bank Materials		Features		Right Bank Materials	
<input type="checkbox"/> Bedrock	<input type="checkbox"/> Gravel	<input checked="" type="checkbox"/> Station location		<input type="checkbox"/> Bedrock	<input type="checkbox"/> Gravel
<input type="checkbox"/> Till	<input type="checkbox"/> Small Cobble	<input type="checkbox"/> Monumented XS		<input type="checkbox"/> Till	<input type="checkbox"/> Small Cobble
<input checked="" type="checkbox"/> Clay	<input type="checkbox"/> Large Cobble	<input type="checkbox"/> Monumented photo		<input type="checkbox"/> Clay	<input type="checkbox"/> Large Cobble
<input type="checkbox"/> Silt	<input type="checkbox"/> Small Boulder	----- Undercut bank		<input type="checkbox"/> Silt	<input type="checkbox"/> Small Boulder
<input type="checkbox"/> Sand	<input type="checkbox"/> Large Boulder	#### Eroded bank/slope		<input type="checkbox"/> Sand	<input type="checkbox"/> Large Boulder

Bank Height: <u>0.75</u> m		XXXXX Bank stabilization		Bank Height: <u>1.0</u> m	
Bank Angle: <u>55</u> °		x--x--x Fence		Bank Angle: <u>60</u> °	
Root Depth: <u>0.20</u> m		vvvv Grasses		Root Depth: <u>1.0</u> m	
Root Density: <u>10</u> %		→ Leaning tree		Root Density: <u>10</u> %	
Undercut: <u>0</u> m		☁ Tree		Undercut: <u>0.16</u> m	
Erosion Pin: <u>—</u> m		* * * Woody Debris		Erosion Pin: <u>—</u> m	
Torvane: <u>1.0</u> kg/cm²		☐ Sediment sample		Torvane: <u>3.0</u> kg/cm²	
Penetrometer: <u>0.75</u> kg/cm²		Erosion pin		Penetrometer: <u>1.75</u> kg/cm²	
Foot Used: <input type="checkbox"/> Yes <input checked="" type="checkbox"/> No		o Scour/bed chain		Foot Used: <input type="checkbox"/> Yes <input checked="" type="checkbox"/> No

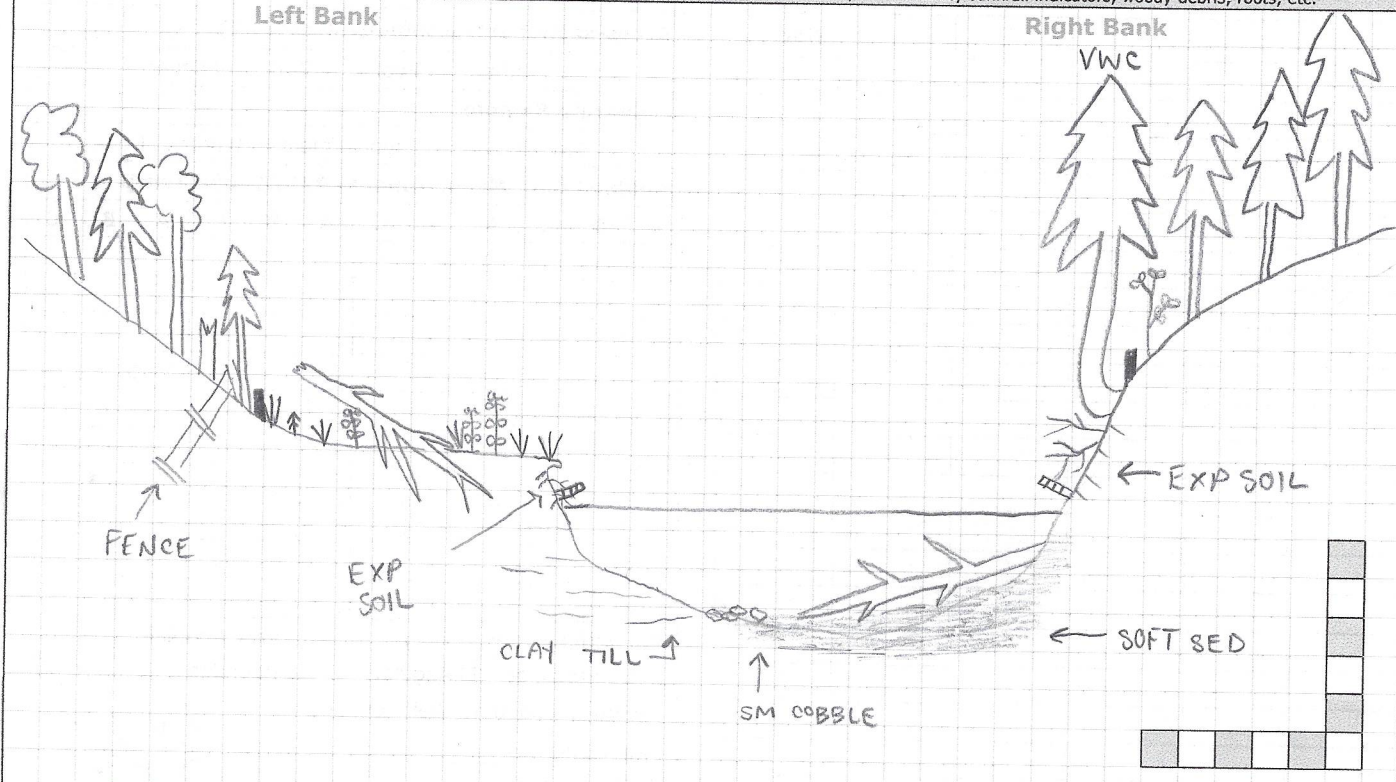
Date:	10-10-24	Cross-section:	XS 2-M
Time:	12:45	Reach:	C10
Weather:	10°C SUN/CLOUD	Location:	CARDINAL CREEK
Field Staff:	KS CM MK	Watershed/Subwatershed:	OTTAWA RIVER

Left Bank Materials	
<input type="checkbox"/> Bedrock	<input type="checkbox"/> Gravel
<input type="checkbox"/> Till	<input type="checkbox"/> Small Cobble
<input checked="" type="checkbox"/> Clay	<input type="checkbox"/> Large Cobble
<input type="checkbox"/> Silt	<input type="checkbox"/> Small Boulder
<input type="checkbox"/> Sand	<input type="checkbox"/> Large Boulder
Bank Height: <u>1.75</u> m	
Bank Angle: <u>50</u> °	
Root Depth: <u>0.55</u> m	
Root Density: <u>15</u> %	
Undercut: <u>0.06</u> m	
Erosion Pin: <u>0.26</u> m	
Torvane: <u>0.5</u> kg/cm ²	
Penetrometer: <u>0.75</u> kg/cm ²	
Foot Used: <input type="checkbox"/> Yes <input checked="" type="checkbox"/> No

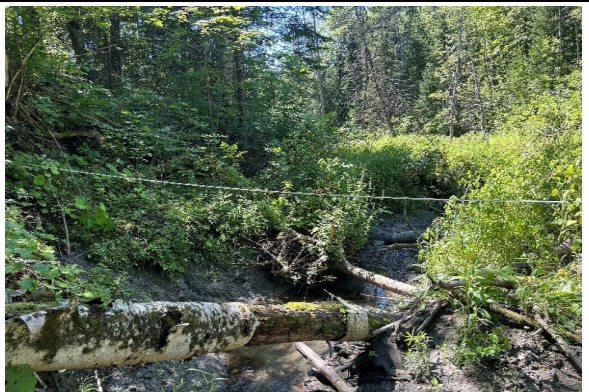
Representative Cross-Section #1

Photograph at cross section 1 (looking downstream)

Reach **R3** was characterized by a sinuous channel set within a confined, wooded valley. The valley floor was previously inundated due to beaver activity and had since drained to reveal accumulated fine sediment deposits (e.g. clay to sand sized particles). Short grasses and herbaceous vegetation are populating the deposits, forming a beaver meadow. At the time of inspection, a channel was forming within the meadow and actively reworking the deposits of fine sediments. The channel bed morphology consisted of alternating riffle-pool sequences comprised primarily of fine sediments. A small proportion of the channel sediments were gravel sized and were generally limited to riffle features. The channel banks were vegetated but were relatively soft in composition and thus sensitive to erosion (e.g. slumping). The channel exhibited evidence of systematic aggradation and widening. For example, channel banks were generally unstable and in-channel bars/fine sediment deposits were common.

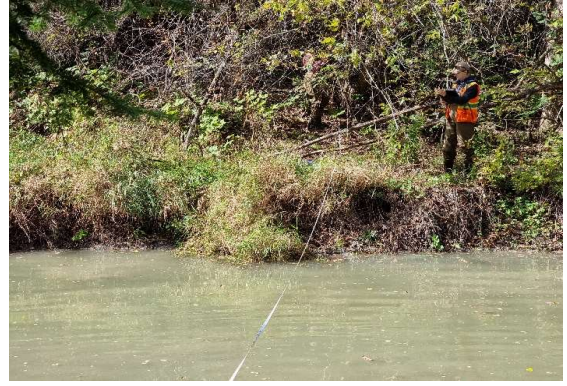
Representative Cross-Section 2

Photograph at cross section 2 facing the left bank

The subject reach was characterized by a meandering channel set within a confined wooded valley. Dominant riparian vegetation consisted of trees and grasses, which provided limited cover over the channel. Channel bed morphology was characterized by alternating riffle-pool sequences. The channel exhibited evidence of systematic widening. For example, leaning trees, accumulation of organic debris in the channel and basal scour throughout the reach was observed. Additionally, evidence of planimetric adjustment was noted due to multiple channels, the formation of two islands, and cutoff channels were noted. The channel also displayed multiple indicators associated with "good" channel health. For example, the channel was characterized by a variable bed morphology with diverse flow conditions and habitat refuge potential. Notably, extensive beaver activity was observed, including the establishment of three beaver dams towards the upstream extent of the assessed reach, resulting in the formation of several cutoff channels and scour pools. The channel flowed over bedrock along the center of the reach while exposed till, gravel and cobbles were noted along the up and downstream extents. Valley wall contact was observed at two locations, and large armour stones and geotextile were in place for protection.
