Cardinal Creek Village – South Side

Headwater Drainage Feature Assessment

March 2021

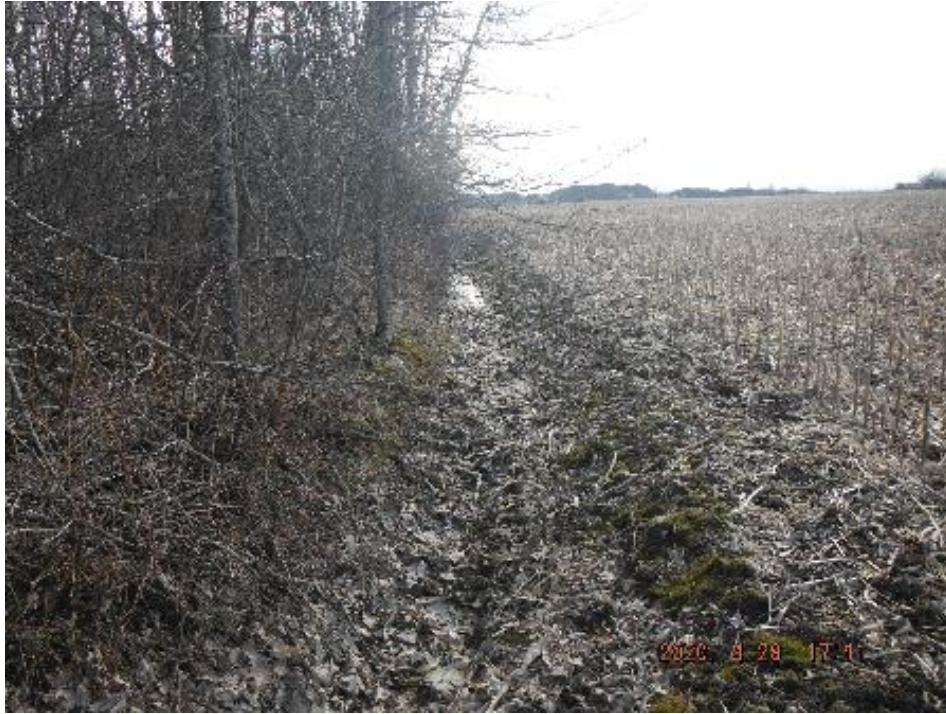
Feature 3 refers to the channel that is situated on the north and west sides of the forested area. This feature is connected to both Feature 2 and the South Tributary. Very little of this channel has any incline. The shading from the forest resulted in thick snow cover on April 6 and no flowing water was present anywhere. The feature was visited again on April 16 at which time there was standing water in the entire feature but there was no contributing water to Feature 2. Because of the strange alignment, this feature has been separated in two sections. The portion labelled as 3a is that along the north side of the forest and is 150 m long. The portion labelled as 3b is that along the west side of the forest and is 65 m. It is noted that there was no flowing water in all but the very southwest section (last few meters) which flowed down the valley bank of the South Tributary.

Photo 7: Feature 3a, looking upstream (April 28, 2020)

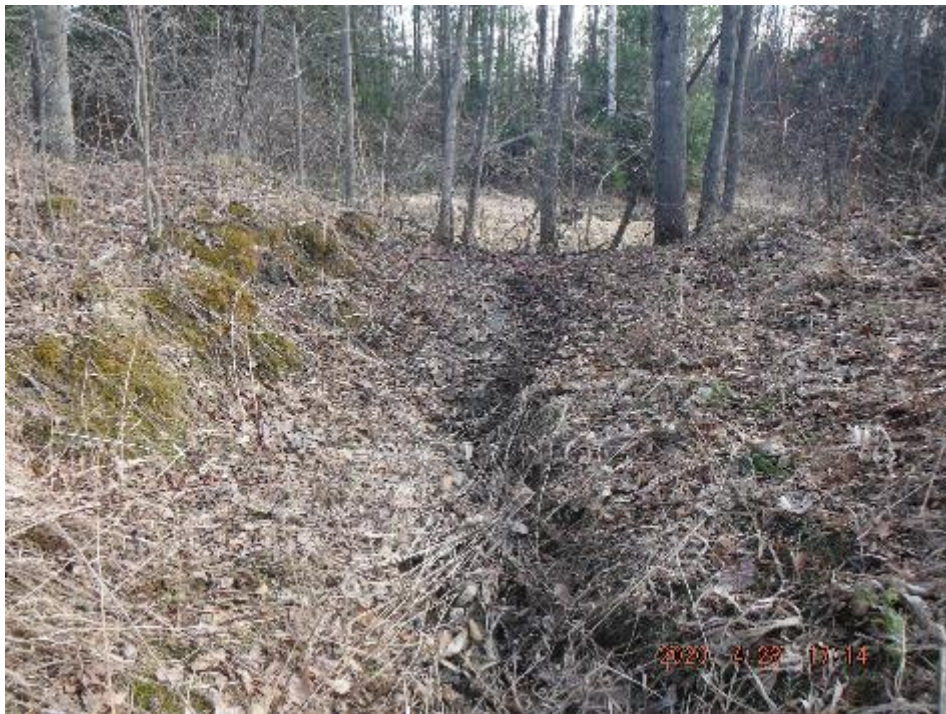
Photo 8: Feature 3b that is inclined and flows to South Tributary (April 28, 2020)

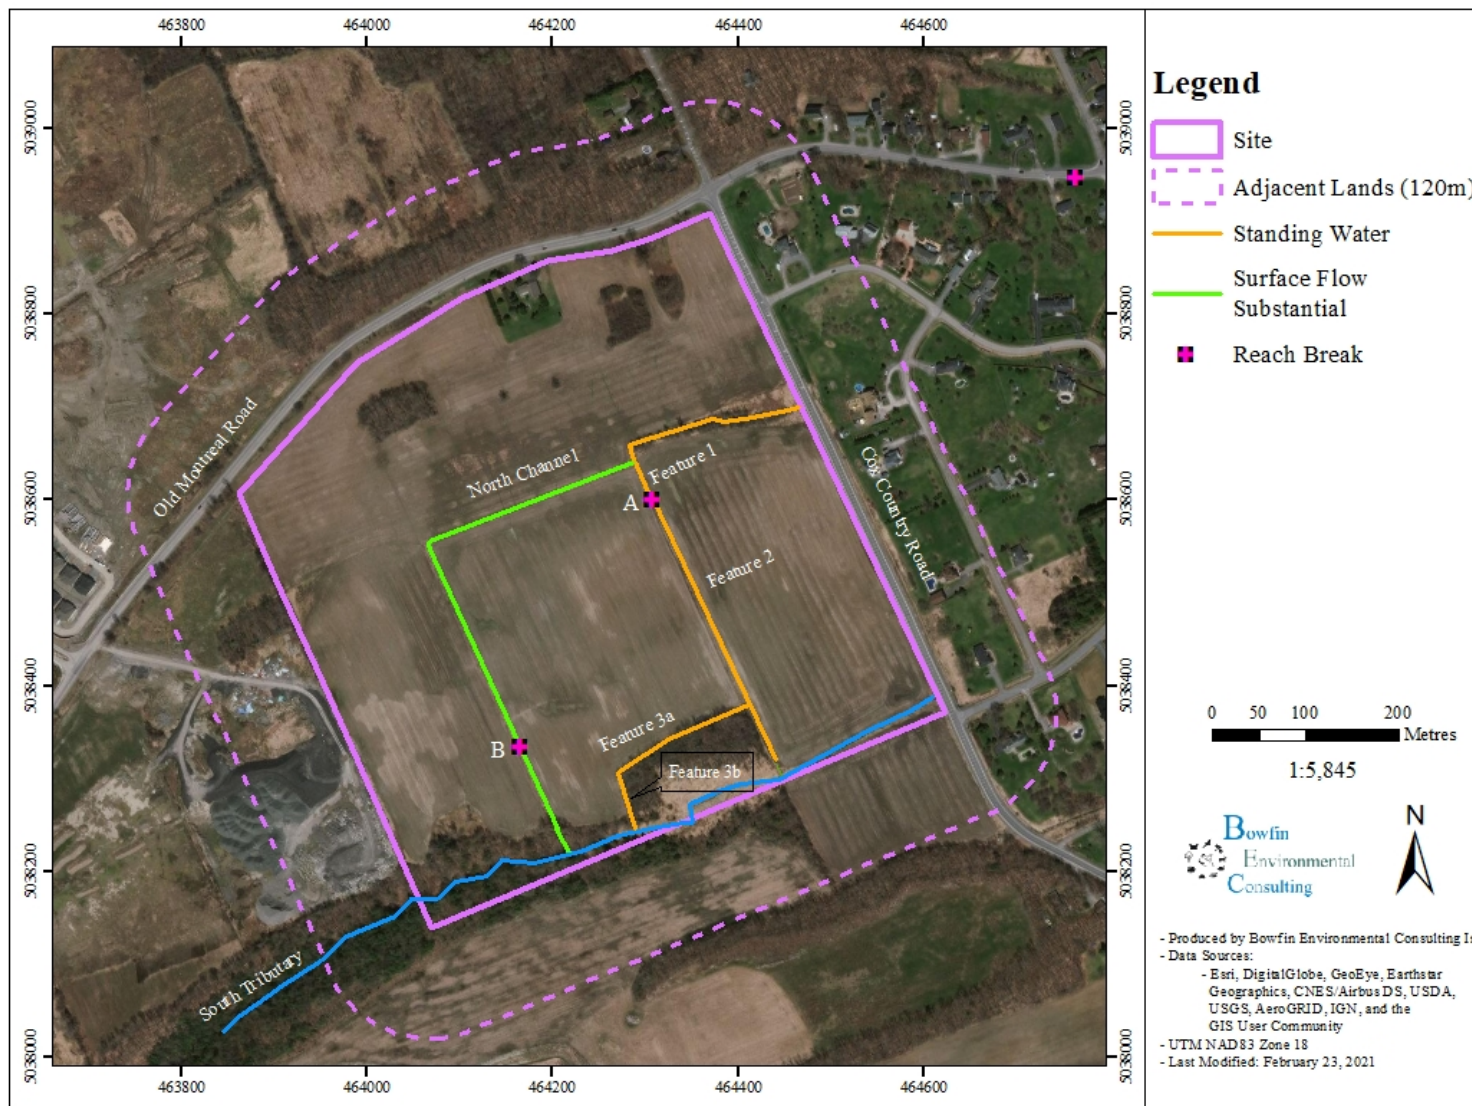
Figure 3: Summary of Flow Conditions – Freshet Visit and Second Visit (April 6, 16 and 28, 2020)

In Step 1 the flow is classified based on the amounts recorded during the three flow visits. These are summarized in Table 3 (as per OSAP S4.M10). There were no significant rainfall events in the week before any flow visit, however near 10 mm fell prior to the first two visits (Table 2). To further put the field work results into context of the conditions of 2020, the snowpack and water levels in the general area have been summarized. The winter of 2019-2020 was unusually mild, with lower than average snowfall (just under 200 cm by early April), resulting in a below-average snowpack. By early April, there was little amount of snowpack left in areas that were not shaded and all snow was gone by late April (personal observations). Rideau Valley Conservation Authority issued flood warning conditions from late March to early May. Water levels remained normal until June 4, 2020, when RVCA issued a minor low water status that lasted until July 15, 2020. From July 15 to August 5, 2020, the conservation authority issued a moderate low water status. A minor low water status was put back in place on August 5th until September 2, where water levels went back to normal.

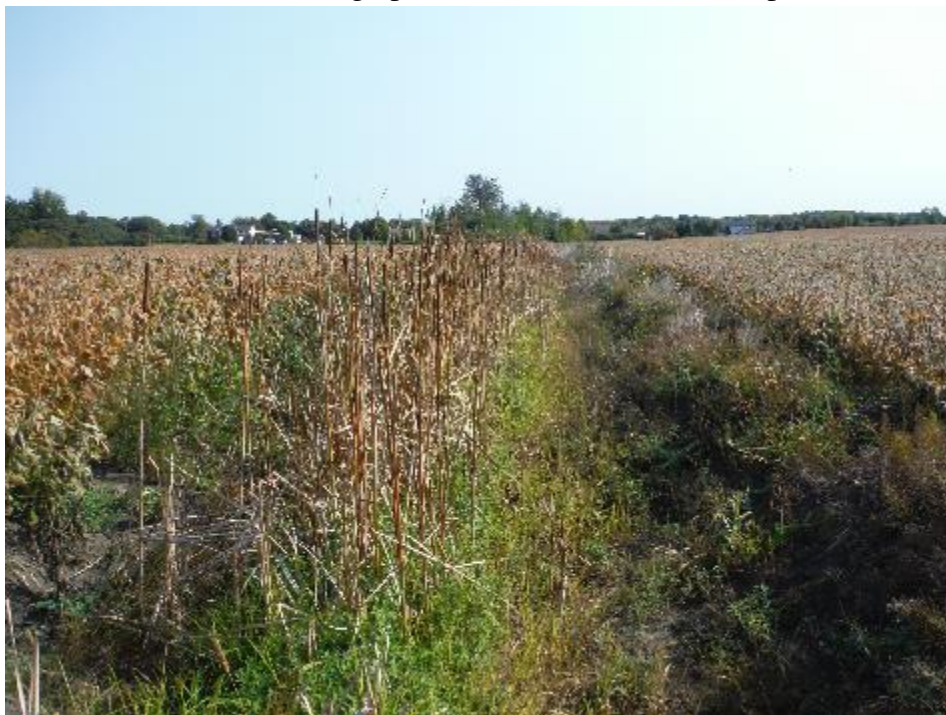
The substrate consisted entirely of fines and the stream morphology was a glide. The in-water cover throughout the station was provided by aquatic vegetation. Minor signs of erosion were noted on the left bank. The tops of the banks were partially vegetated (about 60%). There was also narrow-leaved cattail, manna grass, purple loosestrife, thistle, field horsetail, ragweed. The station had no canopy cover.

Photo 10: Station 1 looking upstream from downstream (September 21, 2020)

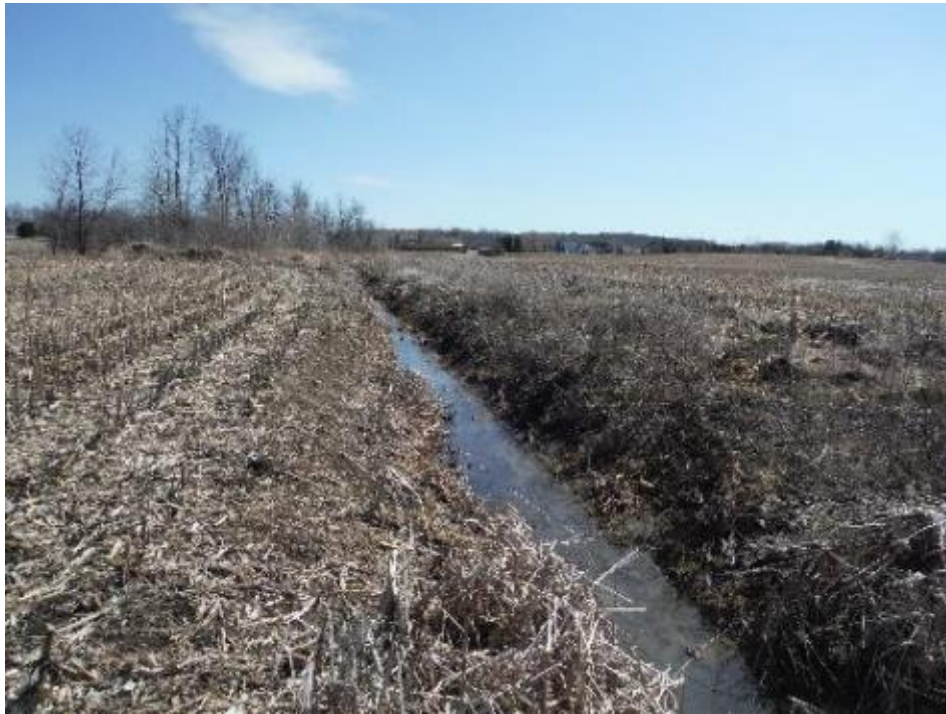
The substrate consisted entirely of fines and the stream morphology was a glide. The in-water cover throughout the station was provided mostly by aquatic vegetation, including algae. Minor signs of erosion were noted on the left bank. The tops of the banks were mostly vegetated (about 80%). There was also narrow-leaved cattail, manna grass, purple loosestrife, knotweed, wild carrot, thistle, field horsetail and ragweed. The station had no canopy cover.

Photo 11: Station 2 looking upstream from downstream (April 6, 2020)

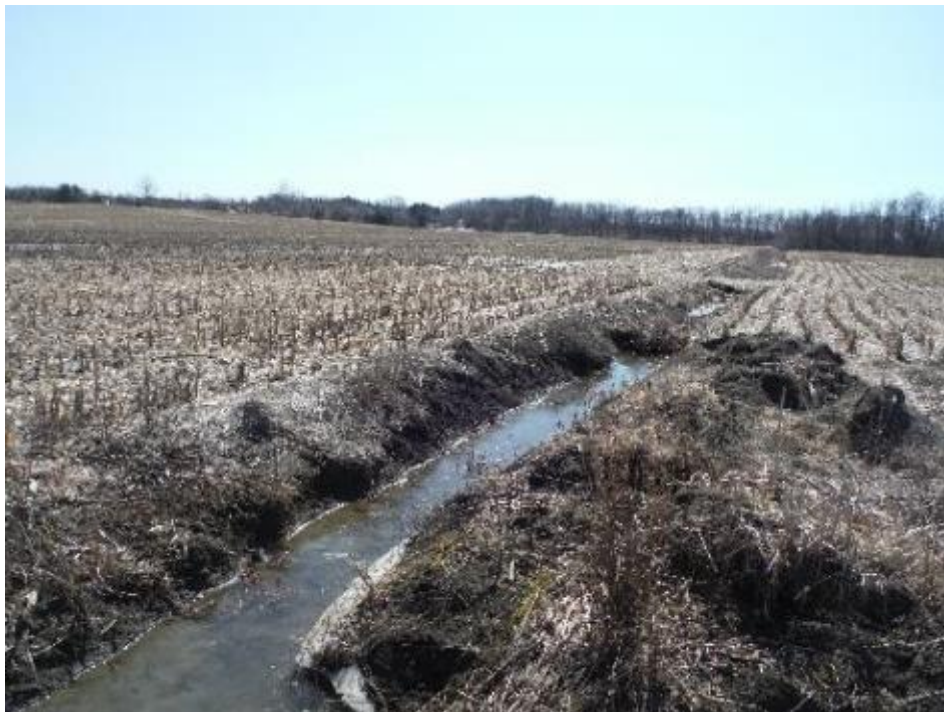
Feature 1 is situated on the northeast side of the site. This feature was 35 m long and flowed into the North Channel. This feature receive water from the agricultural fields surrounding it and had a straight pattern. There is a blocked culvert (reach break “A”) on its upstream end, separating it from feature 2. No station was established within the feature as it was connected to North Channel (which was sampled) and there was no potential for fish to reach this area from the South Tributary.

Photo 15: Feature 1 looking upstream from downstream (April 6, 2020)

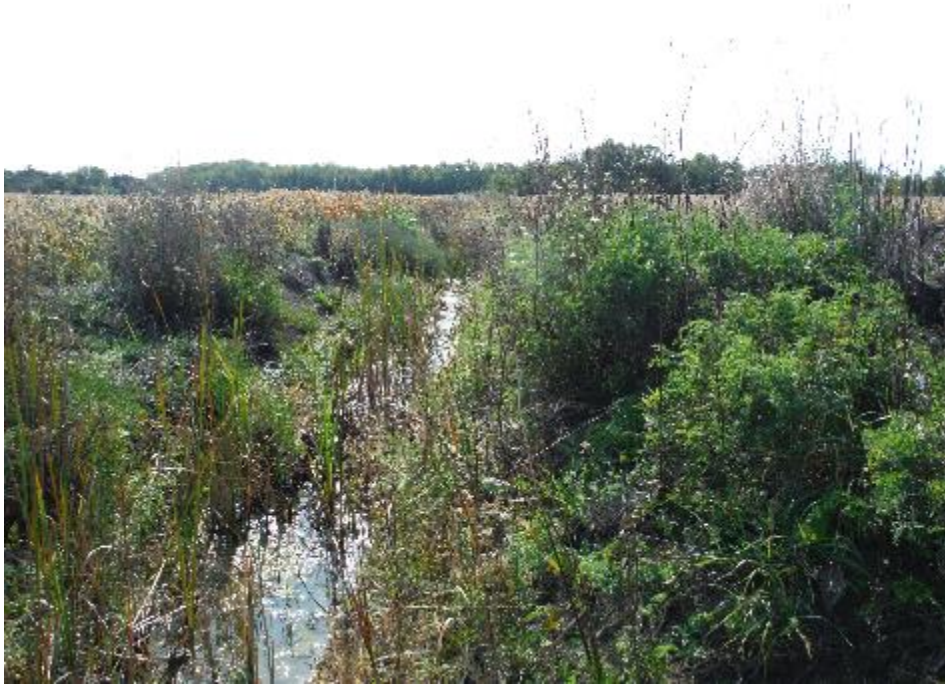
Photo 16: Feature 1 looking upstream from downstream (September 21, 2020)

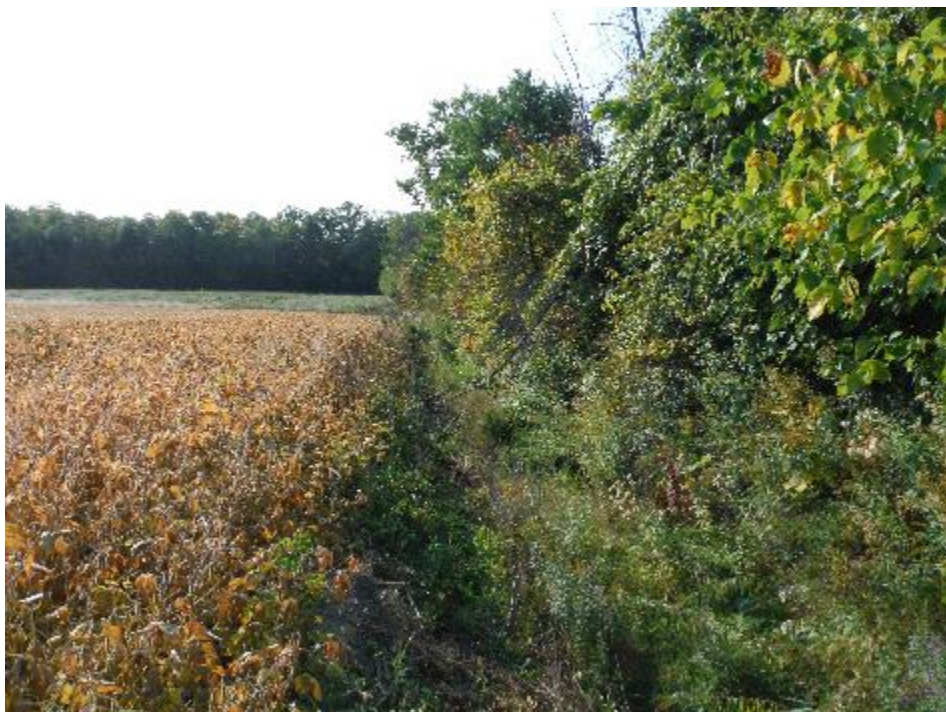
Photo 18: Station 4. looking downstream from the center of the feature (September 21, 2020)

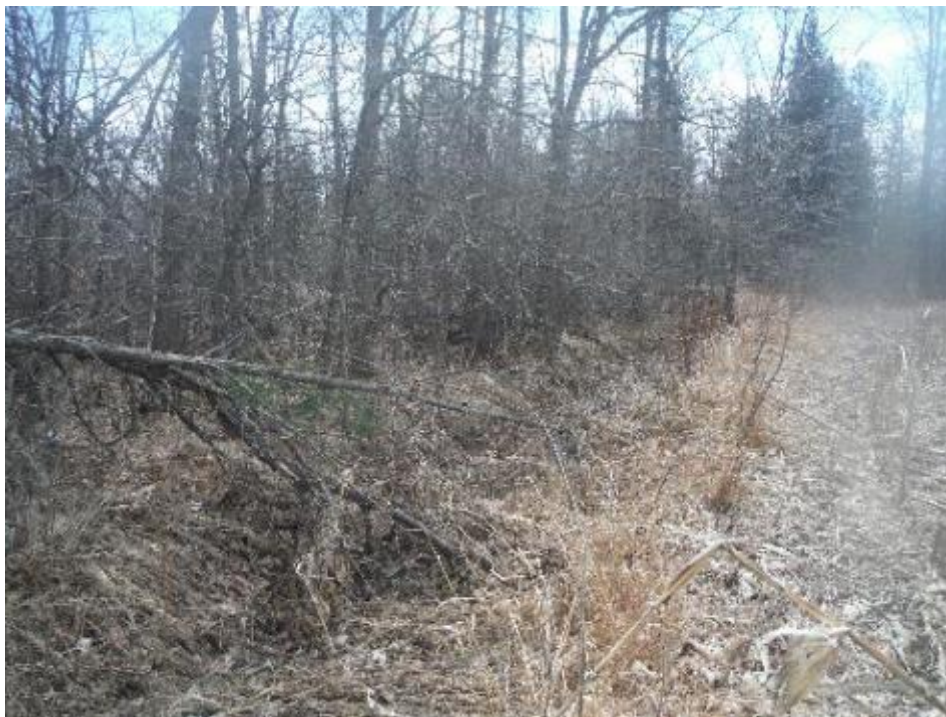
The substrate consisted entirely of fines and the stream morphology was mostly composed of pools, due to the gradient issues. There was little in-water cover present, with some overhanging vegetation (raspberry, colts' foot, and thimbleberry). No signs of erosion were noted. The tops of the banks were mostly vegetated (about 70%). The most common species, other than agricultural species, were dandelion, strawberry, vetch, yarrow, red raspberry, colts' foot, thimbleberry, and hickory.

Photo 21: Station 6 looking downstream from the upstream end (April 16, 2020)

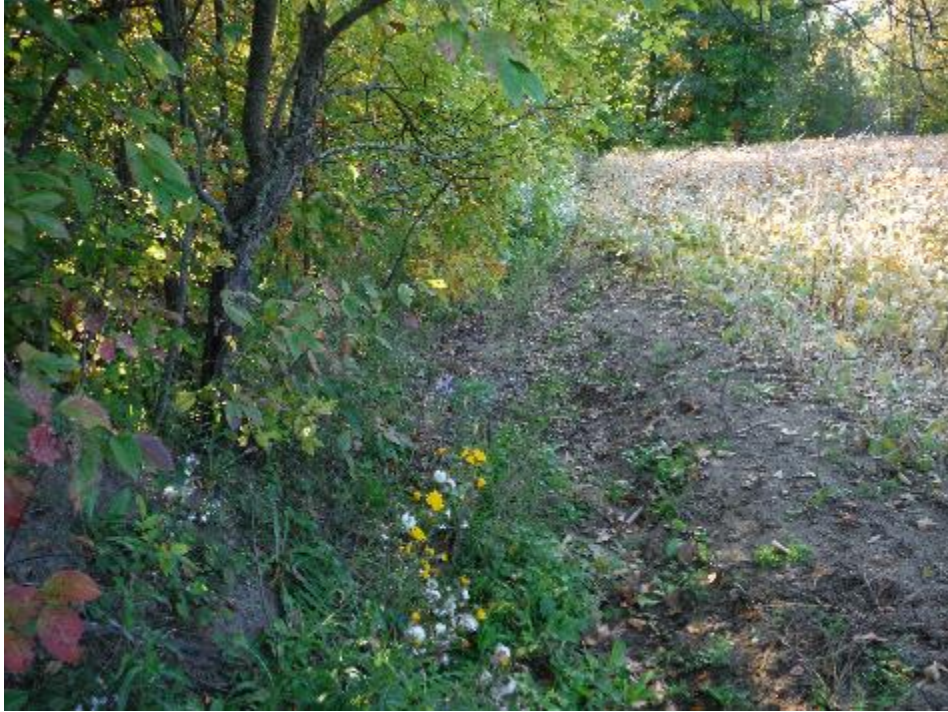
The station was not fished as there was no fish habitat was present. No sampling took place during the summer either as the station was dry (July 27, 2020).

Photo 22: Station 6 looking downstream from the upstream end (September 21, 2020)
