FLUVIAL GEOMORPHIC AND EROSION HAZARD ASSESSMENT
STINSON LANDS
OTTAWA, ONTARIO

Prepared for:
NOVATECH ENGINEERING AND CONSULTANTS LTD.

Prepared by:
MATRIX SOLUTIONS INC.

Version 1.0
November 2022
Guelph, Ontario

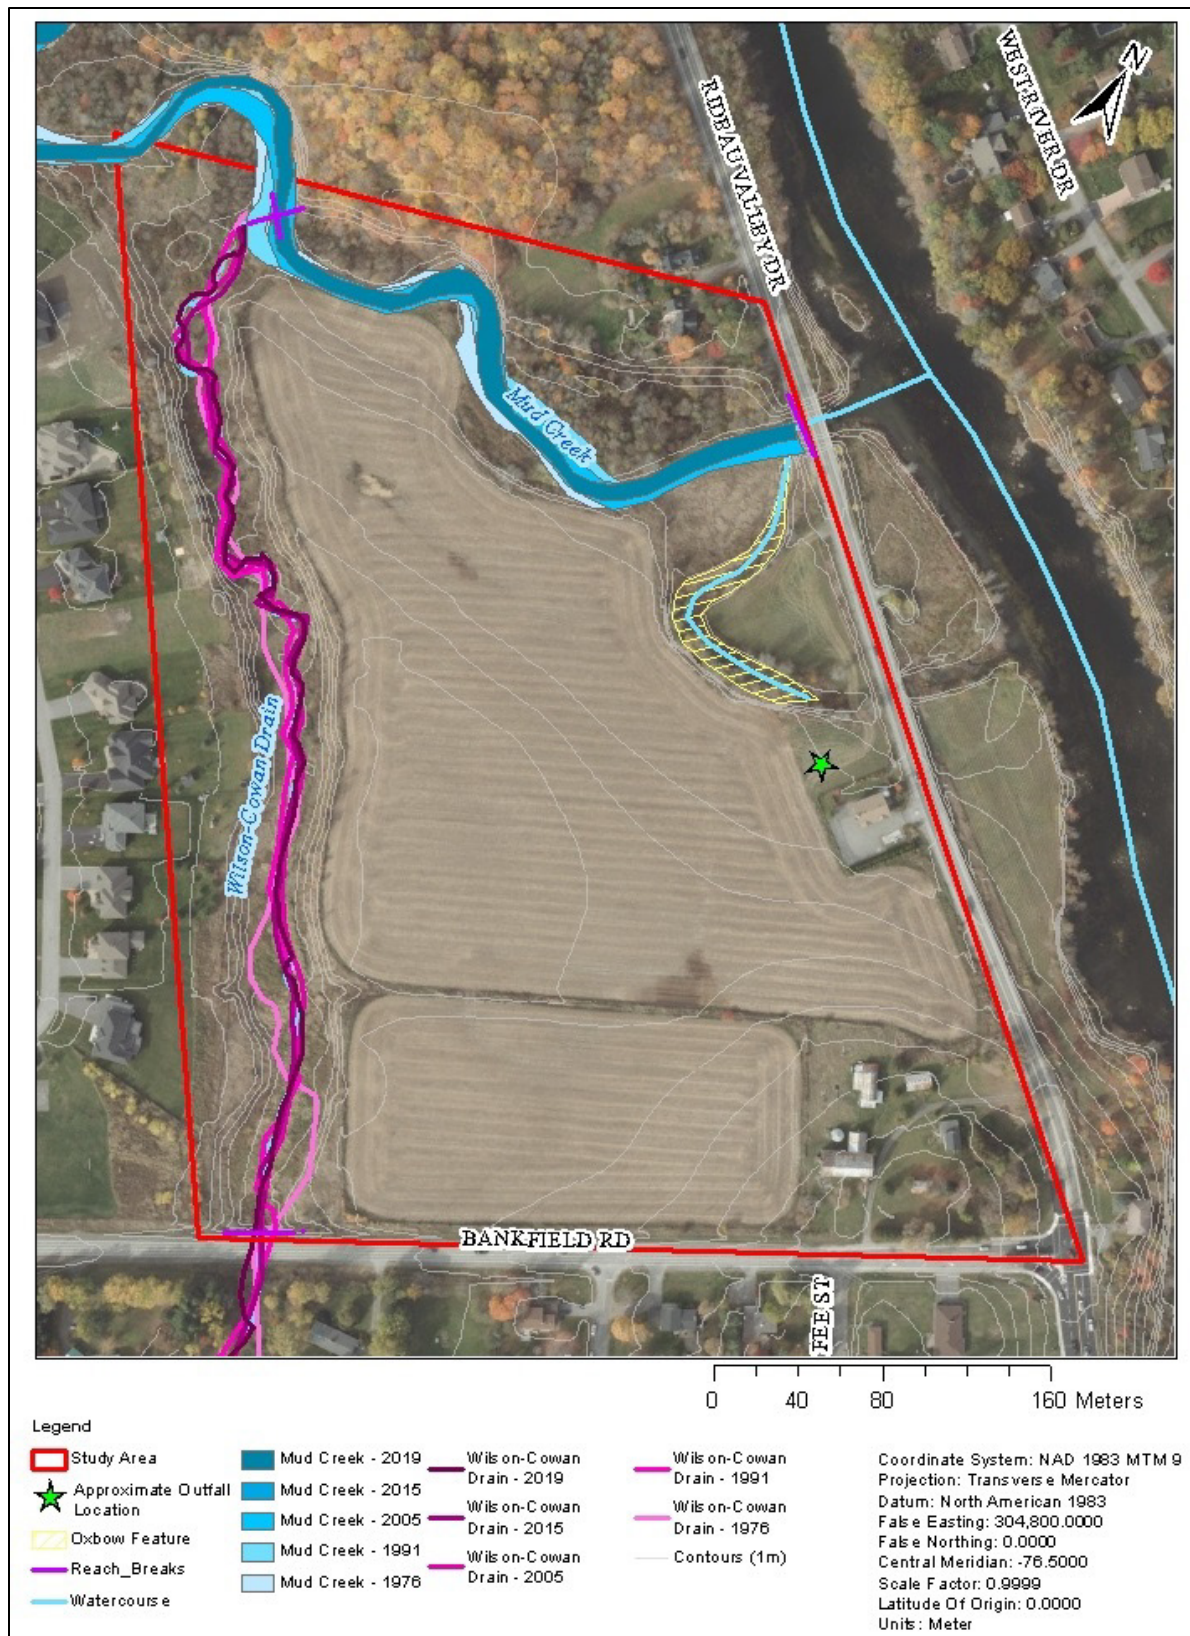
FIGURE 4 Planform Traces of Mud Creek and Wilson-Cowan Drain, 1976 to 2019

Changes in the watershed, such as urbanization and/or deforestation, typically alter the sediment and water contributions to the watercourse, which, in turn, trigger a response of channel adjustment that can be documented through historical aerial photographs. A review of historical aerial images of the Stinson Lands and surrounding area, obtained from the City of Ottawa (via ArcGIS web map service) and the University of Toronto map library (U of T 2022), was undertaken. For the study area, photographs from 1954, 1976, 1991, 2002, 2005, 2015, and 2019 were reviewed. The intent of the historical assessment was to evaluate channel changes in the context of land use adjustment and to quantify the amount and extent of channel migration that may have occurred for Mud Creek and the Wilson-Cowan Drain. The following text describes historical aerial images provided in Figure 3. Figure 4 presents historical planform traces of Mud Creek and Wilson-Cowan Drain adjacent to the Stinson Lands. The historical assessments allowed for meander migration rates to be determined for Mud Creek and the Wilson-Cowan Drain, which have been found to be 17 m per 100 years for both watercourses.

valley with a well-defined, narrow floodplain but with sparse woody vegetation. Aerial photographs from 1976 reveal that no major changes had occurred to the area surrounding Mud Creek or the Wilson-Cowan Drain immediately upstream of Stinson Lands. By 1991, significant urbanization had occurred south of the study site, with the town of Manotick bordering the Stinson Lands and multiple developments encroaching on Mud Creek to the north and south; however, there is no indication of the creek being modified. Air photographs from 2002 show minimal adjustment in the planform of each creek, as it maintains well-vegetated riparian areas in most of the surrounding area. Construction of a subdivision along the west side of the Wilson-Cowan Drain began in 2005, set back from the valley top. This development area is visible in the 2015 photograph; however, limited development expansion was evident in 2019, and planform adjustment revealed little to no change.

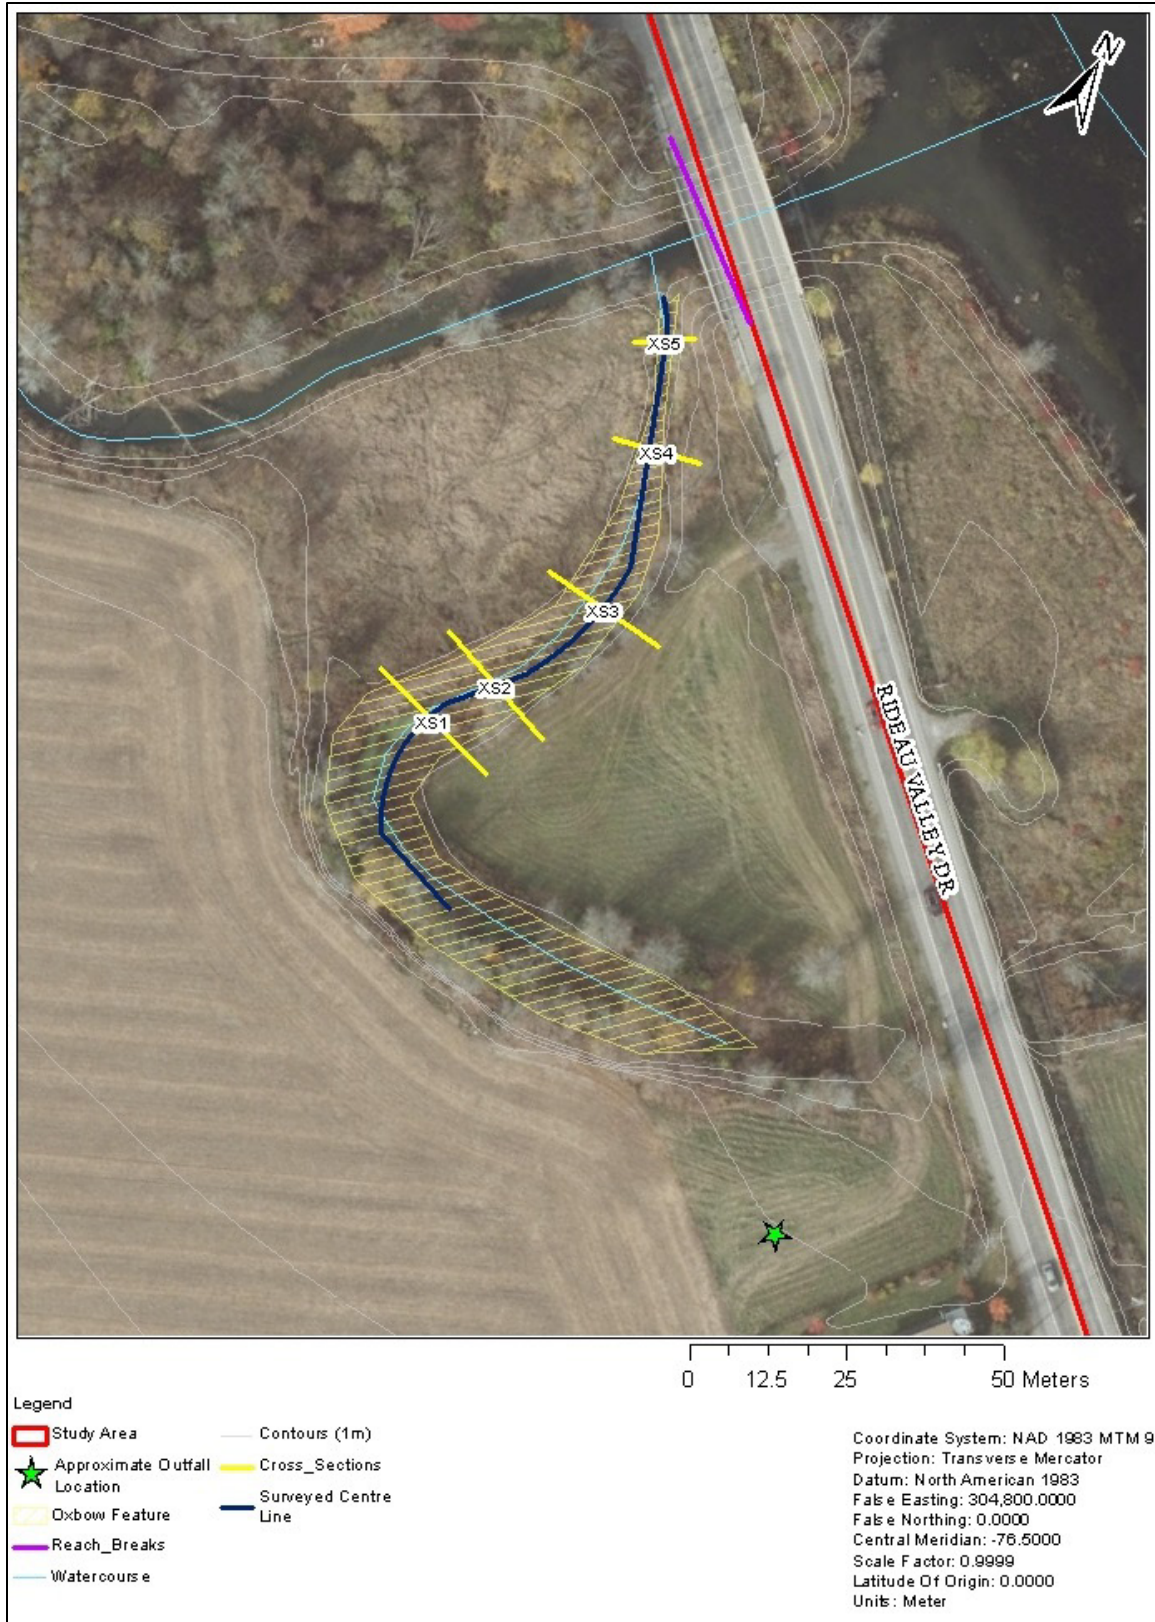
FIGURE 4 Survey Extents and Cross-section Locations Within the Oxbow Feature

The oxbow feature consists of a depression/scar that represents a historic meander of Mud Creek (Figure 4). This is assumed to be a relic feature of Mud Creek based on the feature dimension, orientation/position relative to the upstream planform trends, and straight planform of Mud Creek approaching Rideau Valley Drive. As noted in the historical assessment (Section 14), it has been interpreted that the channel was straightened to support the construction of Rideau Valley Drive prior to 1954 (earliest available air photograph set). The oxbow is approximately 175 m in length and varies in feature width from 2 to 15 m. Observations were made for the length of the feature, extending to Mud

Creek, with detailed surveys of profile and cross-sections being completed for a portion from the apex extending across Mud Creek (Figure 4). Standing water was observed within the feature during the field assessment, with depths exceeding 1.5 m, having a thick layer of unconsolidated silts. The outer banks of the oxbow were well-defined and exhibited signs of previous erosion. The oxbow is currently situated between cropped land to the north and the densely vegetated valley contact to the south. Where defined, widths ranged between 2 and 4 m, while depths ranged between 0.07 and 0.15 m. The entire oxbow is well-vegetated with reeds and cattails. The water depth increases toward the bend in the oxbow with standing water and saturated ground, allowing for survey rods to sink upwards of 0.5 m deep into the sediment. The oxbow becomes shallower in water depth approaching Mud Creek. Evidence of erosion was noted around the confluence with Mud Creek as a result of water flowing over the bank; however, no water was actively flowing from the oxbow into Mud Creek at the time of the site visit and is assumed to occur following precipitation/melt events.

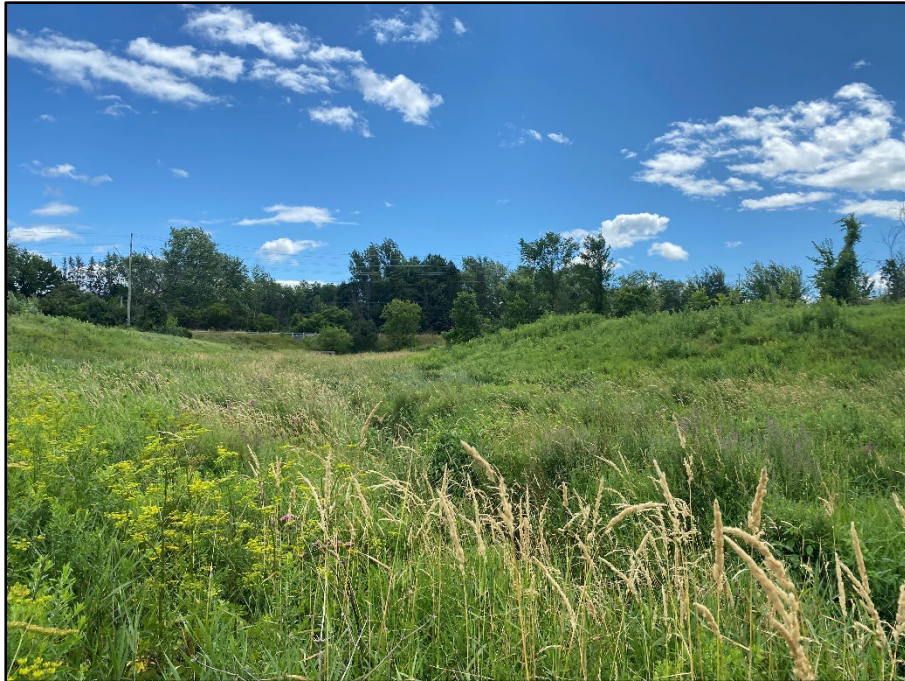
5. Wilson Cowan Drain - Looking upstream, despite being well vegetated, the channel maintains it's definition along the reach
