FLUVIAL GEOMORPHIC AND EROSION HAZARD ASSESSMENT STINSON LANDS OTTAWA, ONTARIO

Prepared for: NOVATECH ENGINEERING AND CONSULTANTS LTD.

Prepared by: MATRIX SOLUTIONS INC., A MONTROSE ENVIRONMENTAL COMPANY

Version 1.0 April 2024 Guelph, Ontario

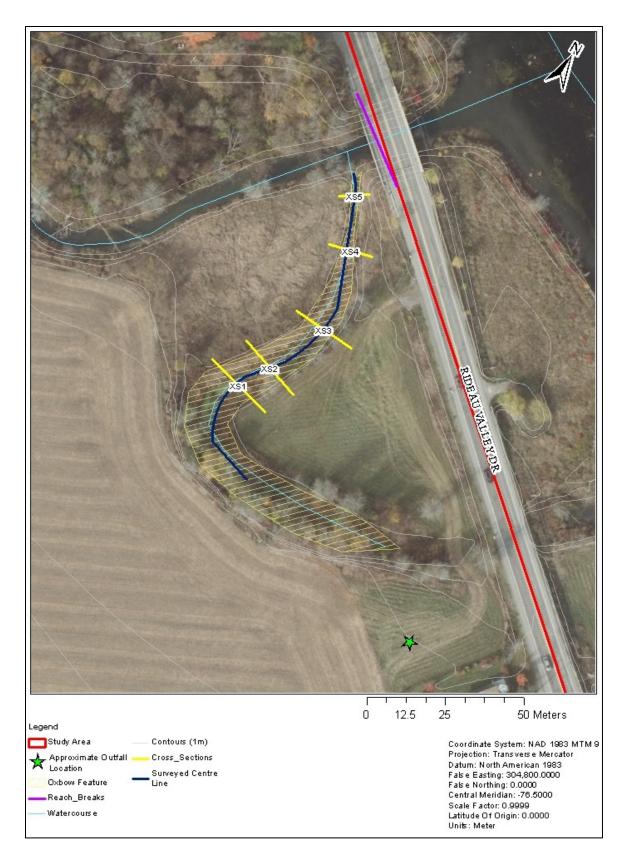
FIGURE 5 Survey Extents and Cross-section Locations Within the Oxbow Feature

The oxbow feature consists of a depression/scar that is assumed to be a relic feature (meander) of Mud Creek based on the feature dimension, orientation/position relative to the upstream meandering trends compared to the current straight planform of Mud Creek approaching Rideau Valley Drive. As noted in the historical assessment (Section 2.4), it has been interpreted that the channel was straightened to support the construction of Rideau Valley Drive prior to 1954 (earliest available air photograph set). The oxbow is approximately 175 m in length and varies in feature width from 2 to 15 m. Observations were made for the length of the feature, extending to Mud Creek, with detailed surveys of profile and cross-sections being completed for a portion from the apex extending across Mud Creek (Figure 5, and Appendix B).

The initial intent of this survey was to evaluate sensitivity to increased flows as it is a potential receiver for stormwater from the proposed development, however the oxbow features is no longer the primary stormwater outlet for the site, in the current plan (Novatech, 2024). Standing water was observed within the feature during the field assessment, with depths exceeding 1.5 m, having a thick layer of unconsolidated silts. The outer banks of the oxbow were well-defined and exhibited signs of previous erosion, with oversteepended banks that would have formed when the oxbow was online with flows in contact with the valley toe. The oxbow is currently situated between cropped land to the north and the densely vegetated valley contact to the south. Where defined, widths ranged between 2 and 4 m, while depths ranged between 0.07 and 0.15 m. The entire oxbow is well-vegetated with reeds and cattails. The water depth increases toward the bend in the oxbow with standing water and saturated ground, allowing for survey rods to sink upwards of 0.5 m deep into the sediment. The oxbow becomes shallower in water depth approaching Mud Creek. Evidence of erosion was noted around the confluence with Mud Creek as a result of water flowing over the bank; however, no water was actively flowing from the oxbow into Mud Creek at the time of the site visit and is assumed to occur following precipitation/melt events.

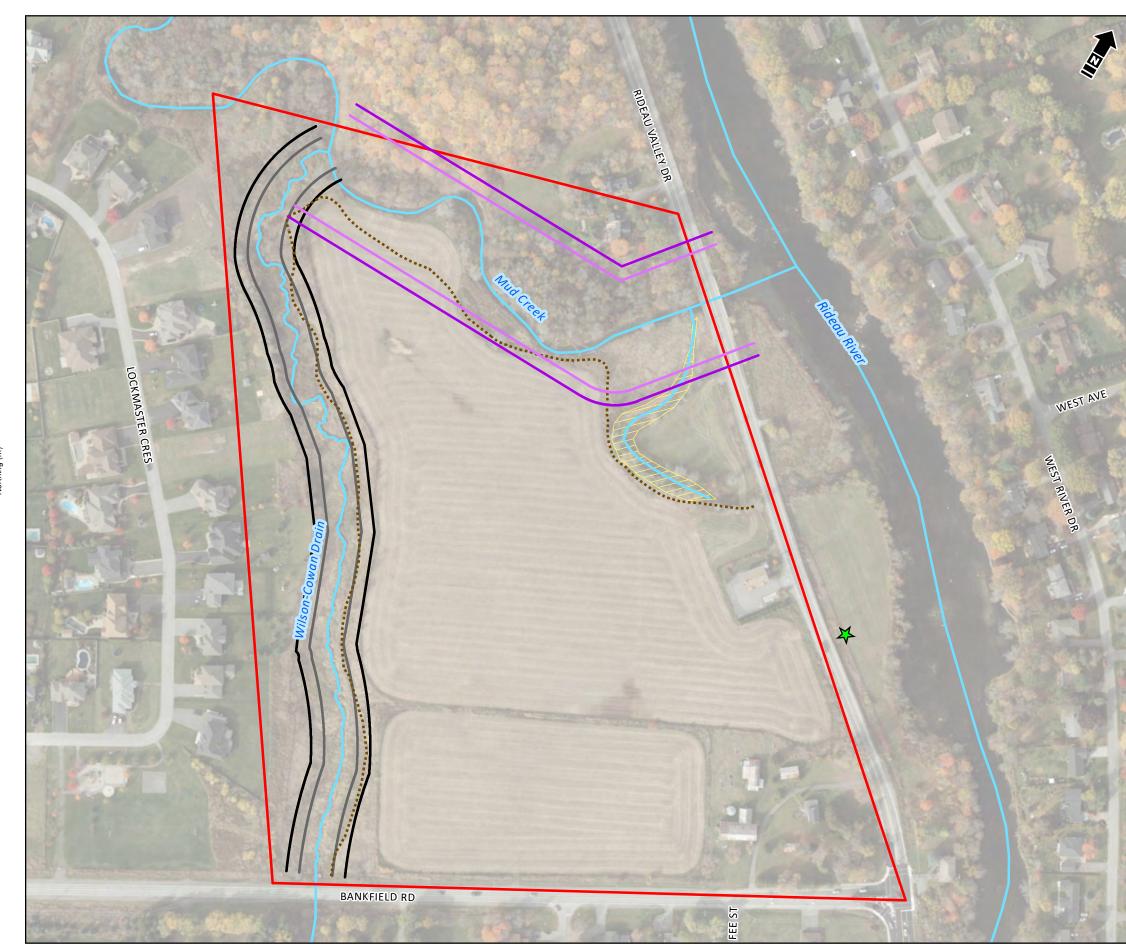
The confinement of the two channels varied can be seen in Figure 7 where the meander belt extends beyond the toe and top of slope, and therefore an erosion hazard limit to inform development has been determined for the confined system. Clay-silt was noted as the dominant material during the field investigations, and due to evidence of erosion noted within both channels, a toe erosion allowance of 5 m was selected using the Technical Guide (MNR 2002b) for areas where the watercourse was within 15 m of the valley toe. This value of 5 m also agrees with the findings and recommendations of the Paterson Group Inc. (2023), which applied a 5 m toe erosion allowance to Mud Creek due to its soil type and erosion activity. The 5 m toe erosion allowance was also applied to the Wilson-Cowan Drain due to the observed soil type, channel size, energy (i.e., not permanently flowing, standing water, or backwatered) and evidence of erosion noted during the field investigations. This value differs from the 1 m toe erosion allowance reported in the Paterson (3) geotechnical study, as they had not observed active erosion.

The preliminary meander belt width derived for the unconfined portion of Mud Creek is 60 m, as determined from the maximum meander amplitude offset from the meander axis. A 100-year erosion rate of 0.2 m/year (or 20 m per 100 years) was calculated, resulting in a final meander belt width of 80 m. For Wilson-Cowan Drain, the preliminary meander belt was determined to be 22 m in width. The final meander belt was determined by adding a 100-year erosion rate of 17 m as a factor of safety, resulting in a 38 m corridor (Figure 7). In this instance, the meander belt extends beyond the toe and top-of-slope within this confined valley setting.

Given that the proposed development is set atop a defined valley slope, the meander belt does not form the erosion hazard limit to development; rather, it may be used to inform of erosion hazards within the floodplain when siting structures, trails, and other infrastructure (e.g., bridges, maintenance holes).

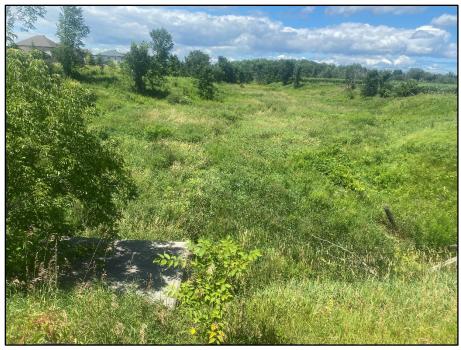
1. Wilson Cowan Drain - Facing downstream, Wilson-Cowan Drain and valley from Bankfield Road

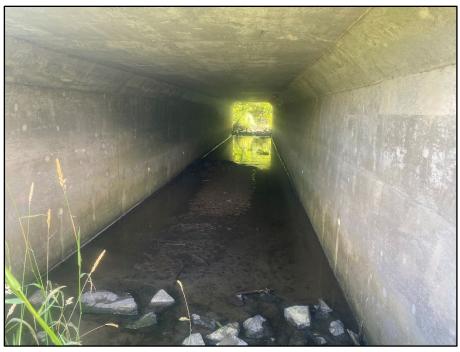
2. Wilson Cowan Drain - Facing upstream from outlet of culvert passing under Bankfield Road

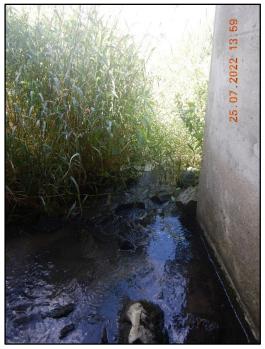
3. Wilson Cowan Drain - Facing downstream from inside culvert, the flow path is to the right side of the culvert flowing into a defined channel

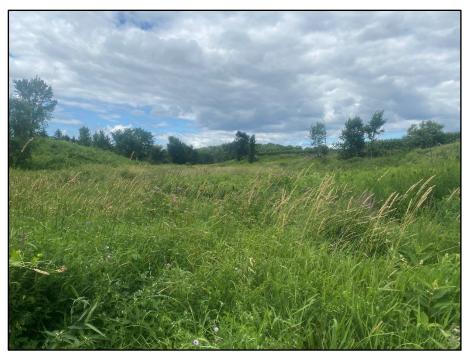
4. Wilson Cowan Drain - Facing downstream from culvert, the valley is well vegetated with tall grasses and aquatic vegetation

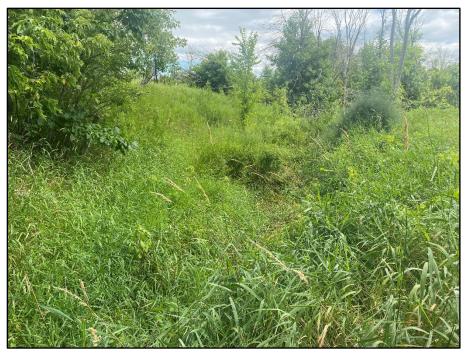
11. Oxbow Feature– Facing upstream from confluence with Mud Creek, feature is a defined valley that's heavily vegetated with grasses and reeds

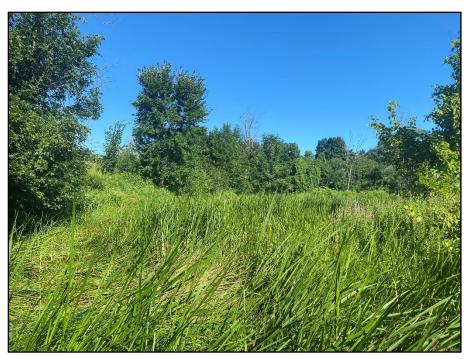
14. Oxbow Feature– Facing downstream, between the define banks, the feature is heavily grasses but maintains water
