# **Geotechnical Investigation**

## **Proposed Residential Development**

4386 Rideau Valley Drive  
Ottawa, Ontario

Report PG5828-1 Revision 4 dated April 4, 2024

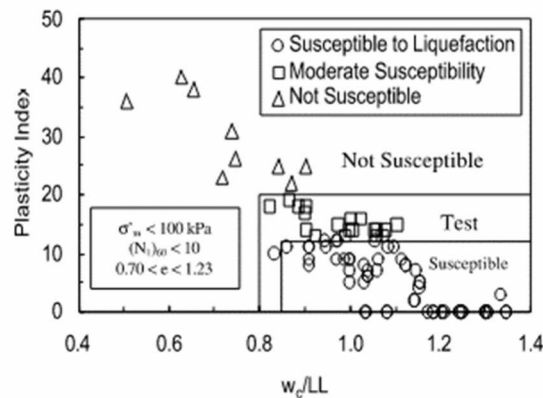
Figure 1. Criteria for evaluating liquefaction susceptibility of fine-grained soils (Bray et al. 2004).

The site class for seismic site response can be taken as **Class D** for the foundations considered at this site. The soils encountered at the subject site consist of silty clays, which are cohesive in nature. These soils were evaluated for liquefaction susceptibility in accordance with the criteria prepared by Bray at al. 2004 which determines that all soils with a plasticity index exceeding 20% are not liquifiable (Figure 1). In general, the plasticity index results completed on samples taken from the silty clay layer were found to be above 20. Therefore, soils underlying the subject site are not susceptible to liquefaction. Reference should be made to the latest revision of the 2012 Ontario Building Code for a full discussion of the earthquake design requirements.
