Geotechnical Investigation

Proposed Residential Development

4386 Rideau Valley Drive
Ottawa, Ontario

Report PG5828-1 Revision 2 dated October 14, 2022

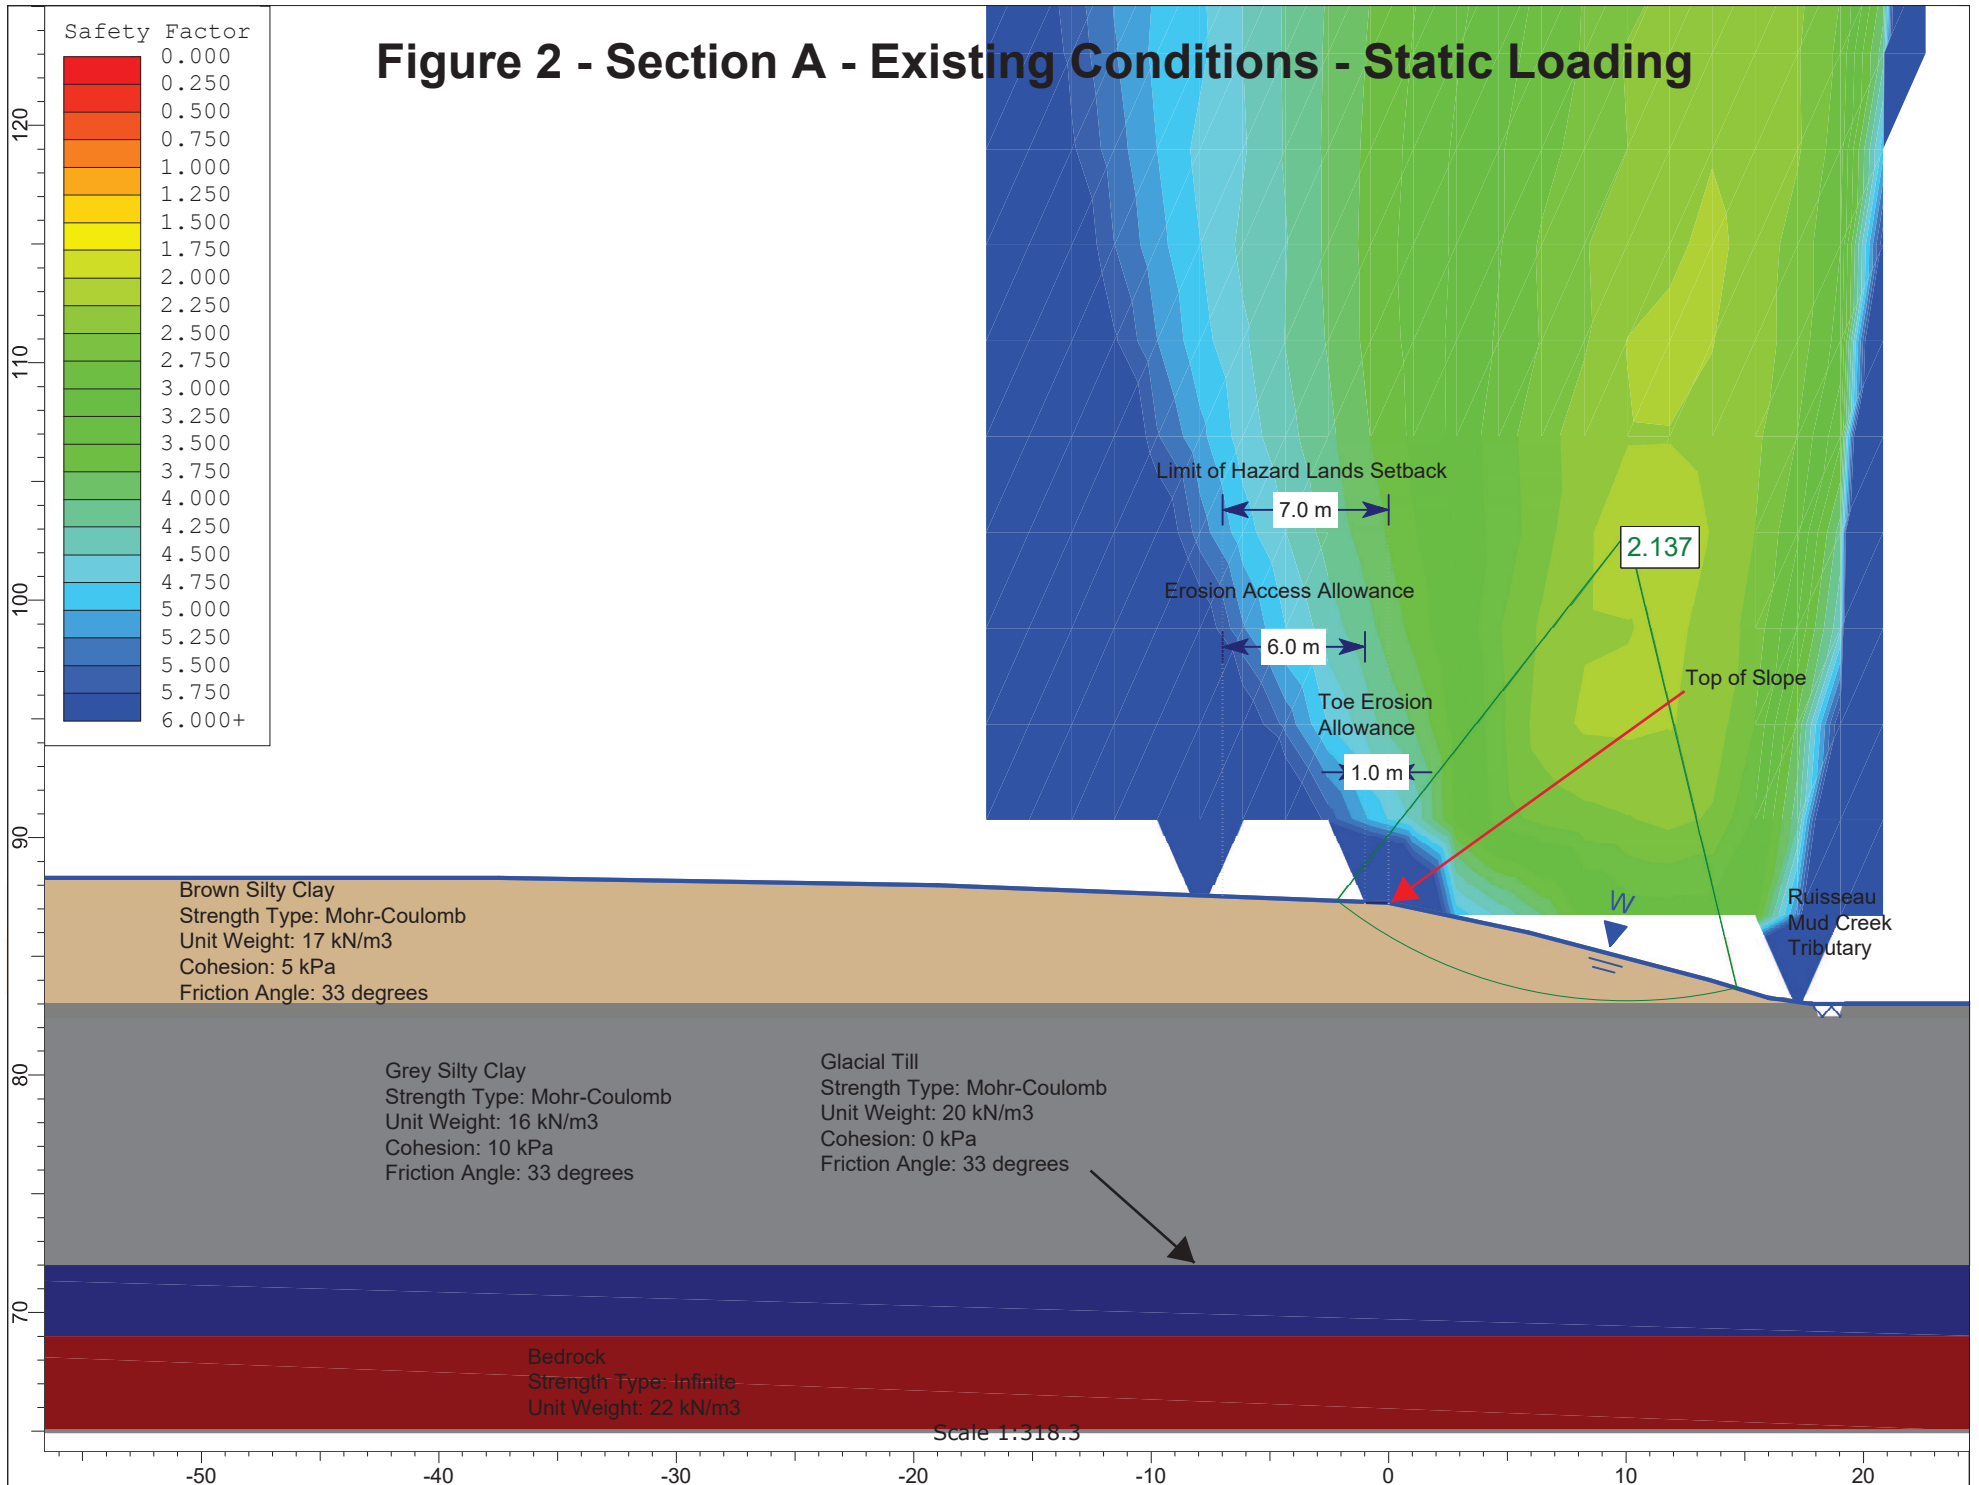
Figure 2 - Section A - Existing Conditions - Static Loading

The results are shown in Figures 2, 4, 6 and 8 in Appendix 2. The results indicate a slope with a factor of safety of 2.1 and 2.4 at Section A and Section B, respectively. The results also indicate slopes with factors of safety less than 1.5 beyond the top of slope at Section C and D. Based on these results, a stable slope setback varying between 1.3 and 5.3 m from the top of the slope are required to achieve a factor of safety of 1.5 for the limit of the hazard lands in the area of Sections C and D.

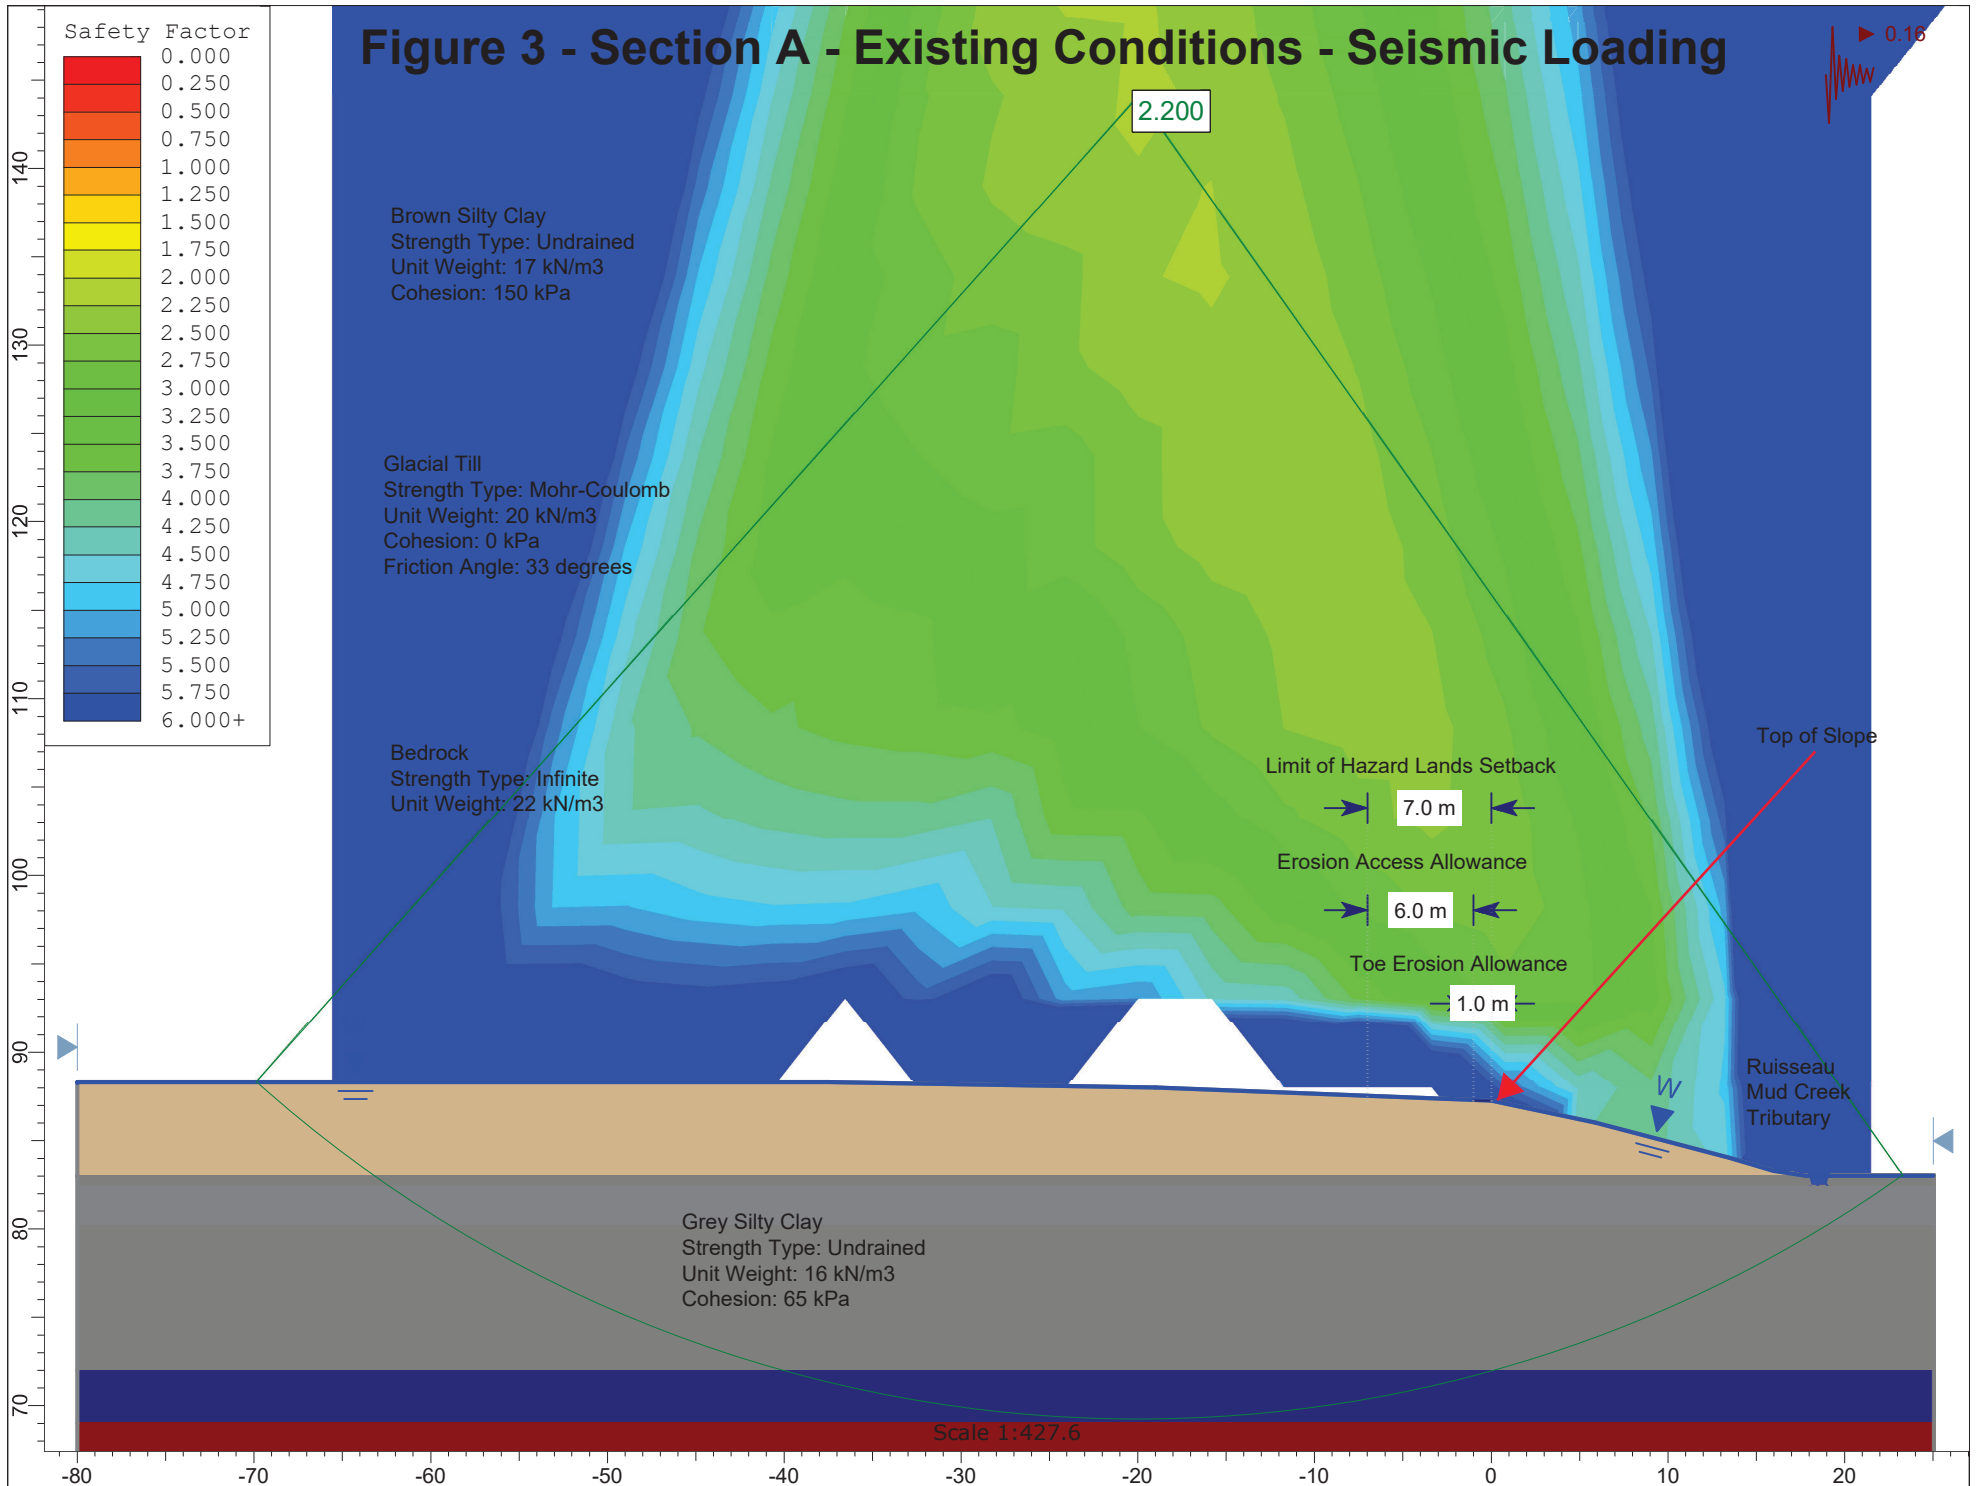
Figure 3 - Section A - Existing Conditions - Seismic Loading

The results of the analyses including seismic loading are shown in Figures 3, 5, 7 and 9 in Appendix 2. The results indicate a slope with a factor of safety greater than 1.1 at all sections. However, it should be noted that the stable slope setback associated with our static loading analysis governs the required stable slope setback required for static conditions.
