Tree Conservation Report

1495 Heron Road

November 23, 2022

Canada Lands Company

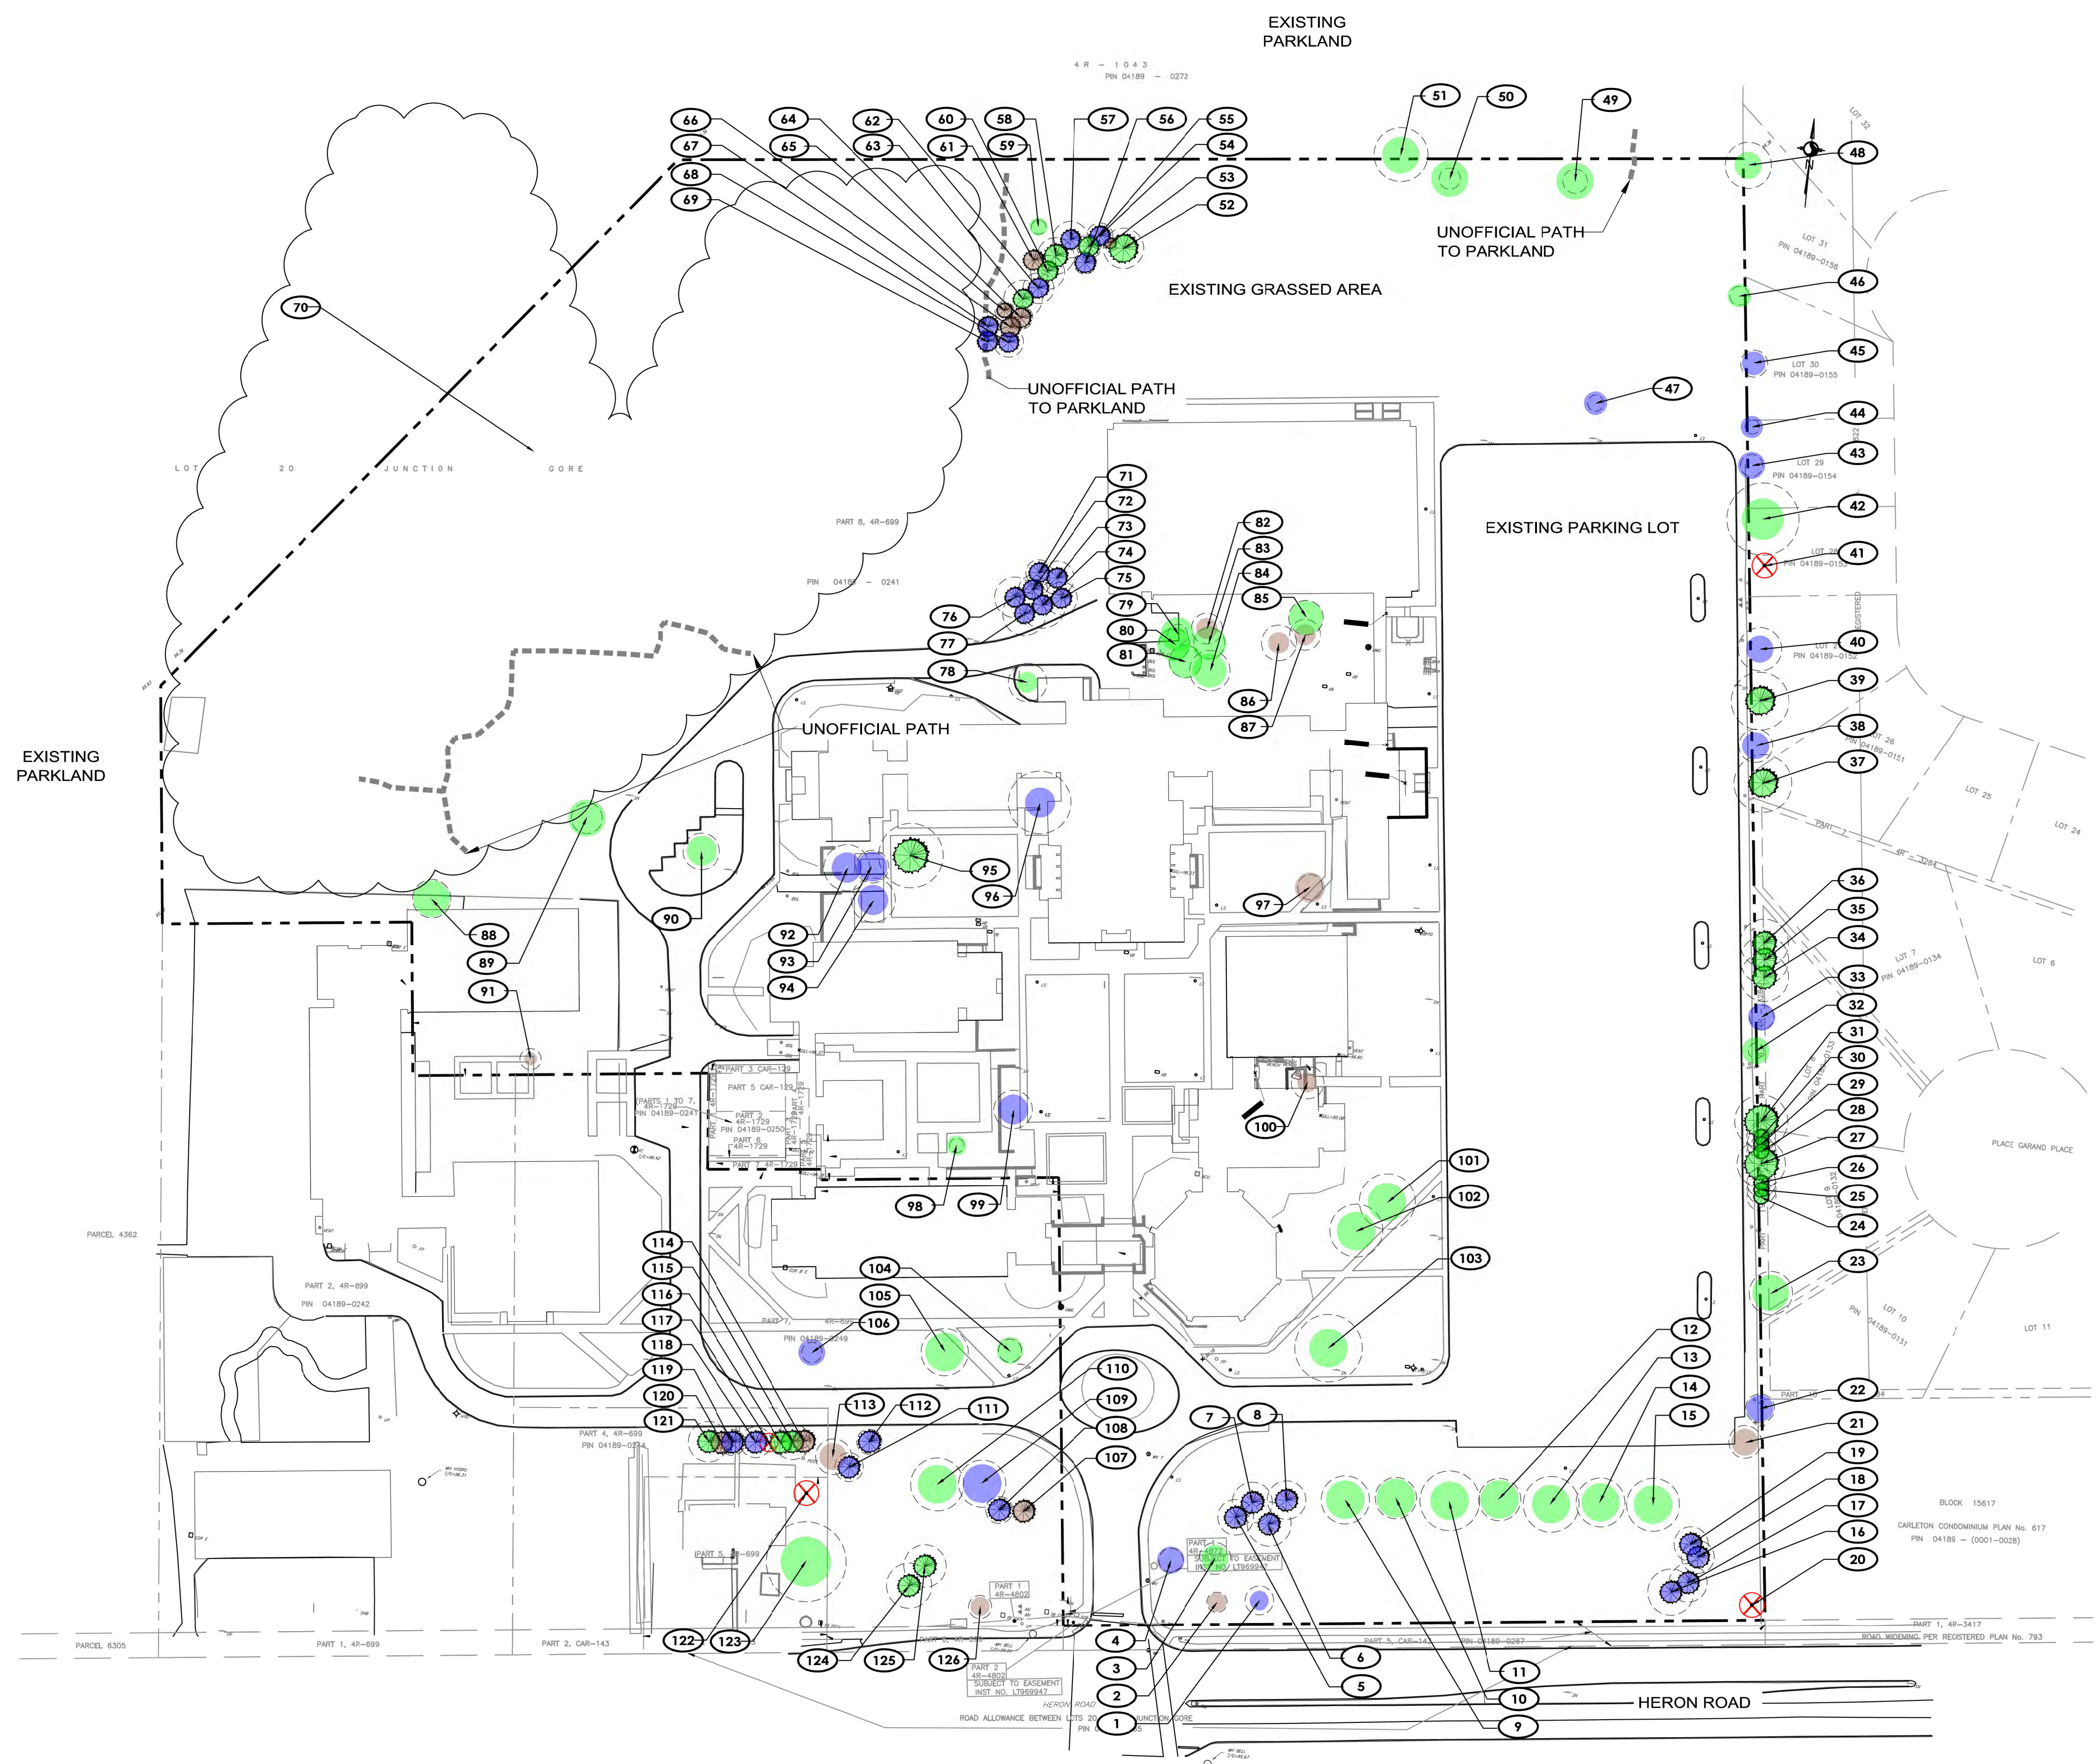
113	<i>Salix fragilis</i>	Crack Willow	32 ; 34 ; 37	Poor/Declining	Adjacent	Multistem (3 stems). Almost dead and hollow trunk.
114	<i>Pinus resinosa</i>	Red Pine	13	Poor	Adjacent	Some of dead branches and dieback possibly due to reduced quantity of sunlight.
115	<i>Pinus resinosa</i>	Red Pine	37	Good	Adjacent	
116	<i>Pinus resinosa</i>	Red Pine	25	Good	Adjacent	
117	<i>Pinus resinosa</i>	Red Pine	14	Dead	Adjacent	
118	<i>Pinus resinosa</i>	Red Pine	32	Fair	Adjacent	Some of dead branches and dieback possibly due to reduced quantity of sunlight.
119	<i>Pinus resinosa</i>	Red Pine	27	Fair	Adjacent	Some of dead branches and dieback possibly due to reduced quantity of sunlight.
120	<i>Pinus resinosa</i>	Red Pine	20	Poor / Fair	Adjacent	Many of dead branches and dieback possibly due to reduced quantity of sunlight.
121	<i>Pinus resinosa</i>	Red Pine	42	Good	Adjacent	
122	Dead tree	Dead tree	NA	Dead	Adjacent

123	<i>Acer platanoides</i>	Norway Maple	83	Good	Adjacent	
124	<i>Pinus sylvestris</i>	Scots Pine	47	Good	Adjacent	
125	<i>Pinus sylvestris</i>	Scots Pine	44	Good	Adjacent	
126	<i>Acer rubrum</i>	Red Maple	24	Poor/Declining	Adjacent	Almost dead with hollow trunk and small canopy.

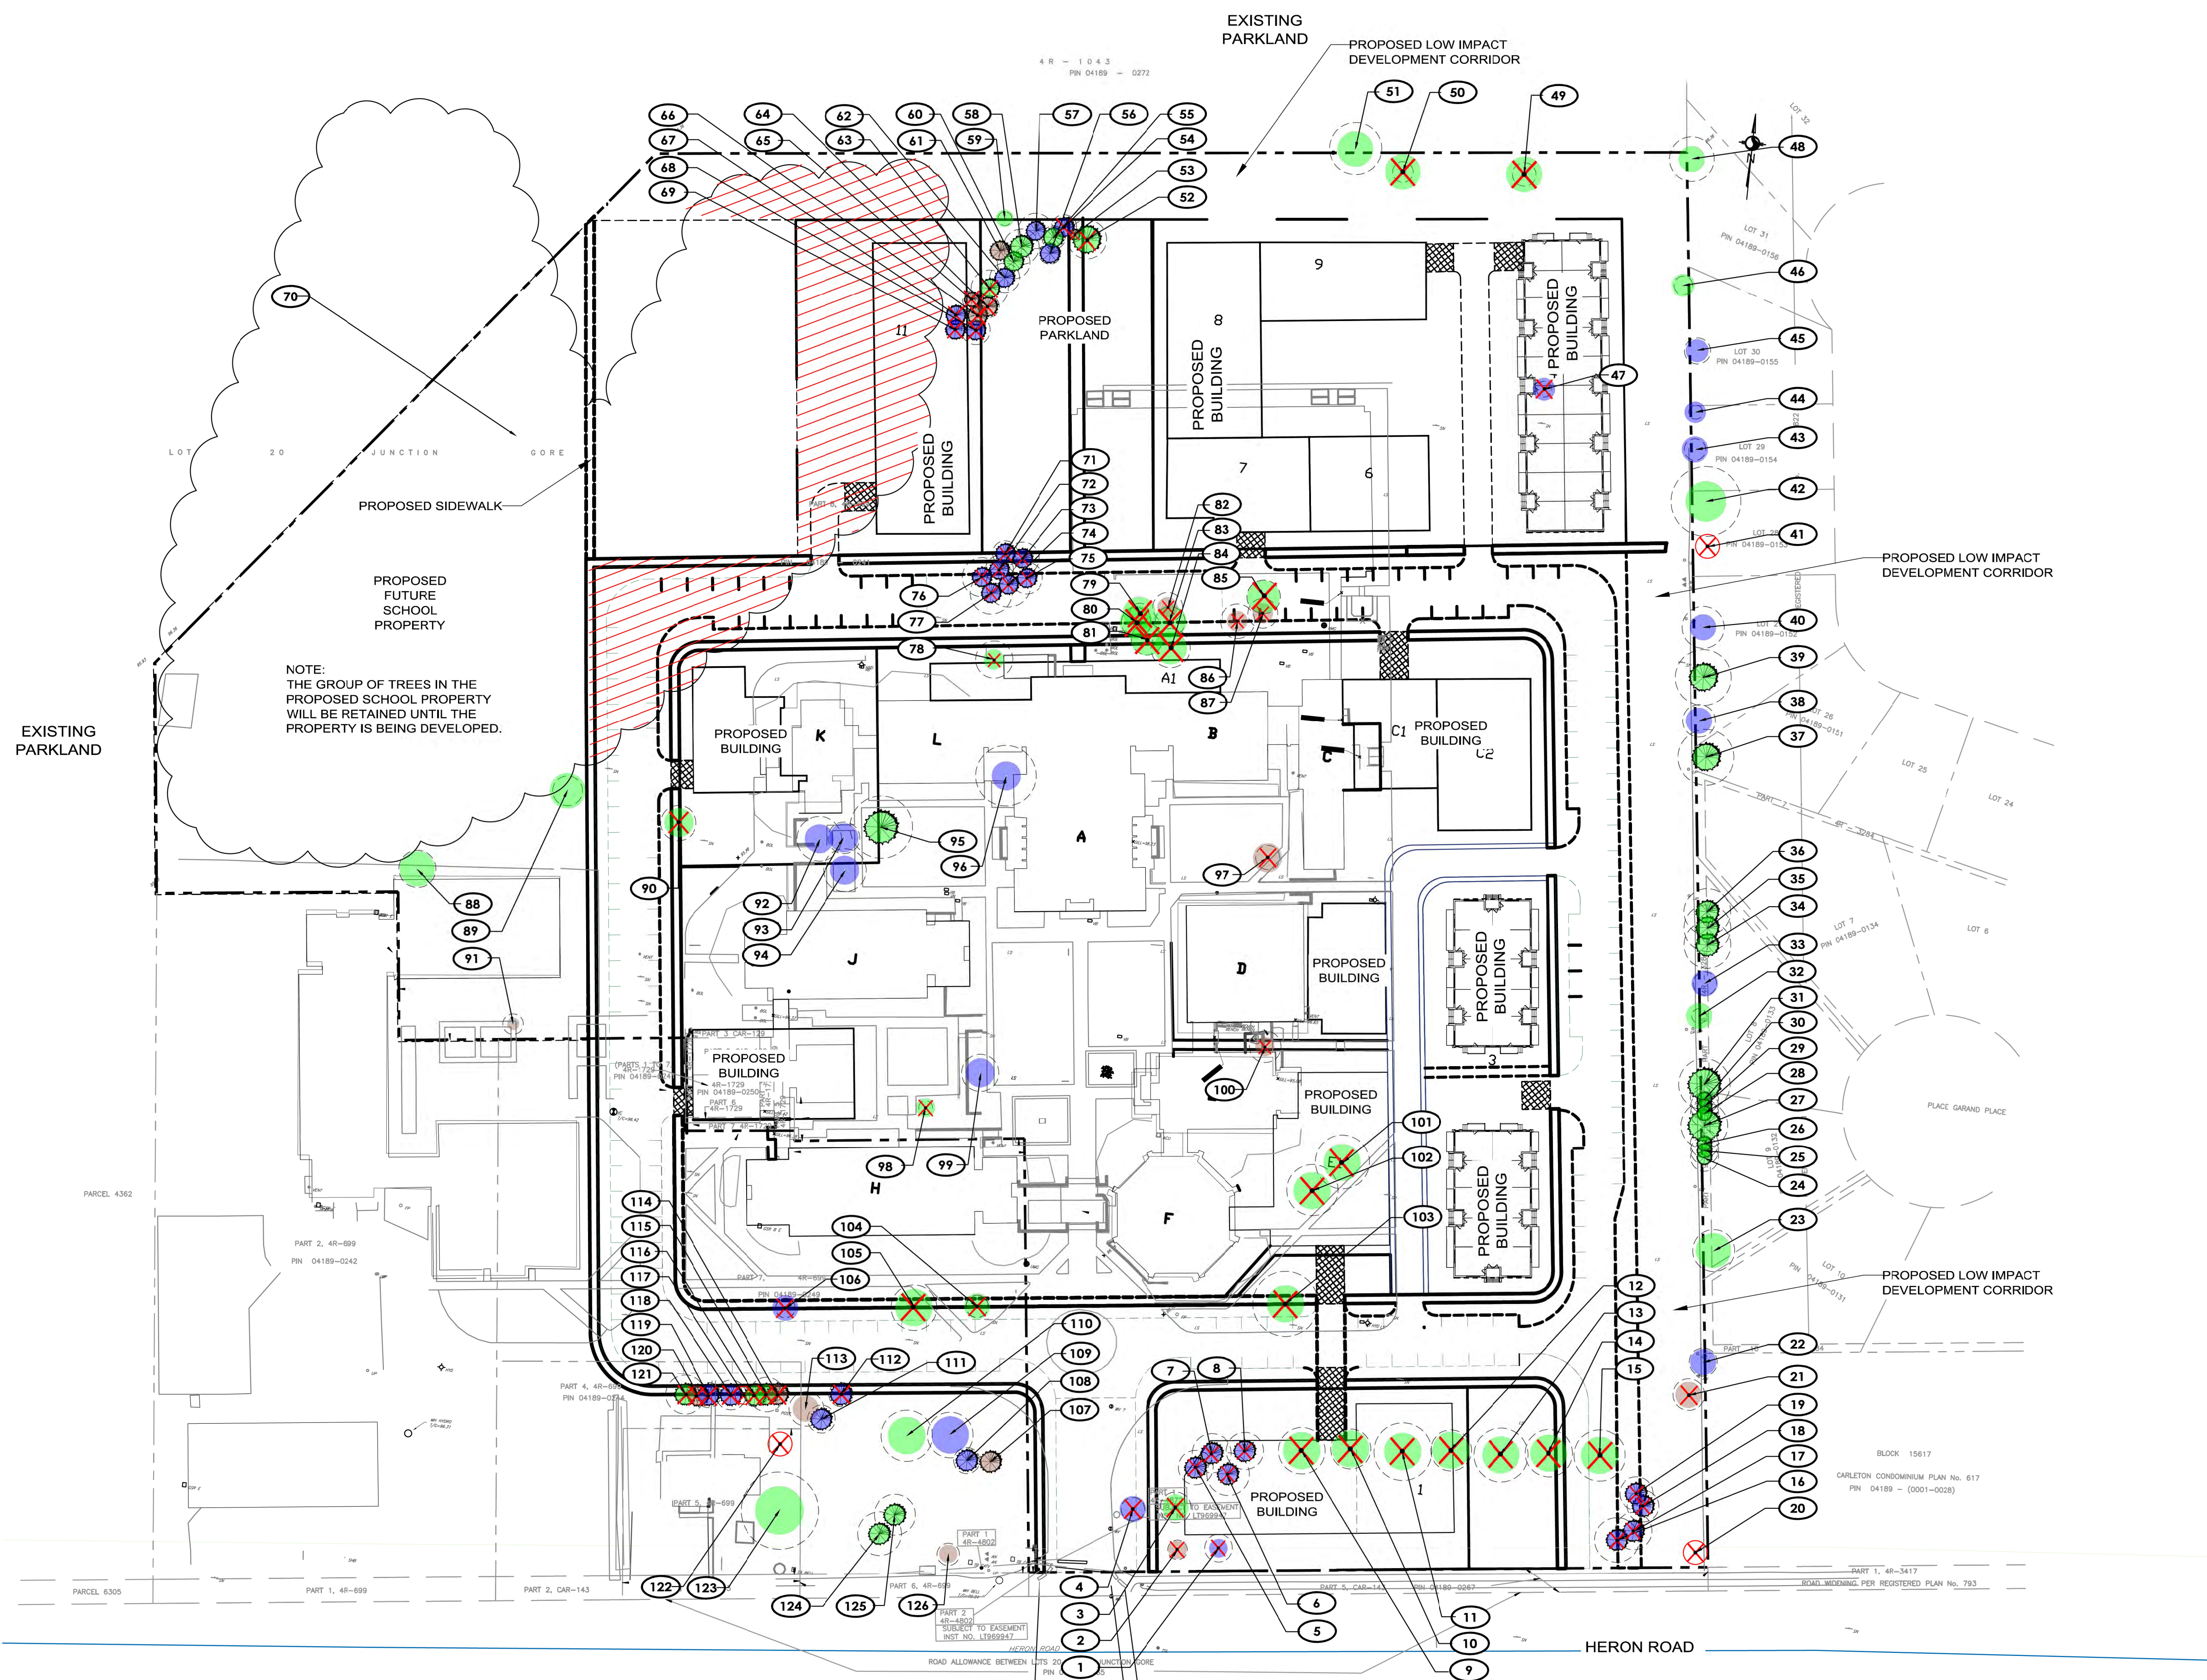
112	Pinus resinosa	Red Pine	26	Fair	Adjacent	Many of dead branches and dieback possibly due to reduced quantity of sunlight.
113	Salix fragilis	Crack Willow	32; 34; 37	Poor/Declining	Adjacent	Multistem (3 stems). Almost dead and hollow trunk.
114	Pinus resinosa	Red Pine	13	Poor	Adjacent	Some of dead branches and dieback possibly due to reduced quantity of sunlight.
115	Pinus resinosa	Red Pine	37	Good	Adjacent	
116	Pinus resinosa	Red Pine	25	Good	Adjacent	
117	Pinus resinosa	Red Pine	14	Dead	Adjacent	
118	Pinus resinosa	Red Pine	32	Fair	Adjacent	Some of dead branches and dieback possibly due to reduced quantity of sunlight.
119	Pinus resinosa	Red Pine	27	Fair	Adjacent	Some of dead branches and dieback possibly due to reduced quantity of sunlight.
120	Pinus resinosa	Red Pine	20	Poor / Fair	Adjacent	Many of dead branches and dieback possibly due to reduced quantity of sunlight.
121	Pinus resinosa	Red Pine	42	Good	Adjacent

122	Dead tree	Dead tree	NA	Dead	Adjacent	
123	Acer platanoides	Norway Maple	83	Good	Adjacent	
124	Pinus sylvestris	Scots Pine	47	Good	Adjacent	
125	Pinus sylvestris	Scots Pine	44	Good	Adjacent	
126	Acer rubrum	Red Maple	24	Poor/Declining	Adjacent	Almost dead with hollow trunk and small canopy.
