REVISED HERITAGE IMPACT ASSESSMENT & CONSERVATION PLAN FOR 211-231 BANK

Applications D02-02-22-0127 / D07-12-22-0188 and plan number 18910 $\,$

Revision 2: October 2024

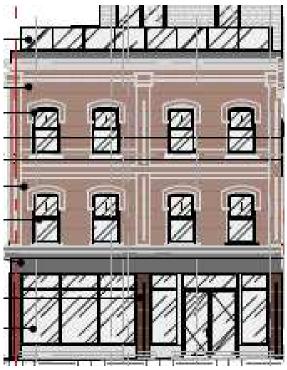
Undertake a detail review of both facades, noting areas of damaged brick, windowsills metal cornices and decorative pilasters.

- 2. Determine is pilasters are still extant under the brick veneer.
- 3. Repair as necessary the elaborate metal cornice. Repaint
- 4. Gentle pressure wash the brick of both façades to remove dirt and staining and provide a clean surface for repointing.
- 5. Selective repointing of brick and repair and repointing window and door sills.
- 6. All upper floor windows to be replaced with new units using similar profile of glazing pattern.
- Reinstate the large glazed commercial storefront that wraps around the corner with two bays on Nepean Street.
- 8. Restore the ground floor fluted pilasters with a capital to frame the two retail spaces.
- Introduce a commercial cornice with signboard, knee wall at base, recessed flared entrance. See comparative illustration of Ketchum's Bank at Bank and Sparks

Install mural on retained orange stucco. See comparative illustration of Bank Street building with large billboard on the return wall.

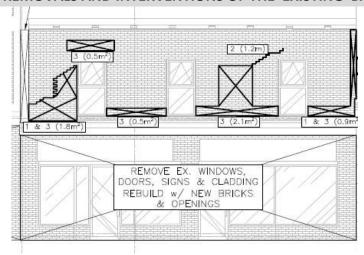
Removals, Interventions

The upper storey is intact with replacement windows. The original signboard, historic transom, and display windows have been removed and the brick piers reclad with a variegated brick siding.

- Undertake detailed assessment of the metal cornice.
- Assess upper floor brick façade and windowsills for damage, undertake detailed assessment of the metal cornice
- 3. Remove variegated brick cladding, signage, and storefronts from the ground floor.
- 4. Infill the gap with metal panel recessed between the adjacent buildings.

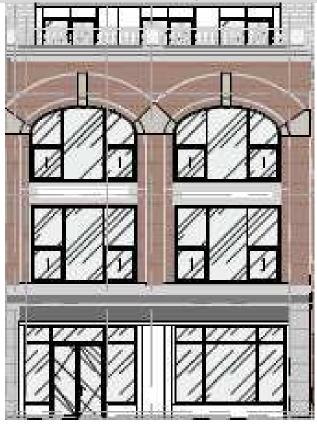
The building's footprint has not been altered. The upper floors show signs of deterioration and lack of maintenance. The retail on the ground floor consists of an aluminum and tile storefront with a recessed entrance flanked by the original stone piers.

- 1. See comparative illustrations.
- 2. Repair as necessary the elaborate metal cornice and balustrade.
- 3. Chemical wash.
- Repair pitted brick in arches, selective repointing of brick, and sills.
- The two large windows to be replaced with new units retaining the mullion pattern and infill metal panels.
- Retain and repoint ground floor stone pilasters with a capital to frame the commercial entrance.
- 7. Insert a support column midway between the columns.
- Insert large glazed commercial storefronts, setting it back to create a foyer with double entrance doors on the north side.
- 9. Re-introduce commercial cornice with signboard,
- 10. Reintroduce knee wall at base.

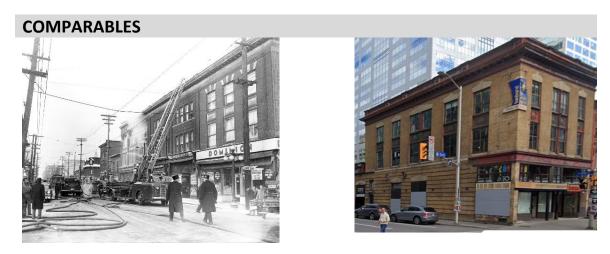
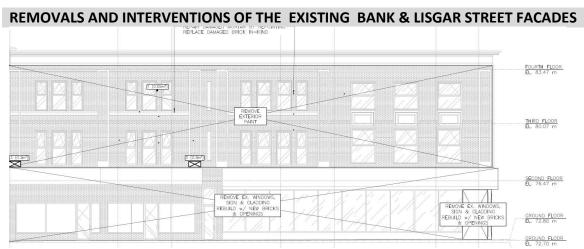
The façade of the Wallack's Building has been painted. In the detailed view, the spalling of the paint is extensive, suggesting that the removal of paint will not be too difficult.

The extent of damage to the brick needs to be assessed. Along the face there is step cracking of the brick below third floor windows. There is some bulging in places.

The pilasters at either end of the facade will have to be replaced at the street level. The large black panels at grade were originally windows that have been boarded over.
