Project No. 2020-134

November 17, 2020

**Re: 1 Maple Lane and 1112 Lisgar Road – Ottawa, ON
Field Inspection Report**

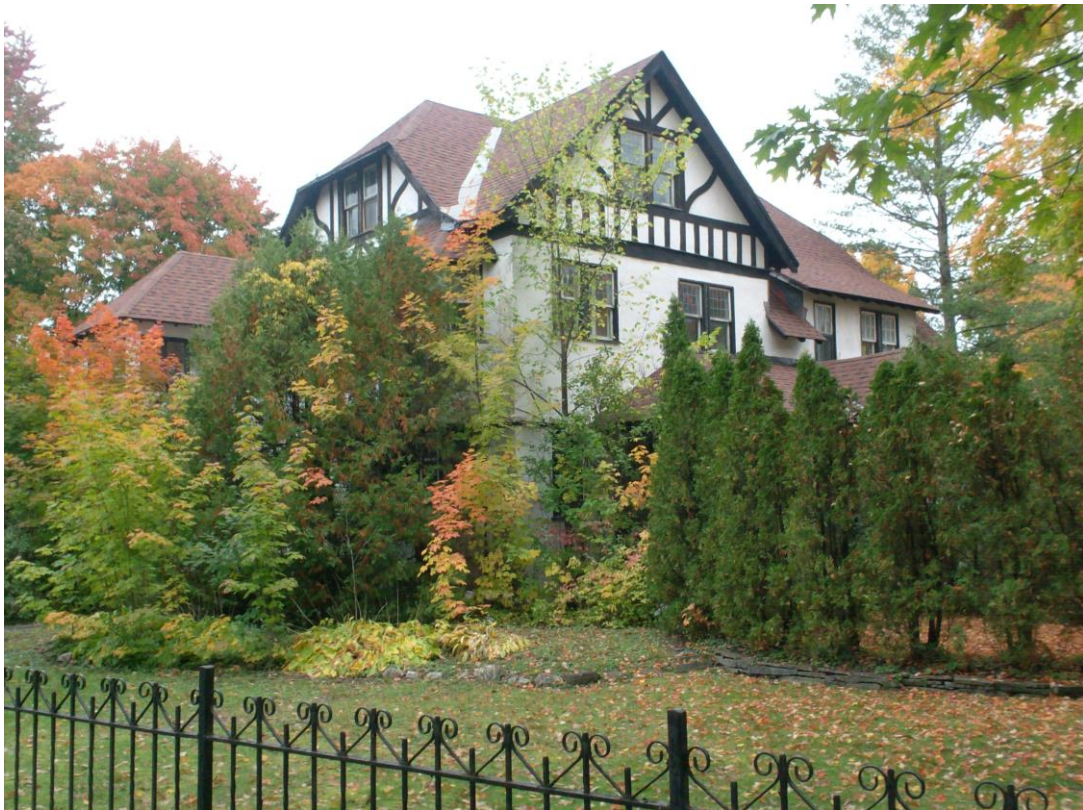
Photo 1

As requested by Roca Homes, REMISZ Consulting Engineers personnel Robert Papiez performed a site inspection of the residential building located at 1 Maple Lane and 1112 Lisgar Road in Ottawa (photo 1), on October 20, 2020. We were accompanied by house owner and representative from Paterson Group who did their own environmental check.
