**AZURE URBAN DEVELOPMENTS INC.**

## **254 ARGYLE AVENUE**

### **Church Relocation Scenarios Analysis**

**Project Number: 2023-049-2**

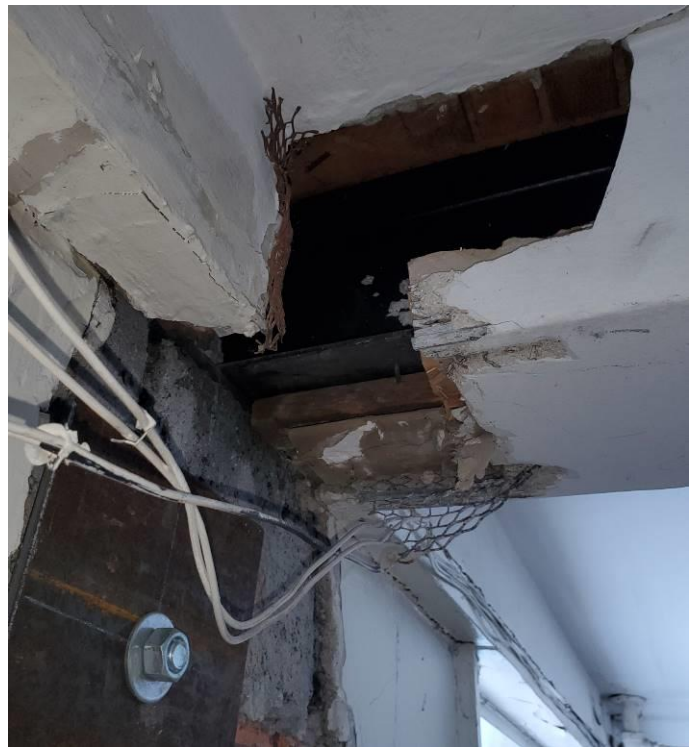
Figure 6: Steel Beam Sitting on Foundation Wall

- The steel columns are size W150x22, (d x b = 152mm x 152mm, see Figure 5).
- The steel beams are size W460x68 (d x b = 459mm x 154mm, see Figure 6).
- Total wall thickness was measured as 360mm (14 inches).
- The height from the basement floor to the left-hand basement windows is approximately 175 cm (70 inches).
- The height from the basement floor to the right-hand basement windows is approximately 137 cm (54 inches).

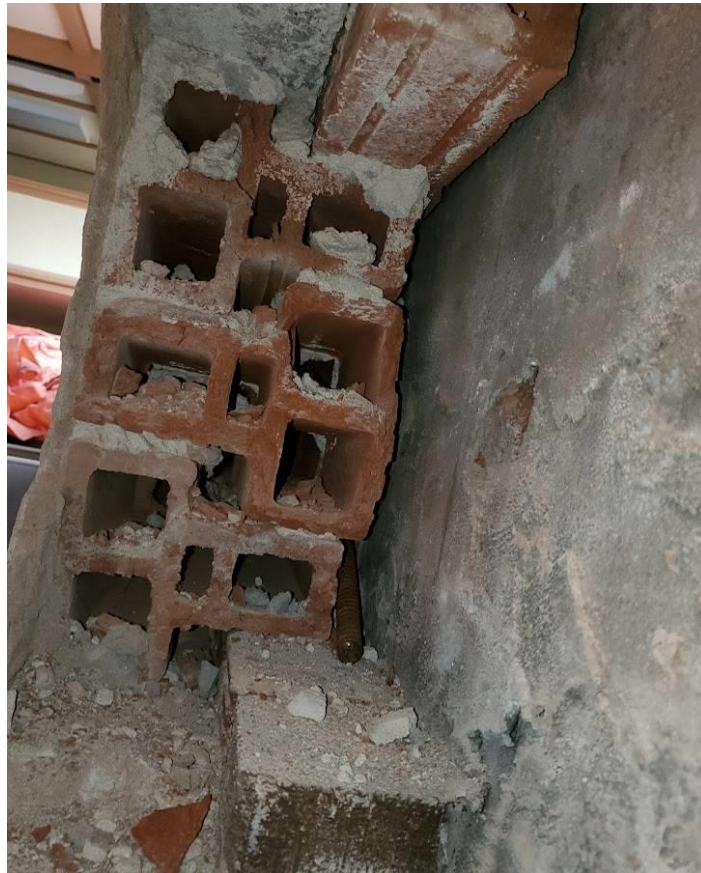
**Figure 8: Wall Section**

A 4' wide exploratory opening was made on the interior left-hand side wall (see Figure 8) and the following materials were found:

- **Material:** The brick veneer is made of clay.
- **Construction:** The brick veneer is a non-structural, decorative layer applied to the exterior of a building. On the back of the bricks is a uniform cementitious parging. The brick veneer is tied to the structural wall using brick headers every seventh course, following a pattern similar to a common bond, as shown in Figure 9 below. **It is important to note that the existing wall does not comply with current local building codes, which specify requirements for energy efficiency and structural integrity. This non-compliance may impact the future seismic performance of the entire project.**

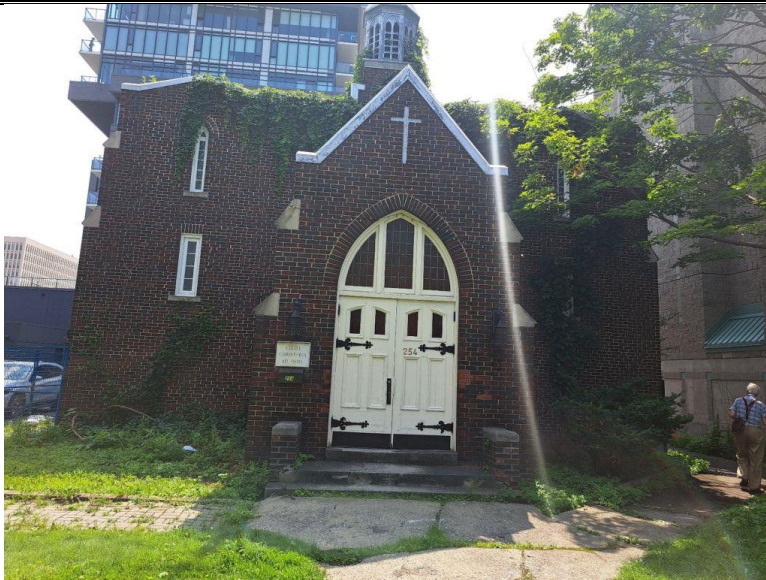
The concrete steps at the main entrance have deteriorated (see Photo 1). The main door is fabricated from painted wood (see Photo 2) and is in fair condition but requires maintenance (see Photo 3). The transom arch is made from glass panels and wood mullions. No ornaments were noted and most of the bricks are in good condition.

Photo 1  
Front entrance (West side)

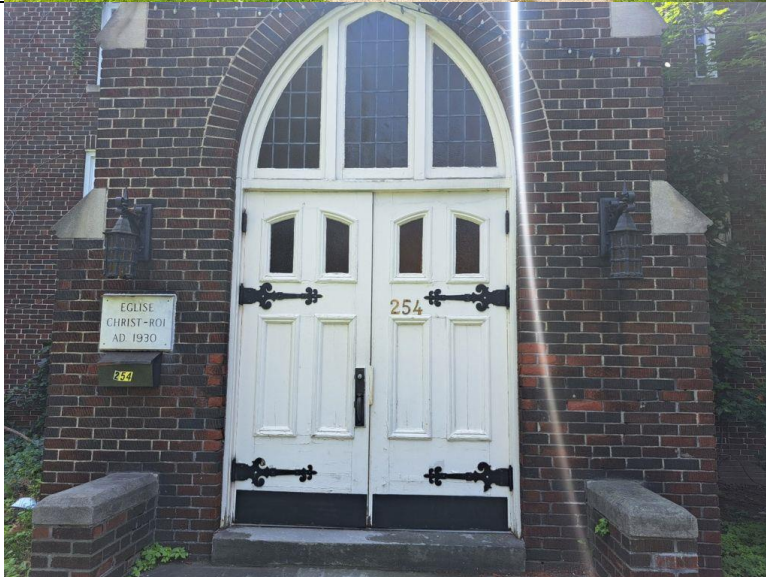
Photo 2  
Main entrance, wood door, Gothic style

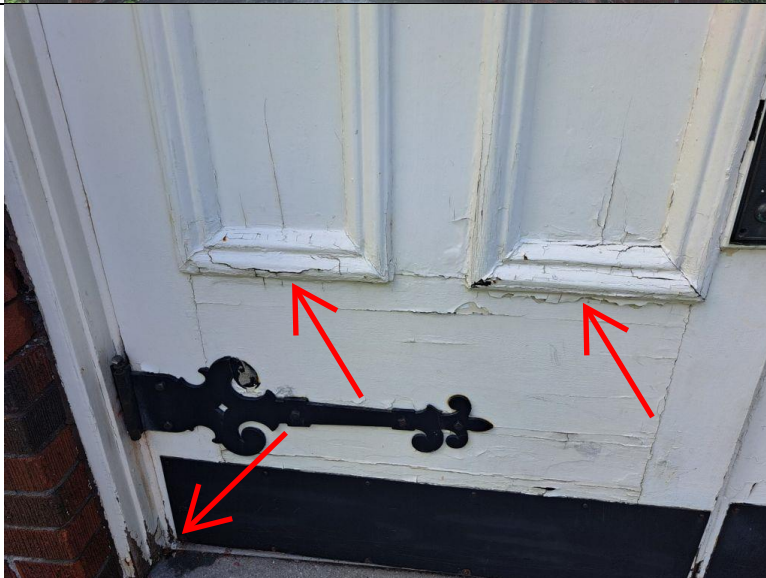
Photo 3  
The main door needs intense maintenance work

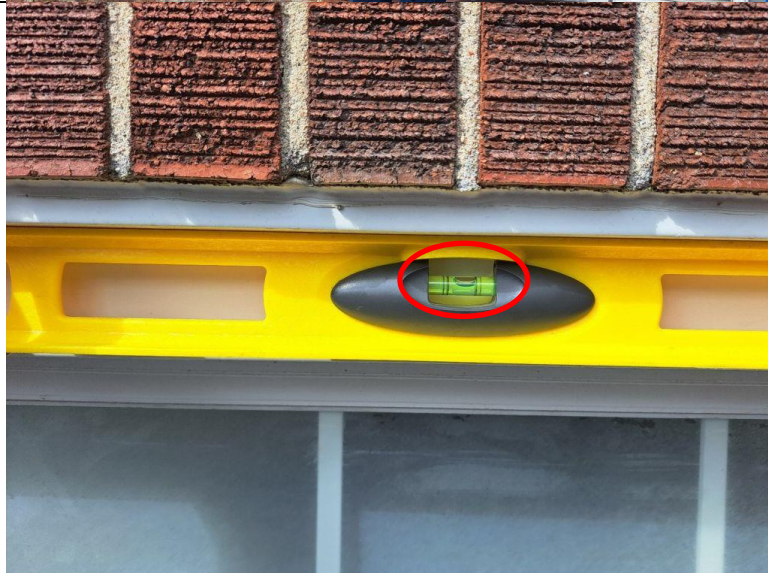
Photo 8

The building is tilted and there is noticeable settlement at the Southeast corner

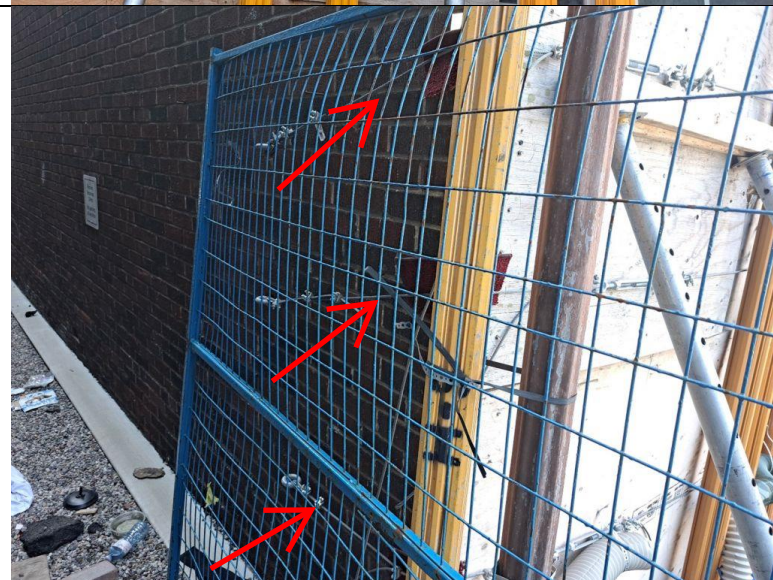
- Sheets of plywood are fastened to the brick cladding in the south-east corner with Tapcon fasteners at regularly spaced intervals to prevent further brick movement in that area. The plywood is secured tight to the building face by three cables (see Photos 11, 12, 13).

Photo 12  
The southeast corner is secured by fastening plywood to the brick and three cables

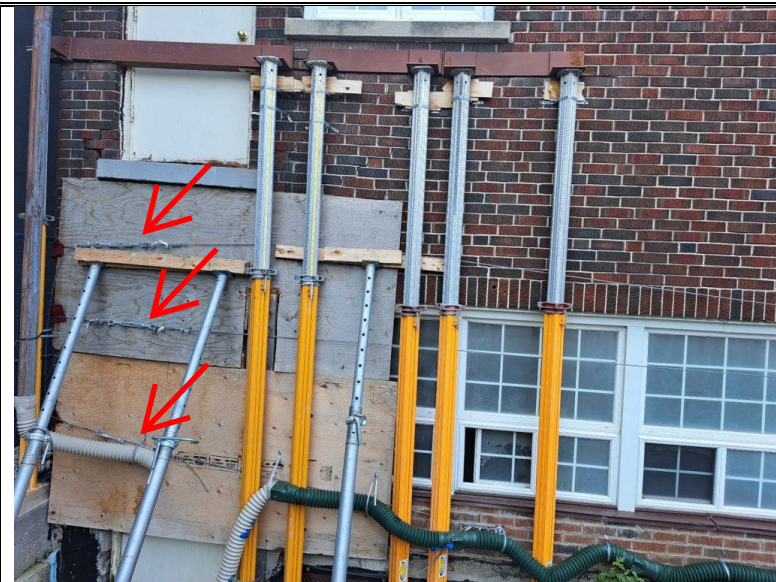
Photo 13

- Downspouts empty too close to the building, concentrating water against the foundation, a very likely source of basement water entry (see Photo 13).
- The staircase to the doorway on the main floor was removed (see Photo 13).

- Vertical supports are provided as temporary measures to prevent the whole south-east corner separating from left and back walls (see Photos 11, 13).
- The wall is leaning outwardly by 1cm for every meter (see Photos 15, 16).

The southeast corner is secured by fastening plywood to the brick and three cables

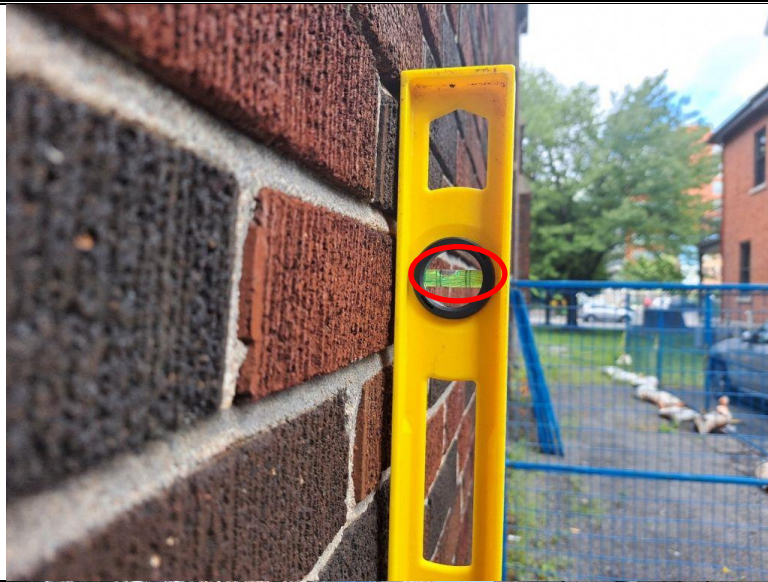
Photo 16  
The South wall is leaning to the outside by 1cm for every meter

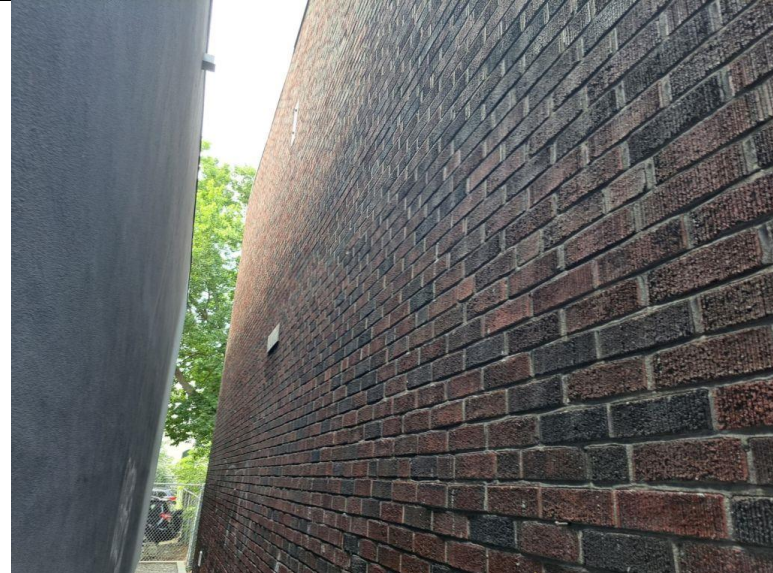
Photo 20

Rear side elevation (East side)

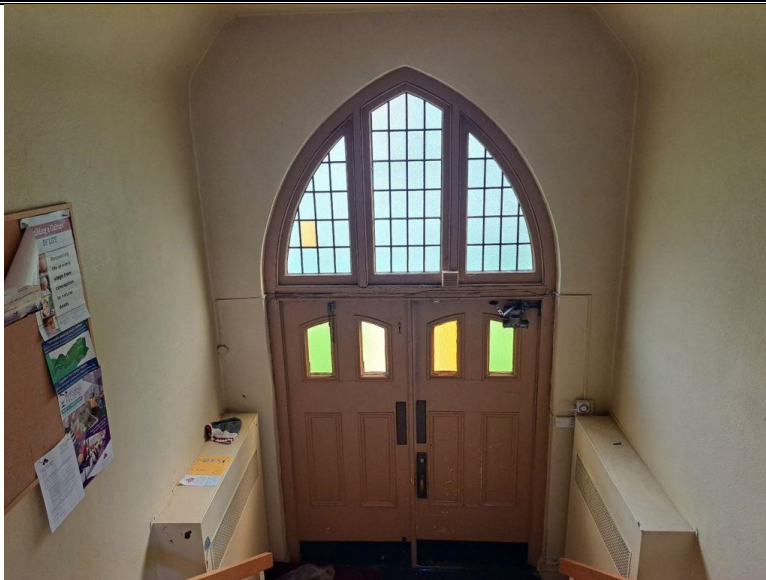
There are no severe cracks noted in this wall (see Photo 22) and the steps leading to the main floor are covered with ceramic tiles and are in fair condition (see Photo 23).

Photo 22  
The entrance door from inside

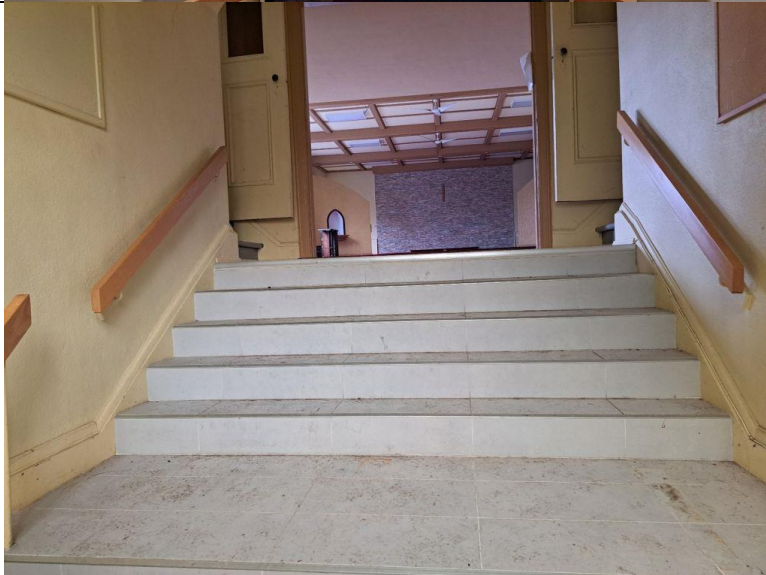
Photo 23  
The internal steps are covered with ceramic tiles

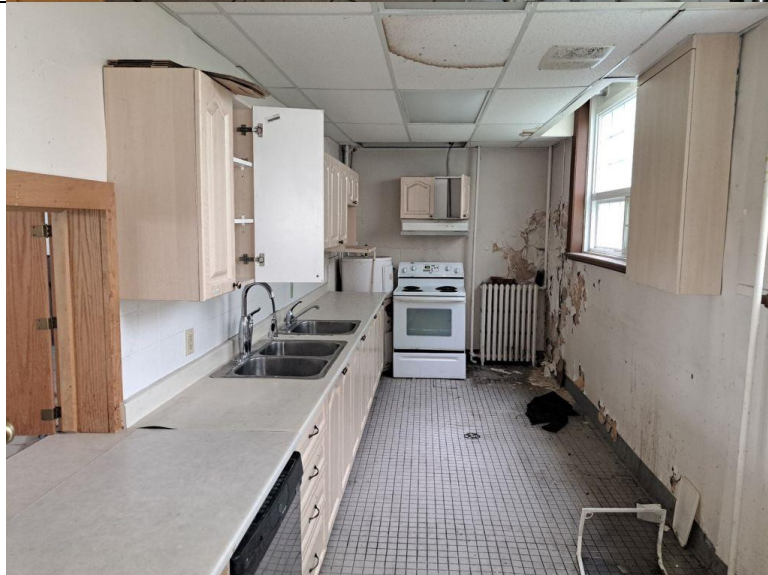
The kitchen area is neglected. The appliances and the water heater are not maintained. The kitchen had visible moisture intrusion and water leakage on the floor. The false ceiling also had broken panels (see Photos 65 – 66).

Photo 65  
Kitchen room view

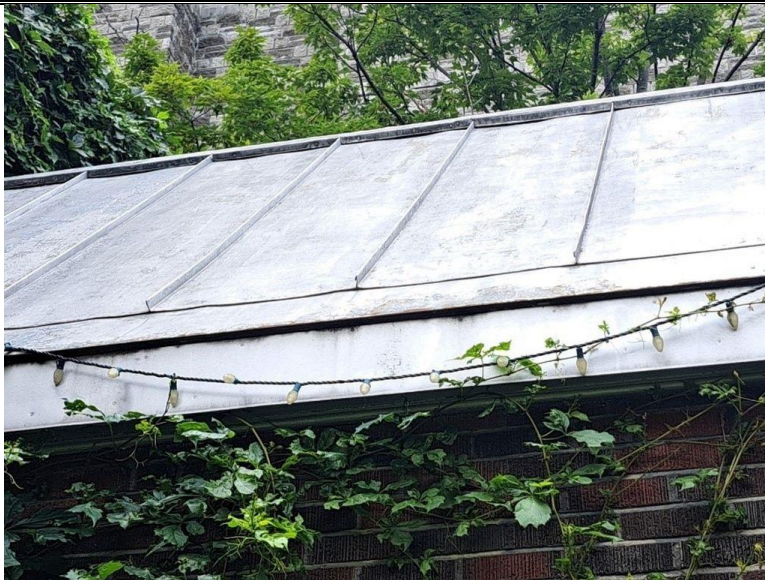
There is damaged flashing on the gabled front entrance roof (see Photos 67 – 68). The main roof is a flat roof with a small slope covered with asphalt roll roofing (see Photo 69). We were unable to properly assess the condition of the roofs due to lack of visibility and access. Do note that all downspouts of the

Photo 67  
Sloped metal roof at the main entrance

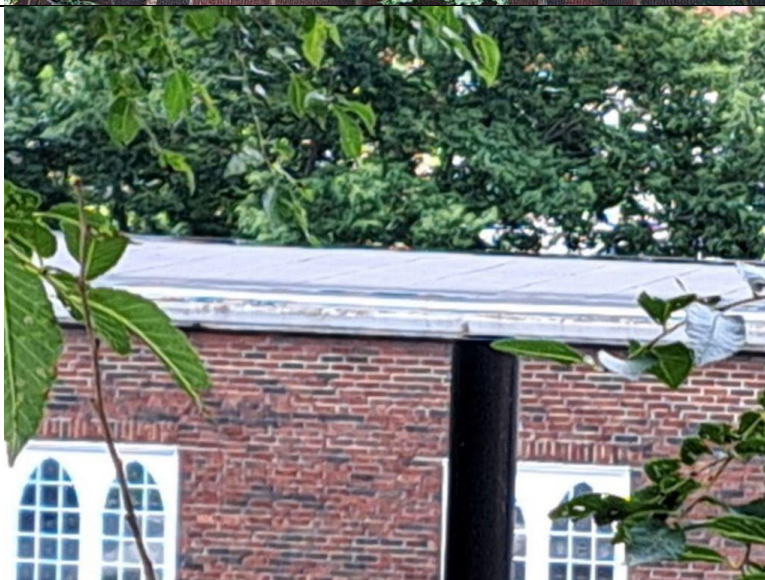
Photo 69  
General view of the flat roof from above the church building

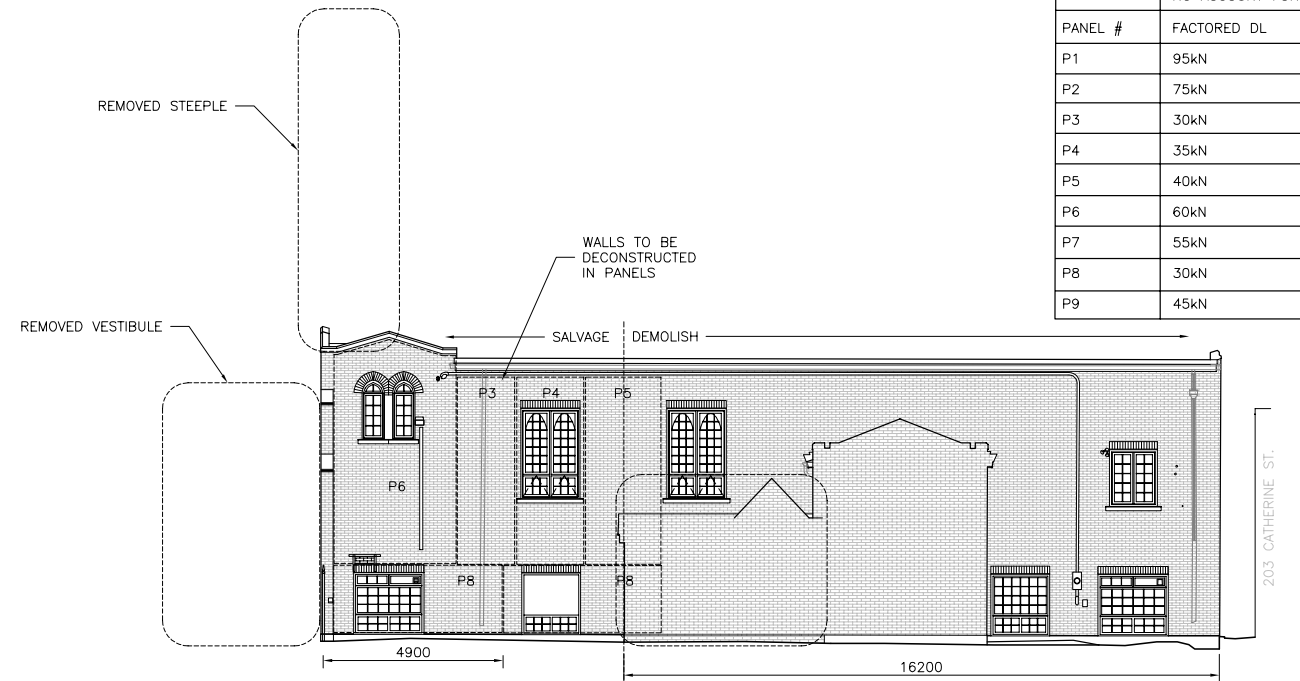
RIGHT ELEVATION — PANEL CUTS  
1:100

PANEL WEIGHTS	
PARAMETERS:	BRICK WALL DL = 2.3kPA, FACTORED LOAD = 1.4D NO ACCOUNT FOR WINDOWS
PANEL #	FACTORED DL
P1	95kN
P2	75kN
P3	30kN
P4	35kN
P5	40kN
P6	60kN
P7	55kN
P8	30kN
P9	45kN

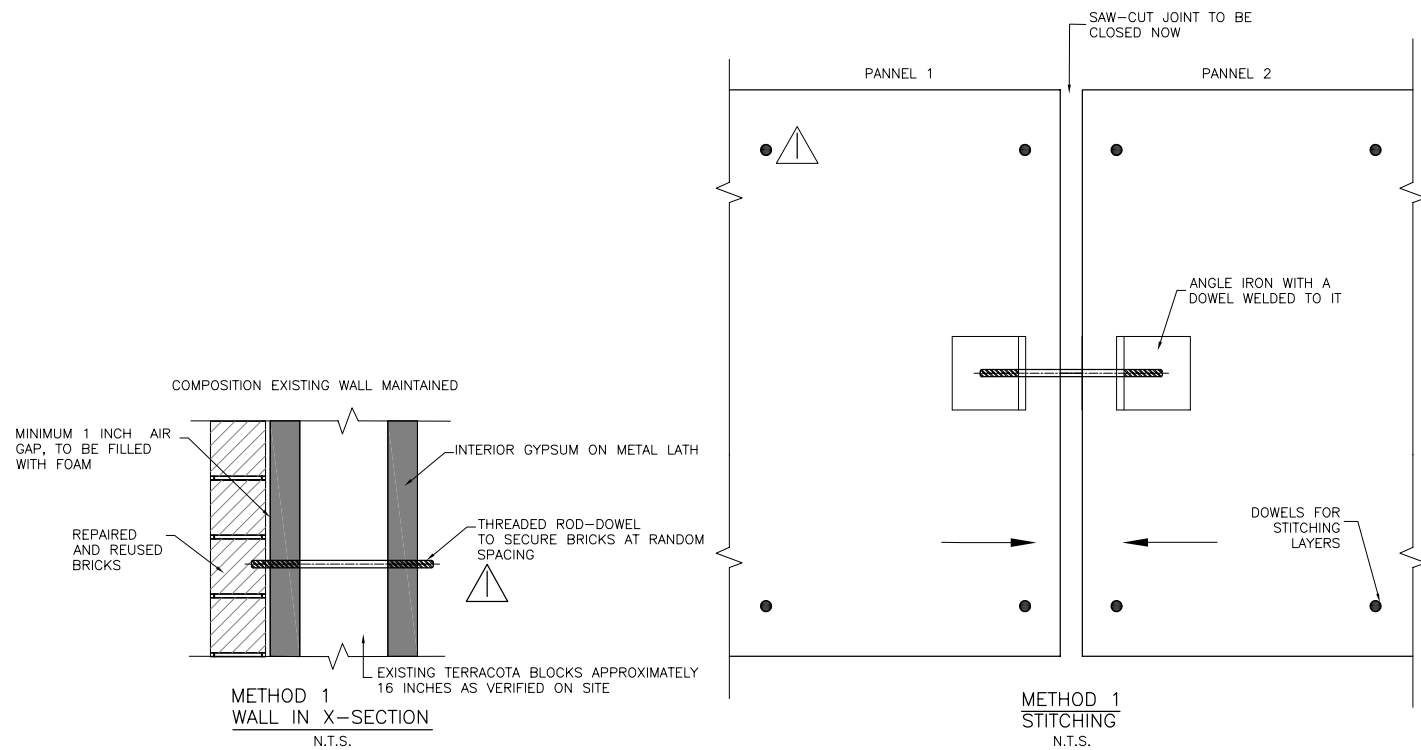
EXISTING WALL COMPOSITION:

- BRICK VENEER
- AIR GAP
- TERRACOTTA BLOCKS

NEW DOWELS/CINTEC ANCHORS OR EQUIVALENT TO TIE BRICK VENEER TO OLD TERRACOTTA WALL. SPACING TO BE DETERMINED.
