# HERITAGE IMPACT ASSESSMENT & CONSERVATION PLAN\*

## 168 -174 MURRAY STREET, OTTAWA

**Owner: David Yoo**  
**Address: 168 – 174 Murray Street, Ottawa, Ontario**

**Revised March 2025**

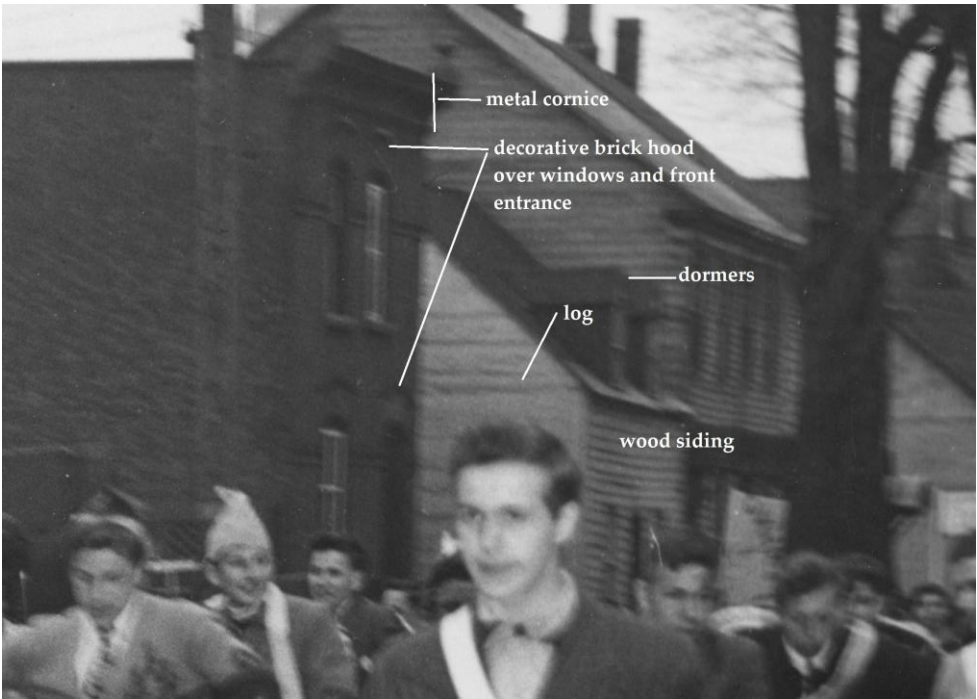
Figure 34: A c.1949 picture with the two houses in the background clearly documents the brick siding of 174 Murray Street and the cottage form of the neighbouring 168 Murray. The textured sidewall of 168 suggests the squared log that has been covered over on the front façade with a horizontal siding. The off-set door on the 2-storey has an arched header. Source: Marc Aubin's collection

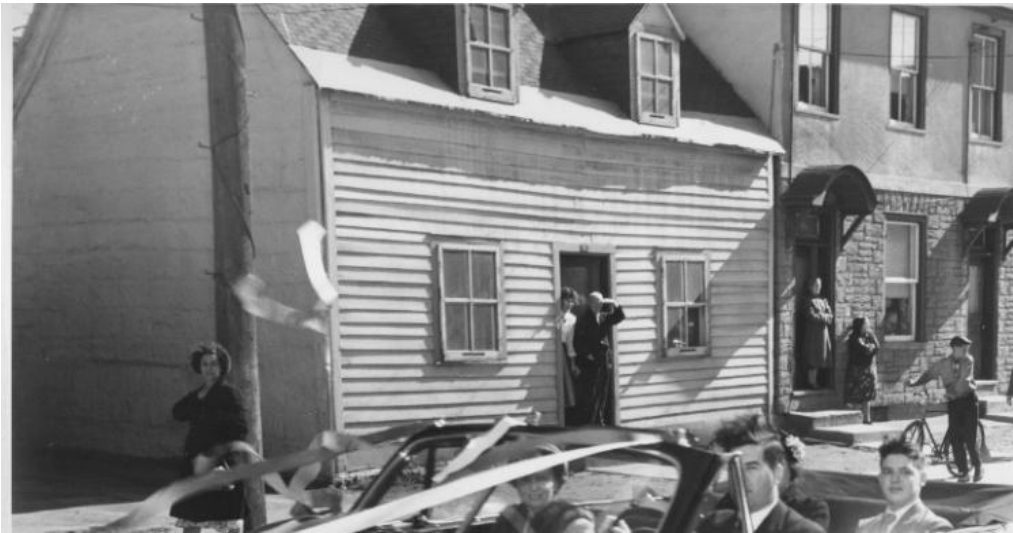
Figure 38: The house at 168 Murray appears in the background of the c.1949 parade. The house is a 1.5 storey side gable with two dormers facing the street, a centre front door with no canopy, horizontal siding on the front and squared timber chinked and whitewashed on the gabled side elevation. Source: Marc Aubin Collection.

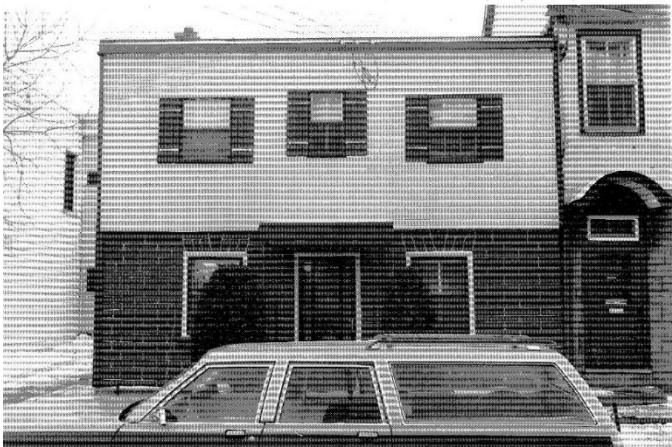
Figure 4: A 1991 view of the house documents the substantive alteration from its original one-and-one half storey side gable roof with gabled dormers facing the street. The house has been remodelled with a flat roof, a second floor added, and three windows replacing the dormers. The exterior was reclad in an angel stone on the ground floor and aluminum siding on the upper floor. A canopy over the front door has been added. Source: City of Ottawa Heritage Survey Forms 1991.

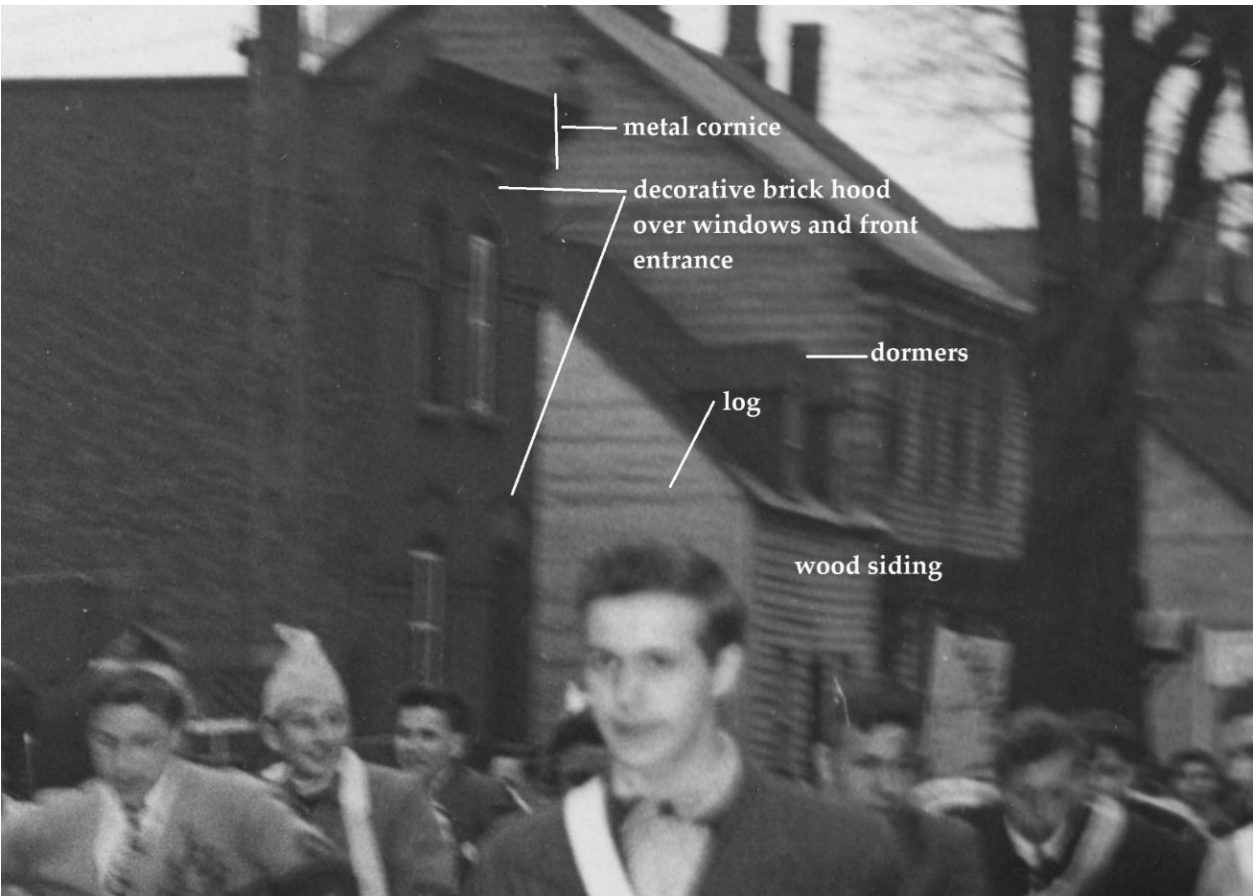
Figure 44: A c.1949 photograph clearly documents the 2-storey brick siding of 174 Murray Street with its off-set door and decorative arched headers over the door and windows. The cottage form of the neighbouring 168 Murray with the textured log sidewall of squared log. The log has been covered over on the front façade with a horizontal siding. Source: Marc Aubin’s collection
