**Environmental Impact Statement  
Phoenix Homes -  
Old Montreal Road**

**Updated Report**

**July 17, 2023**

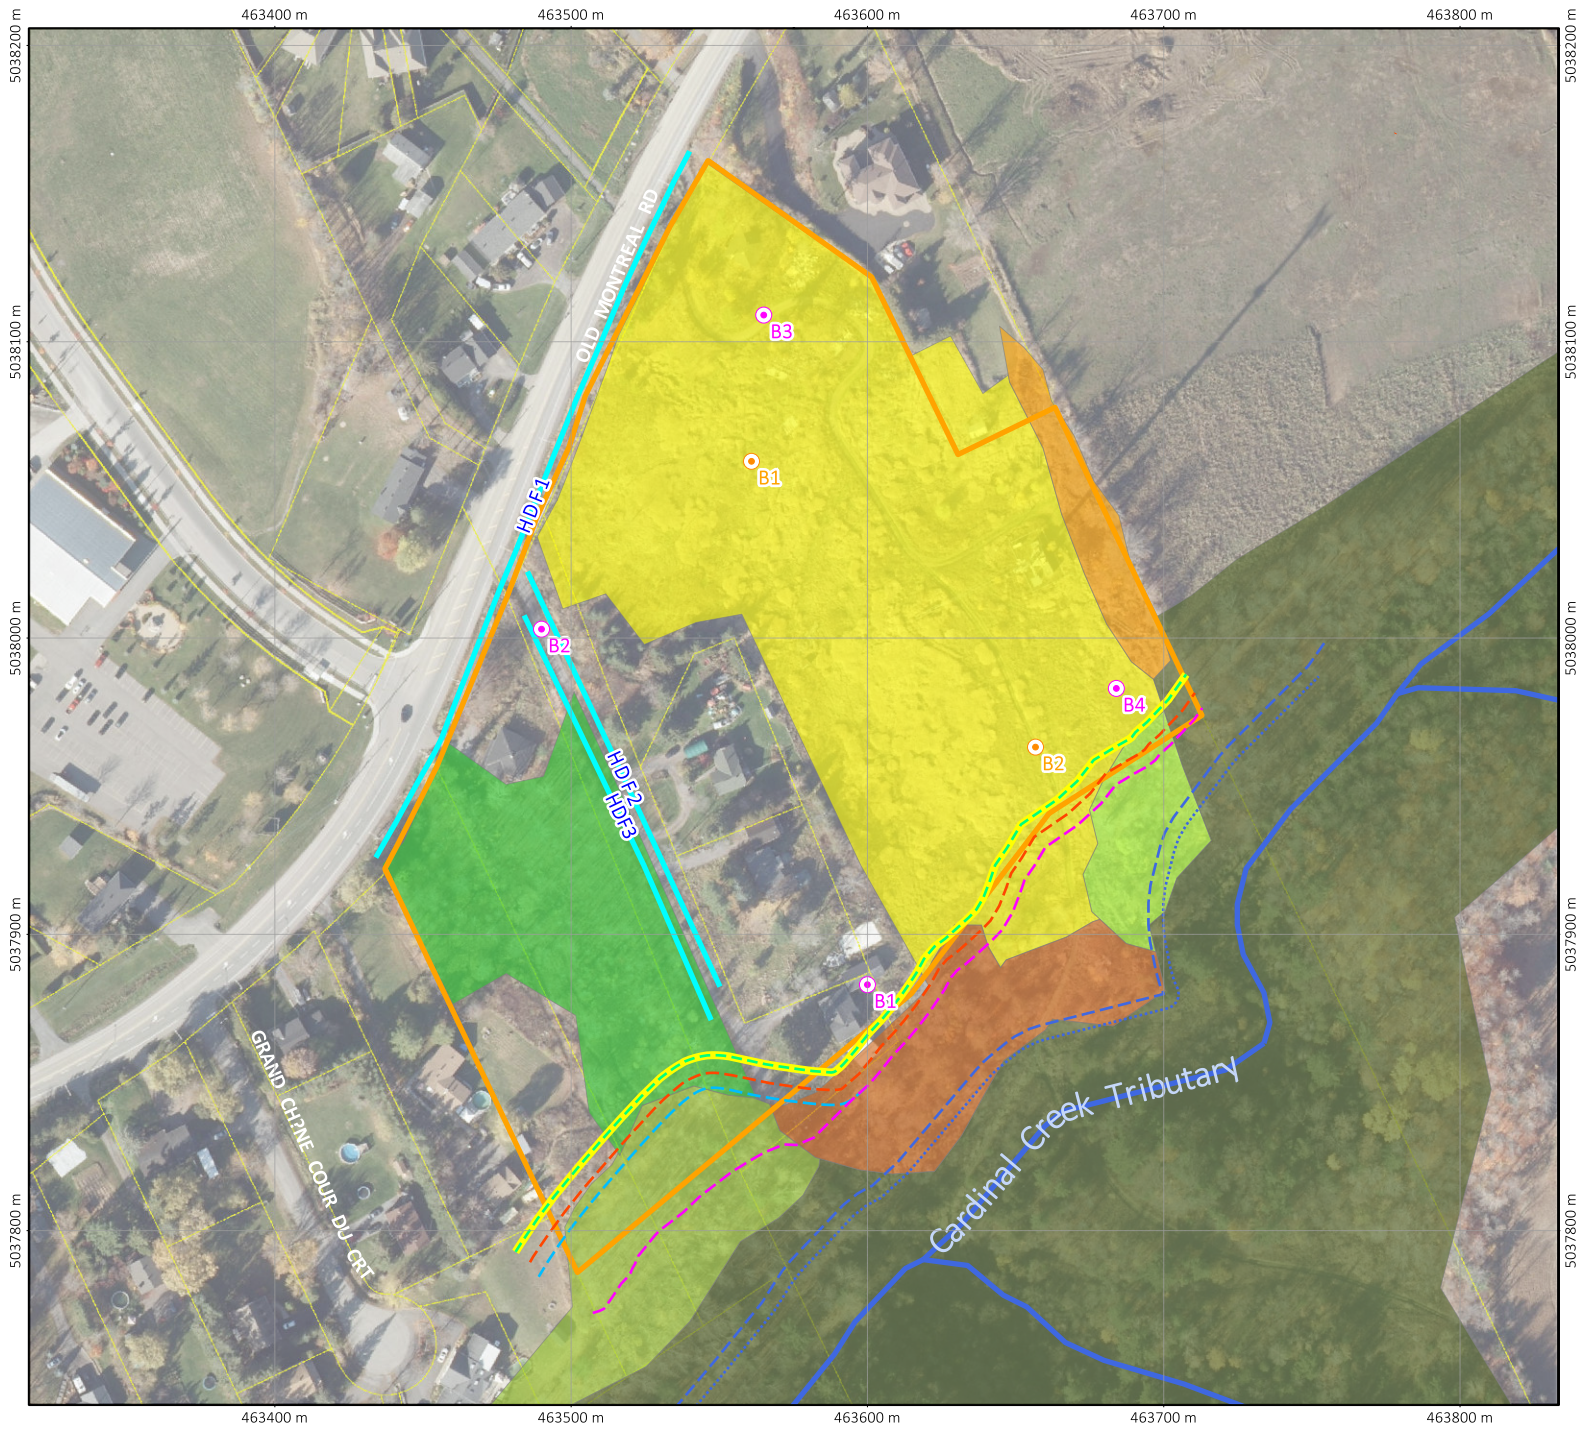
**Figure 2. Existing conditions**

**Figure 2** Existing site conditions.

- Development Area
- HDF
- Bird Survey Station**
  - 2018
  - 2021
- ELC**
  - █ CUM
  - █ THDM3
  - █ THDM2
  - █ FOD 2-1
  - █ FOD3
  - █ FOM2
  - █ FOM7
- Creek Setback Review**
  - - - 30 m from NHWM
  - ⋯ 25 m from Top of Bank
  - - - Crest of Slope
  - - - Additional Geotech Setback
  - - - Erosion Allowance
  - - - Erosion Access Allowance (Geotechnical Limit of Hazard)
  - - - **Greatest Setback Line to Cardinal Creek Tributary**

The north slopes of the Cardinal Creek Tributary valley are heavily vegetated and the ravine generally conveys very little water, except possibly during spring run-off. The crest of the slope (i.e. the edge of the valley top) as determined by EXP is indicated in Figure 2. Setbacks to protect the valley slope stability (i.e. limit of hazardous lands) are measured from the crest of the slope, except along the eastern end of the development area, where the geotechnical set back is pulled back an additional ~24 m from the crest, encompassing a raised, forested area there (EXP, 2016).

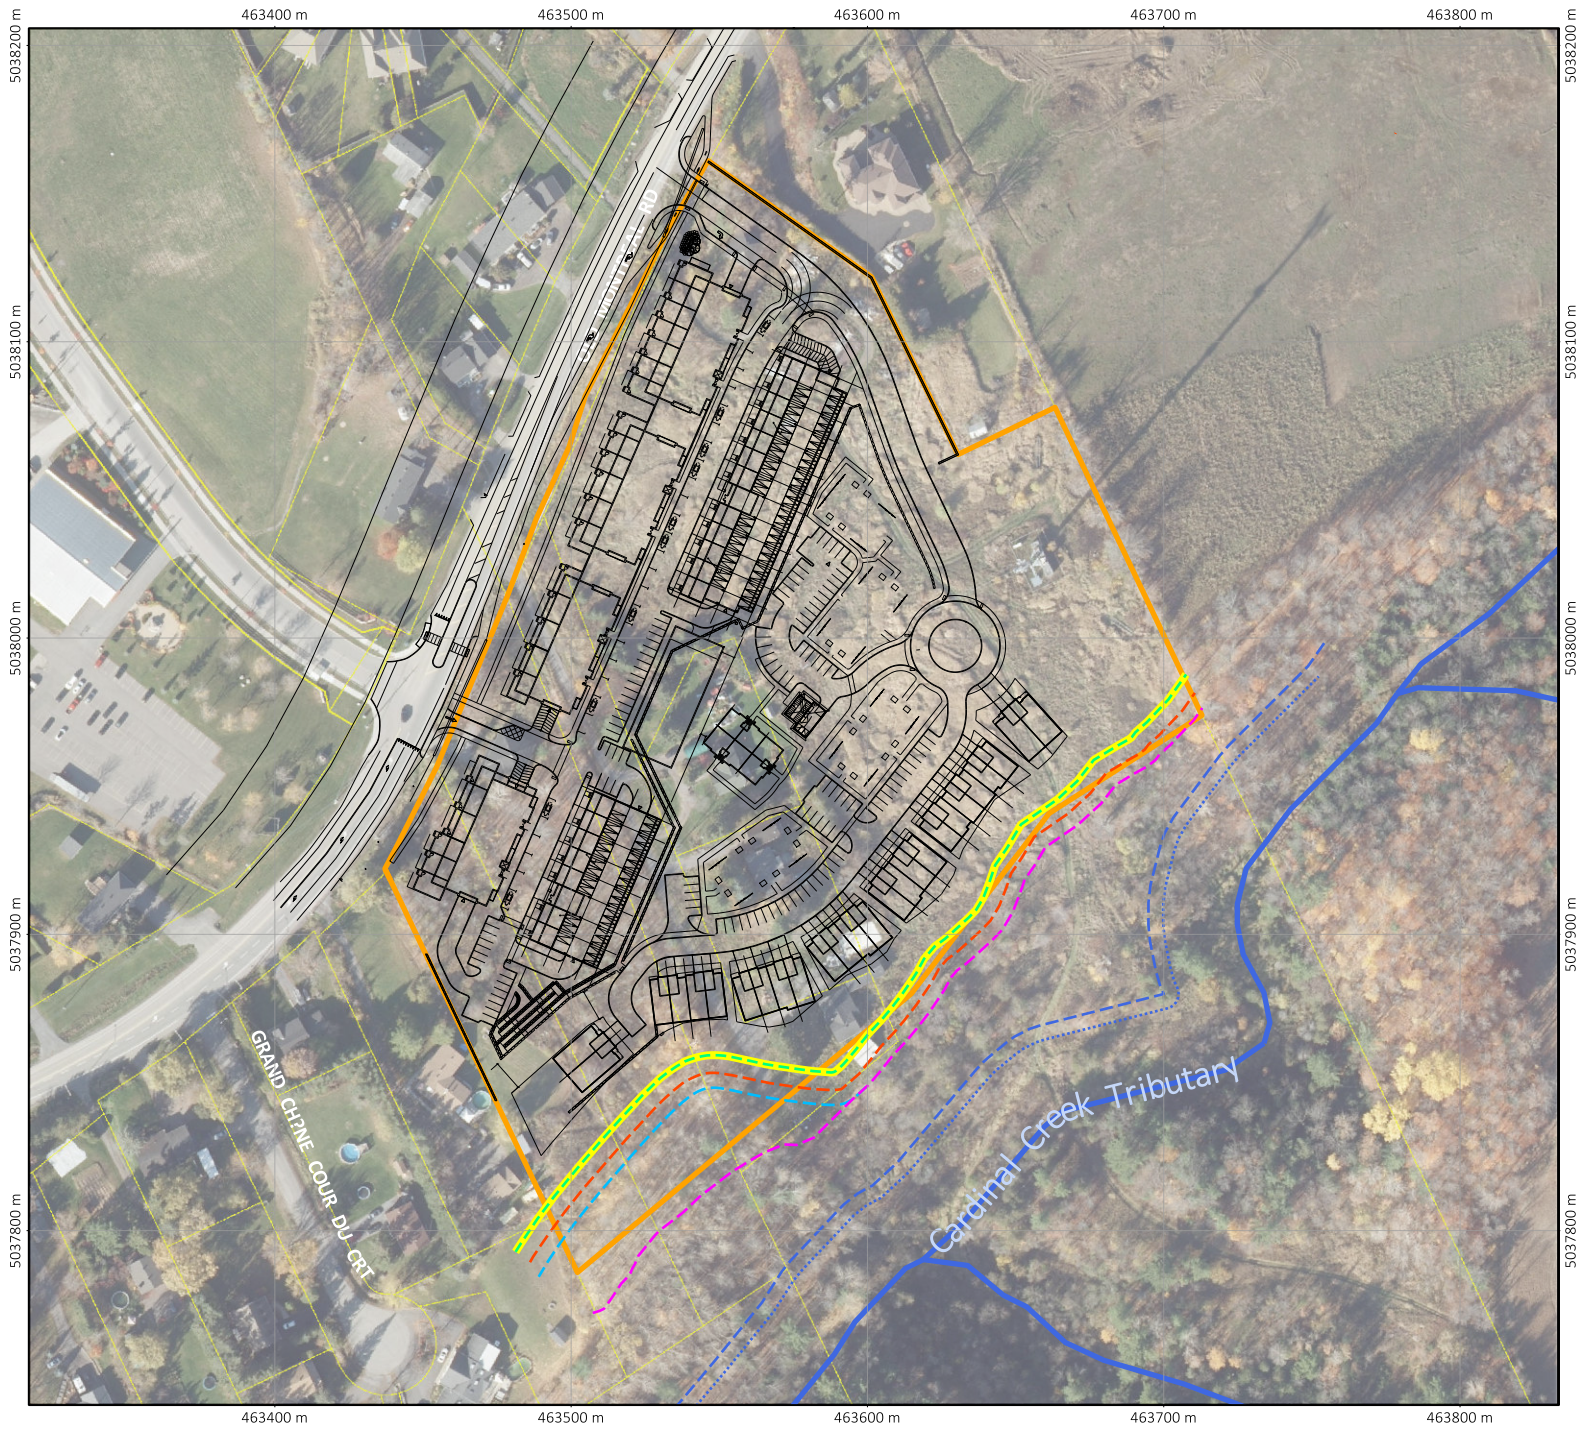
**Figure 4** Proposed development plan

- Development Area

Phoenix Homes is proposing to develop the Site with a mix of medium and high-density residential development. The proposed site would combine low-rise apartment buildings, stacked and back-to-back townhouse condominiums, townhomes, and bungalows on municipal right of ways and private streets (Figure 3).

Site development will require significant regrading and terracing of the steeply sloping properties that will necessitate the removal of all trees from the Site. Land clearing and construction are anticipated to begin in late 2023.

The proposed development respects the required setbacks for the Cardinal Creek Tributary for geotechnical limit of hazard lands, high water mark and top of bank; it is not anticipated that any property lots will encroach into the designated setbacks (Figure 3). There is no regulatory floodplain associated with the Cardinal Creek Tributary at this location. As such no negative impacts are anticipated to the Cardinal Creek Tributary.

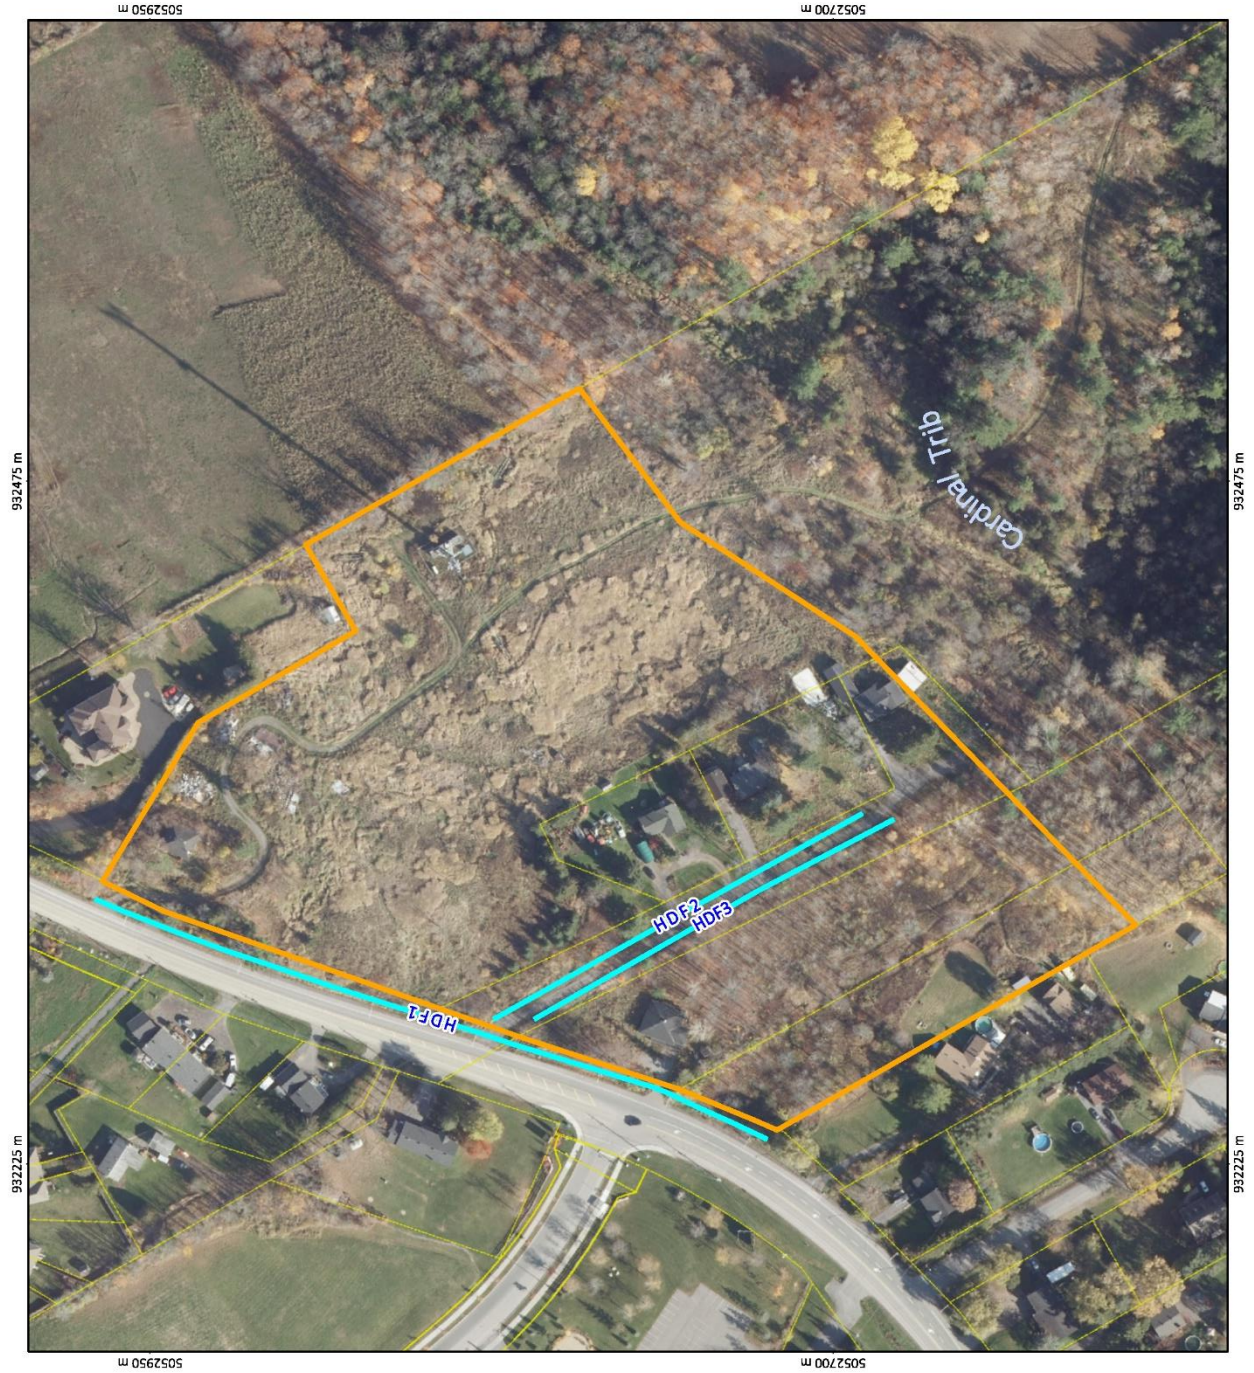
HDFs were reviewed on the Site initially in 2018, then again in 2021. A total of three HDFs were identified and are described in this report (Figure 2). All three features are/were located at the north end of the Site. The southern edge of the Site corresponds with the top of a ravine crossing the Site properties that conveys a tributary to Cardinal creek to the west. The tributary, as a permanent stream, does not meet the definition of an HDF under the HDFA Guidelines. Moreover, it is located outside of the Site area and no HDFs conveyed flows from the rear of the Site flows to that stream. Proposed future development on the Site will adhere to setback requirements as required based on floodplain limits, buffer distances from top-of-bank and/or normal high water mark, and hazard limits. The Cardinal Creek tributary is therefore not addressed further within this report.

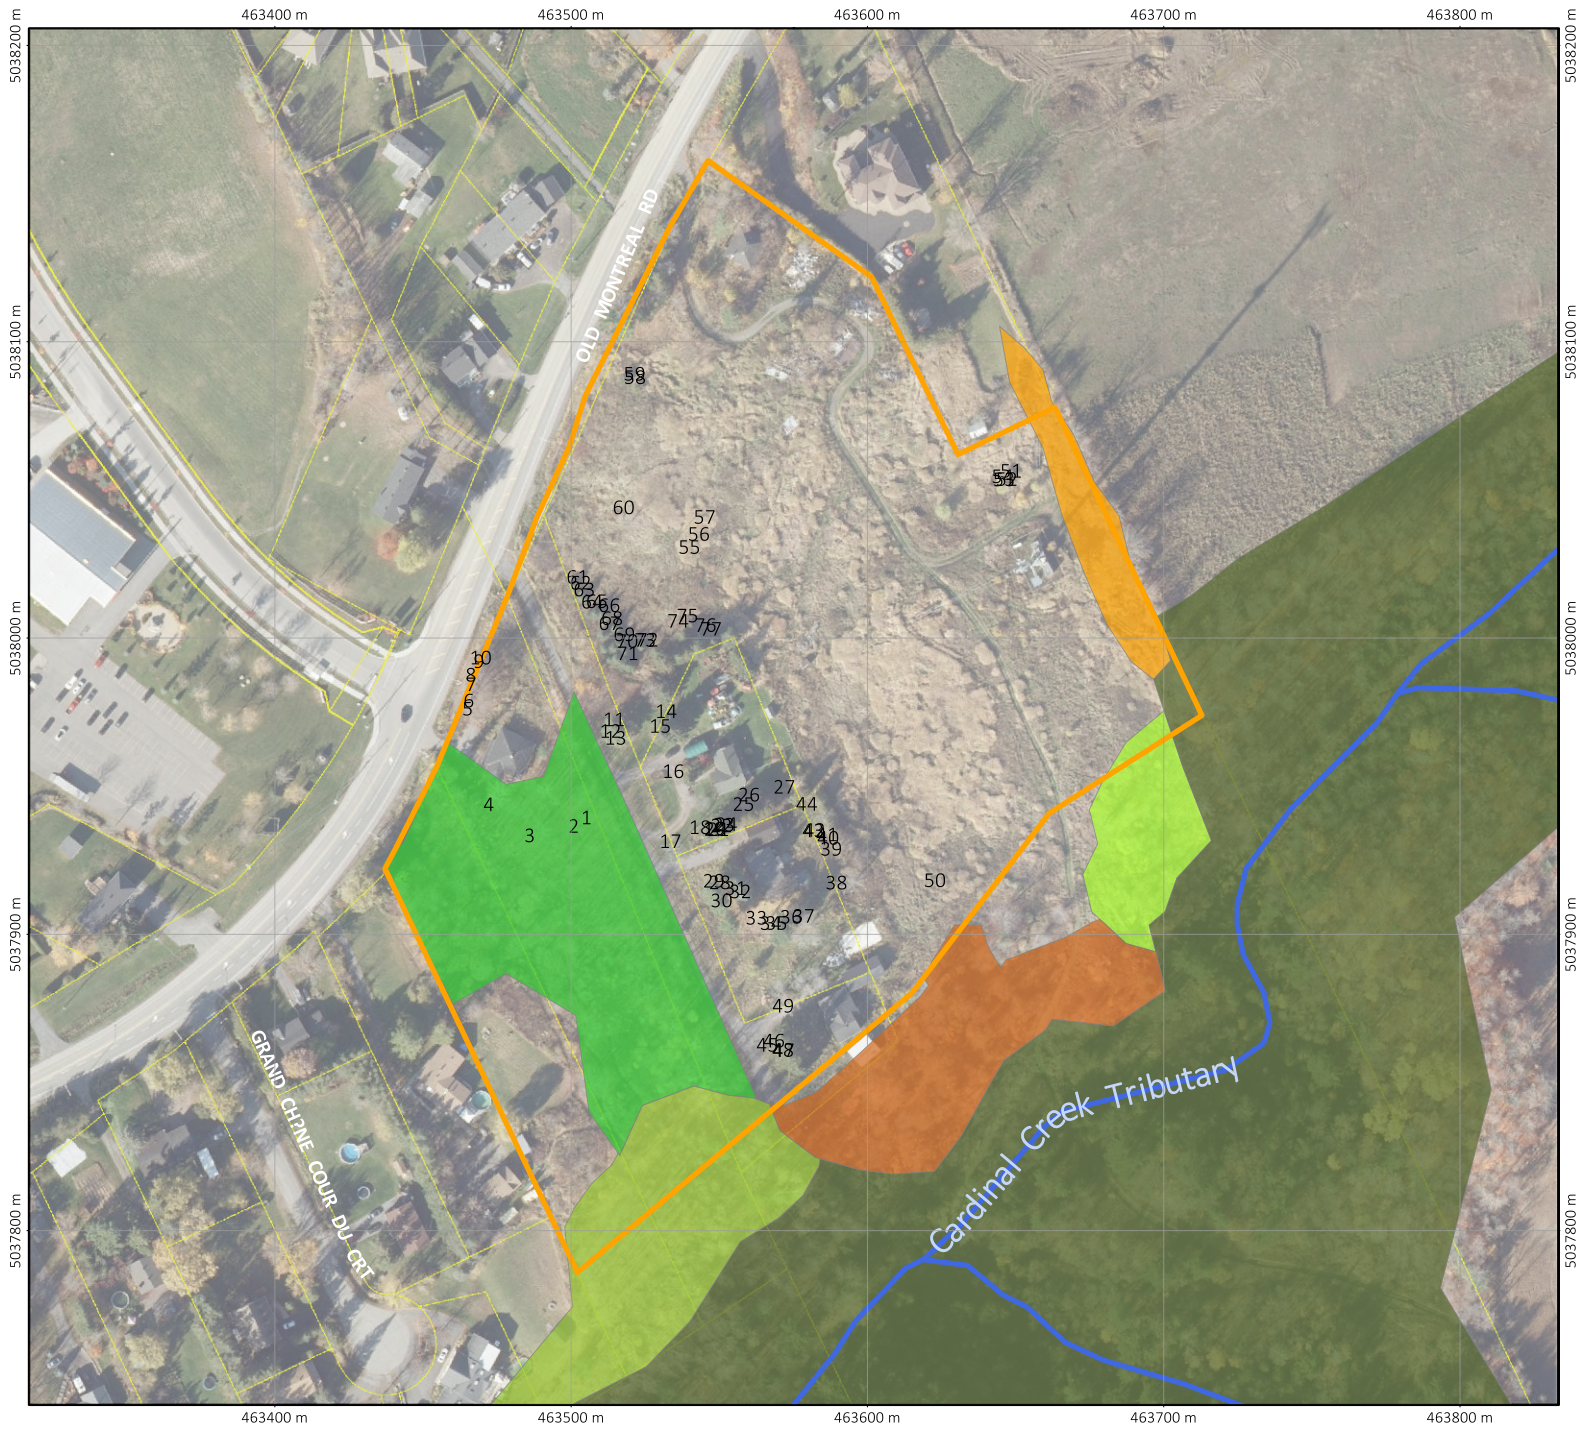
**Figure 2** Existing site conditions.

— Development Area
