# **KANATA GOLF & COUNTRY CLUB 2019 MONITORING & HYDROLOGIC MODEL CALIBRATION REPORT**

**July 2020**

David Schaeffer Engineering Ltd  
120 Iber Rd  
Stittsville, ON  
K2S 1E9

J.F. Sabourin and Associates Inc.  
52 Springbrook Drive,  
Ottawa, ON K2S 1B9  
T 613-836-3884 F 613-836-0332

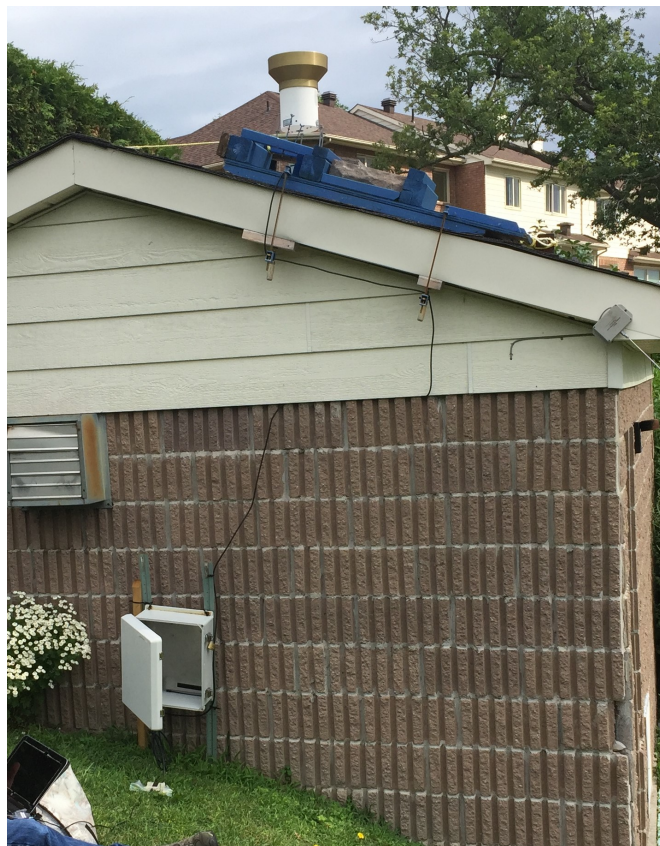
**Figure 2: 2019 Rain Gauge Setup**

A TE525-series tipping bucket rain gauge was installed on-site on April 30<sup>th</sup>, 2019 and was located on the roof of the pumphouse on the Kanata Golf and Country Club property. The gauge was installed on the roof to avoid any interruption to precipitation due to nearby vegetation or trees. The rain gauge was mounted on a device enabling a level placement and that would withstand large rainstorms and wind without shifting the rain gauge. The gauge was calibrated before it was initiated and the lip of the funnel was horizontal, and at least 30 cm above the ground. To avoid climbing on the roof during each download, the logger was placed in a waterproof box at ground level for easy access and locked with a padlock to ensure no interference. See Figure 2 below for a photo of the rain gauge setup.

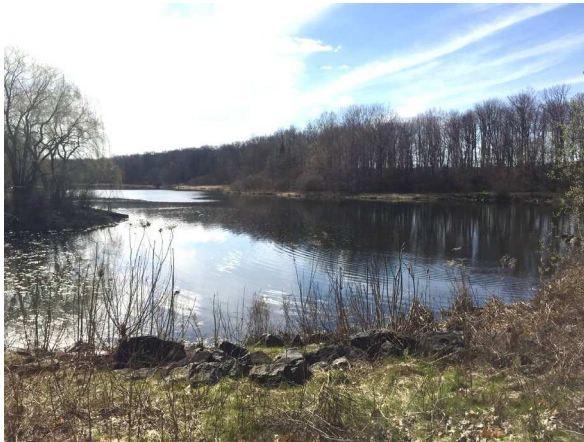
**Figure 4: April 30, 2019**

Below are photos taken from the field of the Beaver Pond throughout the monitoring period to validate the fluctuation of water levels.

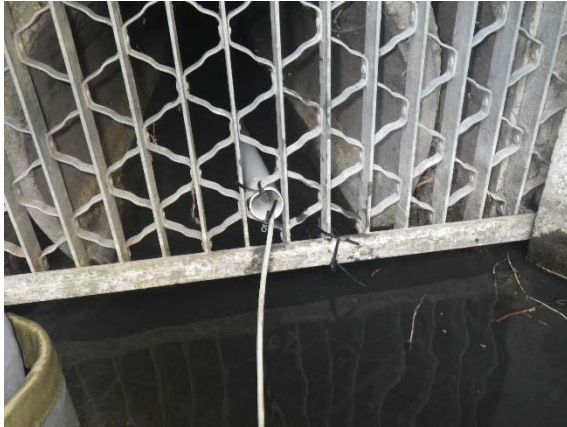
**Figure 2a:** Stingray and water level logger Installation on culvert grate at Q1

The level logger at Q1 was fixed to an existing steel grate at the outlet of the storm sewer. The Stingray Portable Level-Velocity Logger was placed approximately 1 m inside the culvert, through the use of a PVC pipe. The level logger at Q2 was installed within a perforated PVC pipe which was mounted to a concrete block and placed on the bottom of the head wall apron. The level logger at Q3 was placed flush against the upstream side of the inlet apron and fixed to an existing large timber grate. The barometric logger was also fixed to the timber grate near the Q3 level logger. A tipping bucket rain gauge was located on the pumphouse roof next to the pond on the 9<sup>th</sup> hole. This rain gauge was located away from any tall trees or structures, to minimize potential interference. **Figures 2a-2e** show the installation/configuration for all field equipment used in this study.

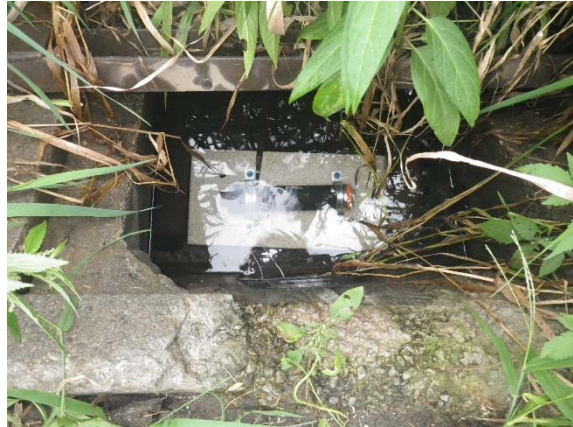
**Figure 2b:** Water level logger installation at Q2

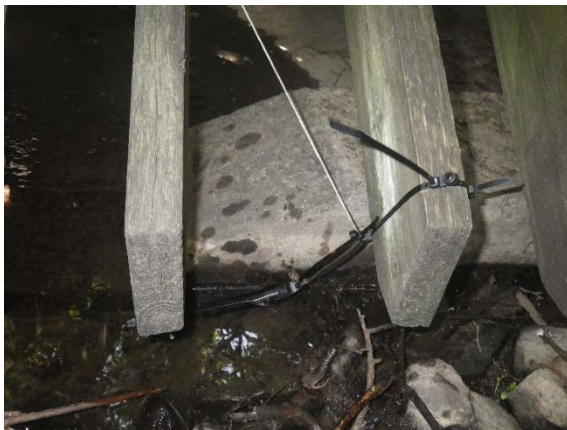
**Figure 2c:** Water level logger installation at Q3

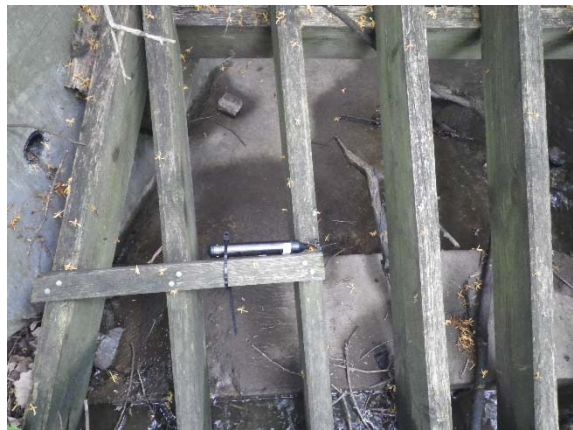
**Figure 2d:** Barometric Logger Installation at Q3

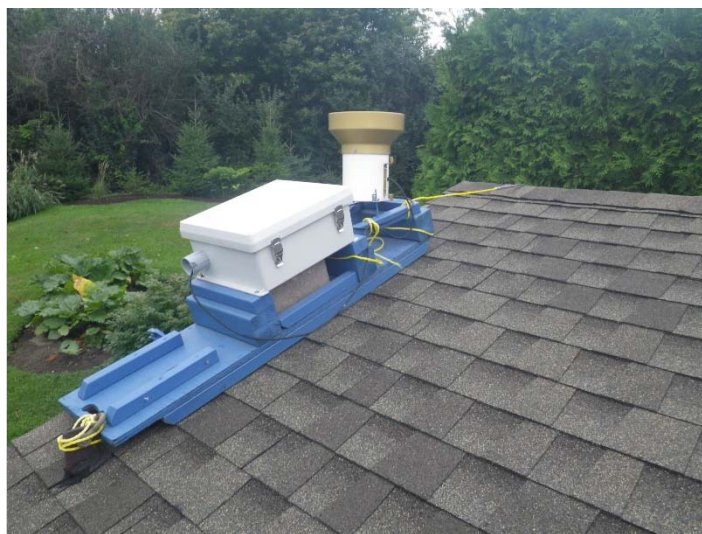
**Figure 2e:** Rain gauge installation

A tipping bucket rain gauge was installed on-site on May 14<sup>th</sup>, 2018 and removed on November 8<sup>th</sup>, 2018, providing 179 days of precipitation data for the year. The first instance of snowfall during this monitoring program occurred on October 27<sup>th</sup>, 2018. Considering that conventional tipping bucket rain gauges, like the one installed on site, are incapable of recording snowfall or determining snow water equivalent, the rainfall dataset has been truncated to a period of 166 days (May 14<sup>th</sup>, 2018 - October 27<sup>th</sup>, 2018). As the intended use of the data obtained from this monitoring program is to guide the calibration of a detailed hydrologic model of the existing subwatershed conditions, the subsequent level/flow monitor data obtained in the field has also been truncated to October 27<sup>th</sup>, 2018. **Table 2** is a summary of the rain gauge data collected in 2018 (from May 14<sup>th</sup> to October 27<sup>th</sup>) at Kanata Golf & Country Club.

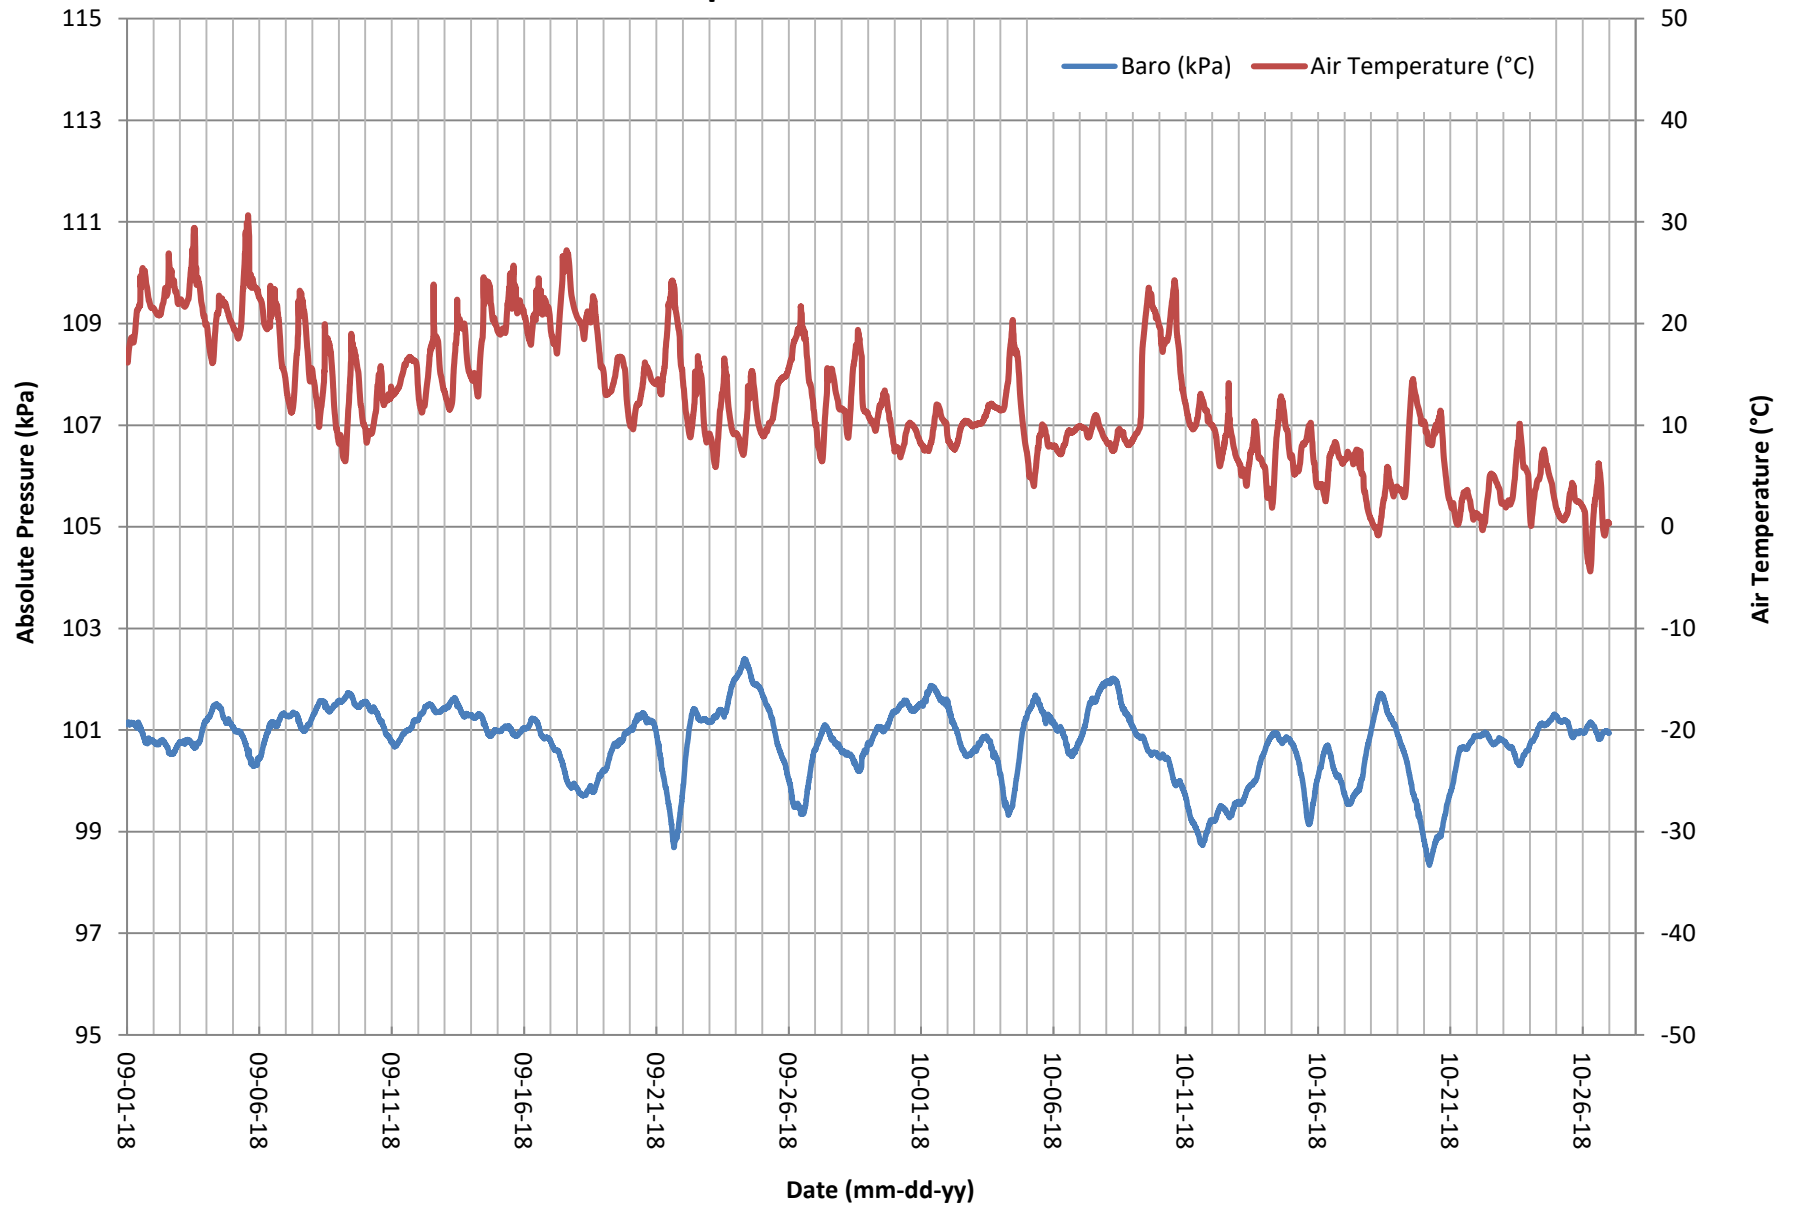
# Kanata Golf & Country Club - Atmospheric Pressure & Air Temperature - September-October 2018

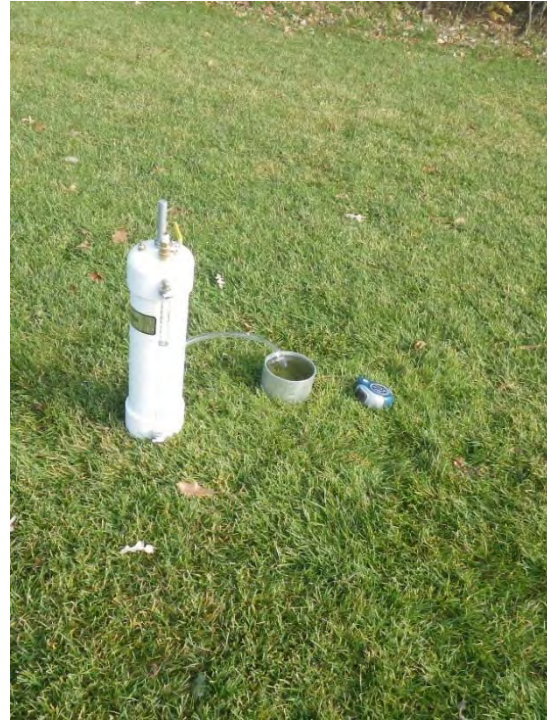
**Figure 3:** Single Ring Infiltrometer Setup (12.7 cm diameter steel ring, single Marriotte bottle)

In addition to the DRI tests, Single-Ring Infiltrometer (SRI) surface infiltration tests were conducted at each of the four sites. See **Figure 3** for an example of the SRI setup. Marriotte bottles were used to maintain a constant head during SRI tests. At sites 1 and 2, constant head SRI tests were successfully run. At sites 3 and 4, field staff were not able to complete constant head SRI tests as a constant head of water could not be sustained. At all 4 sites, falling-head SRI tests were run in the same vicinity as the DRI tests. SRI and falling head tests were completed to provide alternative methods to measure infiltration rates and for comparison with the DRI results. Refer to the Test Methodology section of this memorandum for a more detailed description of how each of the test types was run.

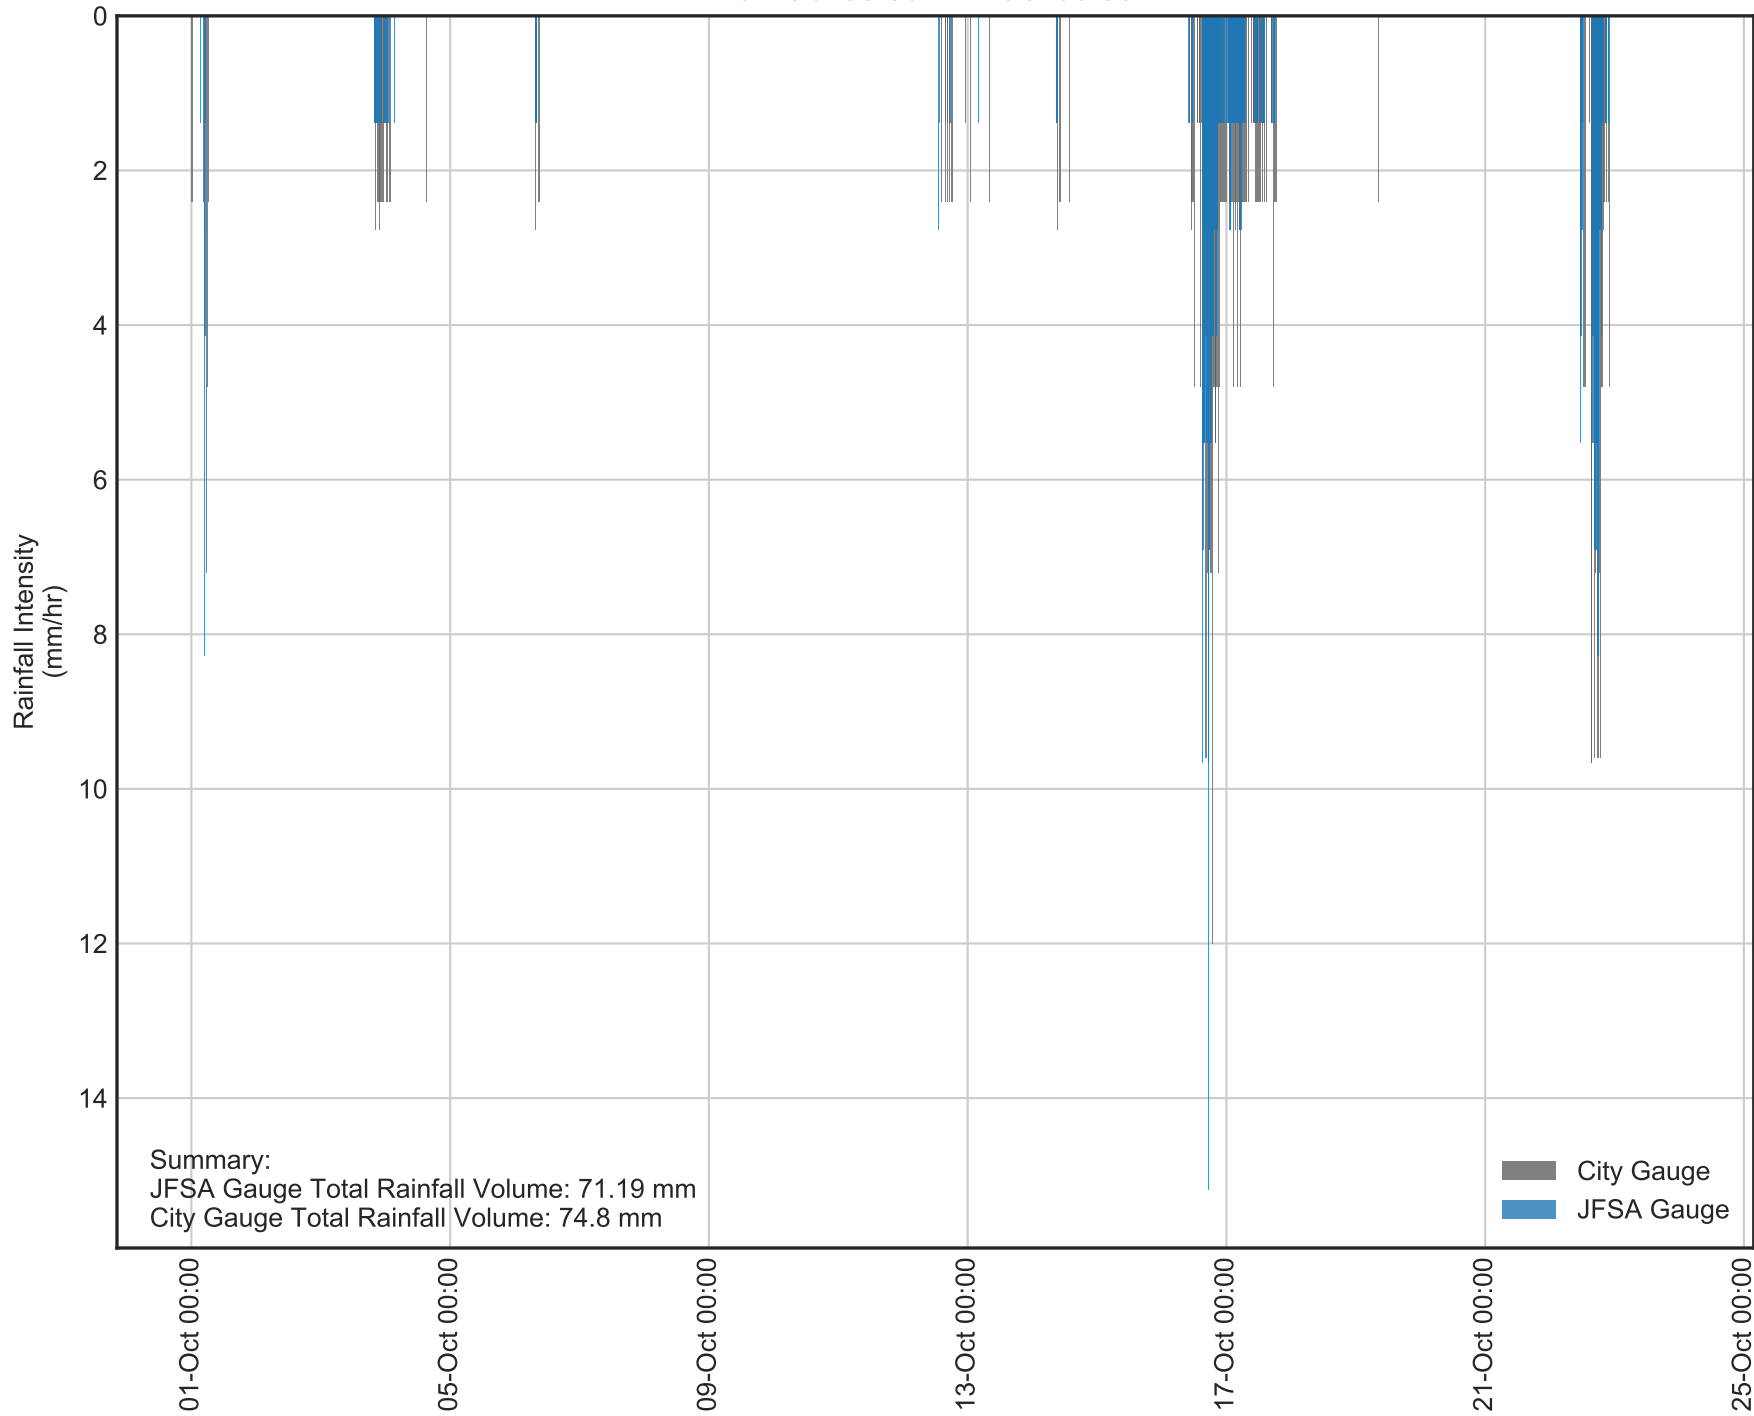
# Rainfall Monitoring - 2019 - JFSA Vs City 01-Oct 00:00 - 24-Oct 00:00

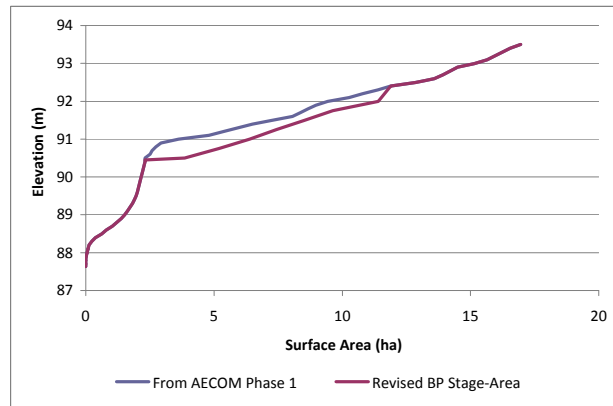
Revised BP Stage-Area

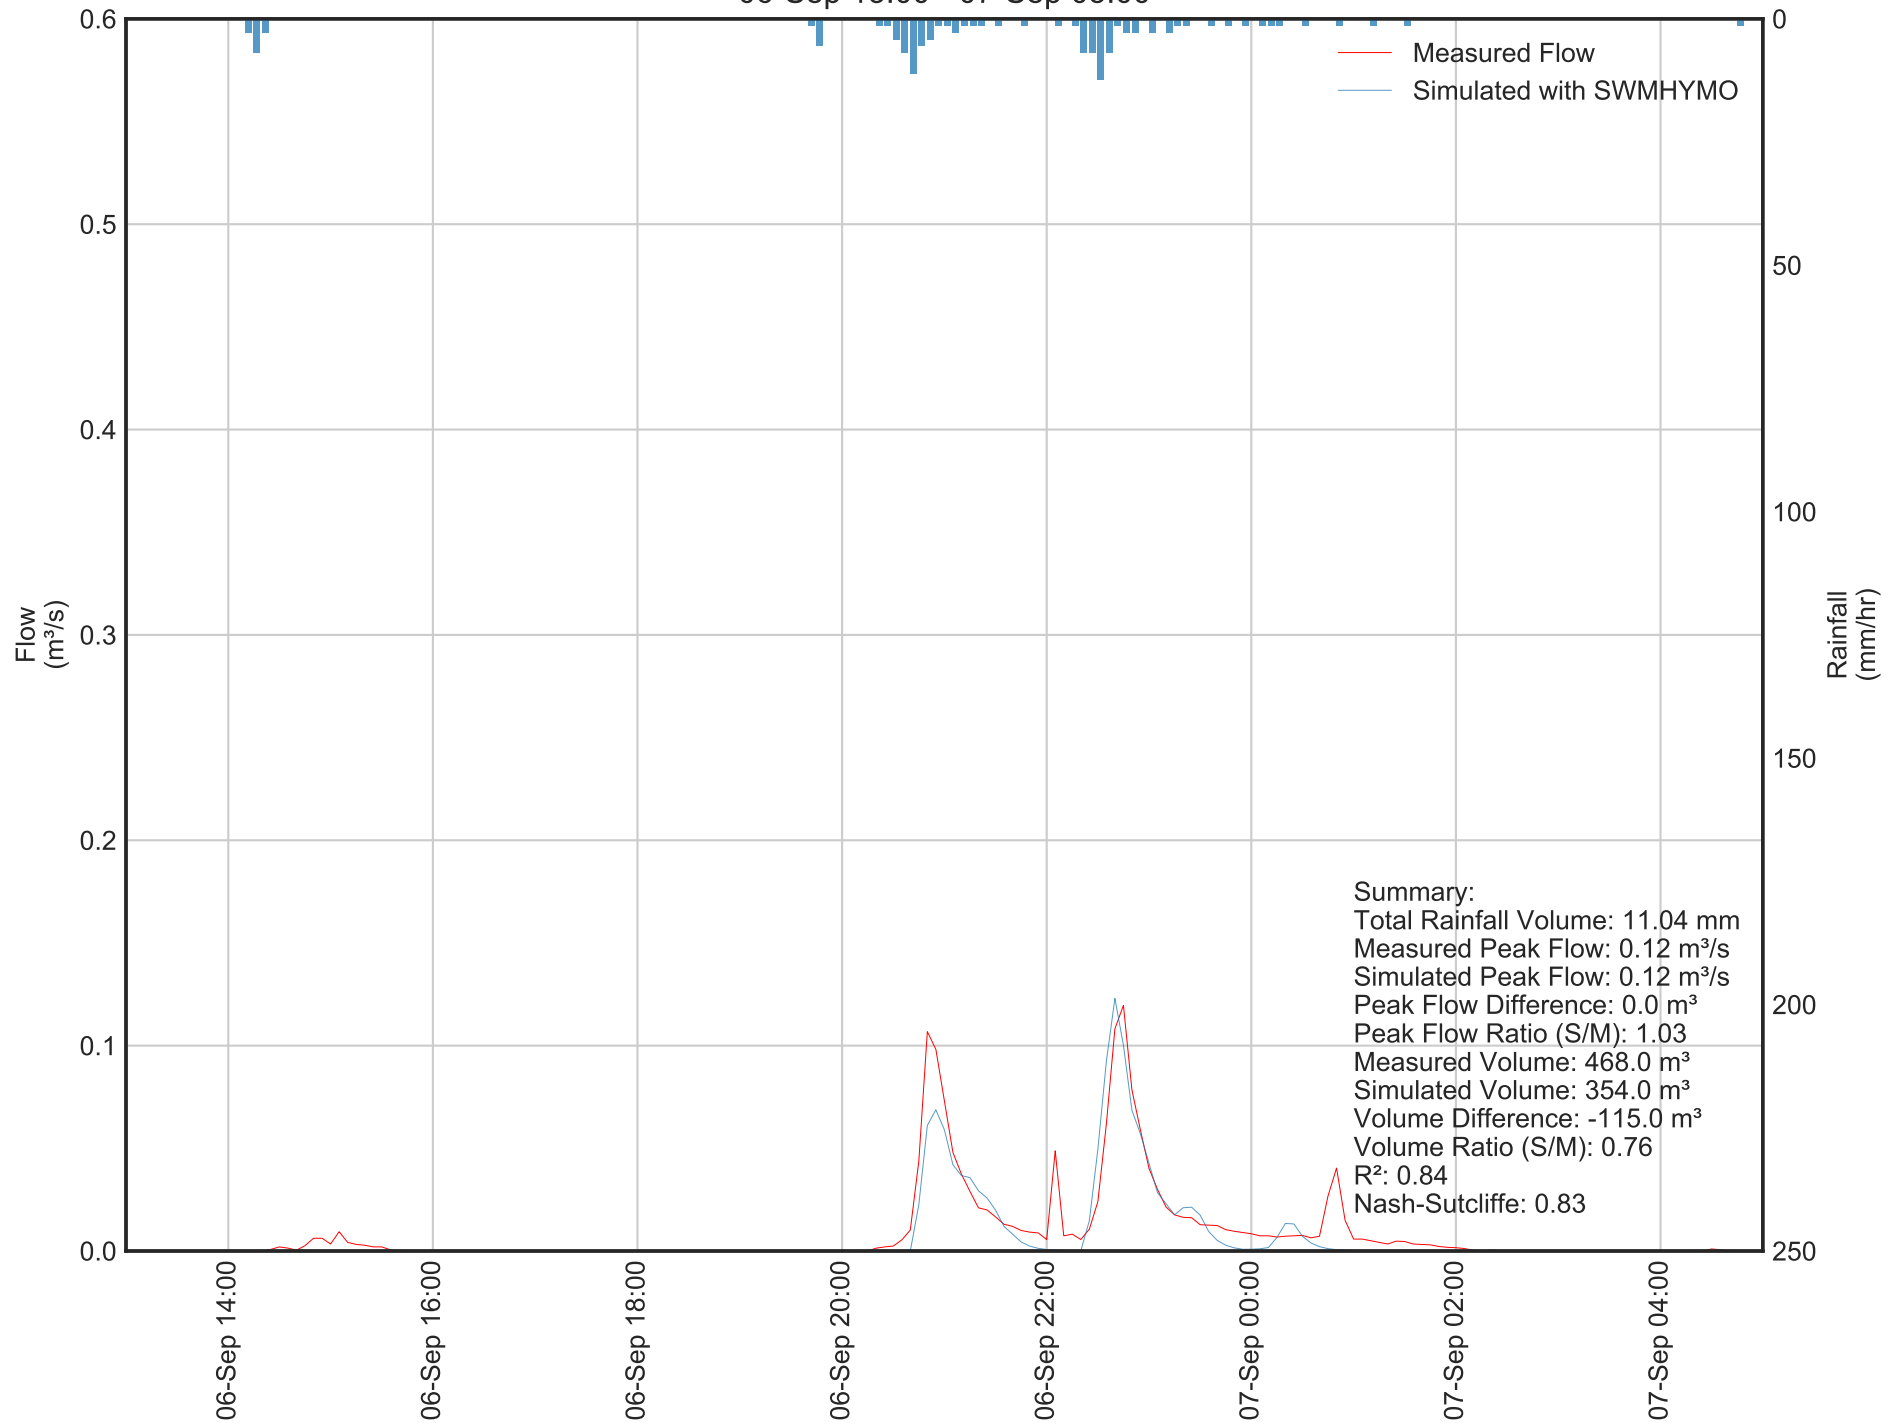
JFSA SWMHYMO - Campeau Storm Sewer Flow Monitoring - 2019  
06-Sep 13:00 - 07-Sep 05:00
