Landslide Hazard Assessment

Proposed Residential Development

Old Montreal Road

Report PG5201-2 Revision 3 dated October 18, 2024

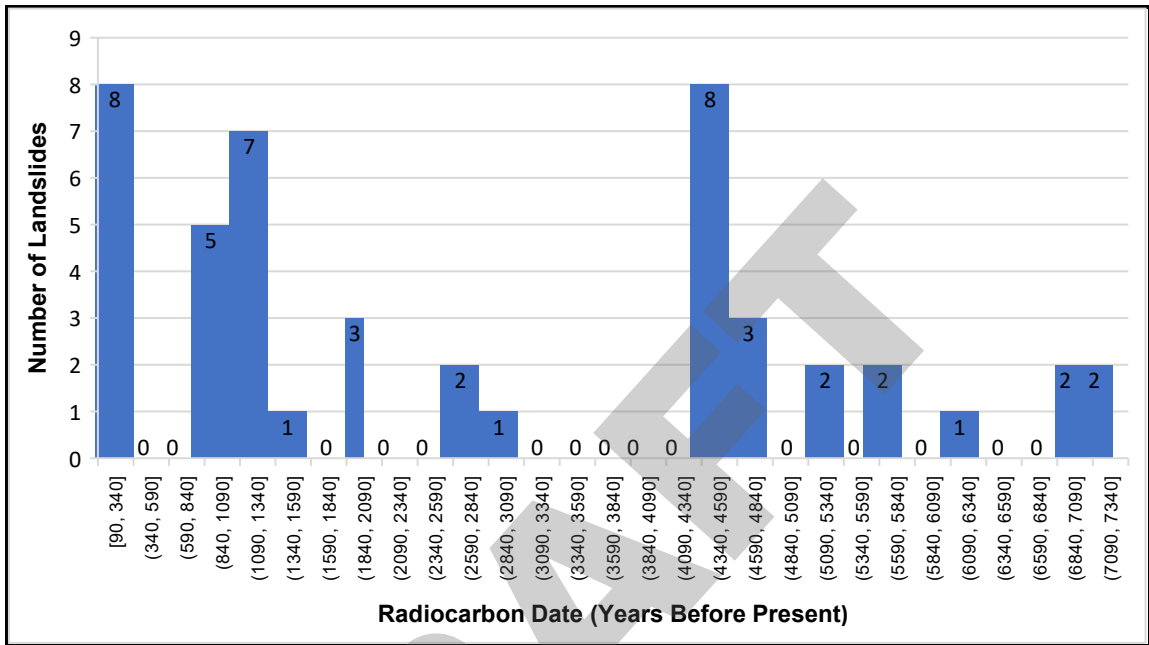
Figure 3 - Summary of Carbon-dated Landslides (GSC OF7432)

The results from the study and approximations provided by OF8600, neglecting the potential deviation and range of uncertainty, are summarized in Figure 3 below.

The temporal frequency of landslide occurrence may vary substantially across the study area. OF7432 sought to carbon date 45 separate landslide features throughout the study area. The landslides interpreted by that study documented landslides having occurred potentially between approximately 90 to 7,140 years before present.

Temporal factors such as periods of increased earthquakes and climatic factors affecting these frequencies have been explored by others. Based on the above, more than half of the carbon dated landslides have occurred within the past 3,090 years, and over a quarter within the past 1,090 years.
