Cardinal Creek Village – South Side

Headwater Drainage Feature Assessment

Bowfin Environmental Consulting Inc.
168 Montreal Road
Cornwall, Ontario
K6H 1B3

March 2021

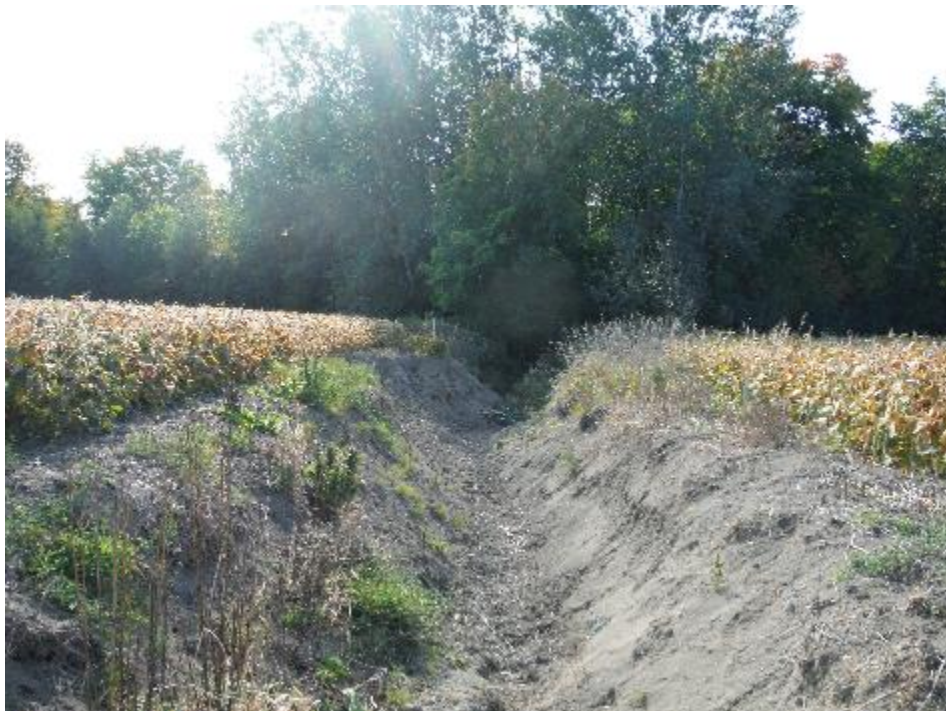
Photo 2: North Channel in the agricultural field (April 28, 2020)

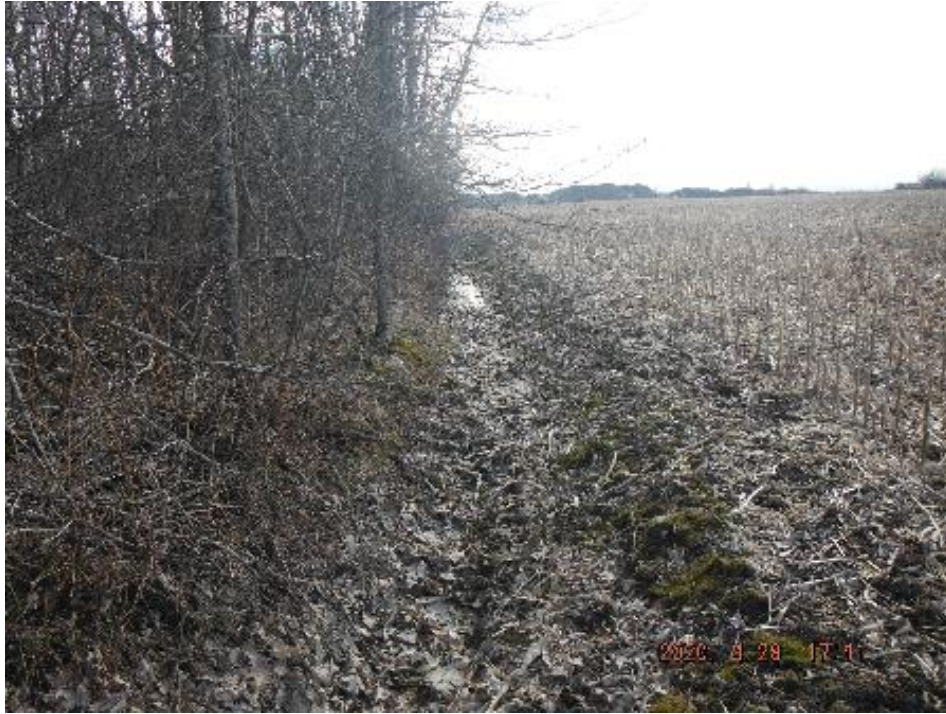
Feature 3 refers to the channel that is situated on the north and west sides of the forested area. This feature is connected to both Feature 2 and the South Tributary. Very little of this channel has any incline. The shading from the forest resulted in thick snow cover on April 6 and no flowing water was present anywhere. The feature was visited again on April 16 at which time there was standing water in the entire feature but there was no contributing water to Feature 2. Because of the strange alignment, this feature has been separated in two sections. The portion labelled as 3a is that along the north side of the forest and is 150 m long. The portion labelled as 3b is that along the west side of the forest and is 65 m. It is noted that there was no flowing water in all but the very southwest section (last few meters) which flowed down the valley bank of the South Tributary.

Photo 7: Feature 3a, looking upstream (April 28, 2020)

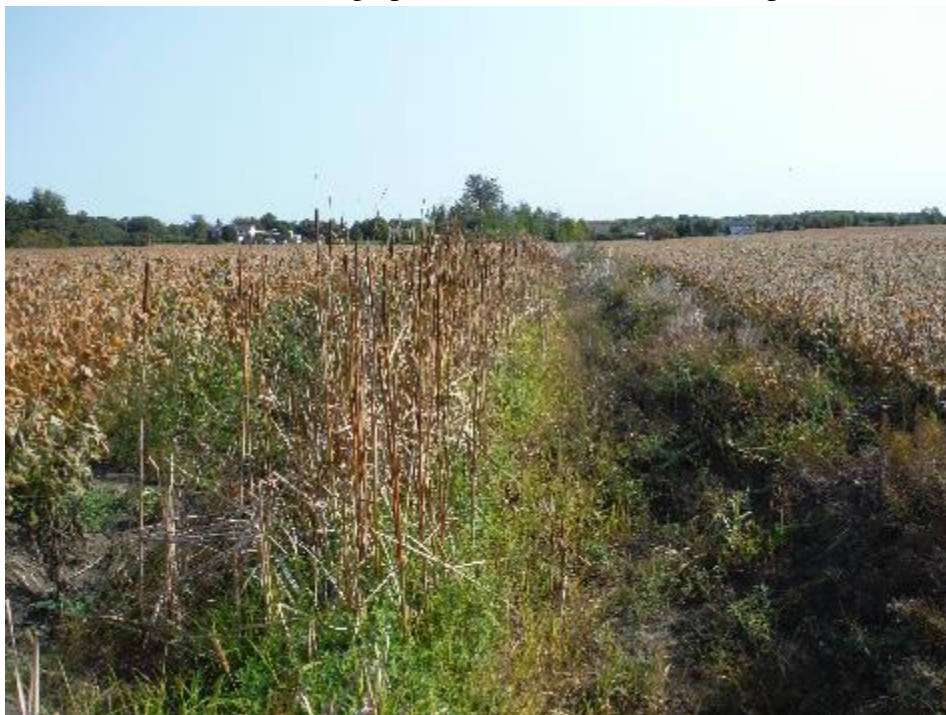
The station was electrofished during the spring of 2020. No fish were observed or captured. No sampling took place during the summer as the station was dry (July 27, 2020). No fish were observed or captured during the 2012 fish sampling either.

Photo 10: Station 1 looking upstream from downstream (September 21, 2020)

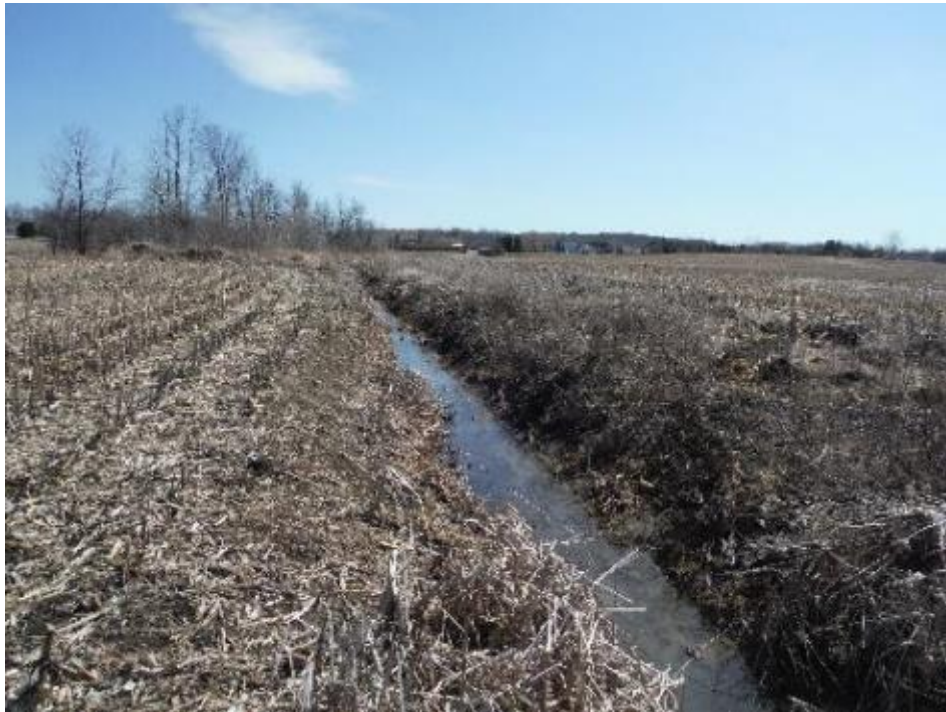
The substrate consisted entirely of fines and the stream morphology was a glide. The in-water cover throughout the station was provided mostly by aquatic vegetation, including algae. Minor signs of erosion were noted on the left bank. The tops of the banks were mostly vegetated (about 80%). There was also narrow-leaved cattail, manna grass, purple loosestrife, knotweed, wild carrot, thistle, field horsetail and ragweed. The station had no canopy cover.

Photo 11: Station 2 looking upstream from downstream (April 6, 2020)

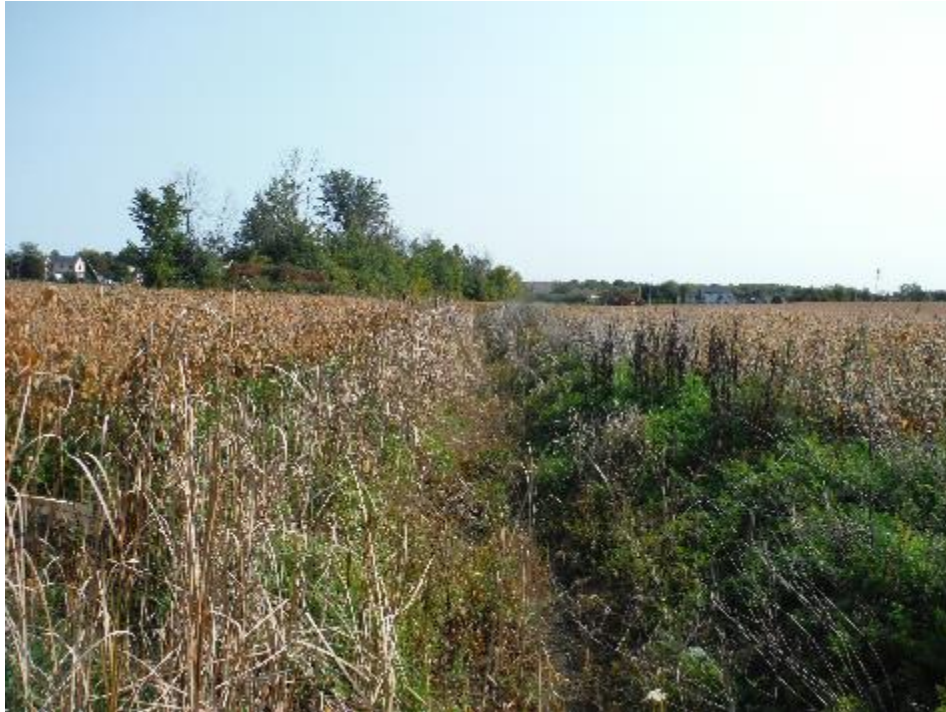
The station was electrofished during the spring 2020. No fish were observed or captured. No sampling took place during the summer as the station was dry (July 27, 2020). No fish were observed or captured during the 2012 fish sampling either.

Photo 12: Station 2 looking upstream from downstream (September 21, 2020)

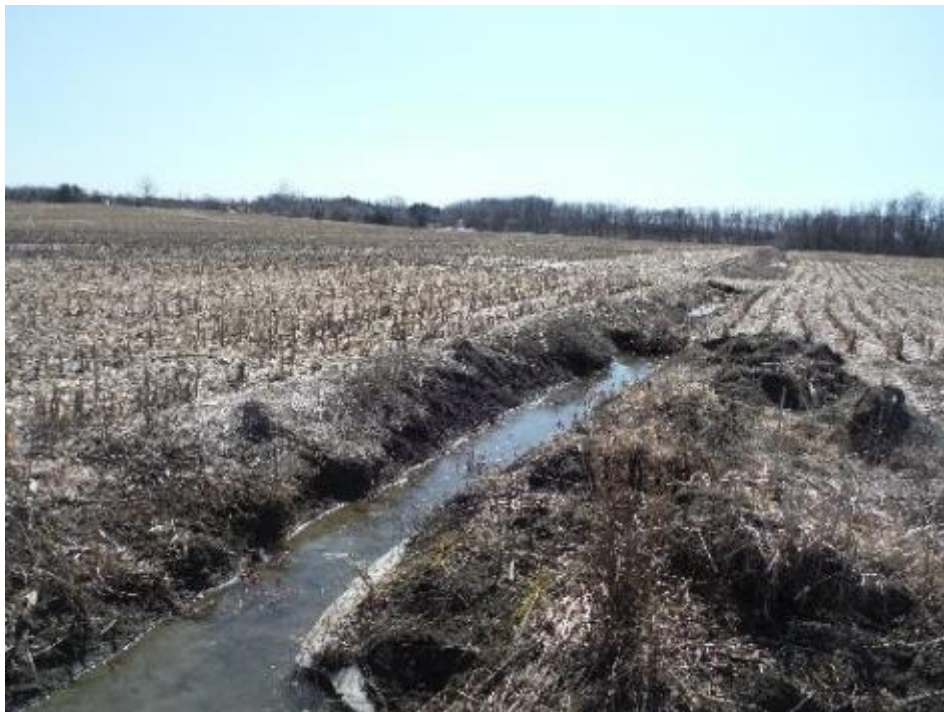
Feature 1 is situated on the northeast side of the site. This feature was 35 m long and flowed into the North Channel. This feature receive water from the agricultural fields surrounding it and had a straight pattern. There is a blocked culvert (reach break “A”) on its upstream end, separating it from feature 2. No station was established within the feature as it was connected to North Channel (which was sampled) and there was no potential for fish to reach this area from the South Tributary.

Photo 15: Feature 1 looking upstream from downstream (April 6, 2020)

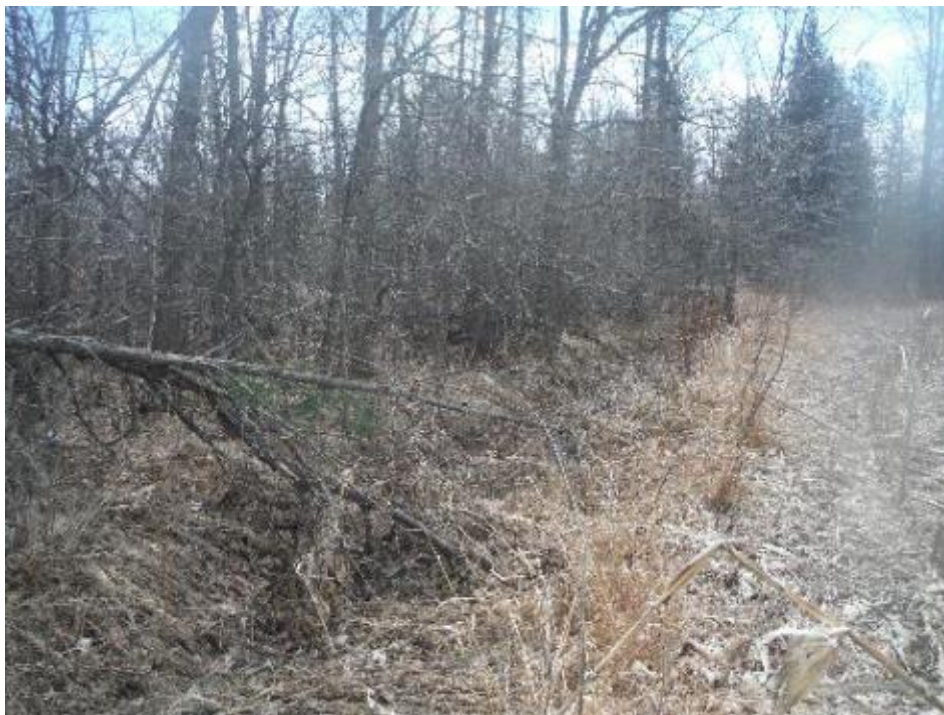
The substrate consisted entirely of fines and the stream morphology was mostly composed of pools, due to the gradient issues. There was little in-water cover present, with some overhanging vegetation (raspberry, colts' foot, and thimbleberry). No signs of erosion were noted. The tops of the banks were mostly vegetated (about 70%). The most common species, other than agricultural species, were dandelion, strawberry, vetch, yarrow, red raspberry, colts' foot, thimbleberry, and hickory.

Photo 21: Station 6 looking downstream from the upstream end (April 16, 2020)

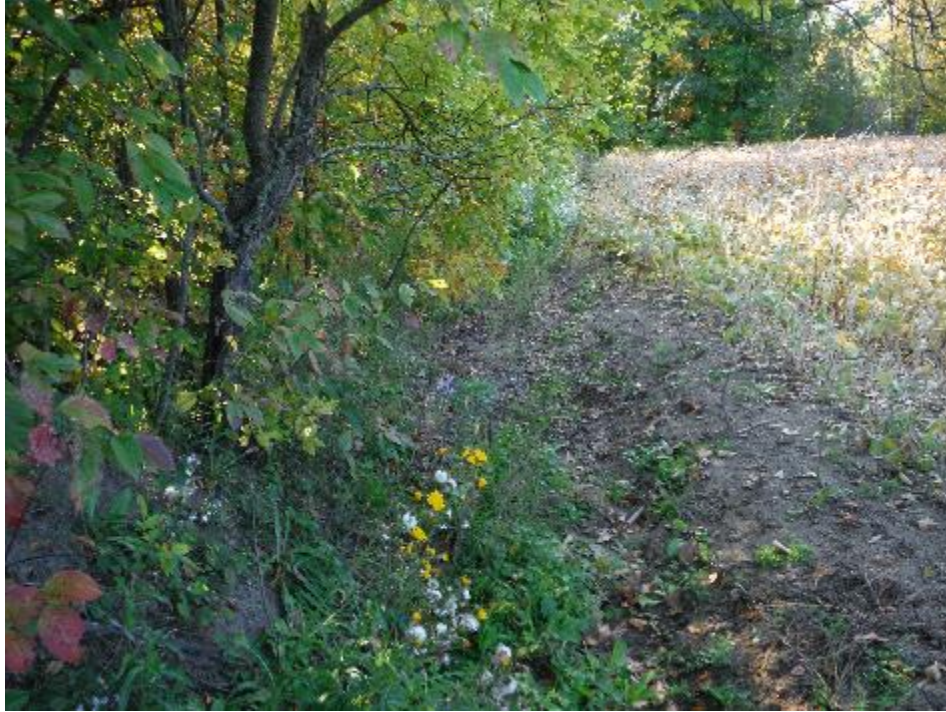
The station was not fished as there was no fish habitat was present. No sampling took place during the summer either as the station was dry (July 27, 2020).

Photo 22: Station 6 looking downstream from the upstream end (September 21, 2020)

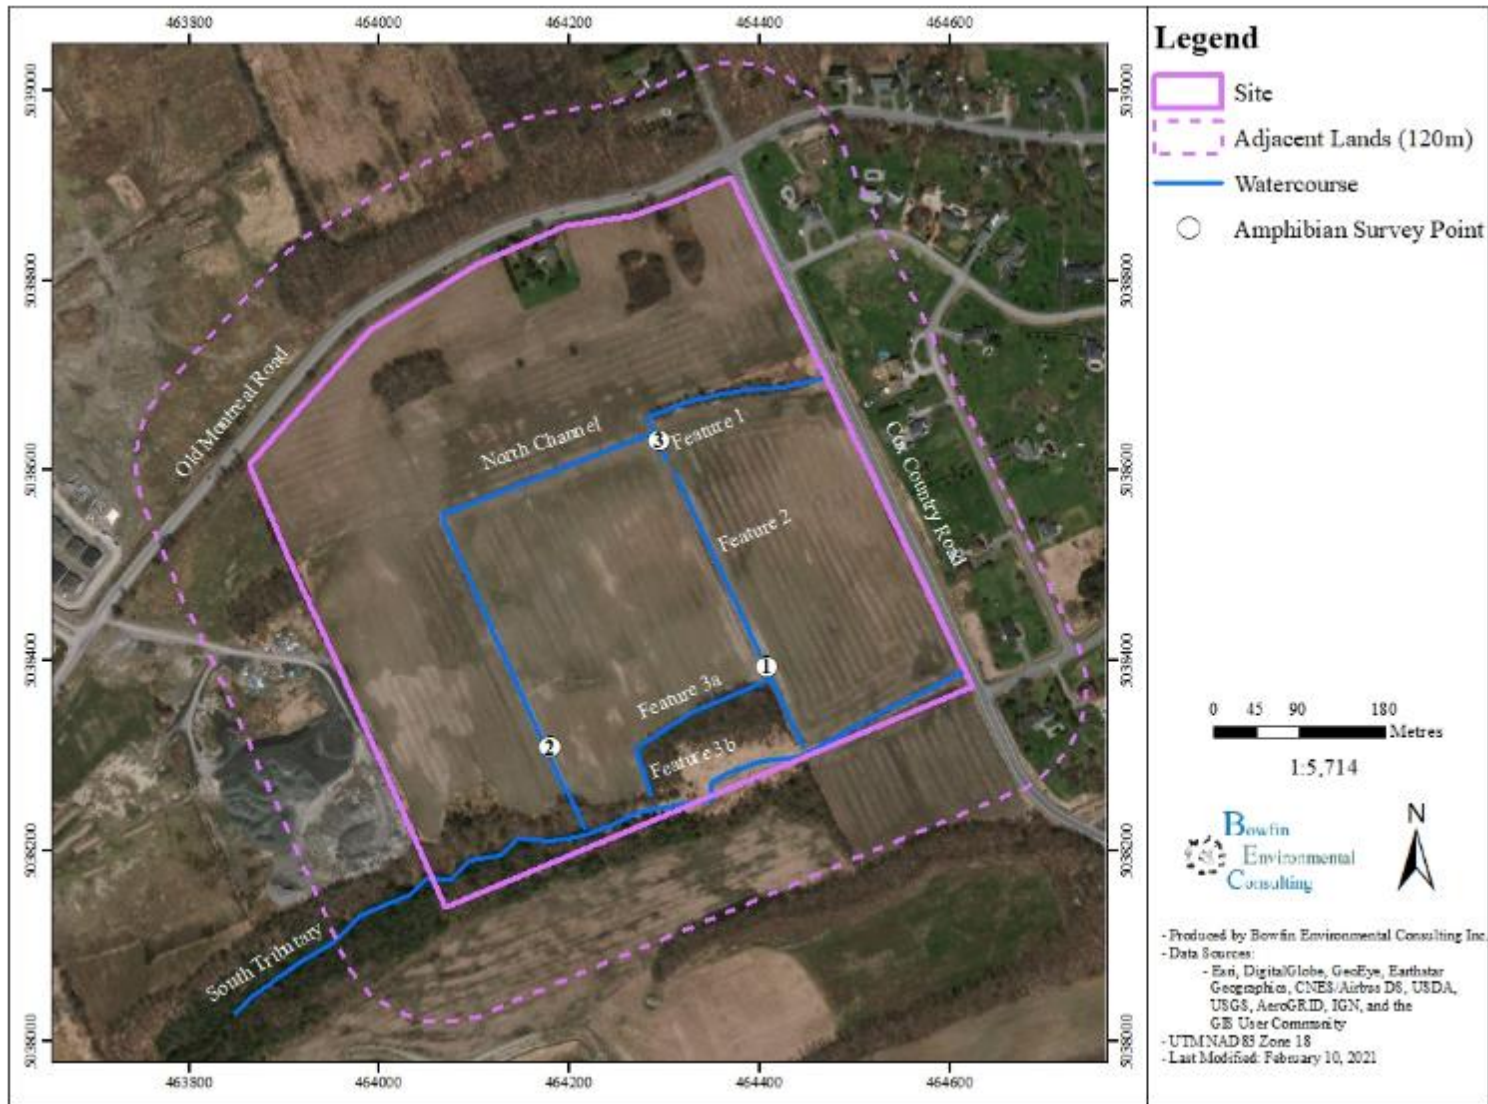
Figure 6: Amphibian Survey Stations
