A CULTURAL HERITAGE IMPACT STATEMENT & CONSERVATION PLAN 168 -174 MURRAY STREET, OTTAWA

Revised V4 June 2022

Commonwealth Historic Resource Management

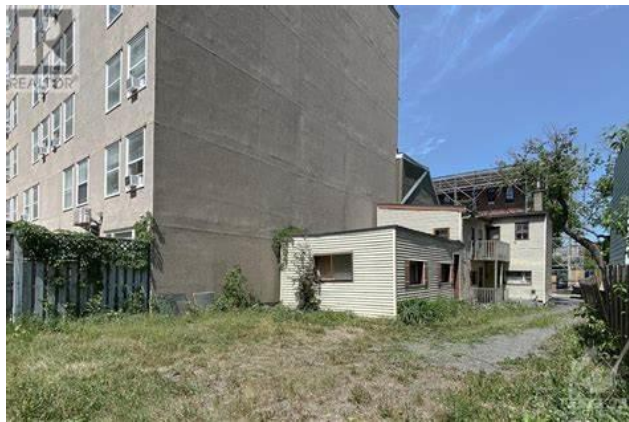
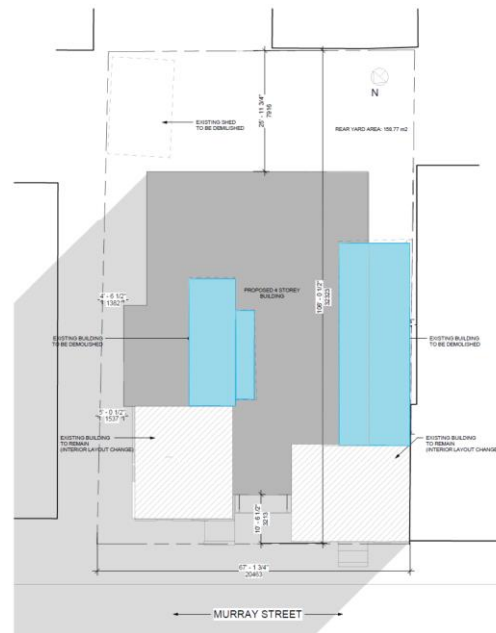
Figure 9 & 10: A view from the rear yard of 168 Murray Street illustrate the context and relationship to 162 Murray. The turquoise indicates the portion of the two buildings that will be removed to construct the apartment.

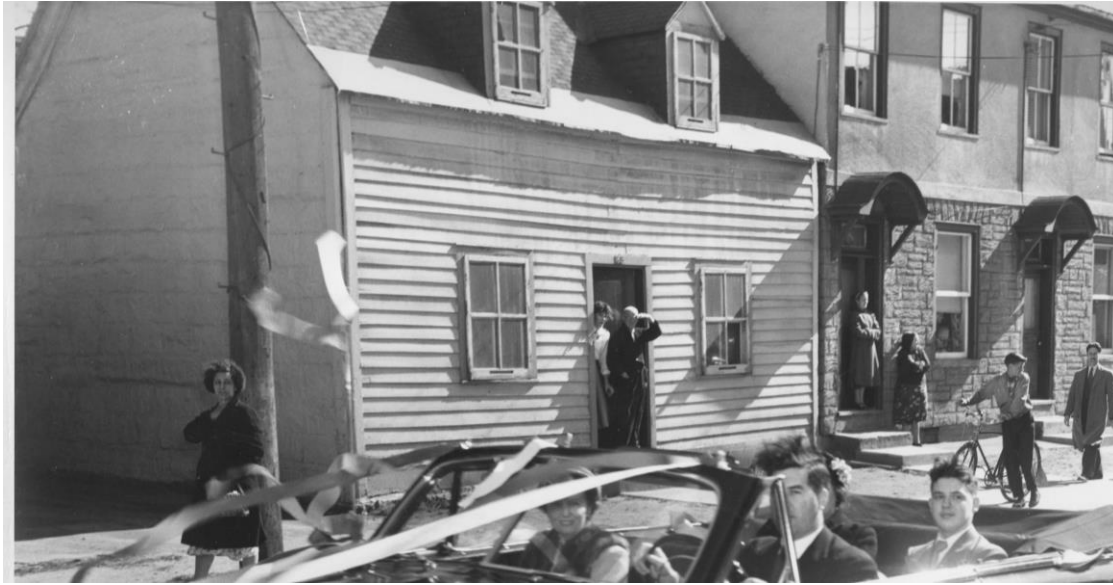
Figure 12: The house at 168 Murray appears in the background of the c.1949 parade. The house is a 1 1/2 storey side gable with two dormers facing the street, a centre front door with no canopy, horizontal siding on the front and squared timber chinked and whitewashed on the gabled side elevation. Source: Marc Aubin Collection

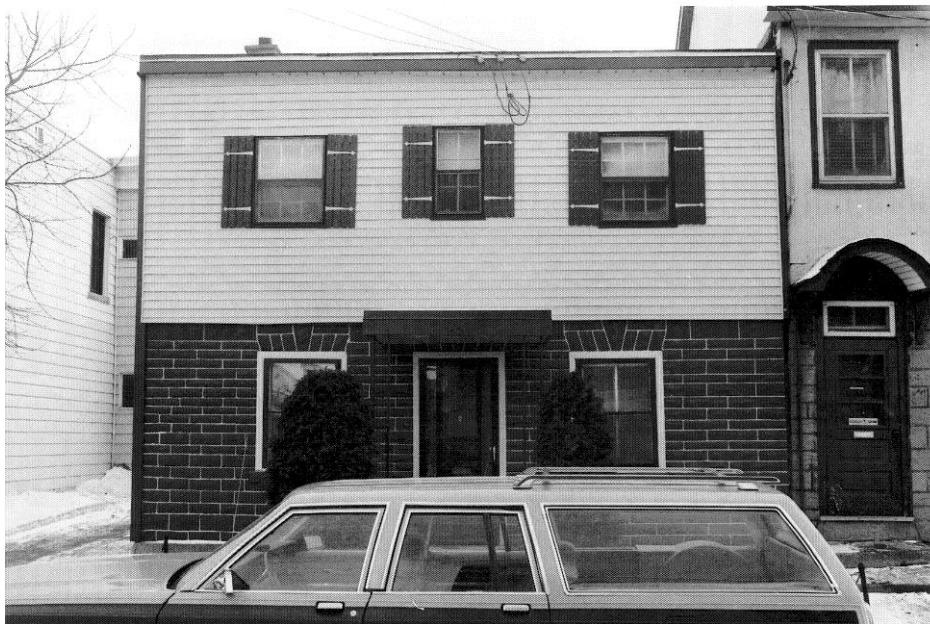
Figure 13: A view of 168 Murray Street as altered circa 1965. The house has been remodelled with a flat roof, second floor added, and three windows replacing the dormers. The exterior was reclad in an angel stone on the ground floor and aluminum siding on the upper floor. A canopy over the front door has been added. Source: City of Ottawa Heritage Survey Forms 1991.

The house was subsequently modified c. 1965 to a two-storey structure when the flat roof and the existing exterior finishes were applied. The building retains its ground floor fenestration pattern with a central entrance and two side windows that are repeated on the second-floor level, possibly the original gable dormer openings. A 1991 view of the house (Figure 13) documents the substantive alteration from its original one-and-one half storey side gable roof with gabled dormers facing the street.

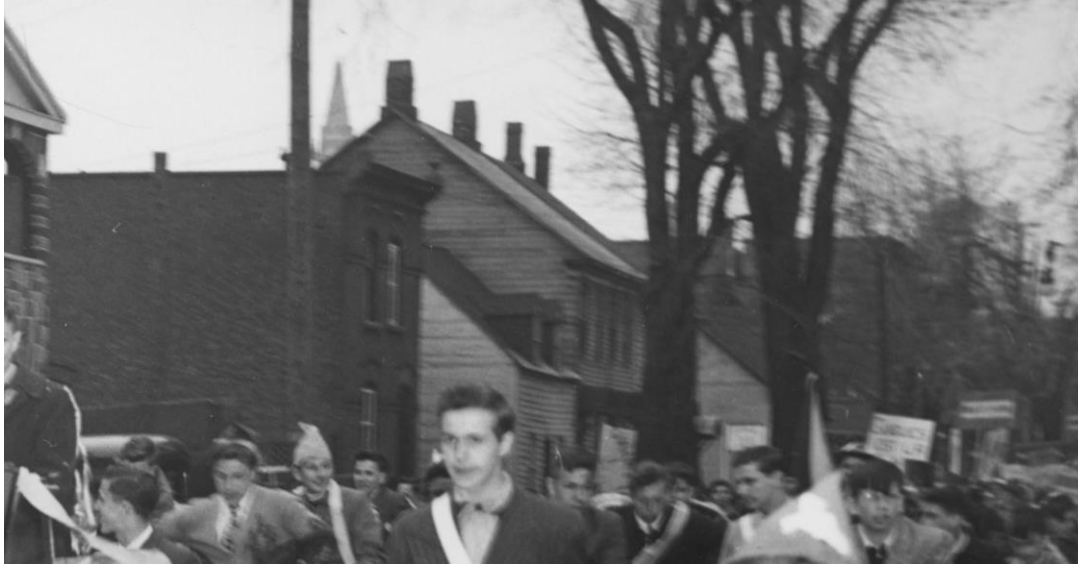
Figure 14: A c.1949 picture with the two houses in the background clearly documents the brick siding of 174 Murray Street and the cottage form of the neighbouring 168 Murray. The textured sidewall of 168 suggests the squared log that has been covered over on the front façade with a horizontal siding. The off-set door on the 2-storey has an arched header. Source: Marc Aubin's collection

The two-storey brick clad frame building with a flat roof at 174 Murray was constructed in 1908. Exterior features include galvanized metal roof trim and detailing, stone window lintels and coursed limestone foundations. The house appears in a c1949 photo.

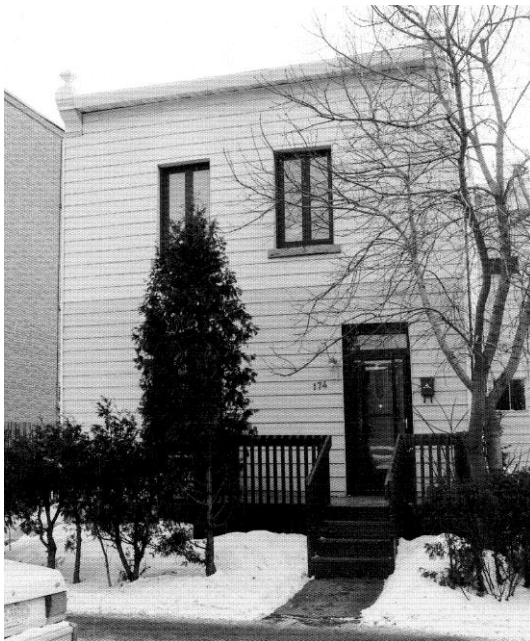
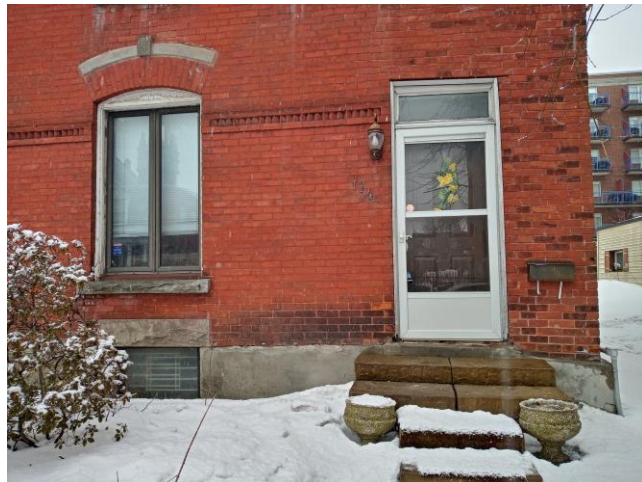
Figure 15 and 16: Two views 1992 and 2022 174 Murray (left) prior to the vinyl siding being removed and rehabilitated front. Note the different brick at the corner (both size and colour consistency) and the lack of corbelled banding and the transom treatment.

The 1992 view of the building retains its form, with the exterior re-clad with a vinyl siding. The finials and a portion of the cornice detail is retained. The offset door is evident in the 1949 picture but has been cover or altered. In the 2022 view the arched brickwork was not incorporated into the replaced brick at the corner.

A renovation post 1992, removed the siding revealing the original brick cladding, limestone window lintels, arch decorative headers and original galvanized metal cornice and detailing. Based on visual inspection the brickwork at the right-hand corner had been replaced. This would explain the lack of arched brick transom, over the front door and the discontinued corbelled brick banding on the right hand side next to the door. Along the front façade there is some bowing of the brick wall at the second floor suggesting that the tiebacks have separated.

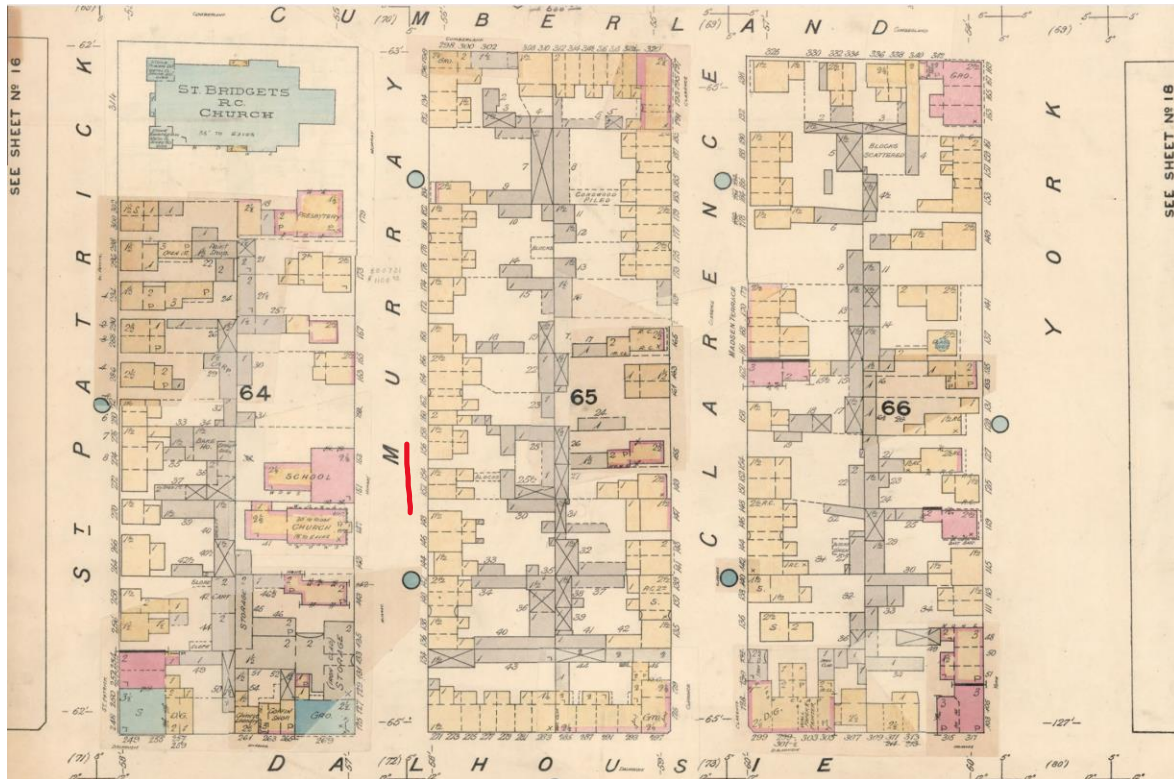
Figure 17: 1901 Fire Insurance Plan Volume 1 Detail Sheet 27. The existing two-storey row house at 162 and a one and one half-storey wood frame cottage at 168 Murray are on the plan. A small workers cottage is on the lot at 174 Murray. Site (highlighted). Source: Library and Archives Canada.

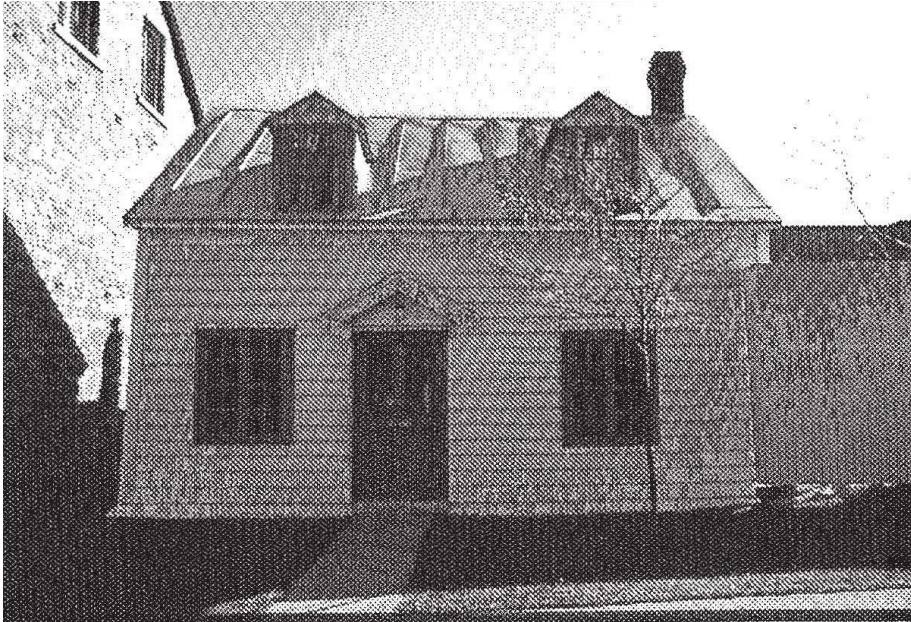
Figure 20: A restored cottage with standing metal seam roof. The offset front door suggests that the building is log with the horizontal siding. Source Lowertown inventory.

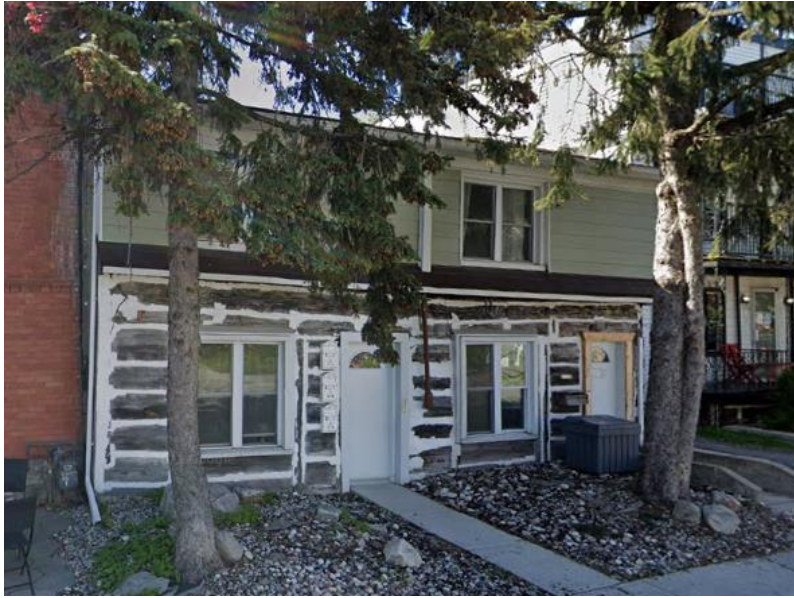
Figure 25: The example of a log cabin at 161 Guigues Avenue with the second-floor addition. Source: Luis Juarez

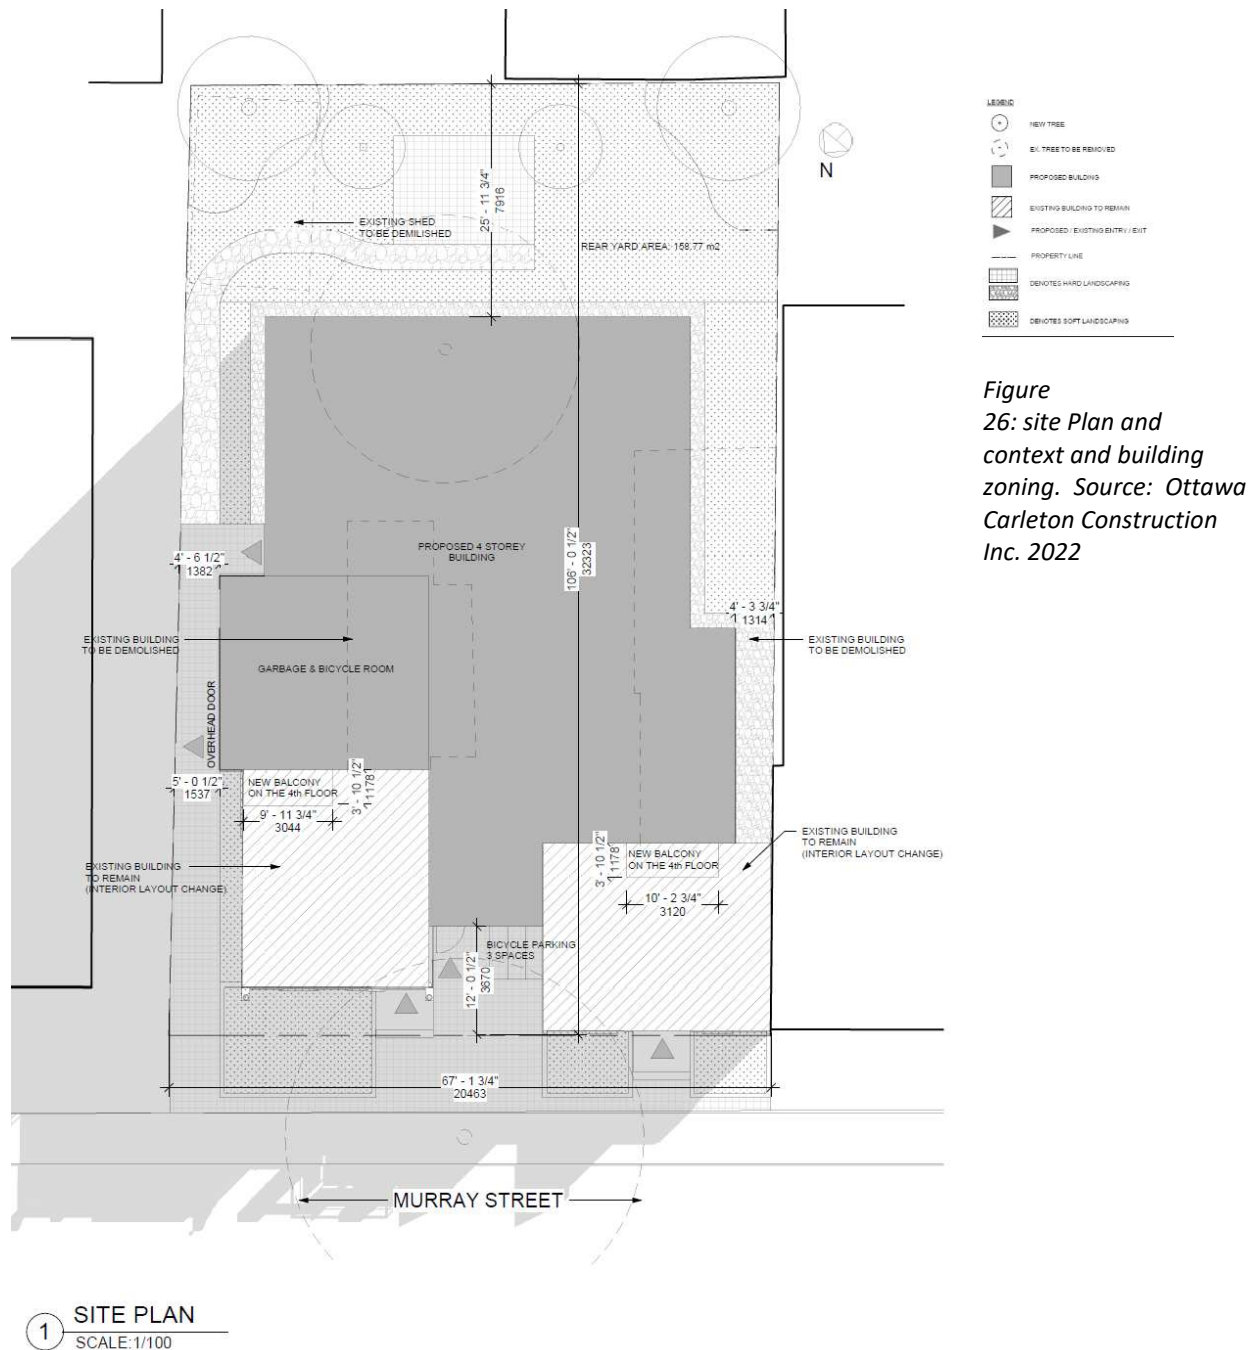
The height of the proposed addition is set well back allowing both extant historic buildings to stand proud. The adjacent development (166-162 Murray) incorporates a six-storey addition set back from the 2.5 side gable. The 4-storey height of the proposed addition respects the neighbouring buildings.

The four-storey scale of the proposed building is sensitive to the visual context of the area. It is a contemporary expression clad in traditional brick and properly set back from the streetscape. The proposed development achieves the intention of small-scale development and relies on the existing buildings and the recessed entrance between the buildings to interpret and maintain the existing lot divisions. In combination with the retention and restoration of the existing buildings there is a clear distinction and integration of existing and new.

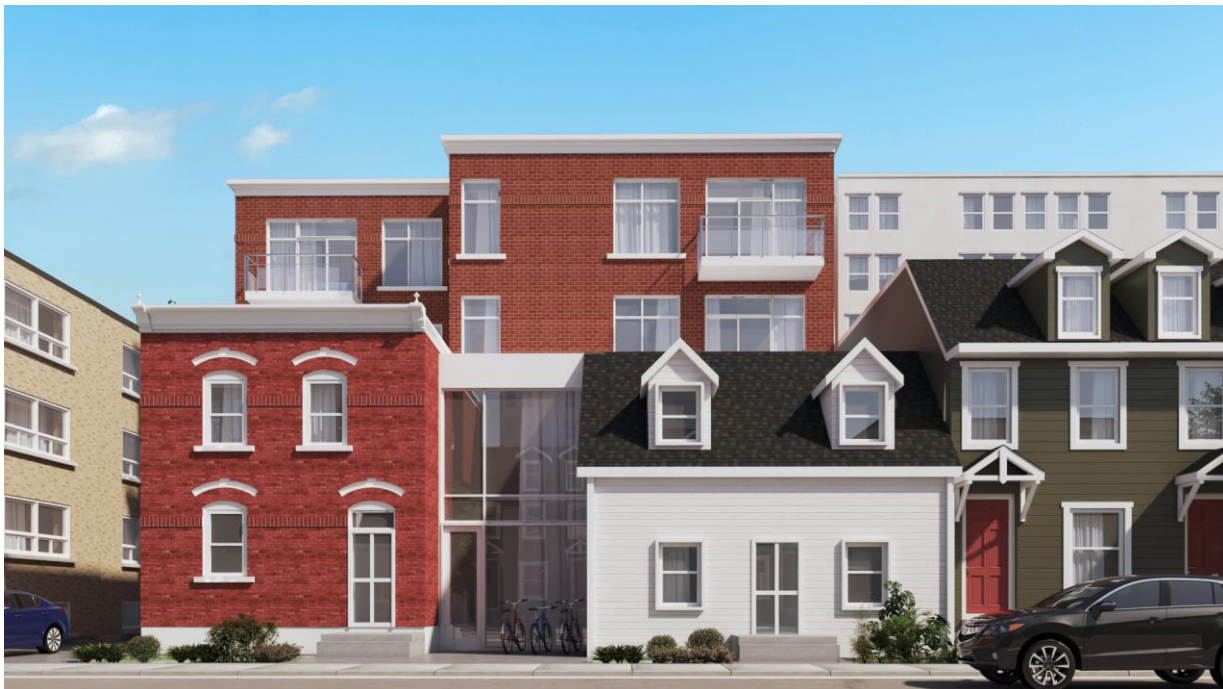
Figure 27: A street elevation of the proposed development in the context with the neighbouring properties. Source: Ottawa Carleton Construction Inc. 2022

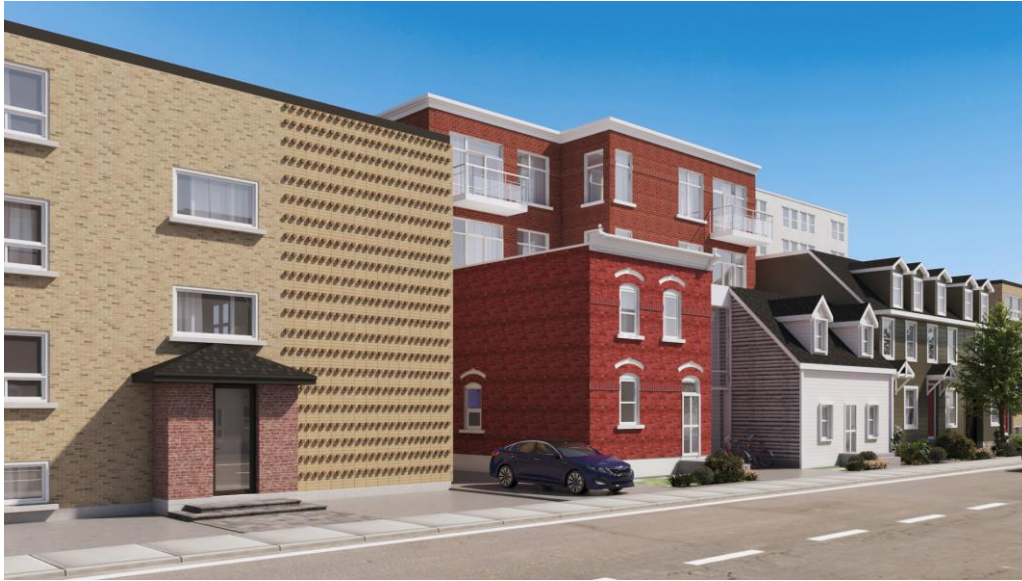
Figure 28: A view looking southeast with the proposed red brick 4-storey apartment positioned behind the heritage buildings. It fits comfortably with in the context of the streetscape and neighbouring built form. Source: Ottawa Carleton construction Inc.

The new apartment will incorporate natural materials including brick cladding along the front and side façades. The colour is a reddish-brown, distinct but complimentary to the restored cladding of the 2-storey semi-detached. Windows will be a painted metal clad, and balconies off the 4th floor will be a contemporary glazed expression.

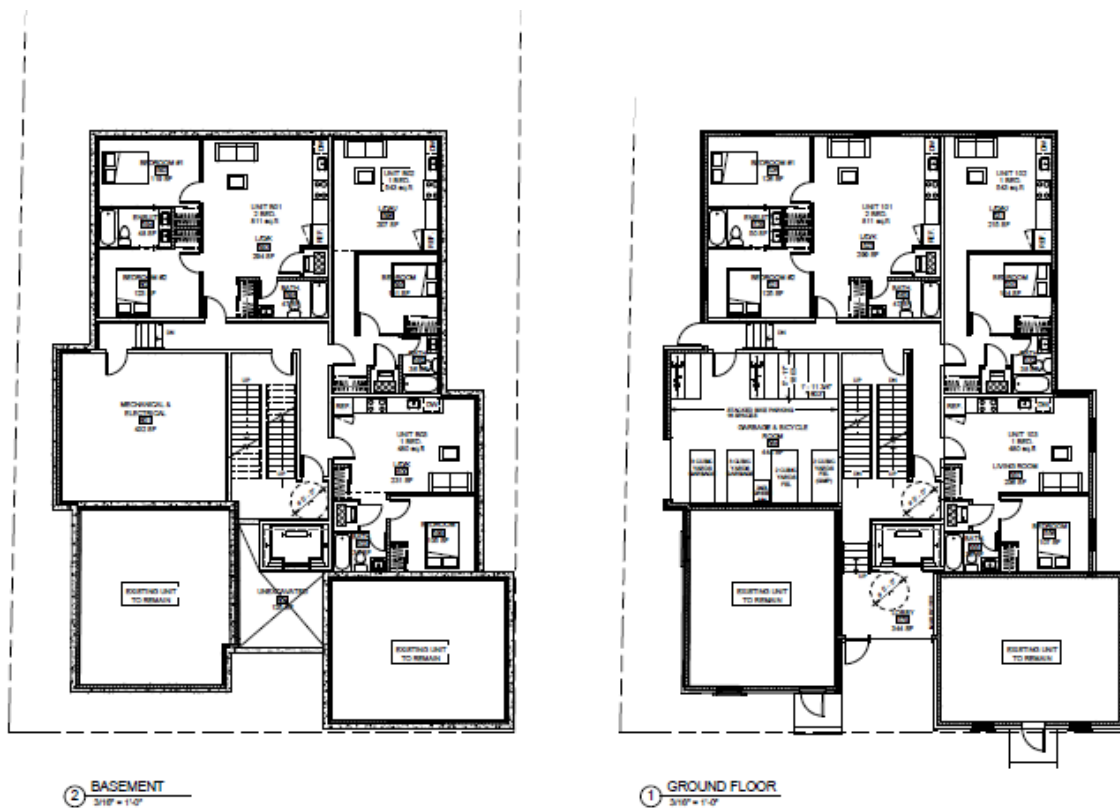
Figure 29: Plan views of the basement and ground floor. Source: Ottawa Carleton Construction Inc.

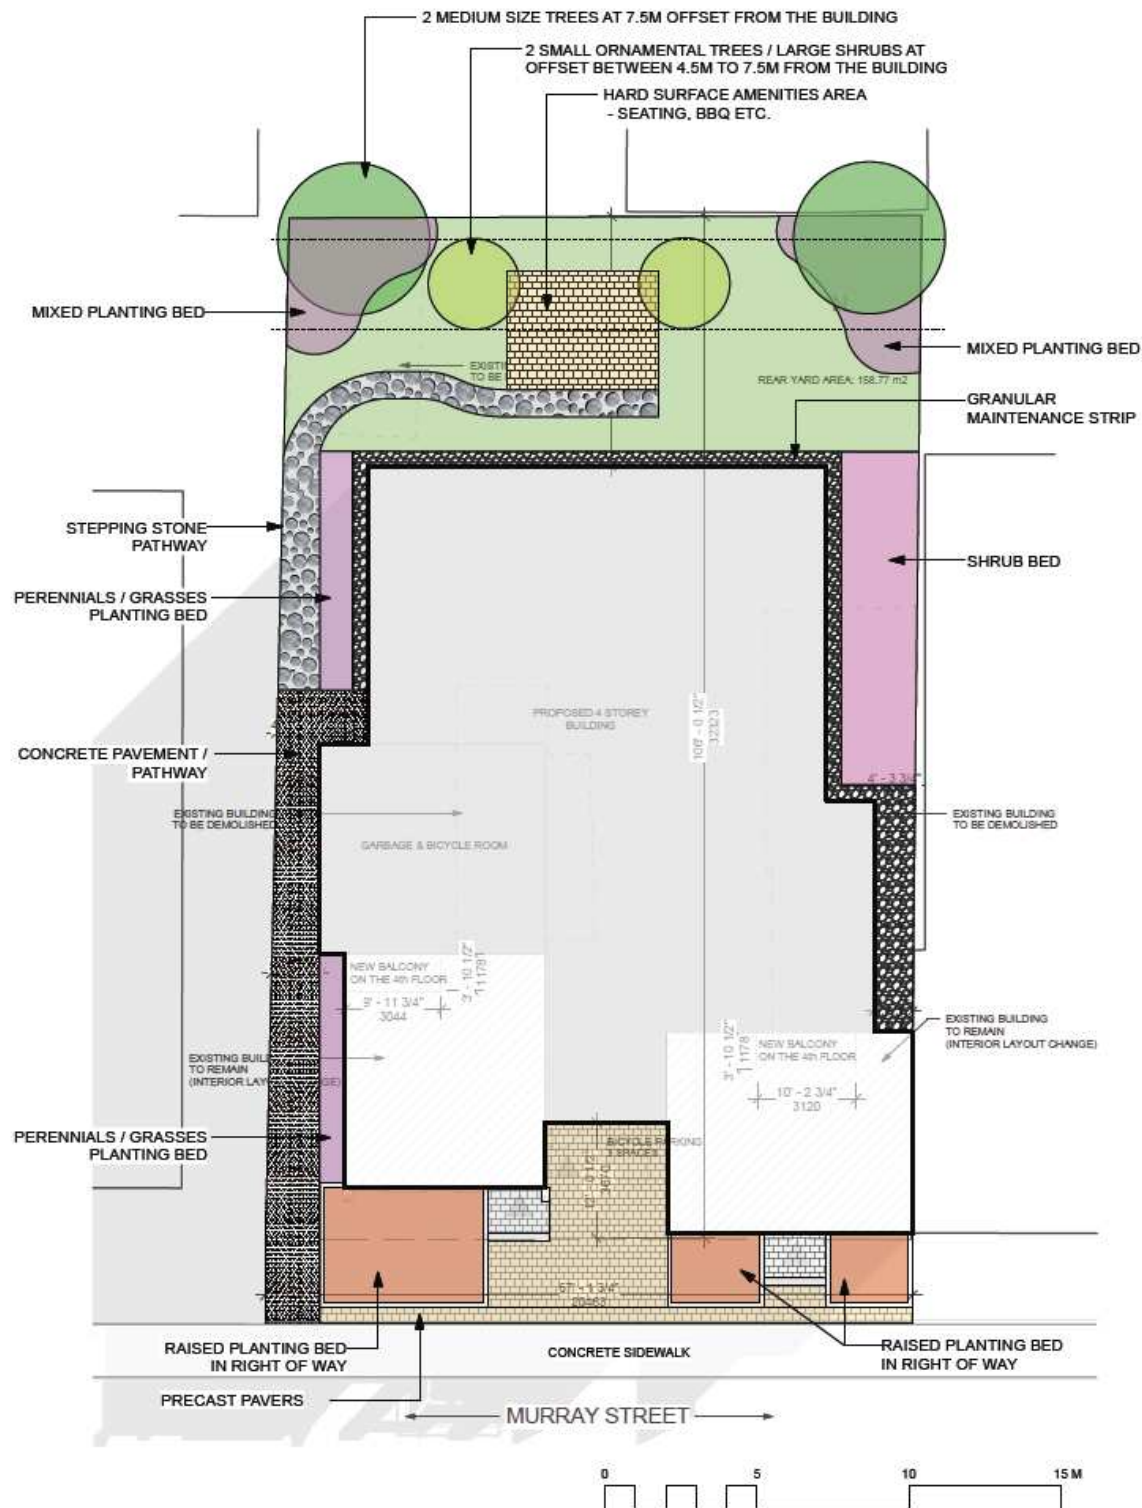
CONCEPT LANDSCAPE PLAN

Figure 30: Landscape Plan Source" Ruhland and Associates Landscape Architects 2022.

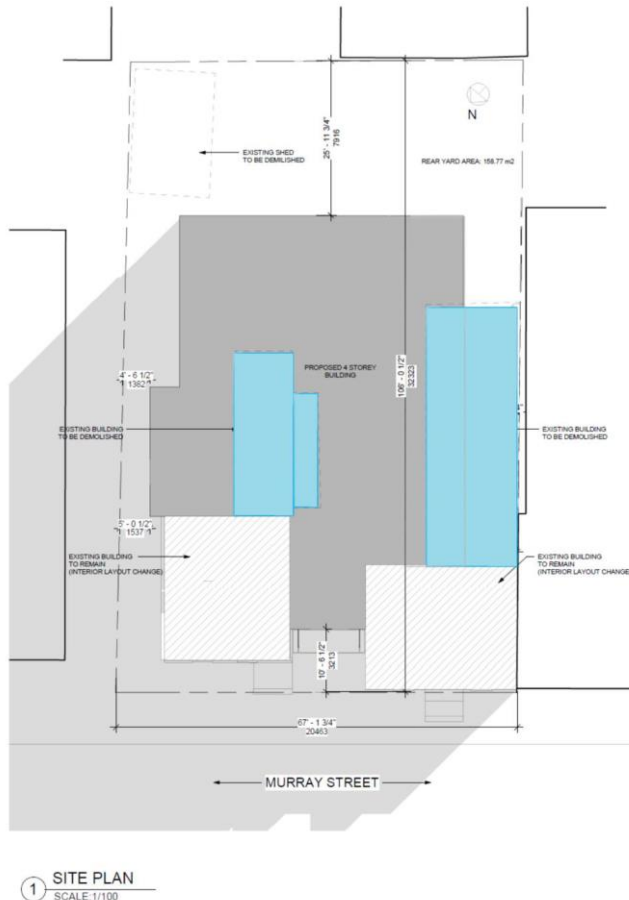
Figure 31: Preliminary site plan of the proposed development. The footprints of the existing buildings have a floor plate of approximately 500sq.ft. (48msq.). Note the relationship of the building at 168 Murray with the adjacent two storey row house illustrating the development footprint. The two existing buildings in light grey and rear sections that will be demolished are in blue. The 4-storey apartment block appears as a darker grey. Source: Ottawa Carleton Construction Group February 2021.

Demolition is not considered a conservation activity and will be limited to the removal of the rear additions of both buildings and the removal of the second storey at 168 Murray street and reroofed with a 1.5 side gable. Figure 31 below delineates structures that will be demolished (shown in turquoise); they are both in poor condition. They will be replaced with the 4-storey apartment shown in the darker grey.

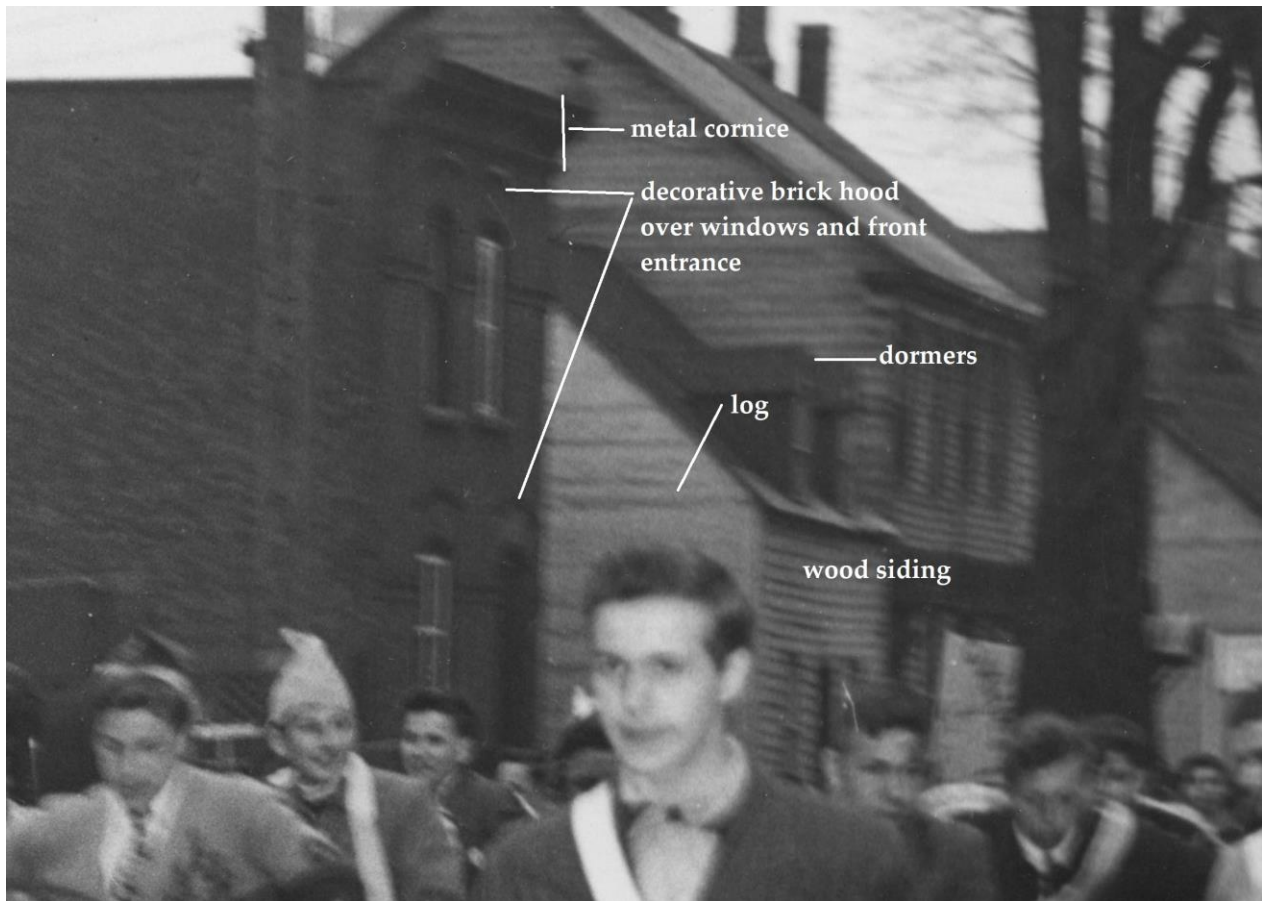
Figure 32: A c.1949 picture with the two houses in the background clearly documents the brick siding of 174 Murray Street and the cottage form of the neighbouring 168 Murray. The textured sidewall of 168 suggests the squared log that has been covered over on the front façade with a horizontal siding. The off-set door on the 2-storey has an arched header. Source: Marc Aubin's collection

As the 1949 photograph (Figure 32) illustrates it had a dressed front façade with horizontal siding and exposed squared log on the side elevations. A collection of exterior sidings were introduced including tin panels, insul-brick, angel stone stucco and vinyl siding. As well as residing the house was subsequently modified c.1965 to a two-storey structure when the flat roof and the existing exterior finishes were applied. The building retains its ground floor fenestration pattern with a central entrance and two side windows that are repeated on the second-floor level, possibly the original gable dormer openings. A 1991 view of the house (Figure 10) documents the substantive alteration from its original one-and-one half storey side gable roof with gabled dormers facing the street.

The two-storey brick clad frame building with a flat roof at 174 Murray was constructed in 1908. Exterior features include galvanized metal roof trim and detailing, stone window lintels and coursed limestone foundations. The house appears in a c.1949 photo figure 32 highlights some of the attributes.

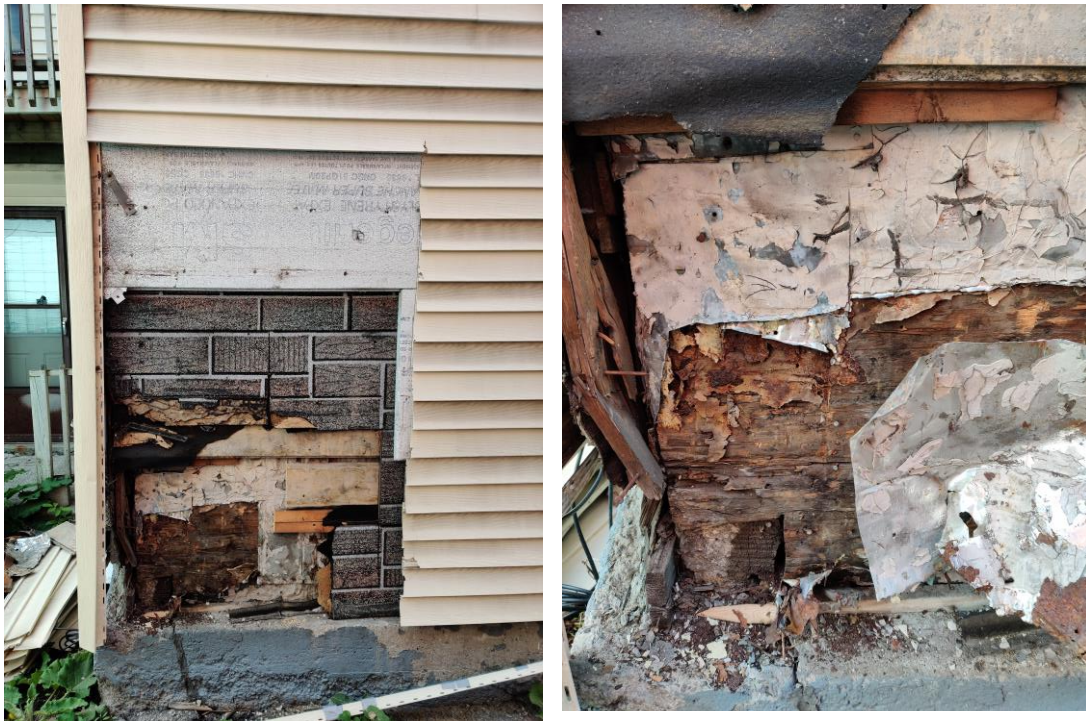
Figure 33: 1861 Census documents the McManus family owned a 66 x.99 lot at 168 Murray and were living in 1.5 storey log house. The Lowertown building inventory recorded that the building was constructed in 1876 based on Fire Insurance plans. The two views illustrate the multiple layers of finishes including squared timber, tin panels insulation, brick, ridged insulation, and vinyl siding. Source David Yoo 2022.

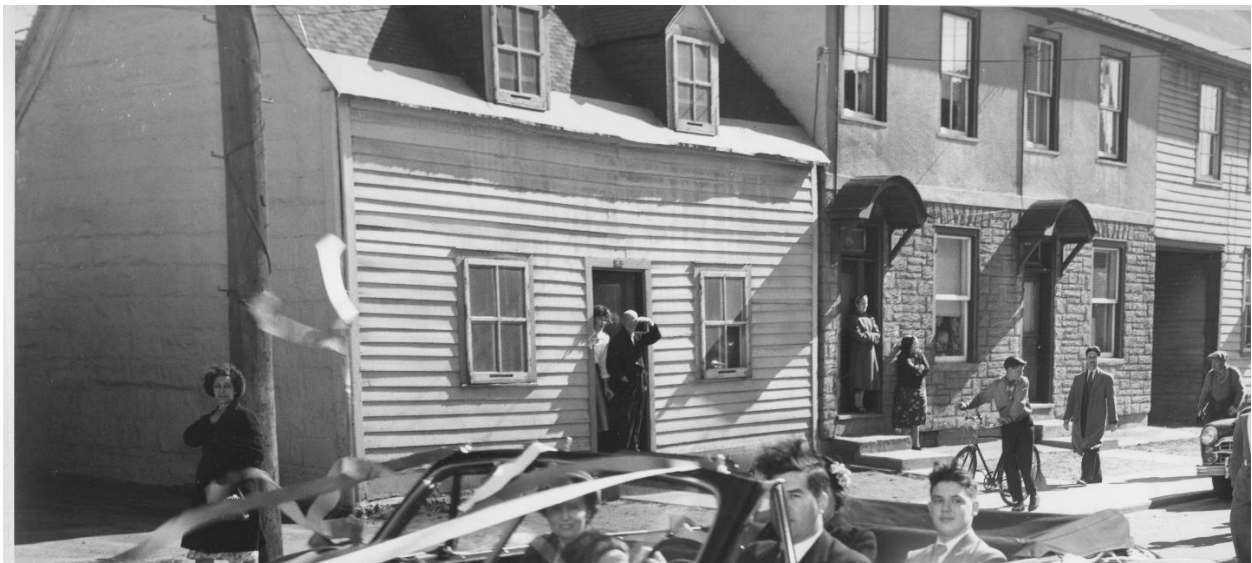
Figure 34: The house at 168 Murray appears in the background of the c.1949 parade. The house is a 1.5 storey side gable with two dormers facing the street, a centre front door with no canopy, horizontal siding on the front and squared timber chinked and whitewashed on the gabled side elevation. The covered carriage way is common feature

as seen in the 2.5 -storey to the right. Source: Marc Aubin Collection

The building is a 1.5 storey squared log cottage with a side gable roof. Recording has been undertaken. Further investigation is required to determine its condition. The intention is to reinterpret the 1949 photo Figure 34 with the log sidewall exposed and the front façade dressed with a horizontal board siding. The façade of the building along the street and west façade will need to be stripped and taken down to the original structure. Historic documents suggest that the building is log, the 1949 photo and removals supports this record. A more aggressive assessment will be undertaken as part of the development phase of the project.

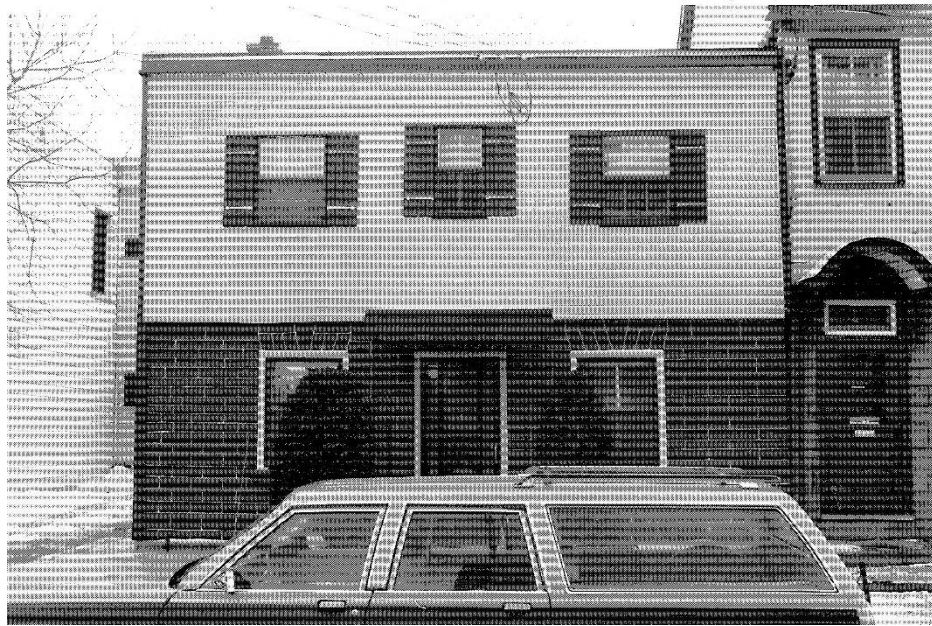
Figure 35: A view of 168 Murray Street as altered circa 1965. The house has been remodelled with a flat roof, second floor added, and three windows replacing the dormers. The exterior was reclad in an angel stone on the ground floor and aluminum siding on the upper floor. A canopy over the front door has been added. Source: City of Ottawa Heritage Survey Forms 1991.

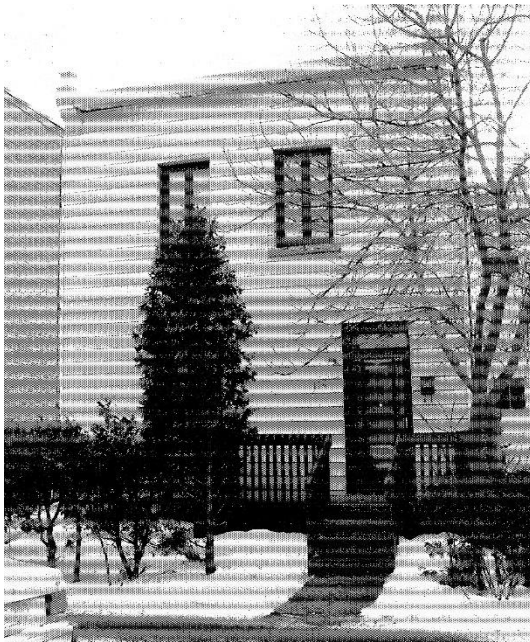
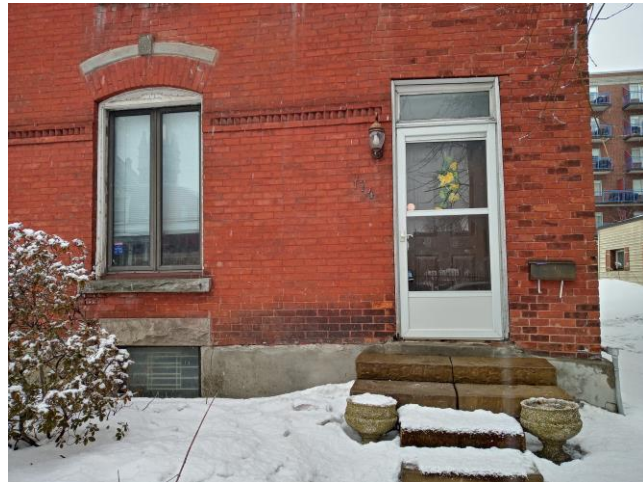
Figure 36 and 37: Two views 1992 and 2022 174 Murray (left) prior to the vinyl siding being removed and rehabilitated front. Note the different brick at the corner (both size and colour consistency) and the lack of corbelled banding and the transom treatment.

Views of the building suggest that the west corner of the building had been rebuilt. The foundation slopes and the replacement brick is of a slightly different size with the transom over the front door and the corbelled band eliminated.

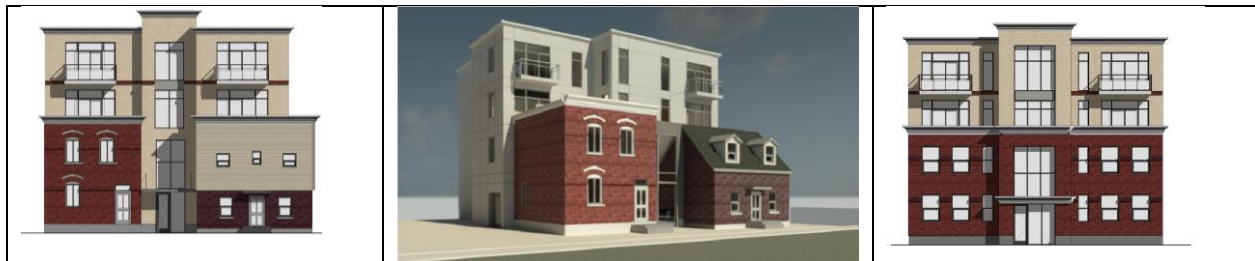
Through out the redevelopment process multiple mitigation measures and alternatives were considered and implemented in response to community and city suggestions, good conservation practise and the owner's expectations: Below are sketches of some of the alternatives.
