# 35 - 37 WILLIAM STREET RECONSTRUCTION AFTER FIRE

BASEMENT PLAN  
1 : 150

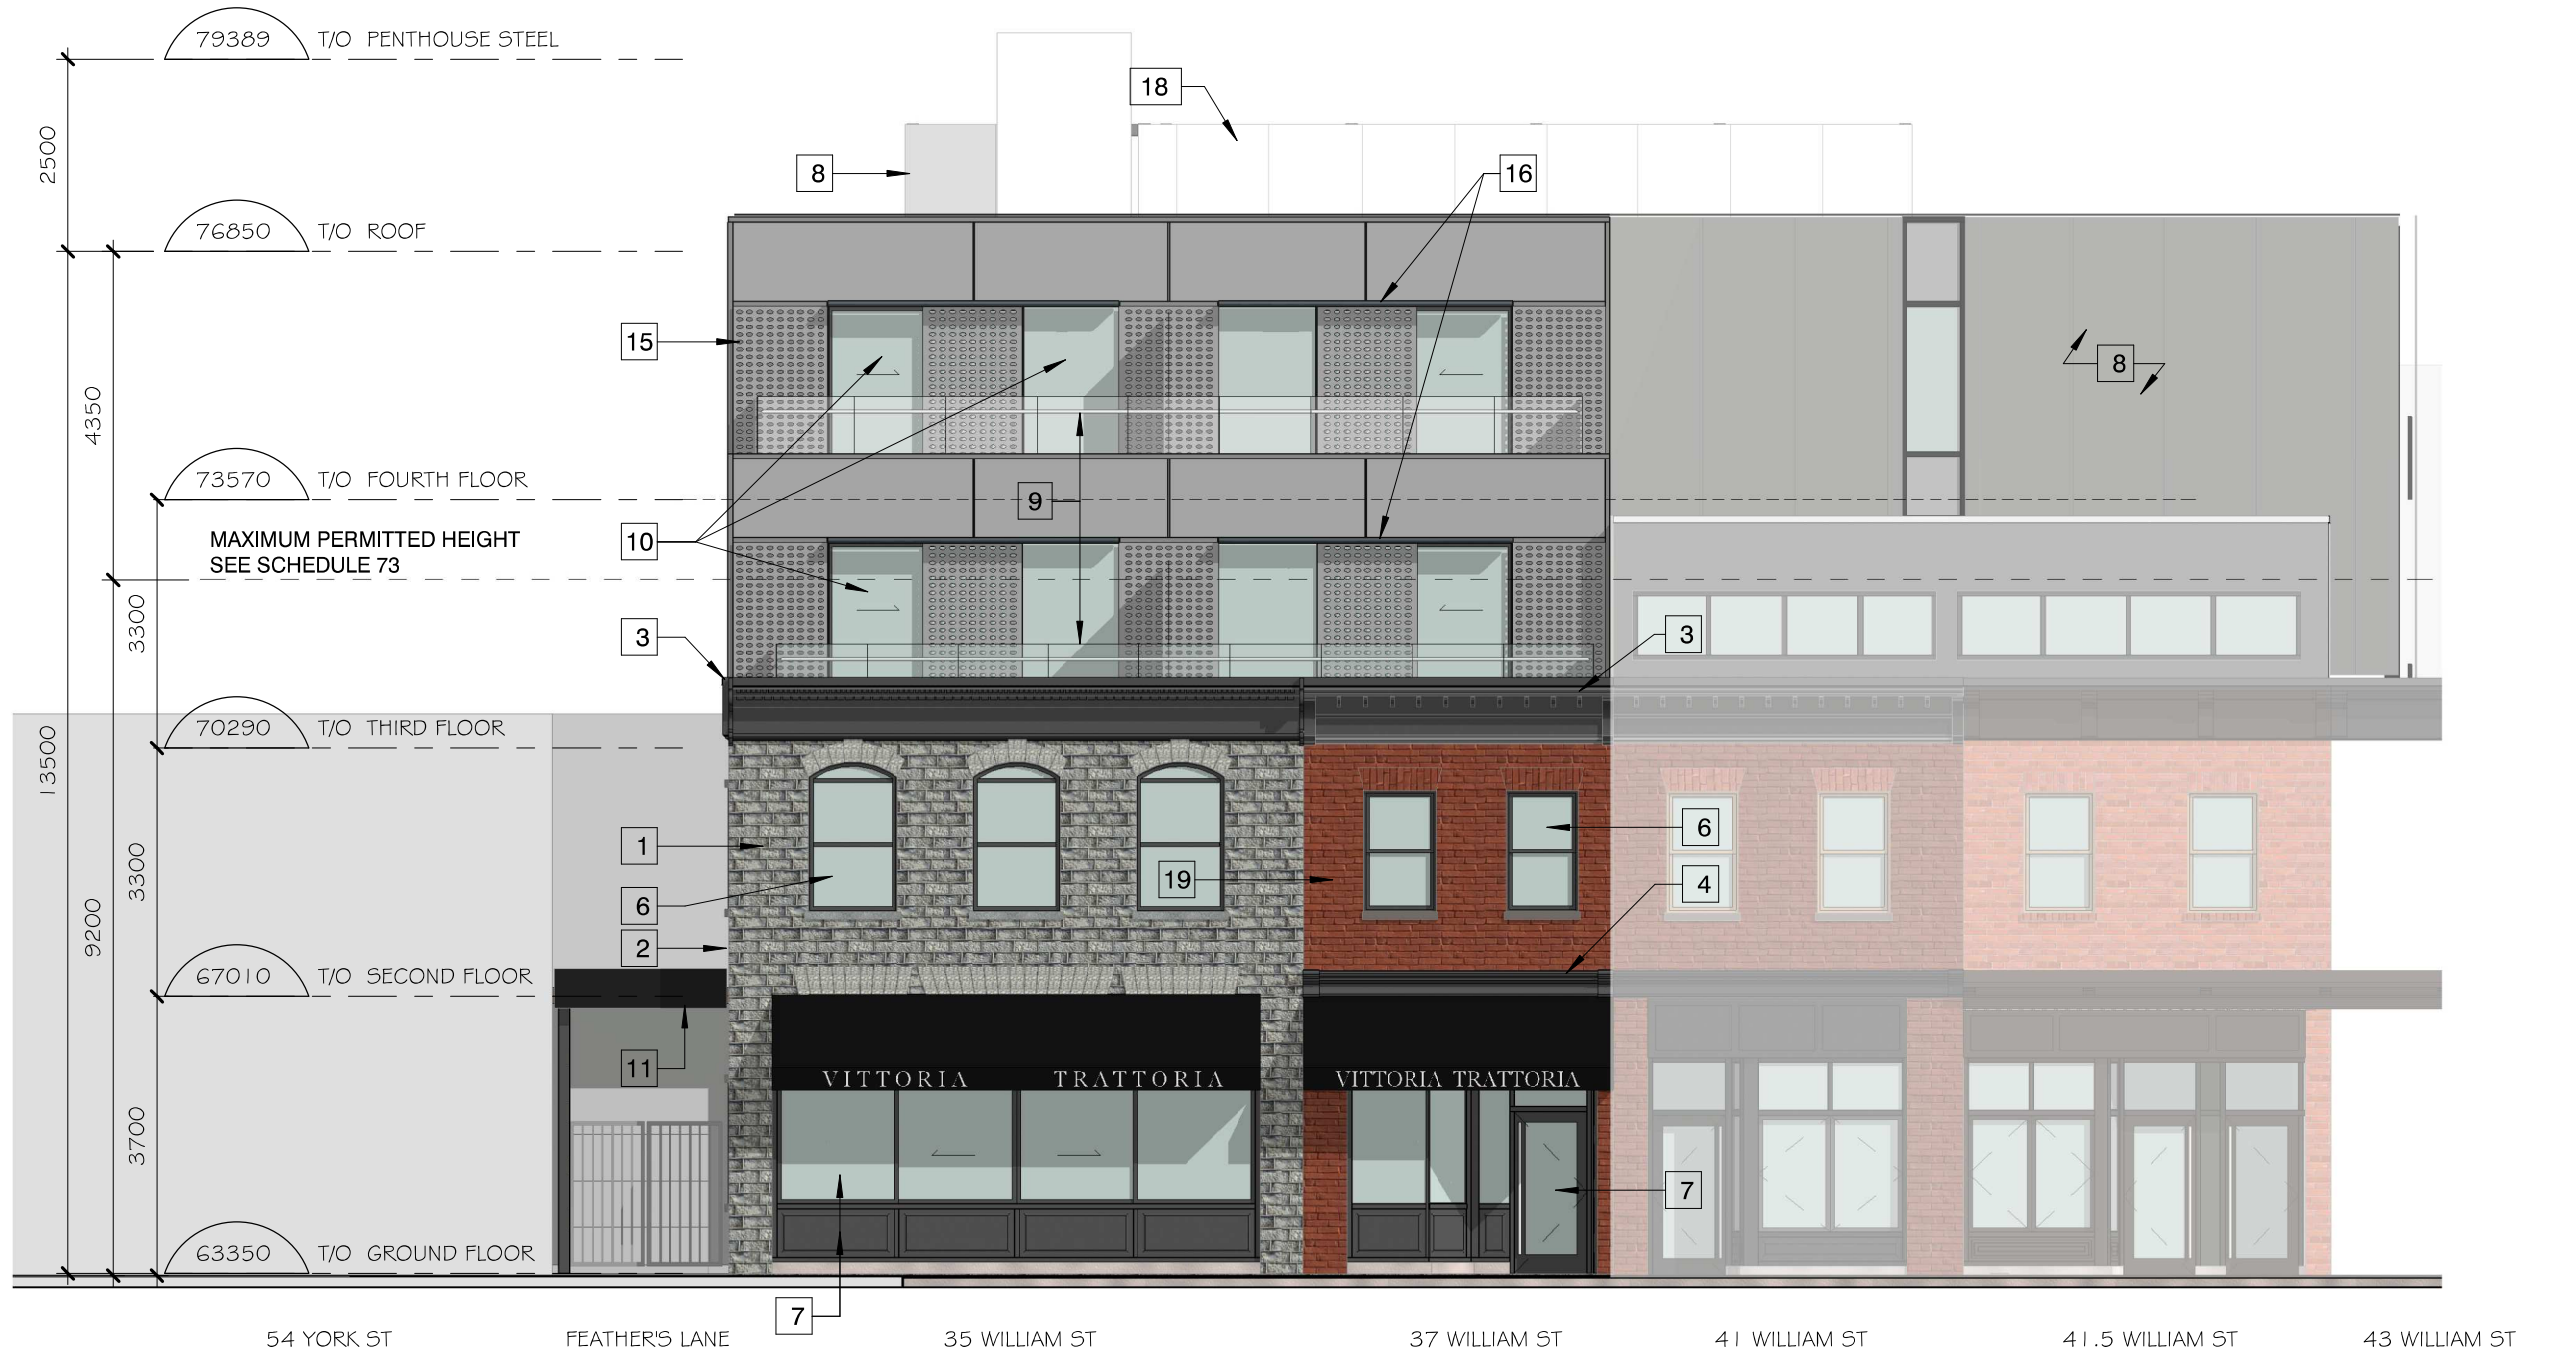
H-11

West Elevation (Front Facade/William Street) Heritage  
1 : 100

- 1. The conservation and rehabilitation of the stone facade of 35 William Street (original Feathers Hotel) and the brick facade of 37 William Street.
- 2. The conservation and rehabilitation of the 9.4 m (approx.) east/west stone facade along "Feathers Lane".

- 3. The reconstruction of a new wood cornice at the top of 35 and 37 William to match the details of the former cornice destroyed by the fire.
- 4. The reconstruction of a new wood cornice at the second floor level of 37 William to match the details of the former cornice damaged by the fire.

- 5. The installation of new one over one wood windows at existing wall openings at ground and second floor level of 35 William St.
- 6. The installation of 2 new one-over-one metal clad wood windows at the second floor level of 37 William that are compatible with the heritage character of the facade.

- 7. The installation of new glazed metal framed store fronts & metal panel knee wall at the ground floor level of 35 and 37 William Street.
- 8. The enclosure of the new north, south, east and west facades of the third and fourth floors of the building with sintered ceramic facade panel (dark grey, black, white above roof).

- 9. Glazed terrace railing.
- 10. The installation of metal window and patio door systems within curtain wall glazing system at the second, third and fourth floors (dark grey frames) with clear glass balcony railings around the outdoor terraces and "Juliet" balconettes.

- 11. New metal fascia (dark grey) at the leading edge of the recessed canopy covering "Feathers Lane" facing William Street.
- 12. The installation of reclaimed stone from 35 William Street at the hotel entrance from the York Street Lane.

- 13. The installation of wood accent screen and wood ceiling for hotel entrance from the York Street Lane.
- 14. The installation of corrugated metal facade material in upper facade areas.
- 15. The installation of a prefinished perforated metal screen on top of new exterior wall assembly/curtain wall glazing. (Backlit at the East Elevation only).
- 16. The installation of a horizontal metal fin on curtain wall mullion.
- 17. The installation of new wood panel aligned with wood cornice at front of 35 William St.
- 18. Roof screen.
- 19. Existing paint removed from face of 37 William Street brick facade.

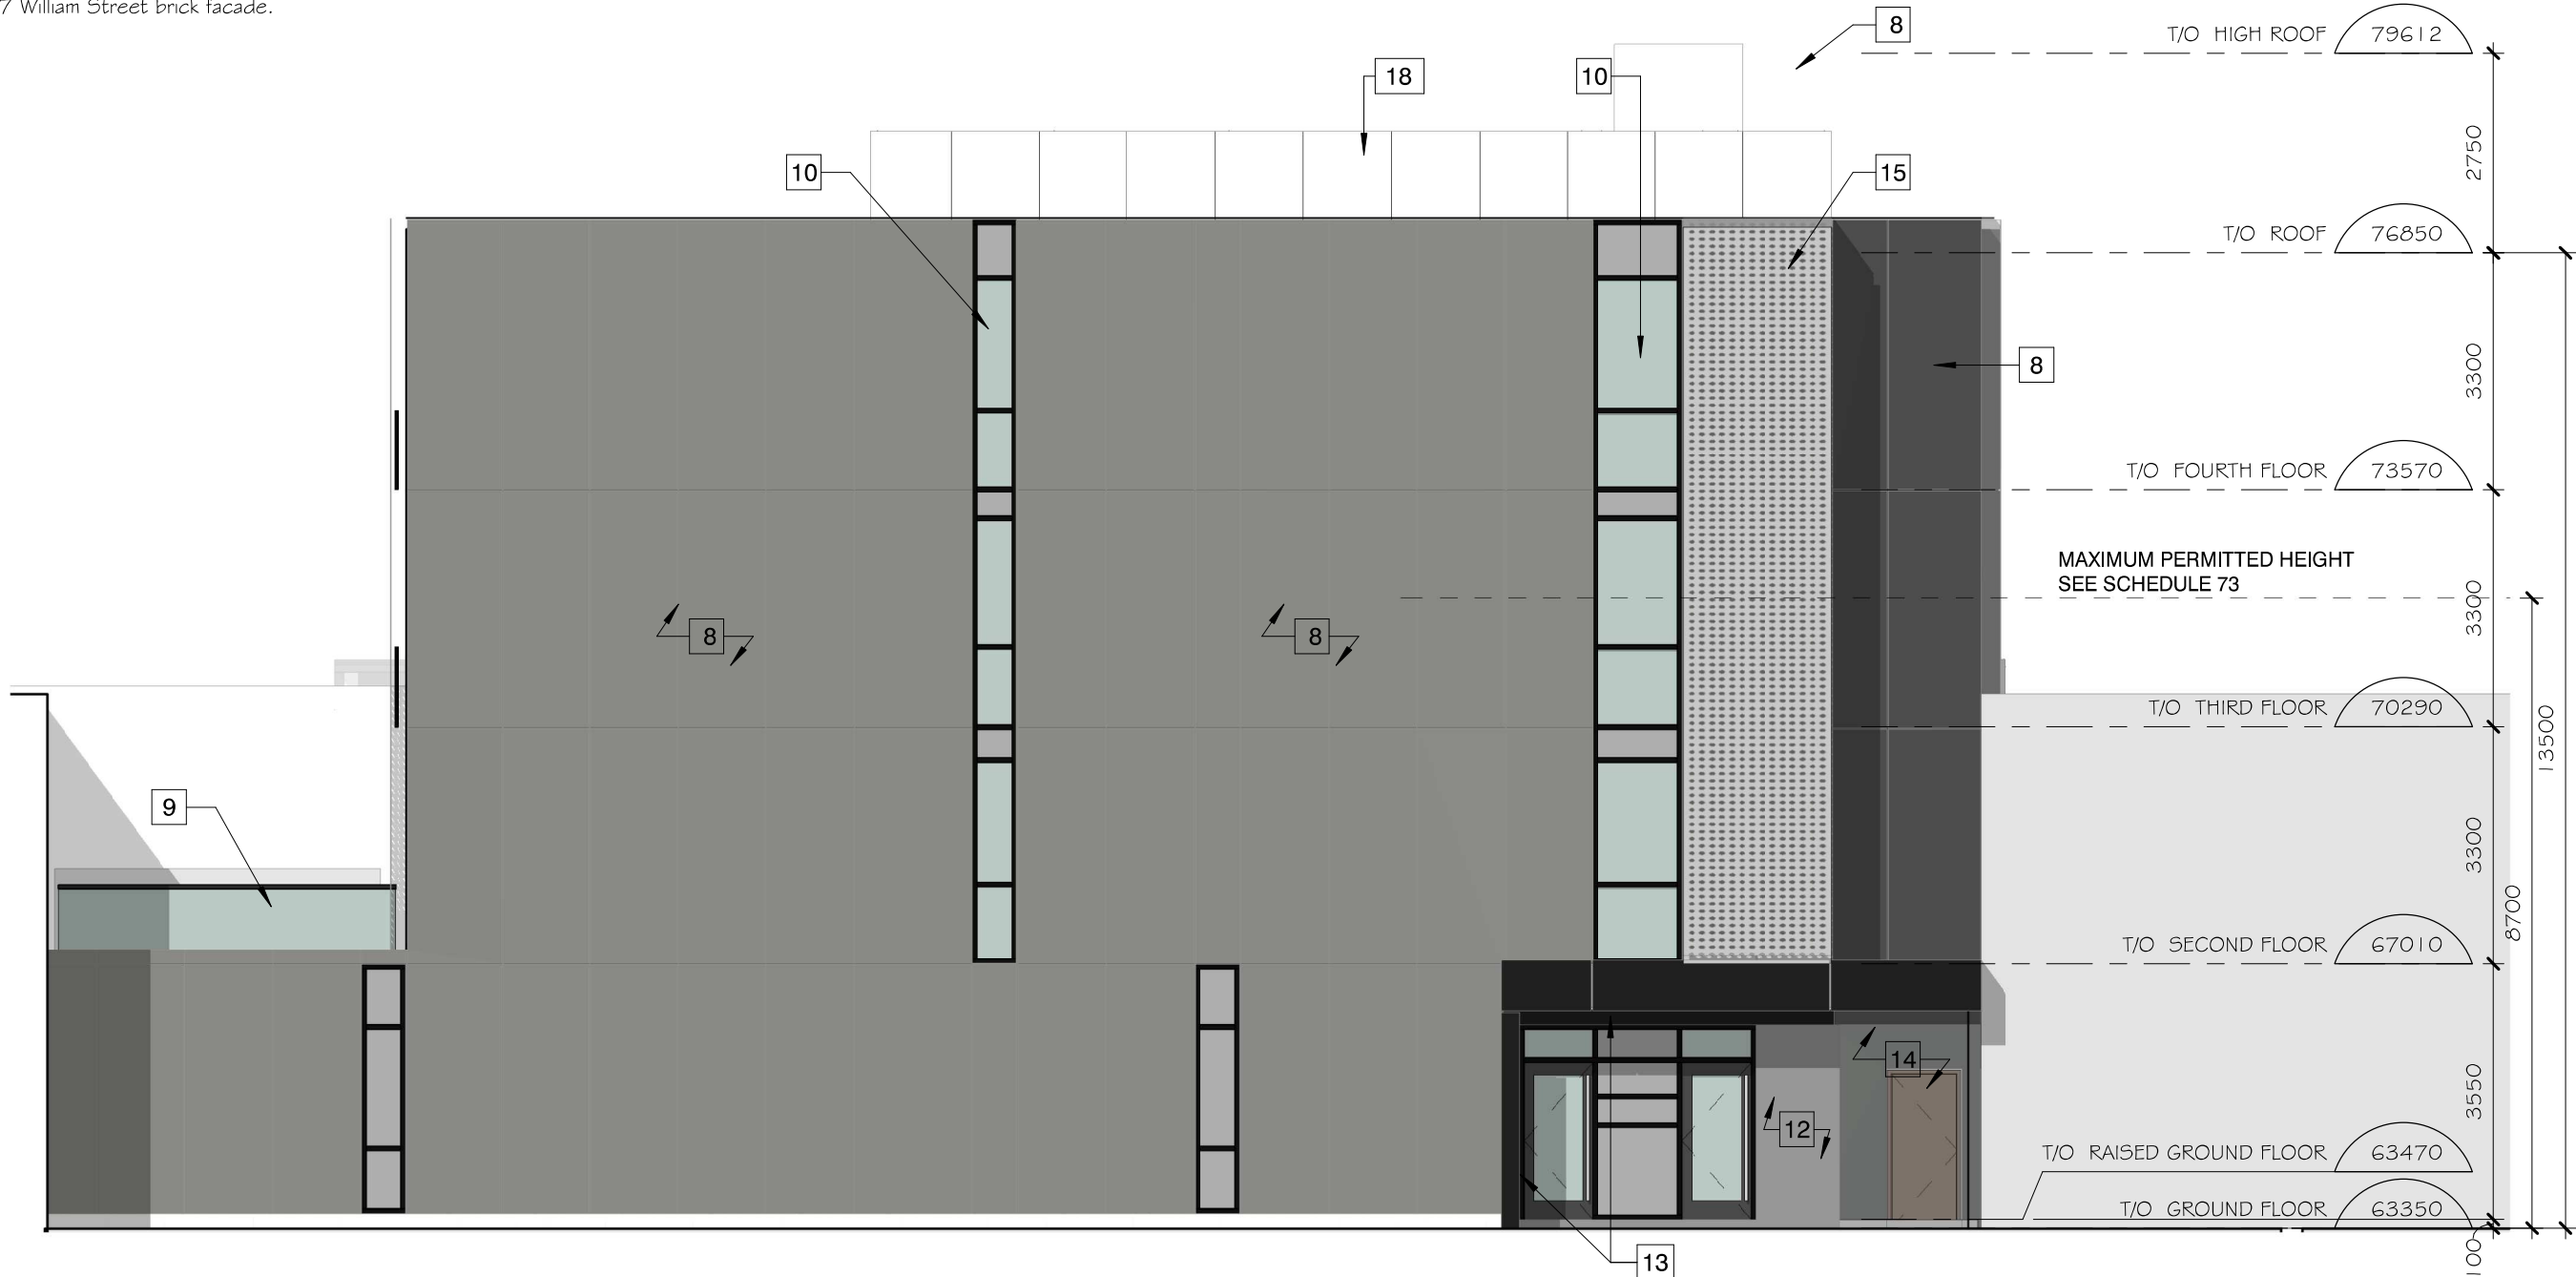
H-12

East Elevation ( Hotel Entrance) - Heritage  
1 : 100

- 1. The conservation and rehabilitation of the stone facade of 35 William Street (original Feathers Hotel) and the brick facade of 37 William Street.
- 2. The conservation and rehabilitation of the 9.4 m (approx.) east/west stone facade along "Feathers Lane".

- 3. The reconstruction of a new wood cornice at the top of 35 and 37 William to match the details of the former cornice destroyed by the fire.
- 4. The reconstruction of a new wood cornice at the second floor level of 37 William to match the details of the former cornice damaged by the fire.

- 5. The installation of new one over one wood windows at existing wall openings at ground and second floor level of 35 William St.
- 6. The installation of 2 new one-over-one metal clad wood windows at the second floor level of 37 William that are compatible with the heritage character of the facade.

- 7. The installation of new glazed metal framed store fronts & metal panel knee wall at the ground floor level of 35 and 37 William Street.
- 8. The enclosure of the new north, south, east and west facades of the third and fourth floors of the building with sintered ceramic facade panel (dark grey, black, white above roof).

- 9. Glazed terrace railing.
- 10. The installation of metal window and patio door systems within curtain wall glazing system at the second, third and fourth floors (dark grey frames) with clear glass balcony railings around the outdoor terraces and "Juliet" balconettes.

- 11. New metal fascia (dark grey) at the leading edge of the recessed canopy covering "Feathers Lane" facing William Street.
- 12. The installation of reclaimed stone from 35 William Street at the hotel entrance from the York Street Lane.

- 13. The installation of wood accent screen and wood ceiling for hotel entrance from the York Street Lane.
- 14. The installation of corrugated metal facade material in upper facade areas.
- 15. The installation of a prefinished perforated metal screen on top of new exterior wall assembly/curtain wall glazing. (Backlit at the East Elevation only).
- 16. The installation of a horizontal metal fin on curtain wall mullion.
- 17. The installation of new wood panel aligned with wood cornice at front of 35 William St.
- 18. Roof screen.
- 19. Existing paint removed from face of 37 William Street brick facade.

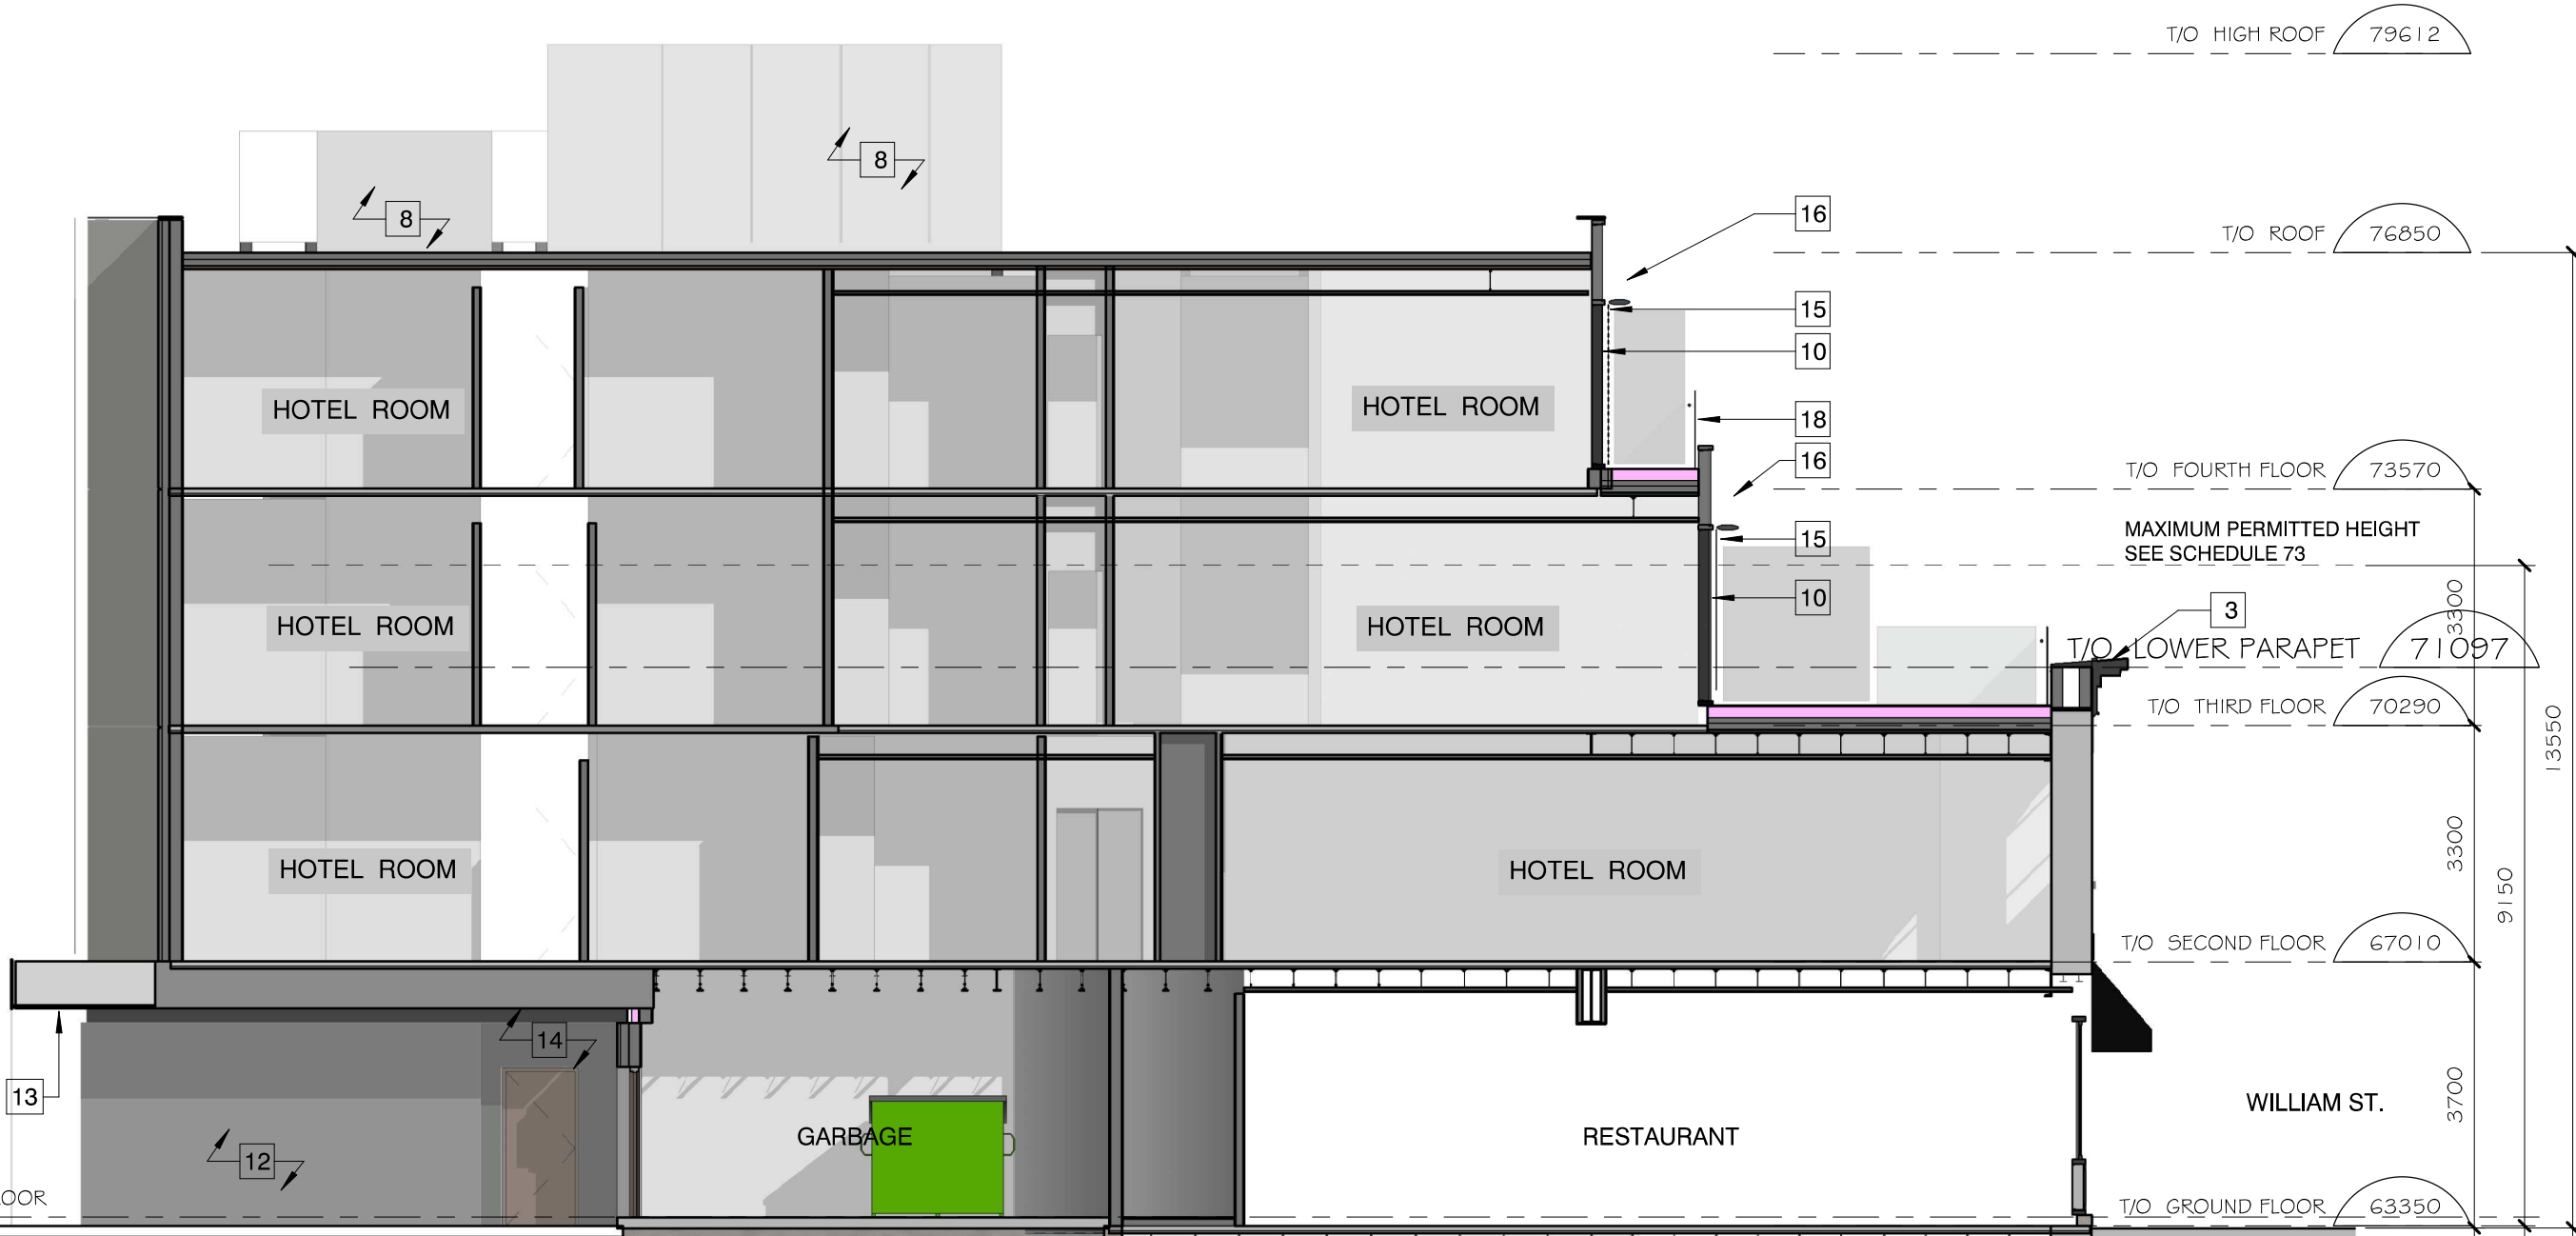
H-15

Building Section Elevation Feathers Lane - Heritage  
1 : 100

1. The conservation and rehabilitation of the stone facade of 35 William Street (original Feathers Hotel) and the brick facade of 37 William Street.
2. The conservation and rehabilitation of the 9.4 m (approx.) east/west stone facade along "Feathers Lane".

3. The reconstruction of a new wood cornice at the top of 35 and 37 William to match the details of the former cornice destroyed by the fire.
4. The reconstruction of a new wood cornice at the second floor level of 37 William to match the details of the former cornice damaged by the fire.

5. The installation of new one over one wood windows at existing wall openings at ground and second floor level of 35 William St.
6. The installation of 2 new one-over-one metal clad wood windows at the second floor level of 37 William that are compatible with the heritage character of the facade.

7. The installation of new glazed metal framed store fronts & metal panel knee wall at the ground floor level of 35 and 37 William Street.
8. The enclosure of the new north, south, east and west facades of the third and fourth floors of the building with sintered ceramic facade panel (dark grey, white above roof).

11. New metal fascia (dark grey) at the leading edge of the recessed canopy covering "Feathers Lane" facing William Street.
12. The installation of reclaimed stone from 35 William Street at the hotel entrance from the York Street Lane.

13. The installation of wood accent screen and wood ceiling for hotel entrance from the York Street Lane.
14. The installation of corrugated metal facade material in upper facade areas.
15. The installation of a prefinished perforated metal screen on top of new exterior wall assembly/curtain wall glazing.
16. The installation of a horizontal metal fin on curtain wall mullion.
17. The installation of new wood panel aligned with wood cornice at front of 35 William St.
18. Glazed terrace railing.
