**CLEAN WATER
WORKS INC.**

**UNIVERSITY OF OTTAWA
200 LEES AVE
Ottawa, Ontario**

SEWER CCTV INSPECTION REPORT

109226ST1

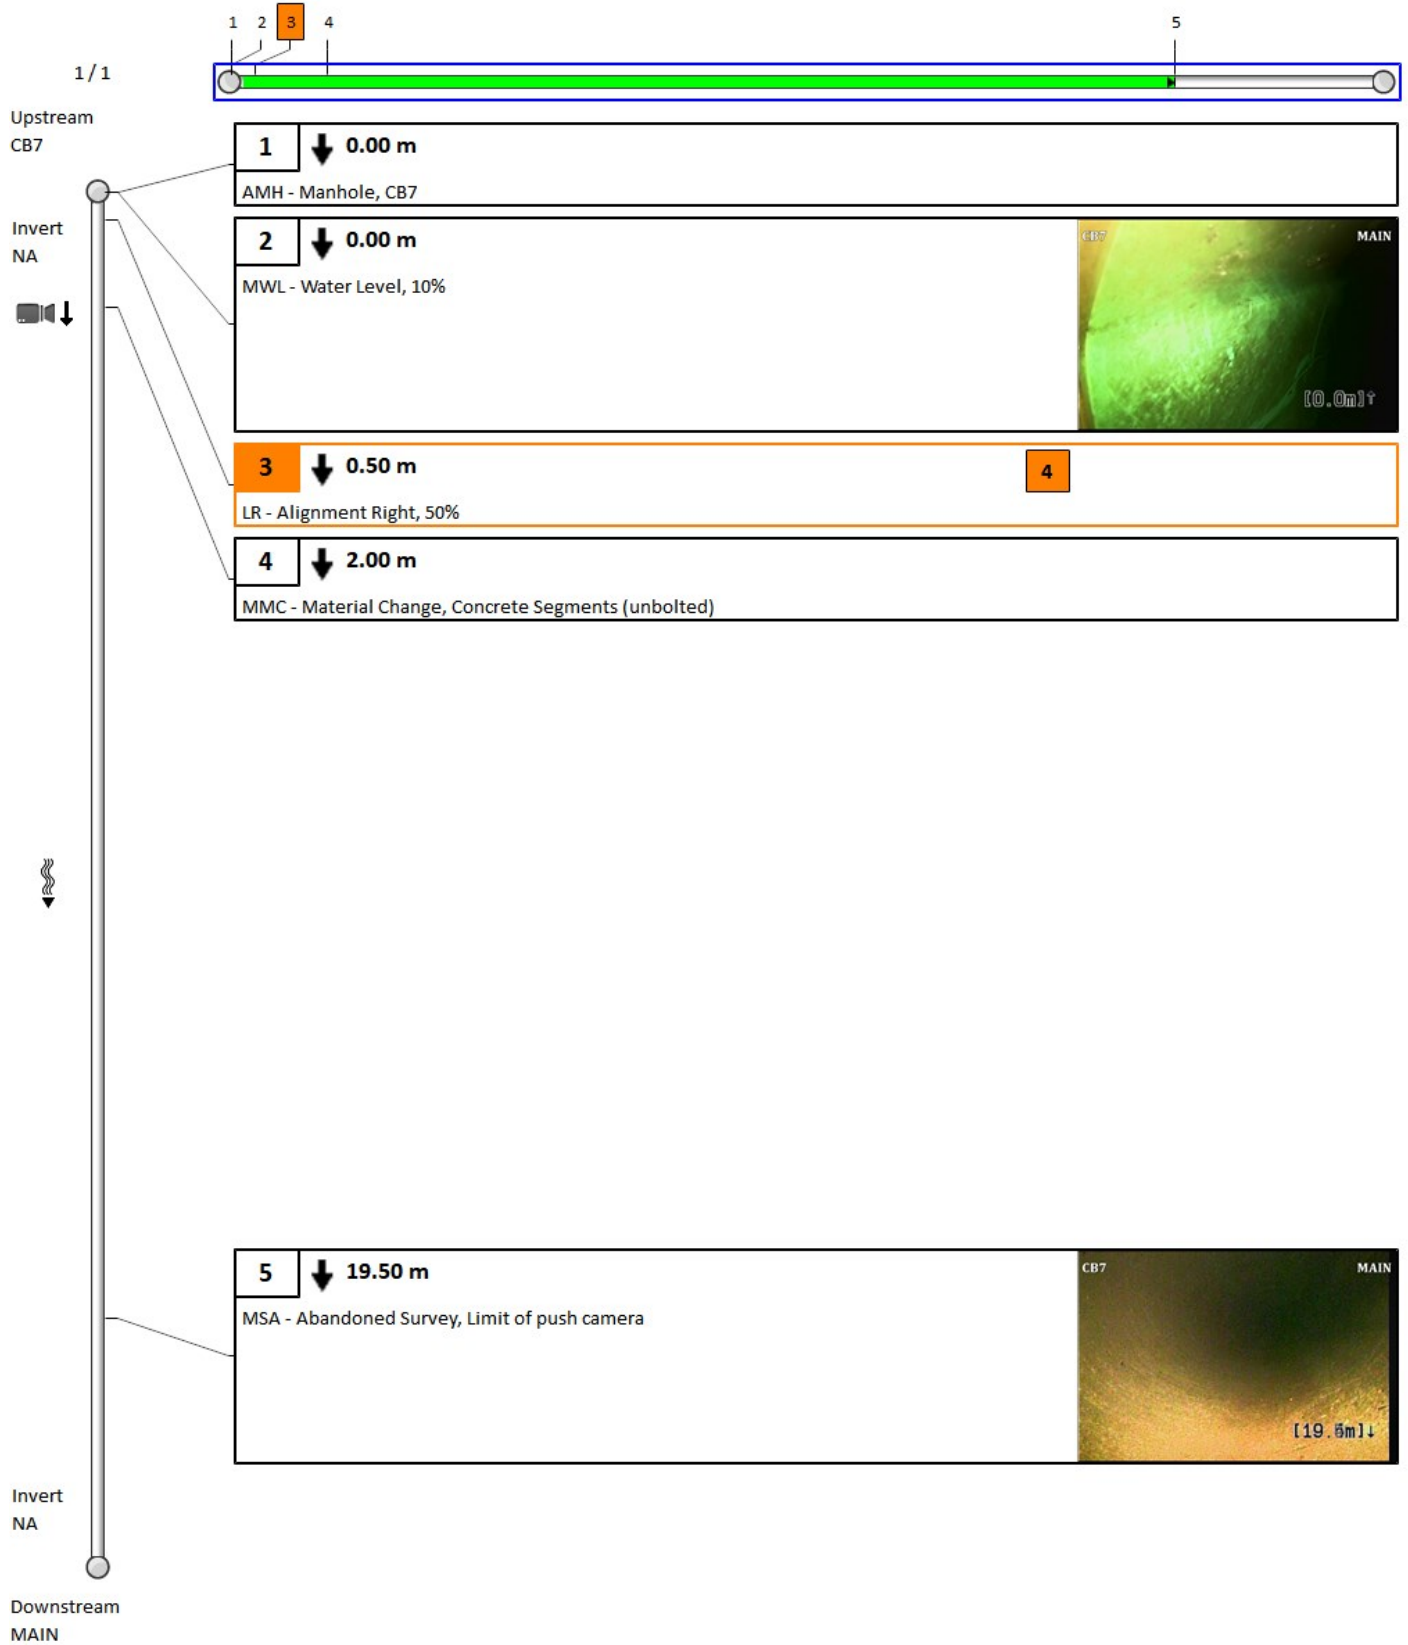
Pipe: CB7 MAIN	Direction of inspection: CB7 --> MAIN
Direction of flow: CB7 --> MAIN	Direction: Direction of flow

Sewer Use: Stormwater	Inspected length: 19.5
Height: 250	Total length: 23.8
Width:	Rim/Inv.:
Shape: Circular	Grade/Inv.:
Material: Polyvinyl Chloride	Rim/Grade:
Lining:	Rim/Inv.:
Joint length: 1	Grade/Inv.:
Year laid:	Rim/Grade:
Year renewed:	Sewer category:

Peak: 0	Peak: 4	Peak: 4
Quick rating: 0000	Quick rating: 4100	Quick rating: 4100
Score: 0	Score: 4	Score: 4
Index: 0	Index: 4	Index: 4

4. Pipe summary and condition details

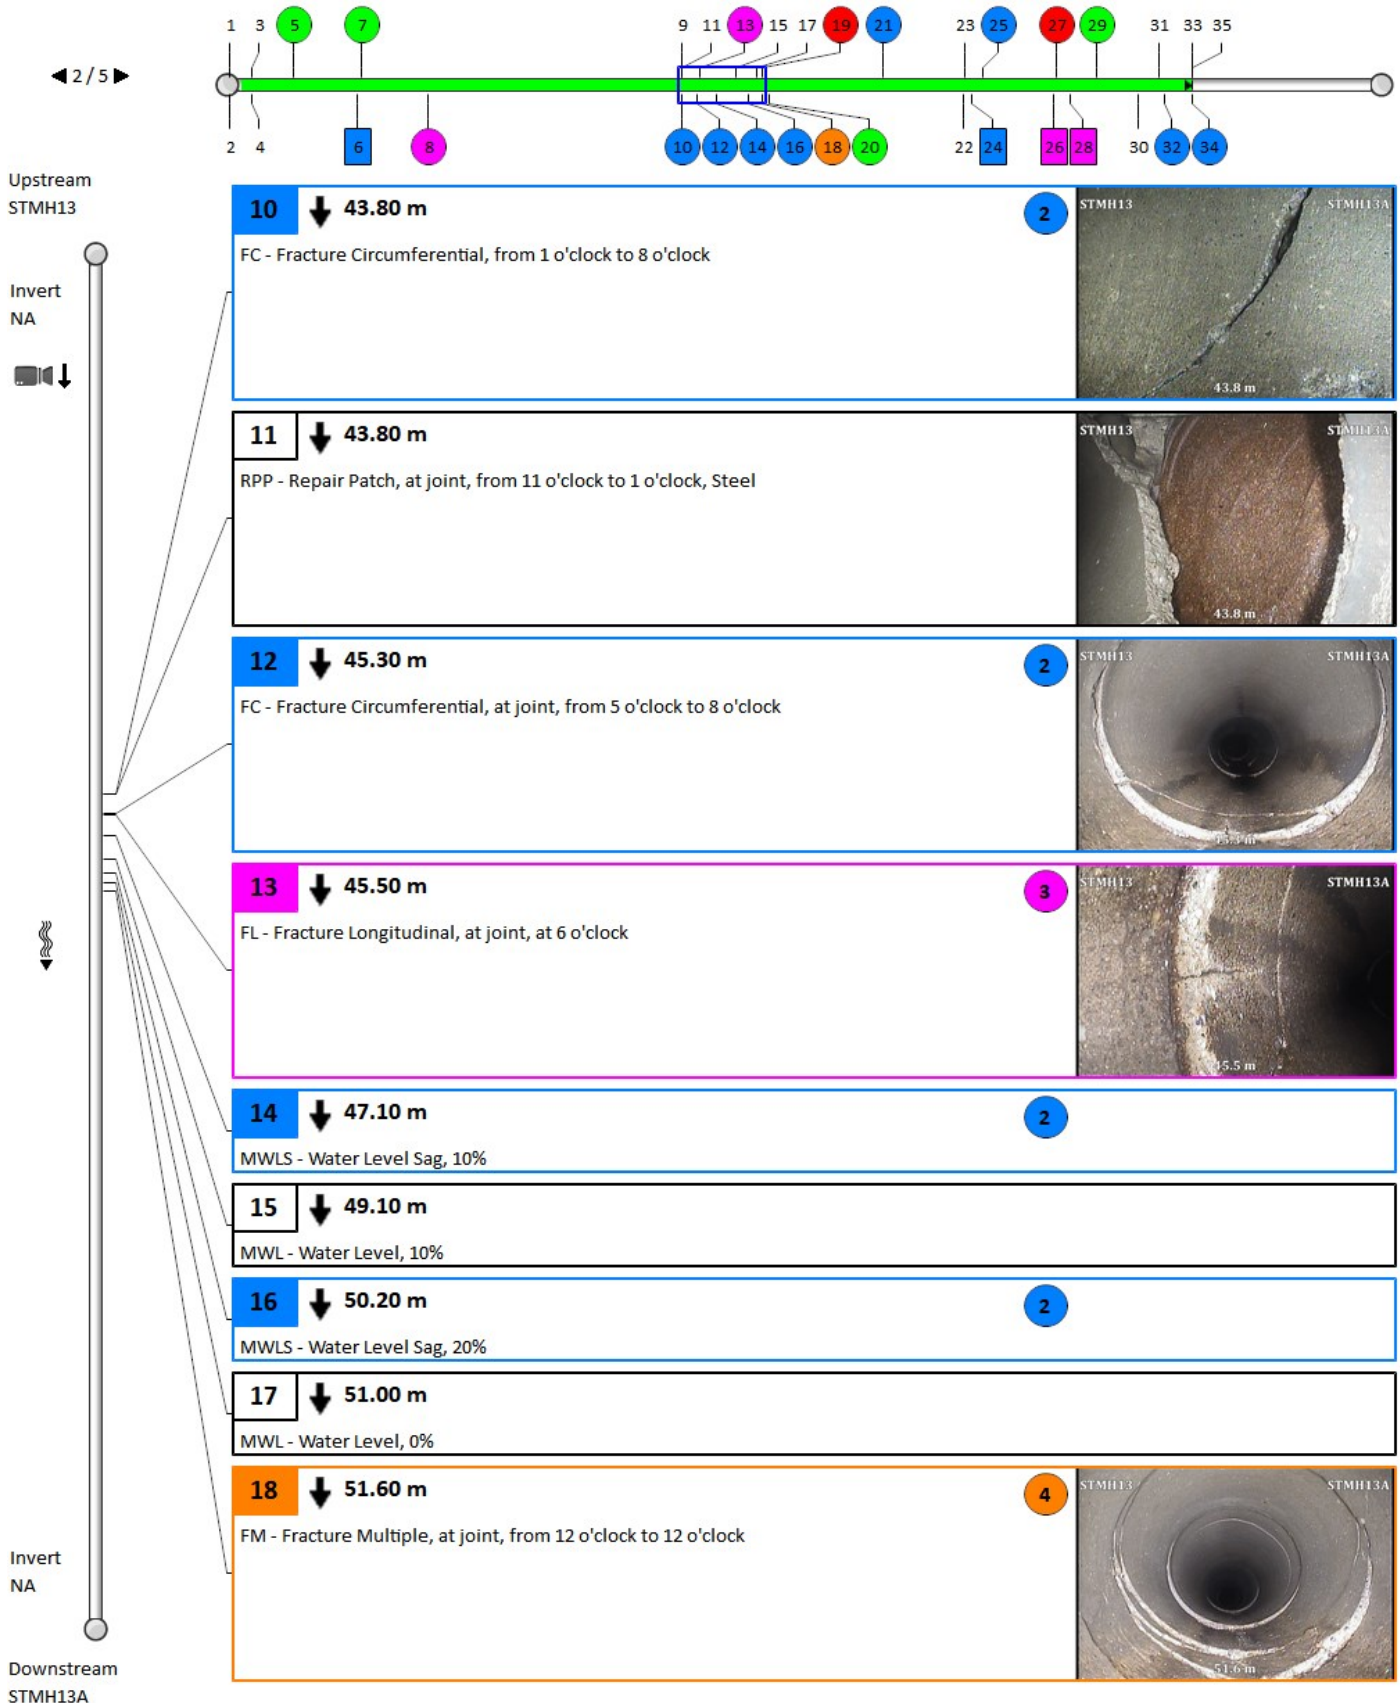
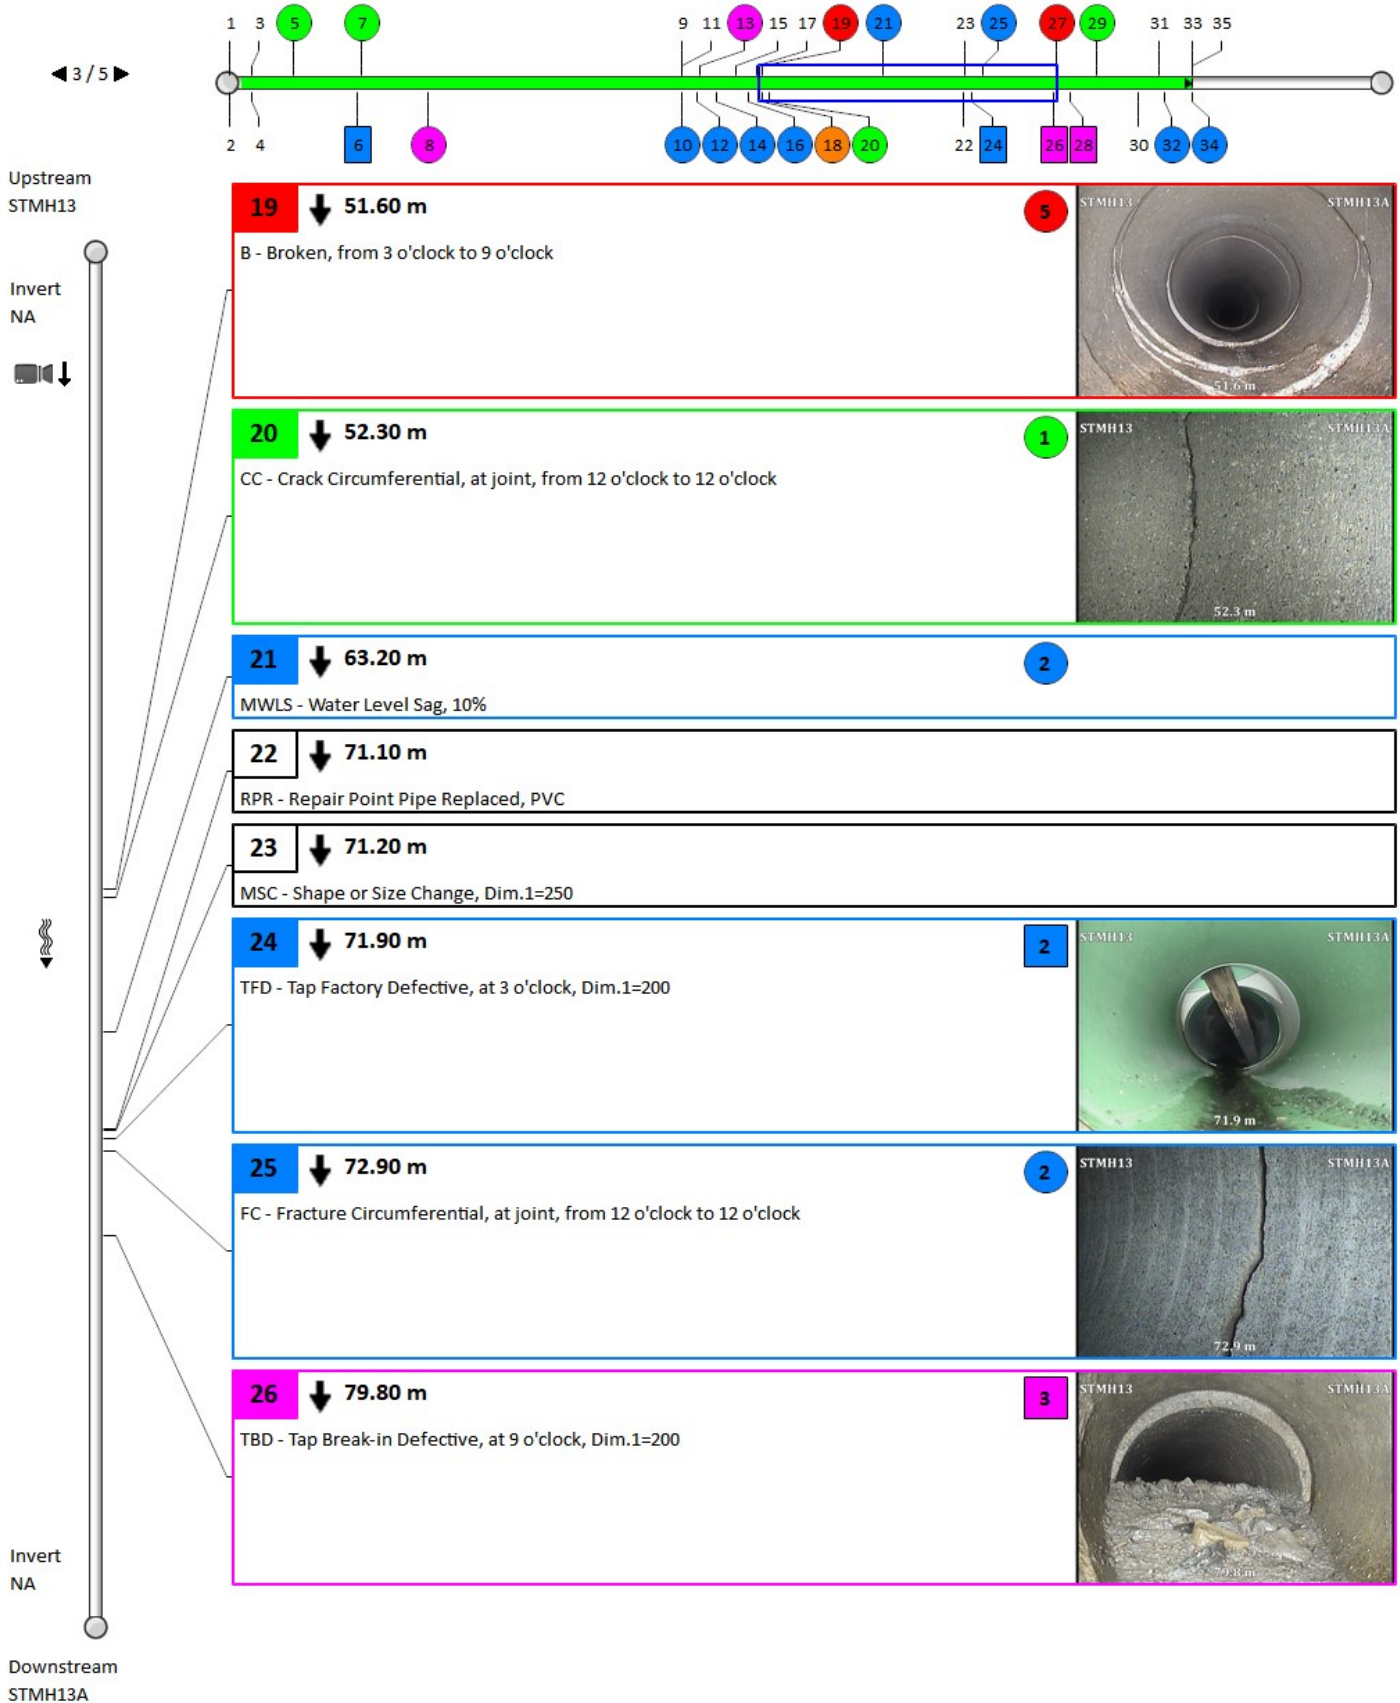
Pipe: STMH13 STMH13A	Direction of inspection: STMH13 --> STMH13A
Direction of flow: STMH13 --> STMH13A	Direction: Direction of flow

Sewer Use: Stormwater	Inspected length: 93.2
Height: 200	Total length: 111.5
Width:	Rim/Inv.:
Shape: Circular	Grade/Inv.:
Material: Polyvinyl Chloride	Rim/Grade:
Lining:	Rim/Inv.:
Joint length: 1	Grade/Inv.:
Year laid:	Rim/Grade:
Year renewed:	Sewer category:

Peak: 5	Peak: 3	Peak: 5
Quick rating: 5241	Quick rating: 3222	Quick rating: 5241
Score: 40	Score: 10	Score: 50
Index: 2.4	Index: 2.5	Index: 2.4

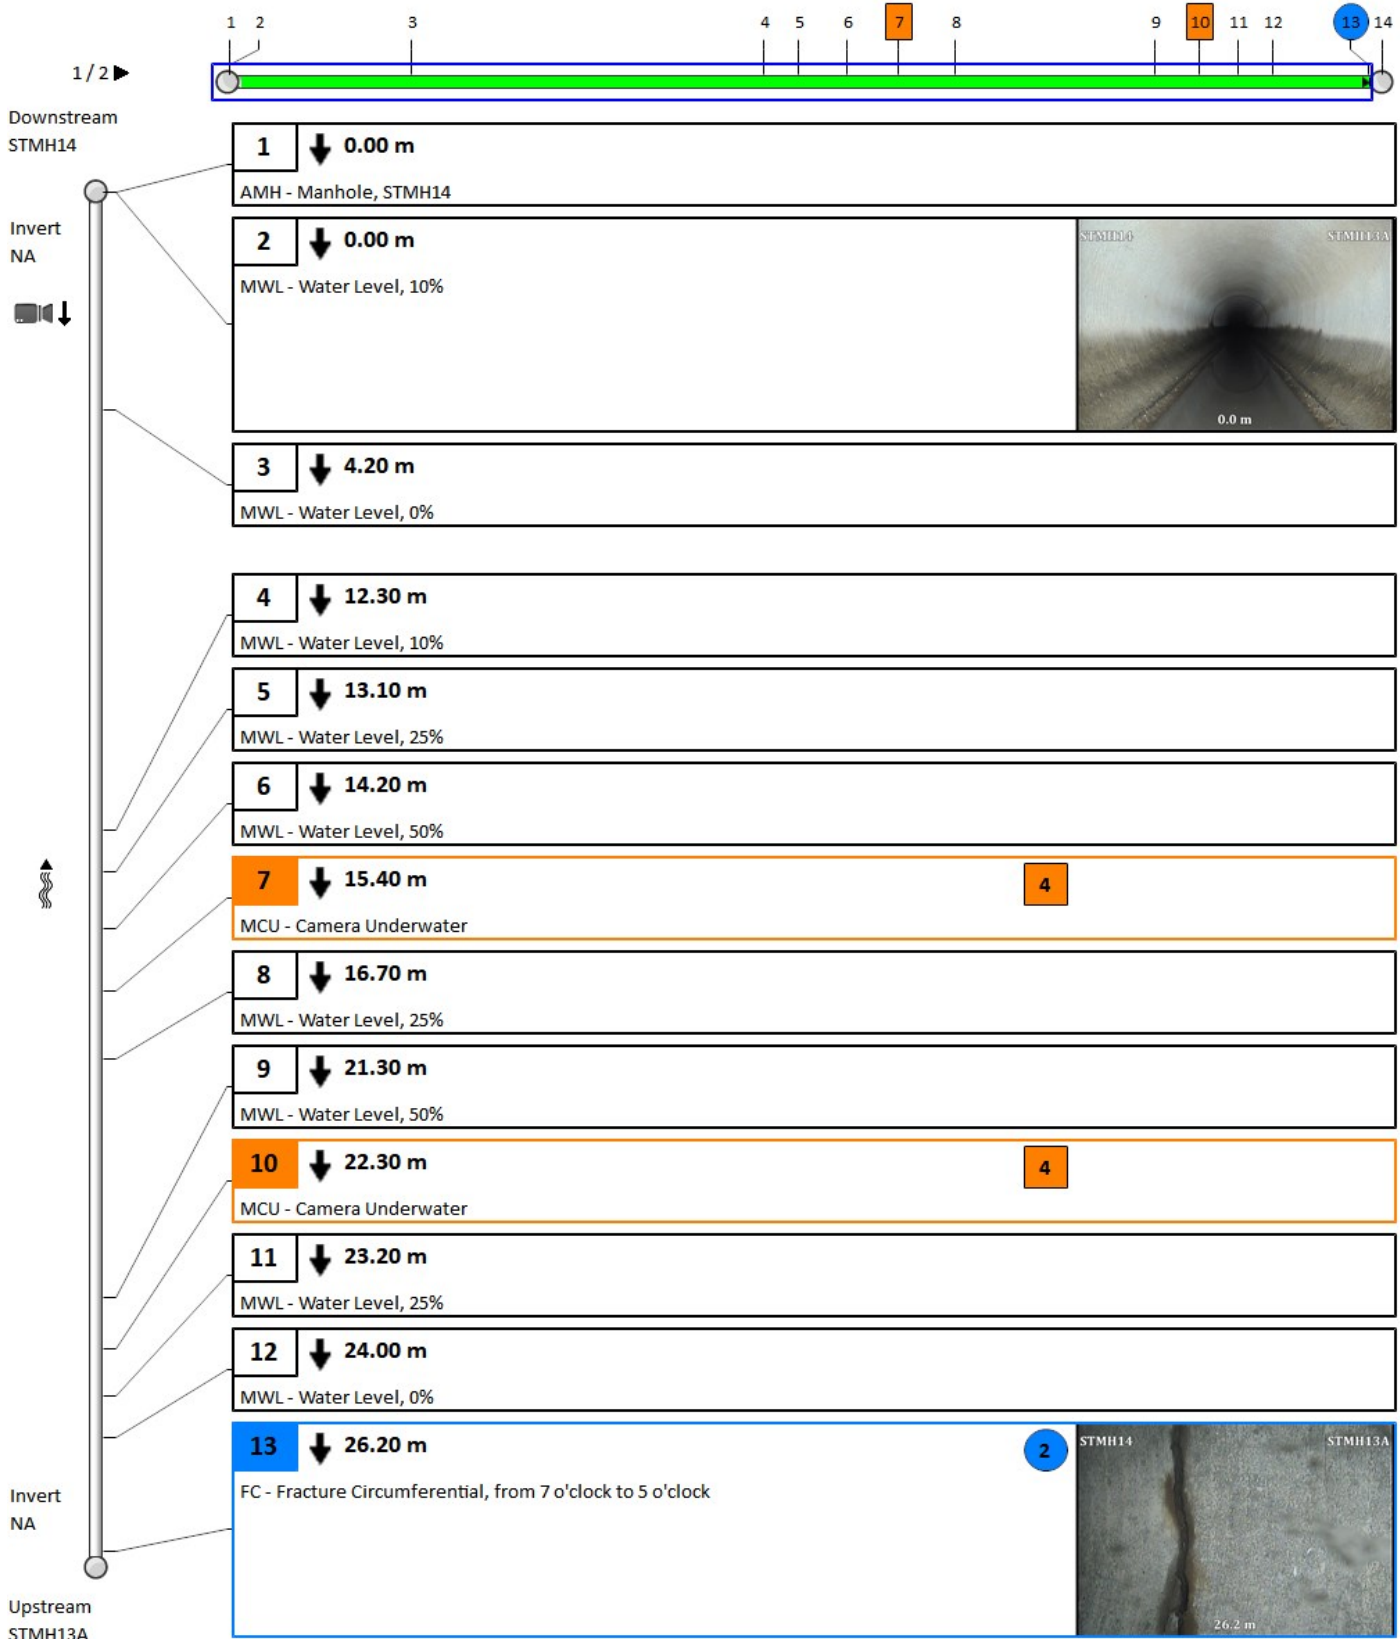
Pipe: STMH13A STMH14	Direction of inspection: STMH14 --> STMH13A
Direction of flow: STMH13A --> STMH14	Direction: Against flow

Sewer Use: Stormwater	Inspected length: 26.5
Height: 300	Total length: 26.5
Width:	Rim/Inv.:
Shape: Circular	Grade/Inv.:
Material: Concrete Segments (unbolted)	Rim/Grade:
Lining:	Rim/Inv.:
Joint length: 2	Grade/Inv.:
Year laid:	Rim/Grade:
Year renewed:	Sewer category:

Peak: 2	Peak: 4	Peak: 4
Quick rating: 2100	Quick rating: 4200	Quick rating: 4221
Score: 2	Score: 8	Score: 10
Index: 2	Index: 4	Index: 3.3

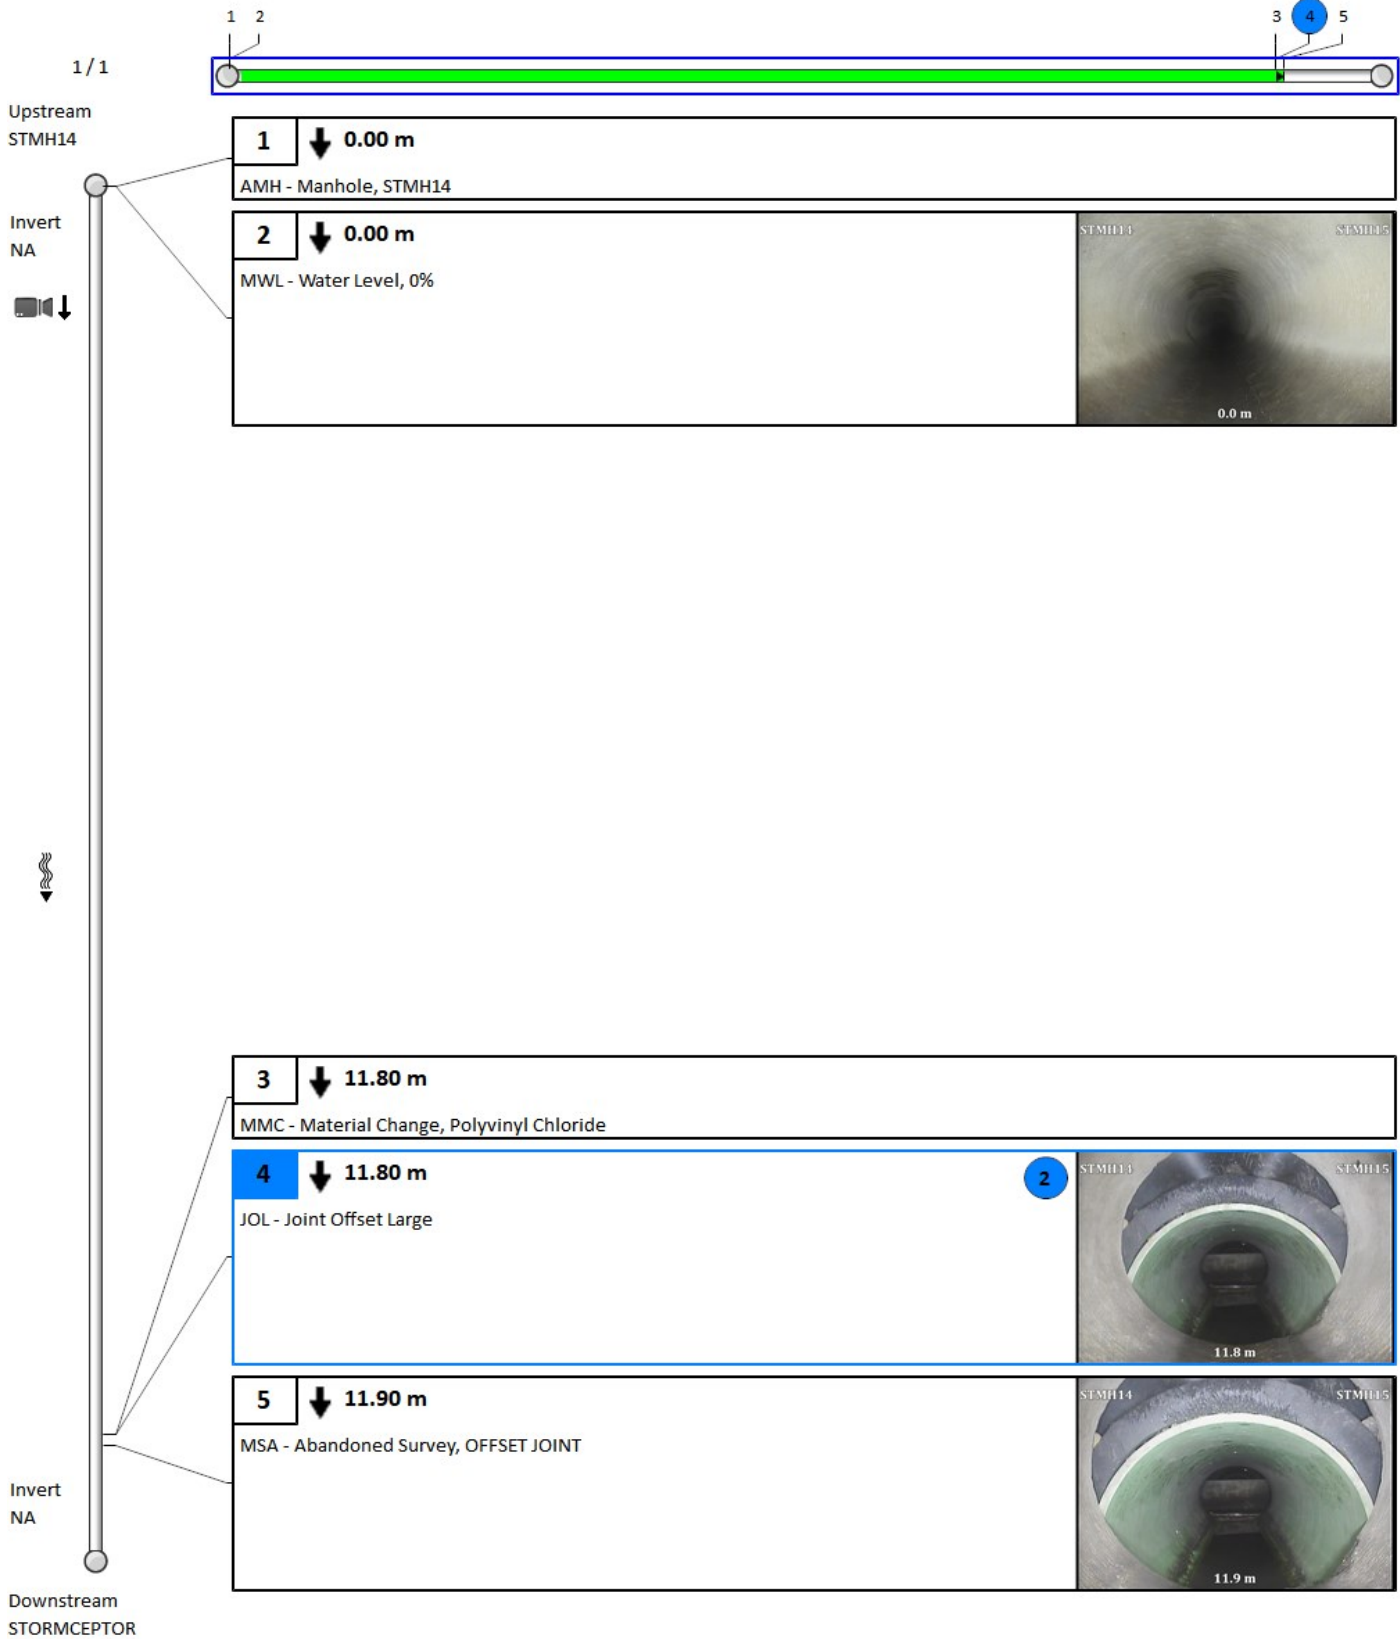
Pipe: STMH14 STMH15	Direction of inspection: STMH14 --> STORMCEPTOR
Direction of flow: STMH14 --> STORMCEPTOR	Direction: Direction of flow
