ADDENDUM #1

211-231 BANK STREET CONSERVATION PLAN

Applications D02-02-22-0127 / D07-12-22-0188 and plan number 18910

August 2024

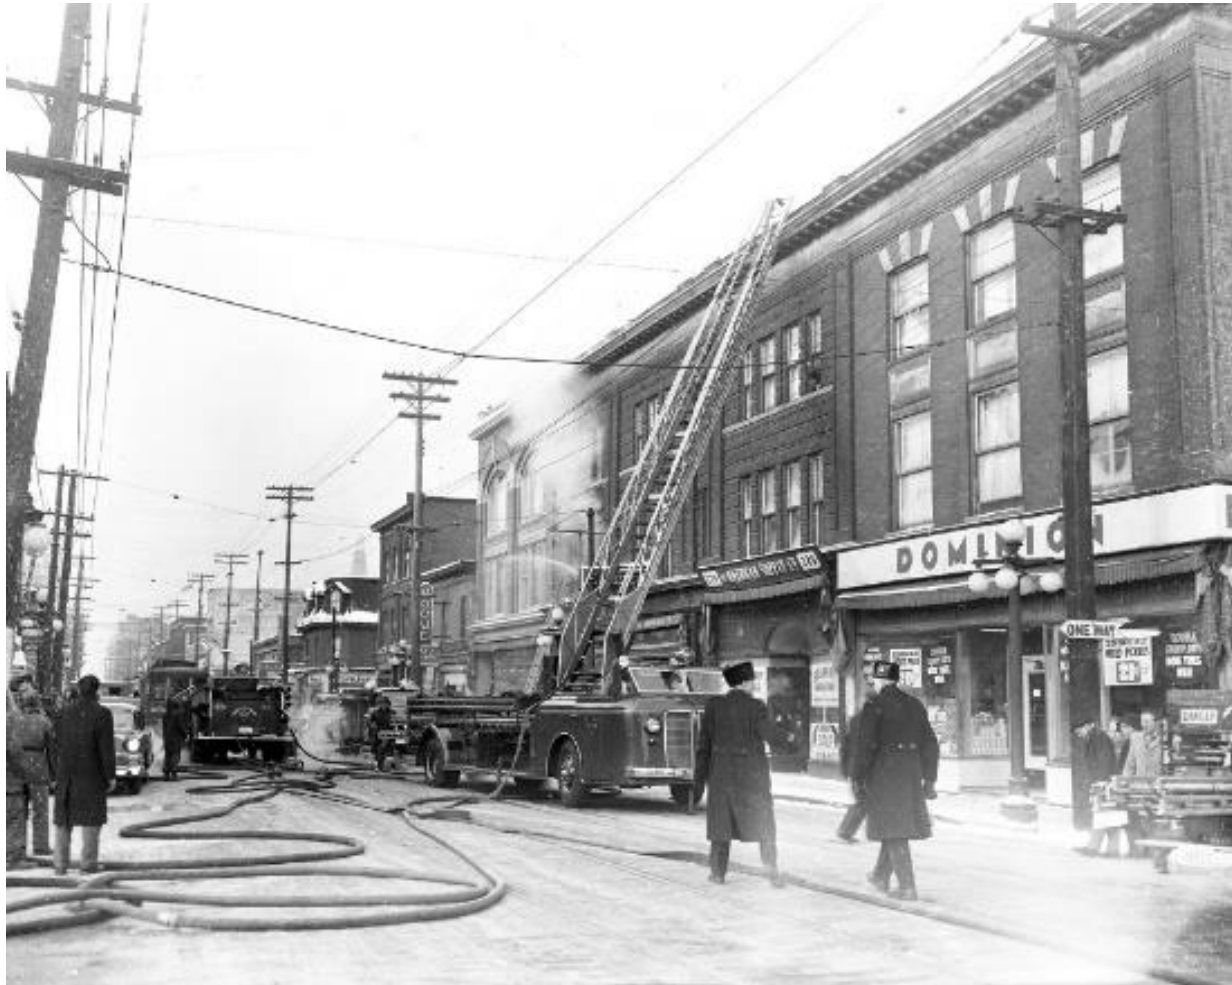
Figure 1: Bank Street view, c.1950. Source: City of Ottawa Archive.

taken from the corner of Lisgar looking north. It has been estimated that the photo dates circa 1950 based on the fire truck with smoke billowing out from what looks like the 219 Bank Street (figure 1.) In the foreground, the Wallack's Building shopfronts are intact, and the elegant polychromatic upper facade has not yet been painted. Since this photo, the street front has undergone extensive alterations and neglect. The Wallack's entrance has shifted to the corner and the Dominion Grocery Store signboard, which appears to wrap around the corner along Lisgar is still in place.

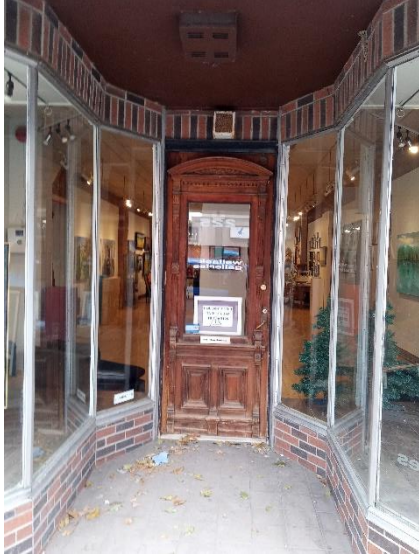
Figure 2: The remnant of the Art Nouveau storefront is being reinterpreted

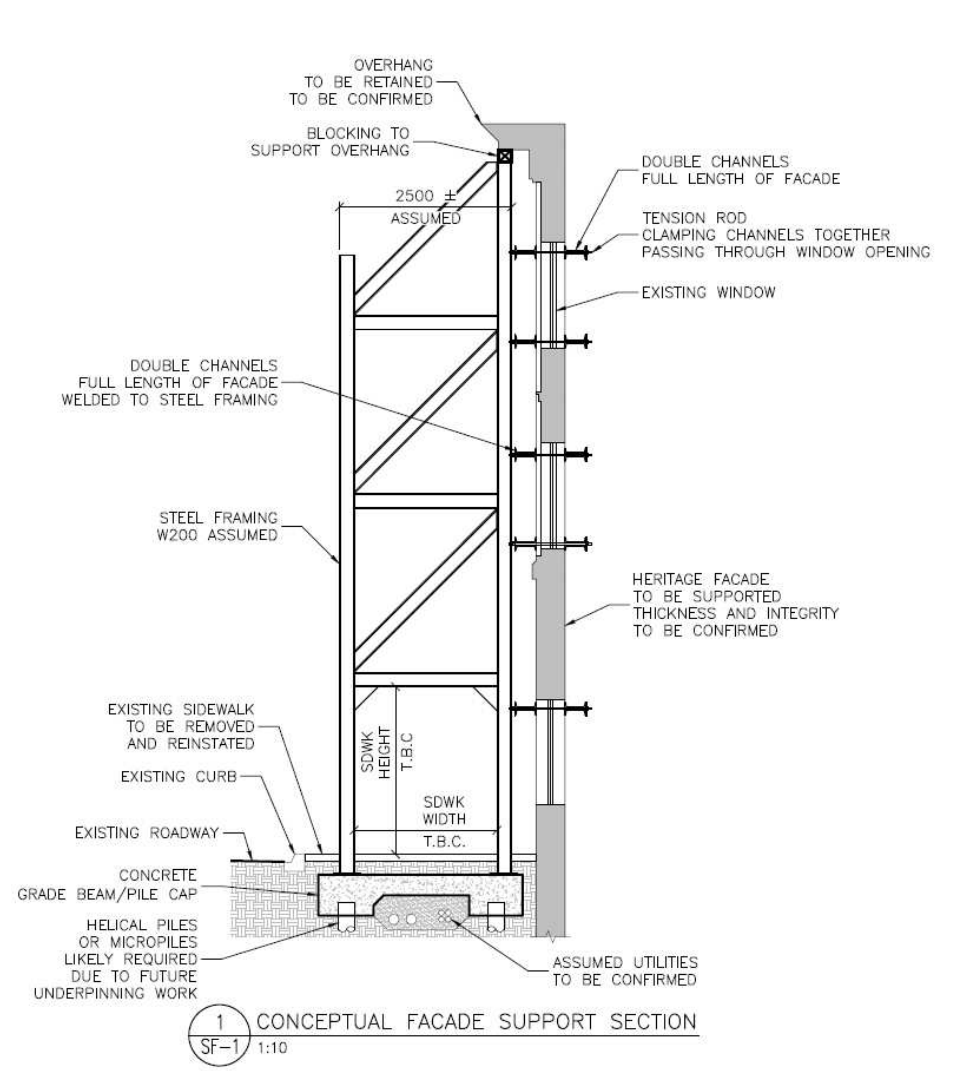
Figure 2: SF-1 Conceptual façade support section. Source Art Engineering Inc. August 24.

Art Engineering Ltd., a structural engineer licenced in Ontario with a background in masonry conservation, is contracted to prepare specifications for masonry conservation and for the structural shoring specifications. It will outline a strategy and provide direction, ensuring temporary shoring to support the heritage façades with bracing erected on the exterior façade along the street. Art Engineering will provide a detail description of the methodology for shoring the existing buildings from the exterior in the design phase.

The temporary shoring plan and masonry restoration addresses the existing exterior masonry on the first, second, and third storeys of the existing buildings at 211, 215, 219 223, and 231 Bank Street as well as the extensions along 178 Nepean and Lisgar Streets. Portions of the rear façade are being demolished and brick will be salvaged for use in repairs and infill with matching material.

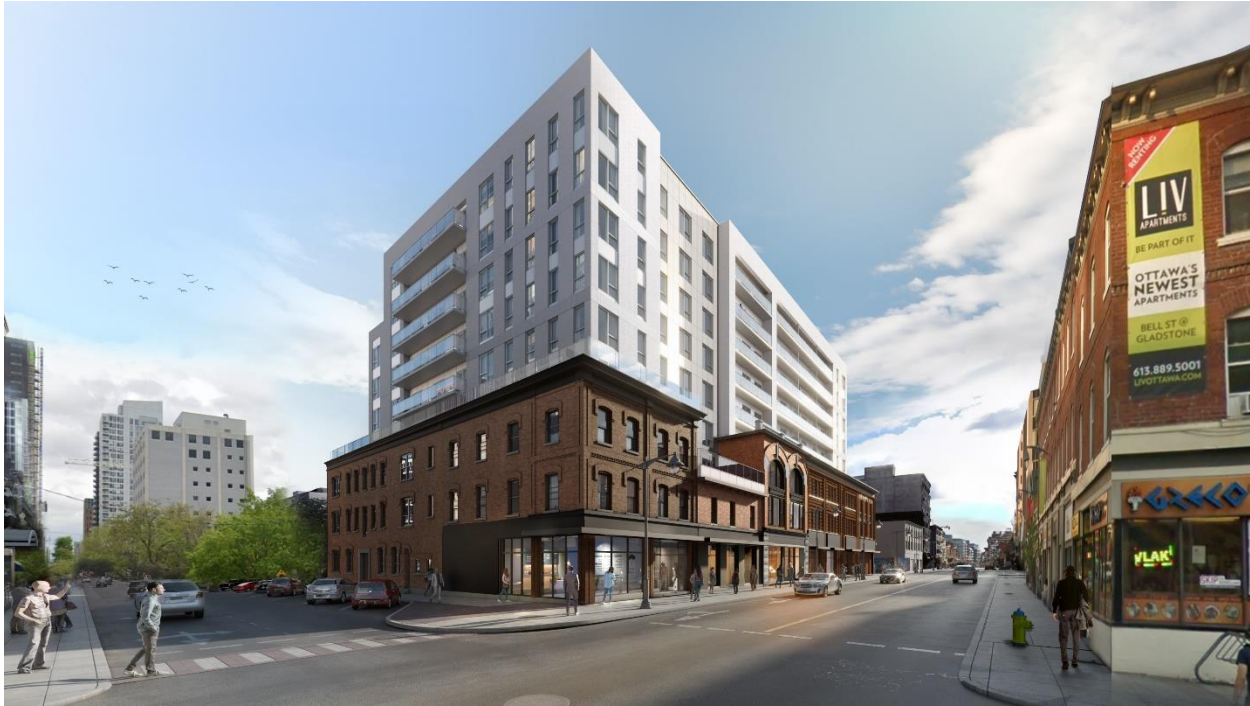
Figure 3: View looking south at the corner of Nepean and Bank Street, with the nine-storey development setback and the existing buildings standing proud. Source: Neuf Architects, August 2024.

The proposed 9-storey superstructure is distinguishable, and of sympathetic contemporary design. The existing buildings serve as a podium, with the new construction setback from the existing buildings by 3m. A palette of materials, and finishes that are neutral, light-coloured help focus on the heritage buildings. Decorative cornices, horizontal and vertical articulations, opening sizes, proportions, and datum lines have taken their cues from the historic buildings. The design respects and reflects the current urban grain and scale, visual relationships, and materials of the neighbouring buildings across the street on the west side of Bank Street. Below is a discussion of each of the existing buildings, identifying their individual character defining features and the work required to rehabilitate each building successfully.

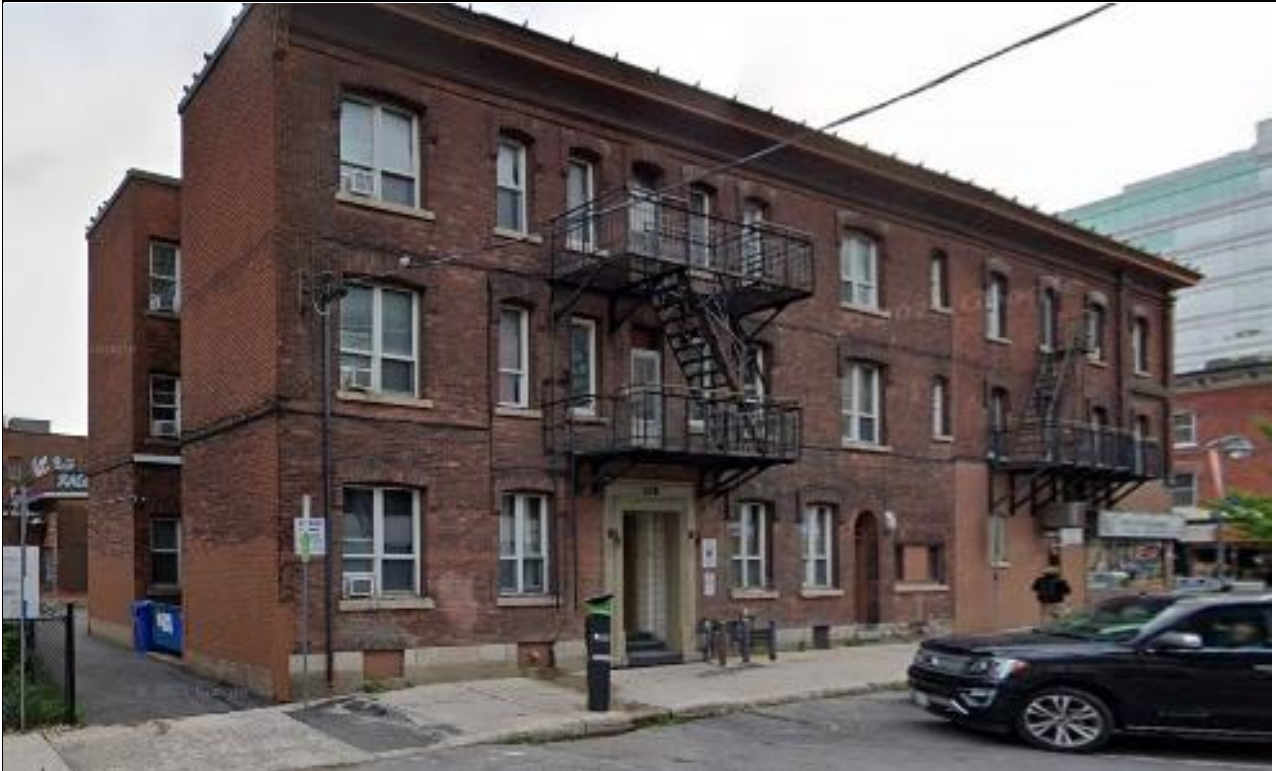
Figure 4 :& 5 views of the north elevation

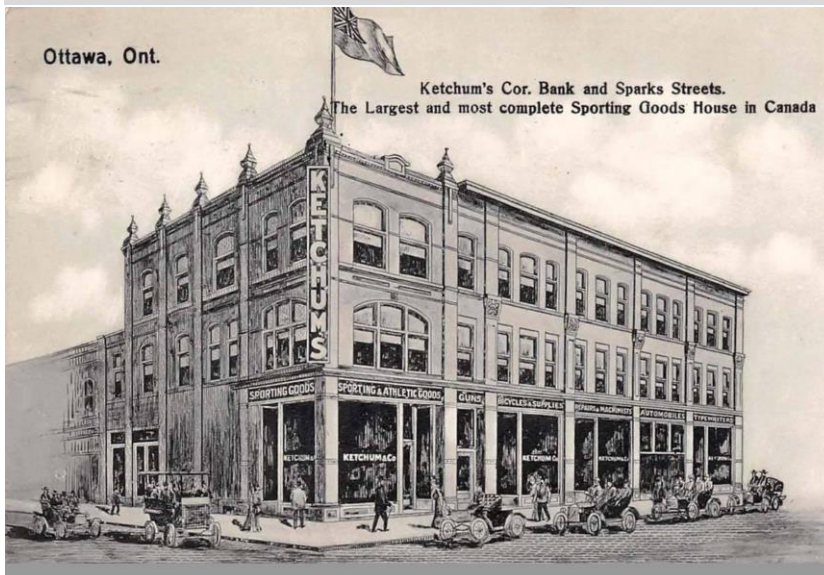
This sketch of Ketchum’s Bank at the corner of Bank & Sparks Streets provides an excellent example to model the replacement shopfront with the raised pilasters framing, commercial units, cornice and signboard wrapping around the corner.

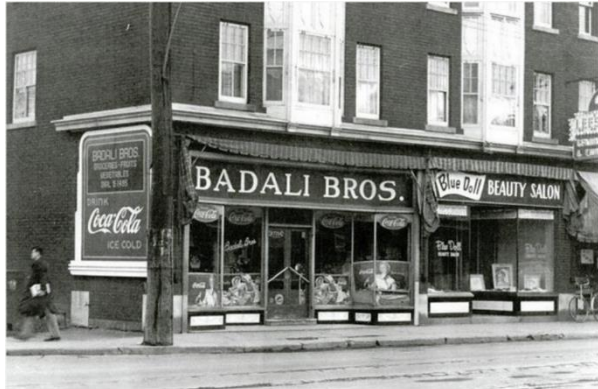
This Bank Street corner building provides a good model comparative example with the large fascia signage and the awning set below the metal cornice, the double door entrances with the recessed flared display windows and brightly accented knee wall. The cornice carries around the corner, with a large signage taking advantage of the corner location.

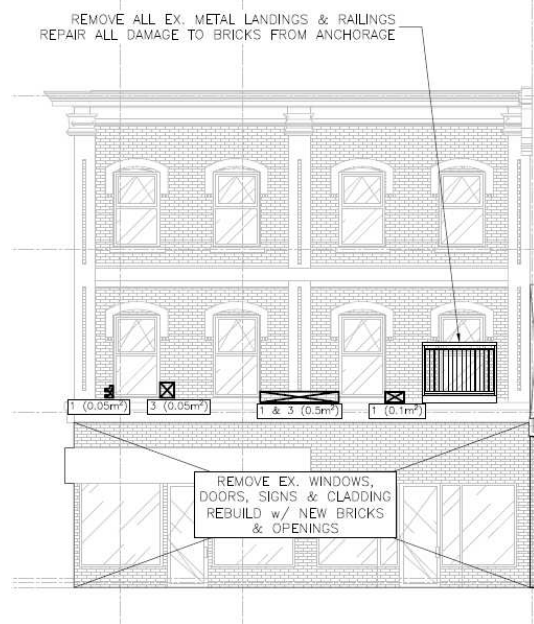
Bank Street removals. Source: Art Engineering August 2024

1. Metal fire escapes, landings, ladders, conduits and wiring are to be removed along with tiebacks.
2. At tiebacks replace damaged brick
3. Repair and replace brick as required with salvaged material.
4. Assess windowsills for damage, undertake detailed assessment of the metal cornice.
5. Remove variegated brick cladding, signage, and storefronts from the ground floor Nepean and Bank Streets storefront(s)
6. Infill basement windows and upper floor entrances from fire escape.
7. Removal of orange plaster and reinserted windows in the newly exposed façade. Alternatively, retain the plaster

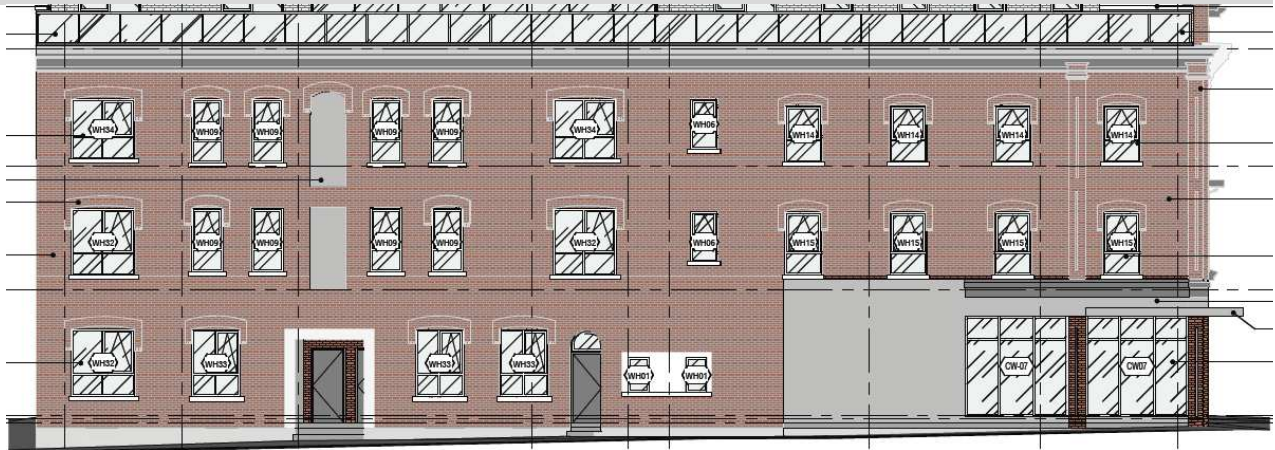
1. Repair as necessary the elaborate metal cornice. Repaint
2. Gentle pressure wash the brick of both façades to remove dirt and staining and provide a clean surface for repointing.
3. Selective repointing of brick and repair and repointing window and door sills.
4. All upper floor windows to be replaced with new units using similar profile of glazing pattern.
5. Reinststate the large glazed commercial storefront that wraps around the corner with two bays on Nepean Street.
6. Restore the ground floor fluted pilasters with a capital to frame the two retail spaces.
7. Introduce a commercial cornice with signboard, knee wall at base, recessed flared entrance. See comparative illustration of Ketchum’s Bank at Bank and Sparks
8. Install mural on retained orange stucco. See comparative illustration of Bank Street building with large billboard on the return wall.

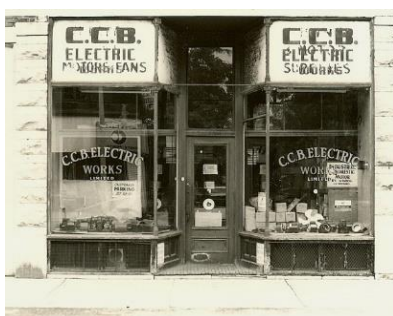
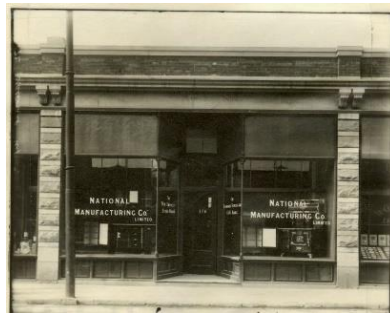
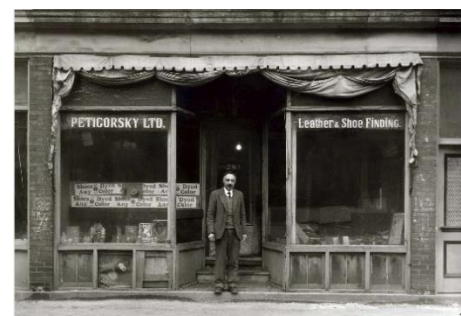
Three Storefronts along Bank Street dating from the turn of the century are maintaining the modest 2-storey building at 213-215 Bank Street. Note the flared recessed entrances, single entrance door, knee wall, and masonry piers framing the retail units.

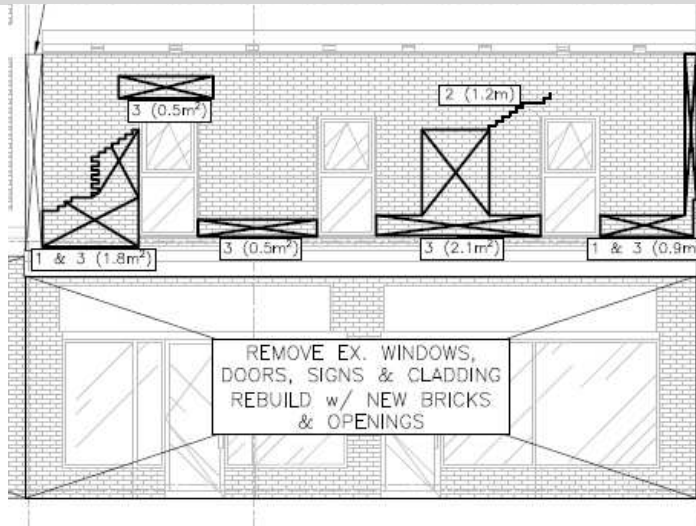
Bank Street removals

1. Undertake detailed assessment of the metal cornice. Landings.
2. Assess upper floor brick façade windowsills for damage, undertake detailed assessment of the metal cornice.
3. Remove variegated brick cladding, signage, and storefronts from the ground floor.
4. Infill the gap with salvaged brick, or metal panel between the adjacent buildings.

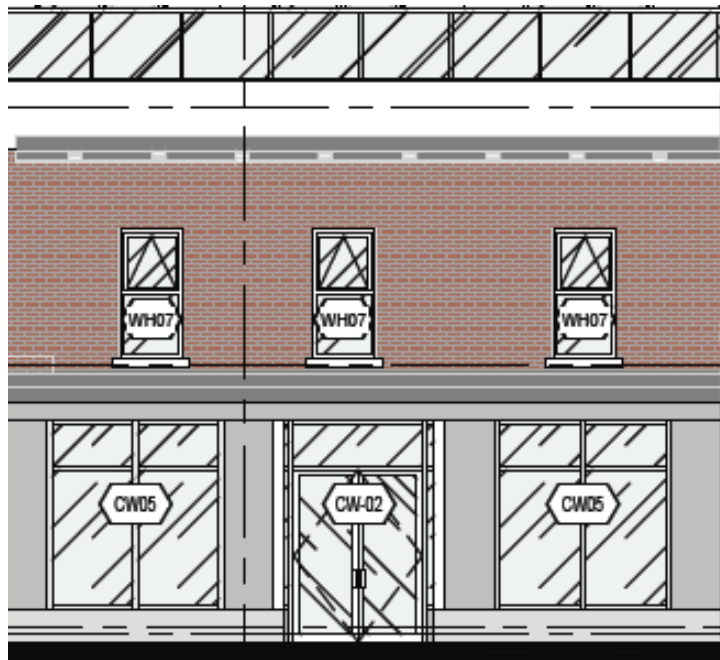
Bank Street Conservation

1. Repair as necessary the elaborate metal cornice at the roofline.
2. Chemical wash to remove paint from the upper level.
3. Install the ground floor cornice set just below the second-floor windowsills.
4. Selective replacement of damaged/spalling brick, repointing of brick facade, and replacing sills.
5. Replace the 3 second-floor windows with new one-over-one units.
6. Restore the ground floor brick piers at either edge of the building and framing the retail entrance.
7. Insert large glazed commercial storefront into the two bays with recessed flared entrance.
8. Introduce commercial cornice with signboard, knee wall at base, recessed flared entrances. See comparative illustrations.

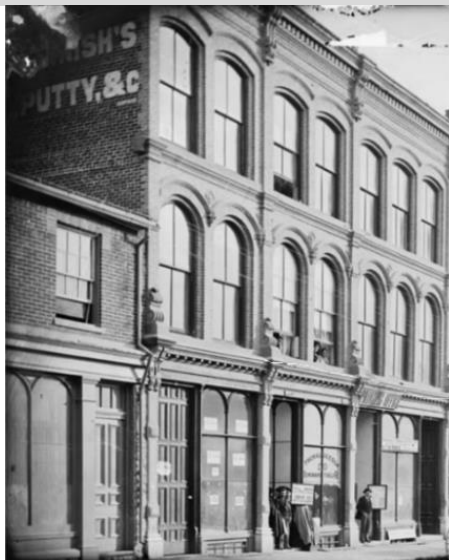
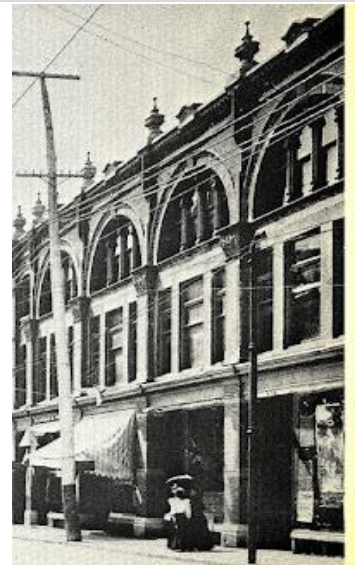
two examples of Ottawa commercial buildings illustrating features comparable to the 219 Bank St.

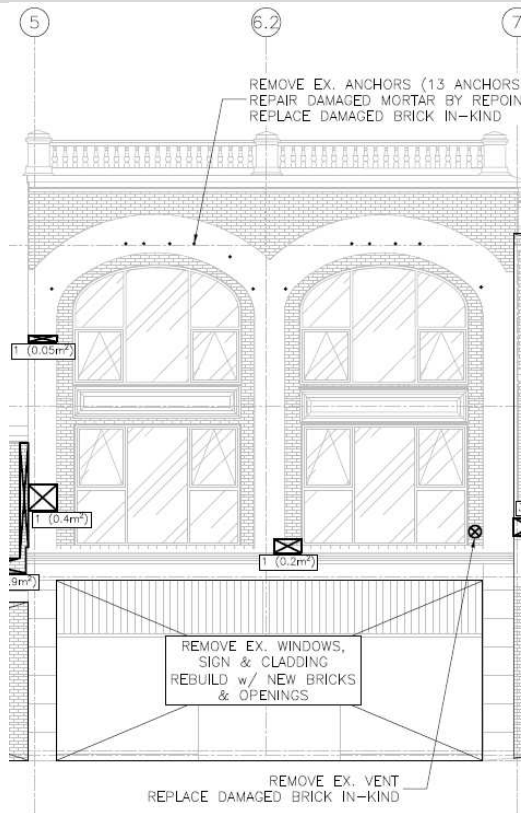
1. Remove exterior anchors
2. Undertake detailed inspection of the cornice and balustrade.
3. Document the commercial ground floor cornice and salvage details for reproduction.
4. Remove the variegated brick infill along the existing commercial storefront, stripping out all features retaining the stone piers.

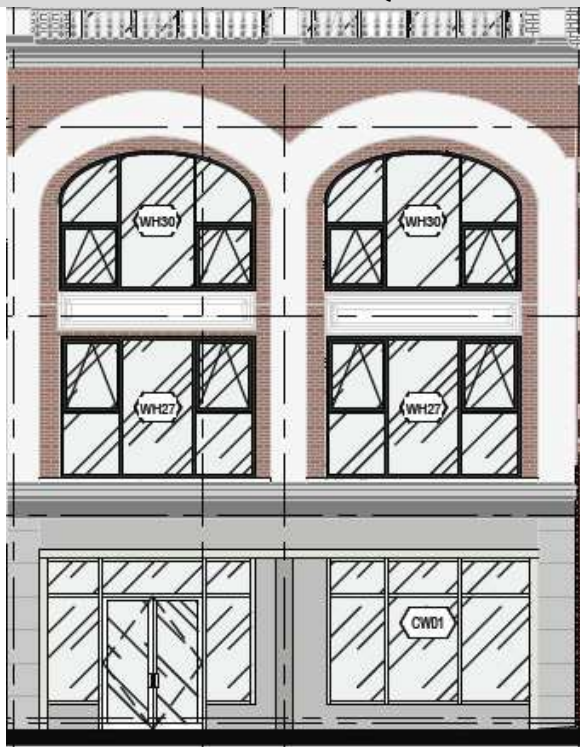
1. See comparative illustrations.
2. Repair as necessary the elaborate metal cornice and balustrade.
3. Chemical wash.
4. Repair pitted brick in arches, selective repointing of brick, and sills.
5. The two large windows to be replaced with new units retaining the mullion pattern and infill metal panels.
6. Retain and repoint ground floor stone pilasters with a capital to frame the commercial entrance.
7. Insert a support column midway between the columns.
8. Insert large glazed commercial storefronts, setting it back to create a foyer with double entrance doors on the north side.
9. Re-introduce commercial cornice with signboard,
10. Reintroduce knee wall at base.

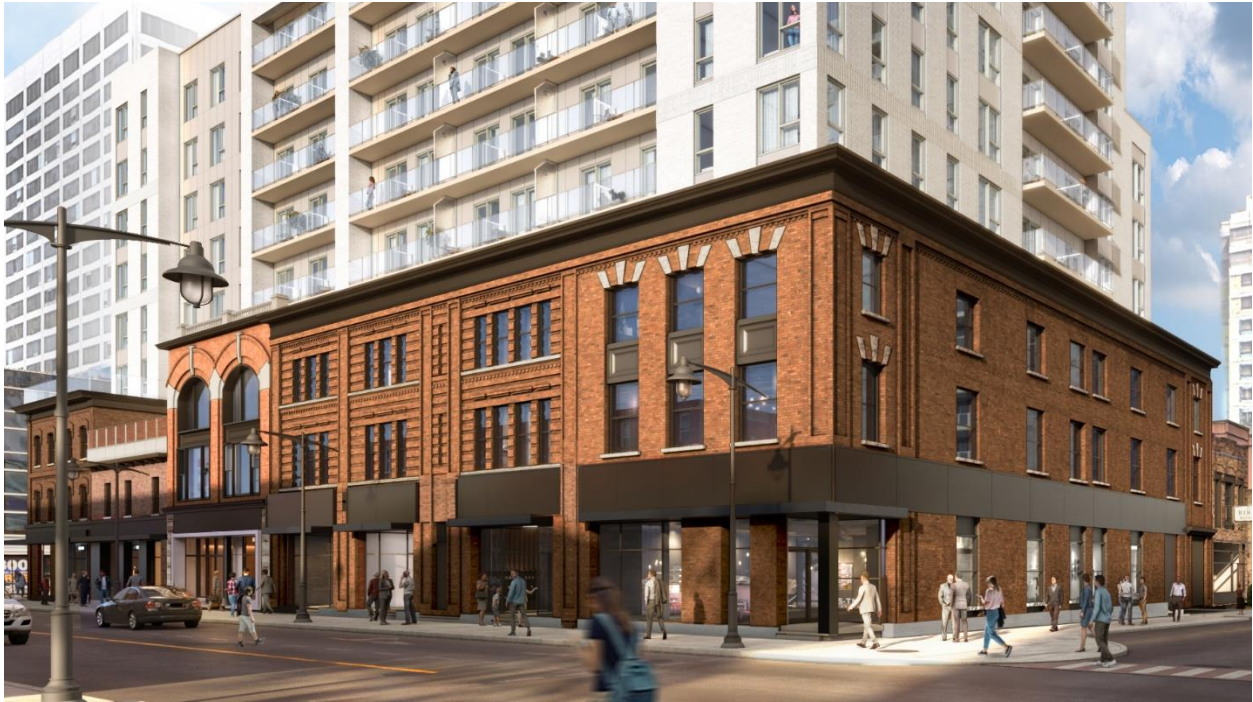
An Artist's rendering of the restored block with the paint removed and the ground floor commercial units. The illustration below positions the properties within the downtown neighbourhood. Source: Neuf Architectes, August 2024.

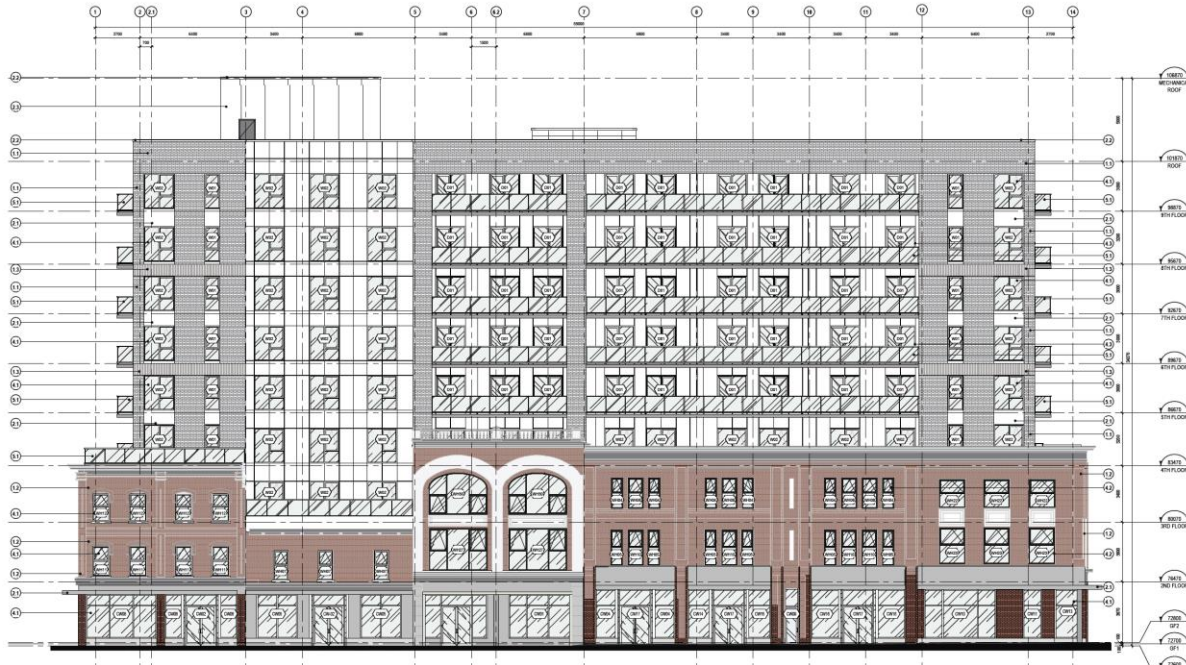
West & East Elevations. Source: Neuf Architectes 2024

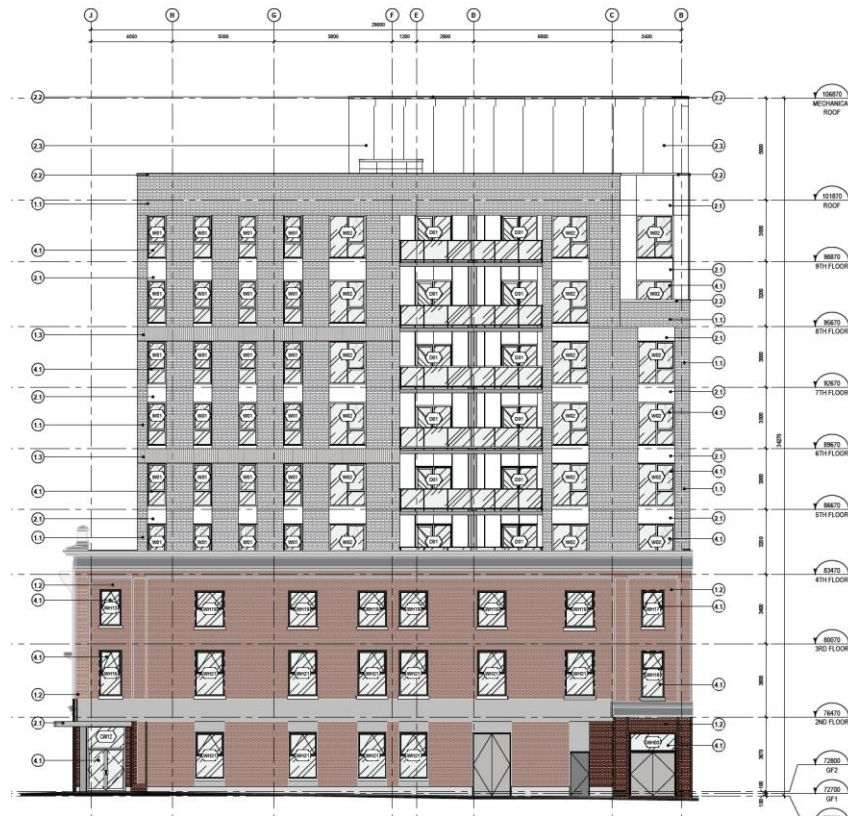
South elevation . Neuf Architectes Inc. 2024
