**98 + 100 BEARBROOK
LANDRIC HOMES**

**PRE-DEVELOPMENT
VEGETATION**

LA PROJECT NO. 21813-1 **L-TP1**

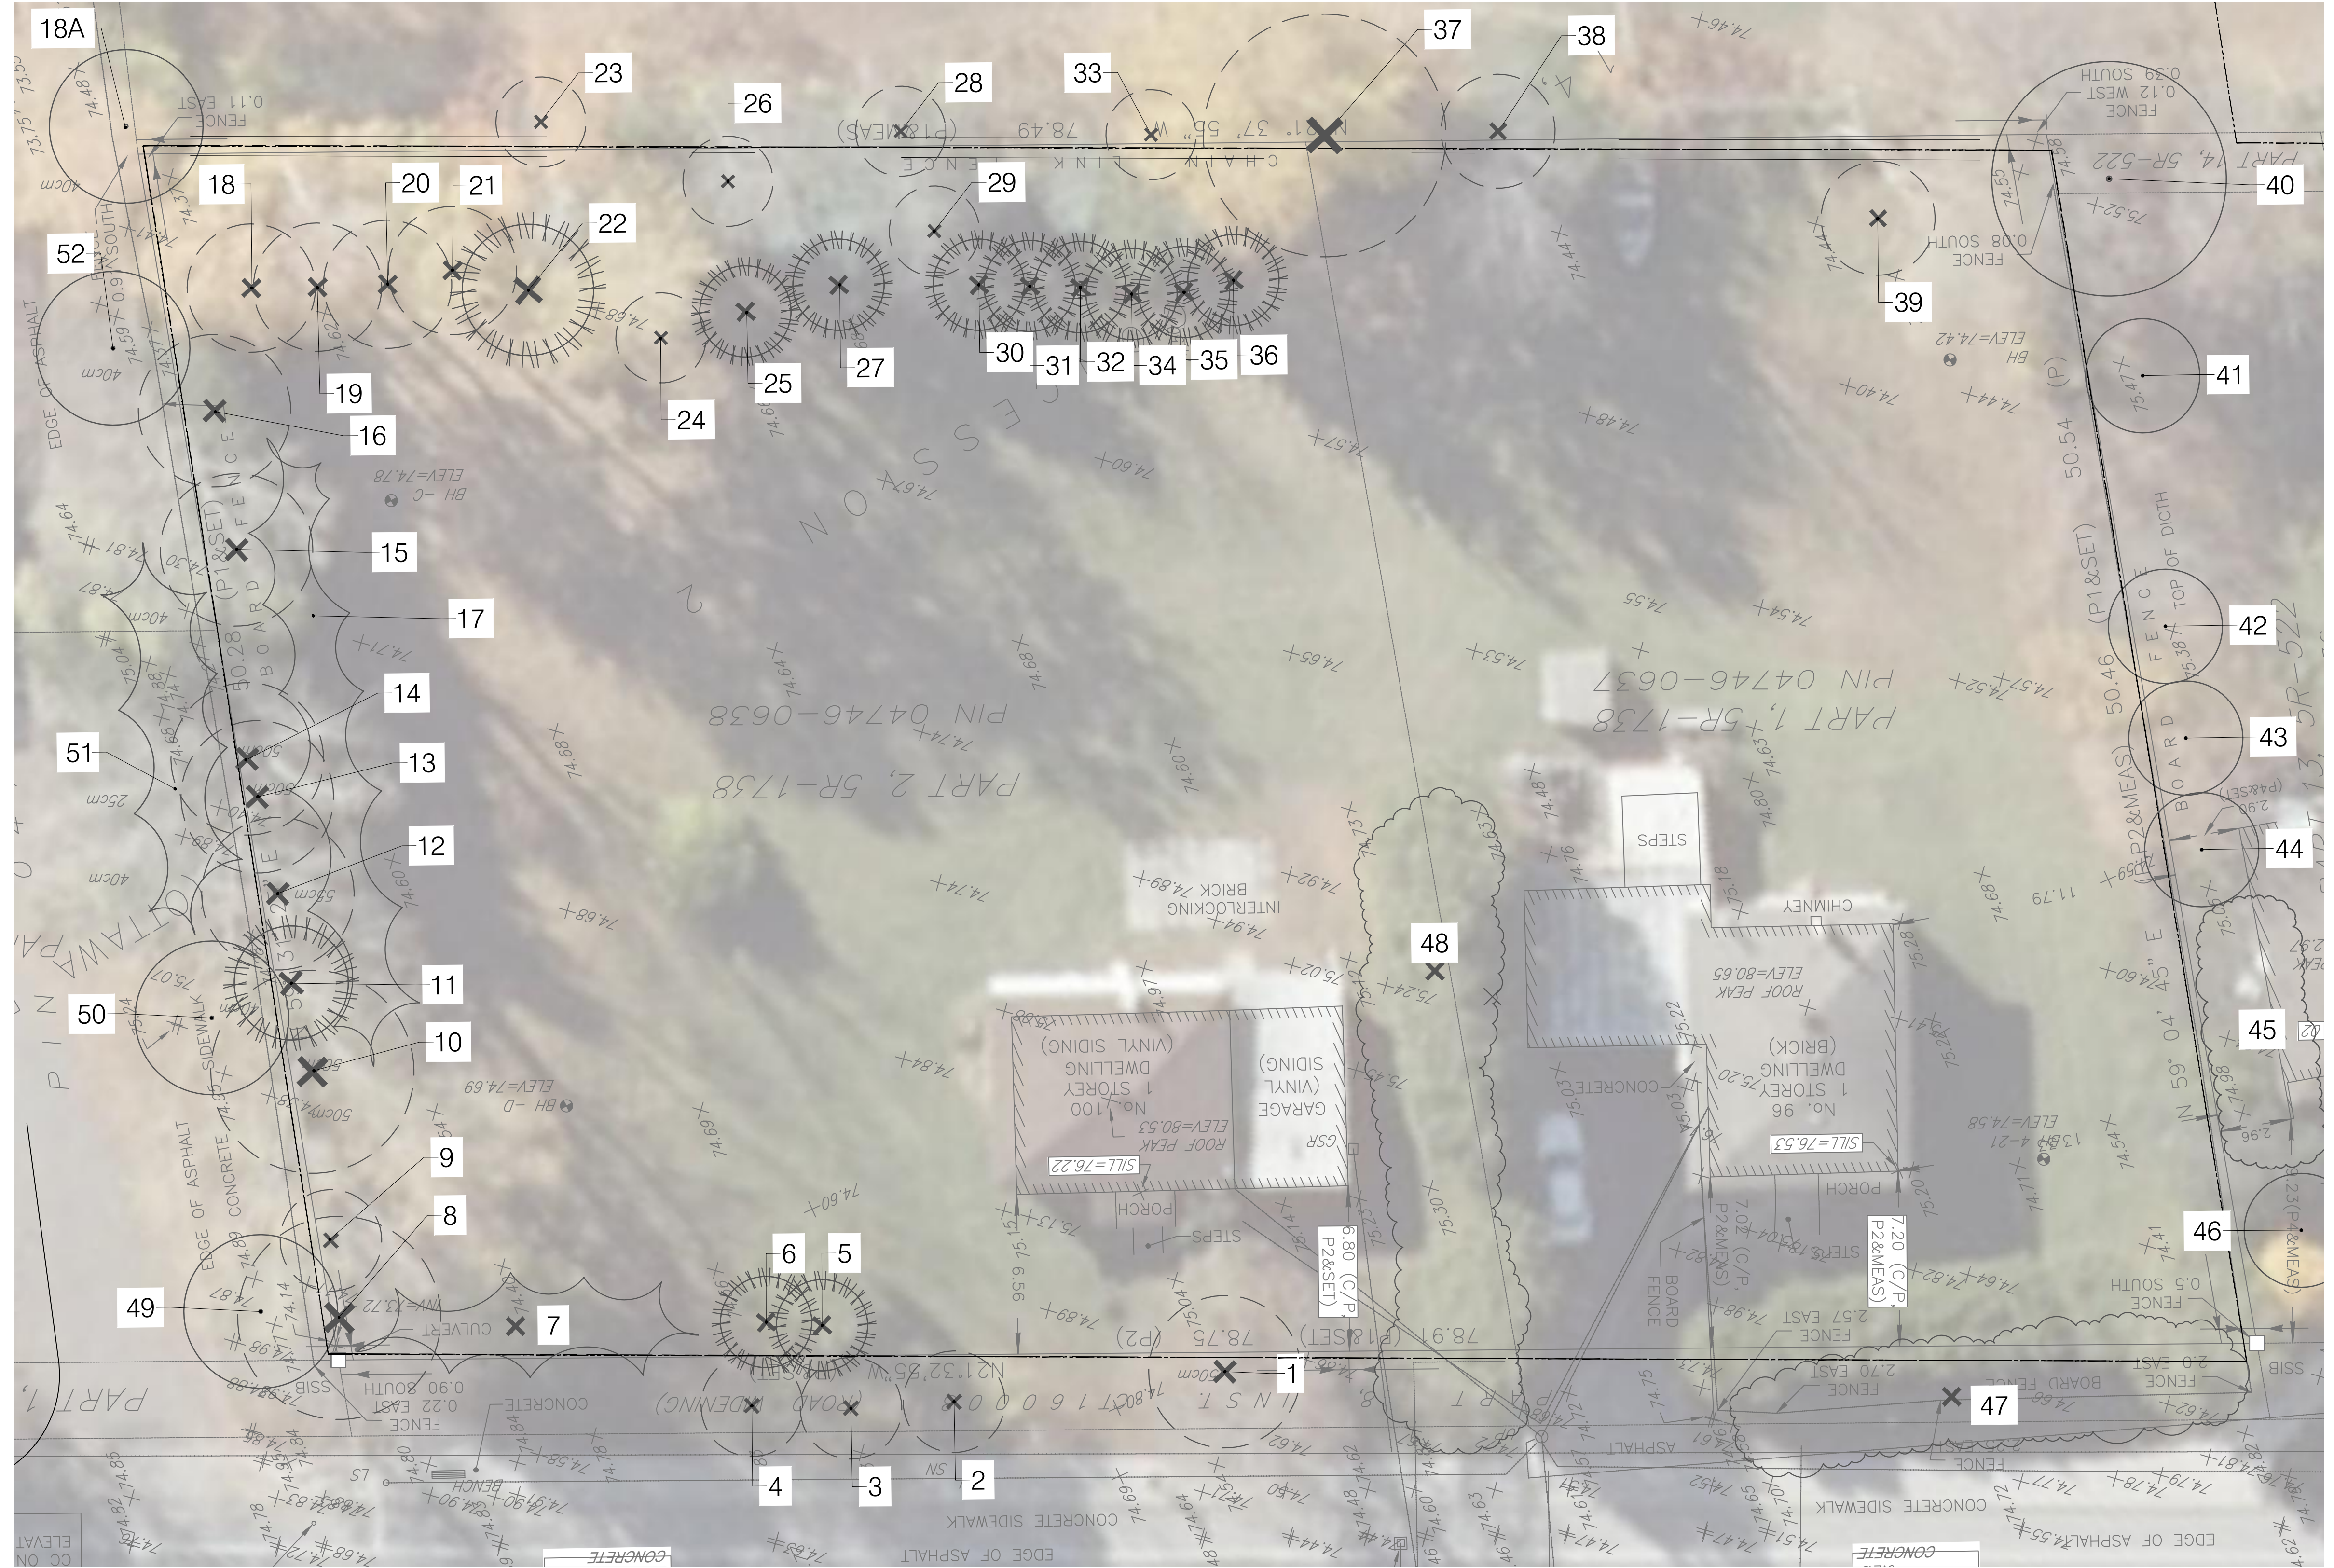
1 PRE-DEVELOPMENT PLAN

NO.	SPECIES	DBH (CM)	HEALTH	COMMENTS
18	Trembling Aspen/ <i>Populus tremuloides</i>	35	Good	Adjacent Property
40	Manitoba Maple / <i>Acer negundo</i>	52	Fair	Adjacent Property. Identified as #1 in dendron report
41	Manitoba Maple / <i>Acer negundo</i>	20	Poor	Adjacent Property
42	Red Maple / <i>Acer rubrum</i>	20	Good	Adjacent Property
43	Apple / <i>Malus sp.</i>	20, 22, 18	Poor	Adjacent Property
44	Manitoba Maple / <i>Acer negundo</i>	33	Fair	Adjacent Property
45	European Buckthorn / <i>Rhamnus cathartica</i>	10-15	Fair	Adjacent Property, Hedge
46	Red Maple / <i>Acer rubrum</i>	16	Fair	Adjacent Property
49	Norway Maple / <i>Acer platanoides</i>	30	Poor	Adjacent Property
50	Norway Maple / <i>Acer platanoides</i>	30	Fair	Adjacent Property
51	Austrian Pine / <i>Pinus nigra</i>	20-28	Good	Adjacent Property, 4 Stems
52	Norway Maple / <i>Acer platanoides</i>	40	Good	Adjacent Property

NO.	SPECIES	DBH (CM)	HEALTH	COMMENTS
5	Eastern White Cedar / <i>Thuja occidentalis</i>	19	Good	
6	Eastern White Cedar / <i>Thuja occidentalis</i>	20	Good	
7	Eastern White Cedar / <i>Thuja occidentalis</i>	8-14	Fair	Hedge
8	Silver Maple / <i>Acer saccharinum</i>	15, 15, 20, 26, 32	Fair	5 stems joined at 1.3m
9	Silver Maple / <i>Acer saccharinum</i>	10, 13, 13, 15	Fair	4 stems joined at base
10	Eastern Cottonwood / <i>Populus deltoides</i>	43, 45	Good	2 stems joined at 1.0m
11	Eastern White Cedar / <i>Thuja occidentalis</i>	35	Good	
12	Eastern Cottonwood / <i>Populus deltoides</i>	64	Good

13	Eastern Cottonwood / <i>Populus deltoides</i>	53	Good	
14	Eastern Cottonwood / <i>Populus deltoides</i>	50	Good	
15	Crack Willow / <i>Salix fragilis</i>	23	Good	
16	Eastern Cottonwood / <i>Populus deltoides</i>	55	Good	
17	Eastern White Cedar / <i>Thuja occidentalis</i>	10-18	Fair-Good	Hedge
18	Trembling Aspen / <i>Populus tremuloides</i>	33	Good	
19	Trembling Aspen / <i>Populus tremuloides</i>	35	Good	
20	Trembling Aspen / <i>Populus tremuloides</i>	44	Good	2 Stems joined at base
21	Trembling Aspen / <i>Populus tremuloides</i>	35	Good	
22	Colorado Blue Spruce / <i>Picea pungens</i>	17	Good

23	Silver Maple / <i>Acer saccharinum</i>	37, 28	Fair-Good	Adjacent Property (per Dendron Report)
24	Trembling Aspen / <i>Populus tremuloides</i>	28	Good	
25	Colorado Blue Spruce / <i>Picea pungens</i>	18	Good	
26	Trembling Aspen / <i>Populus tremuloides</i>	36	Good	
27	Colorado Blue Spruce / <i>Picea pungens</i>	19	Good	
28	Red Maple / <i>Acer rubrum</i>	31	Fair	Adjacent Property (per Dendron Report)
29	Trembling Aspen / <i>Populus tremuloides</i>	17	Good	
30	Colorado Blue Spruce / <i>Picea pungens</i>	22	Good	
31	Colorado Blue Spruce / <i>Picea pungens</i>	32	Good	
32	Colorado Blue Spruce / <i>Picea pungens</i>	18	Good	
33	Red Maple / <i>Acer rubrum</i>	46	Good	Adjacent Property (per Dendron Report)
34	Colorado Blue Spruce / <i>Picea pungens</i>	22	Good	
35	Colorado Blue Spruce / <i>Picea pungens</i>	28	Good

36	Colorado Blue Spruce / <i>Picea pungens</i>	25	Good	
37	Red Maple / <i>Acer rubrum</i>	55-55	Good	Adjacent Property
38	Red Maple / <i>Acer rubrum</i>	40	Good	Adjacent Property (per Dendron Report)
39	Manitoba Maple / <i>Acer negundo</i>	39	Poor	Last of 3 stems, heavy lean
48	Eastern White Cedar / <i>Thuja occidentalis</i>	15-30	Fair-Good	38 Stem
