LANSDOWNE 2.0
EVENT CENTRE,
NORTH SIDE STANDS AND
PUBLIC REALM
ENHANCEMENTS
 945 & 1015 BANK STREET

DWG. TITLE
TREE CONSERVATION REPORT
EXISTING CONDITION

DWG. TITLE
**TREE CONSERVATION REPORT
 PROPOSED DEVELOPMENT**

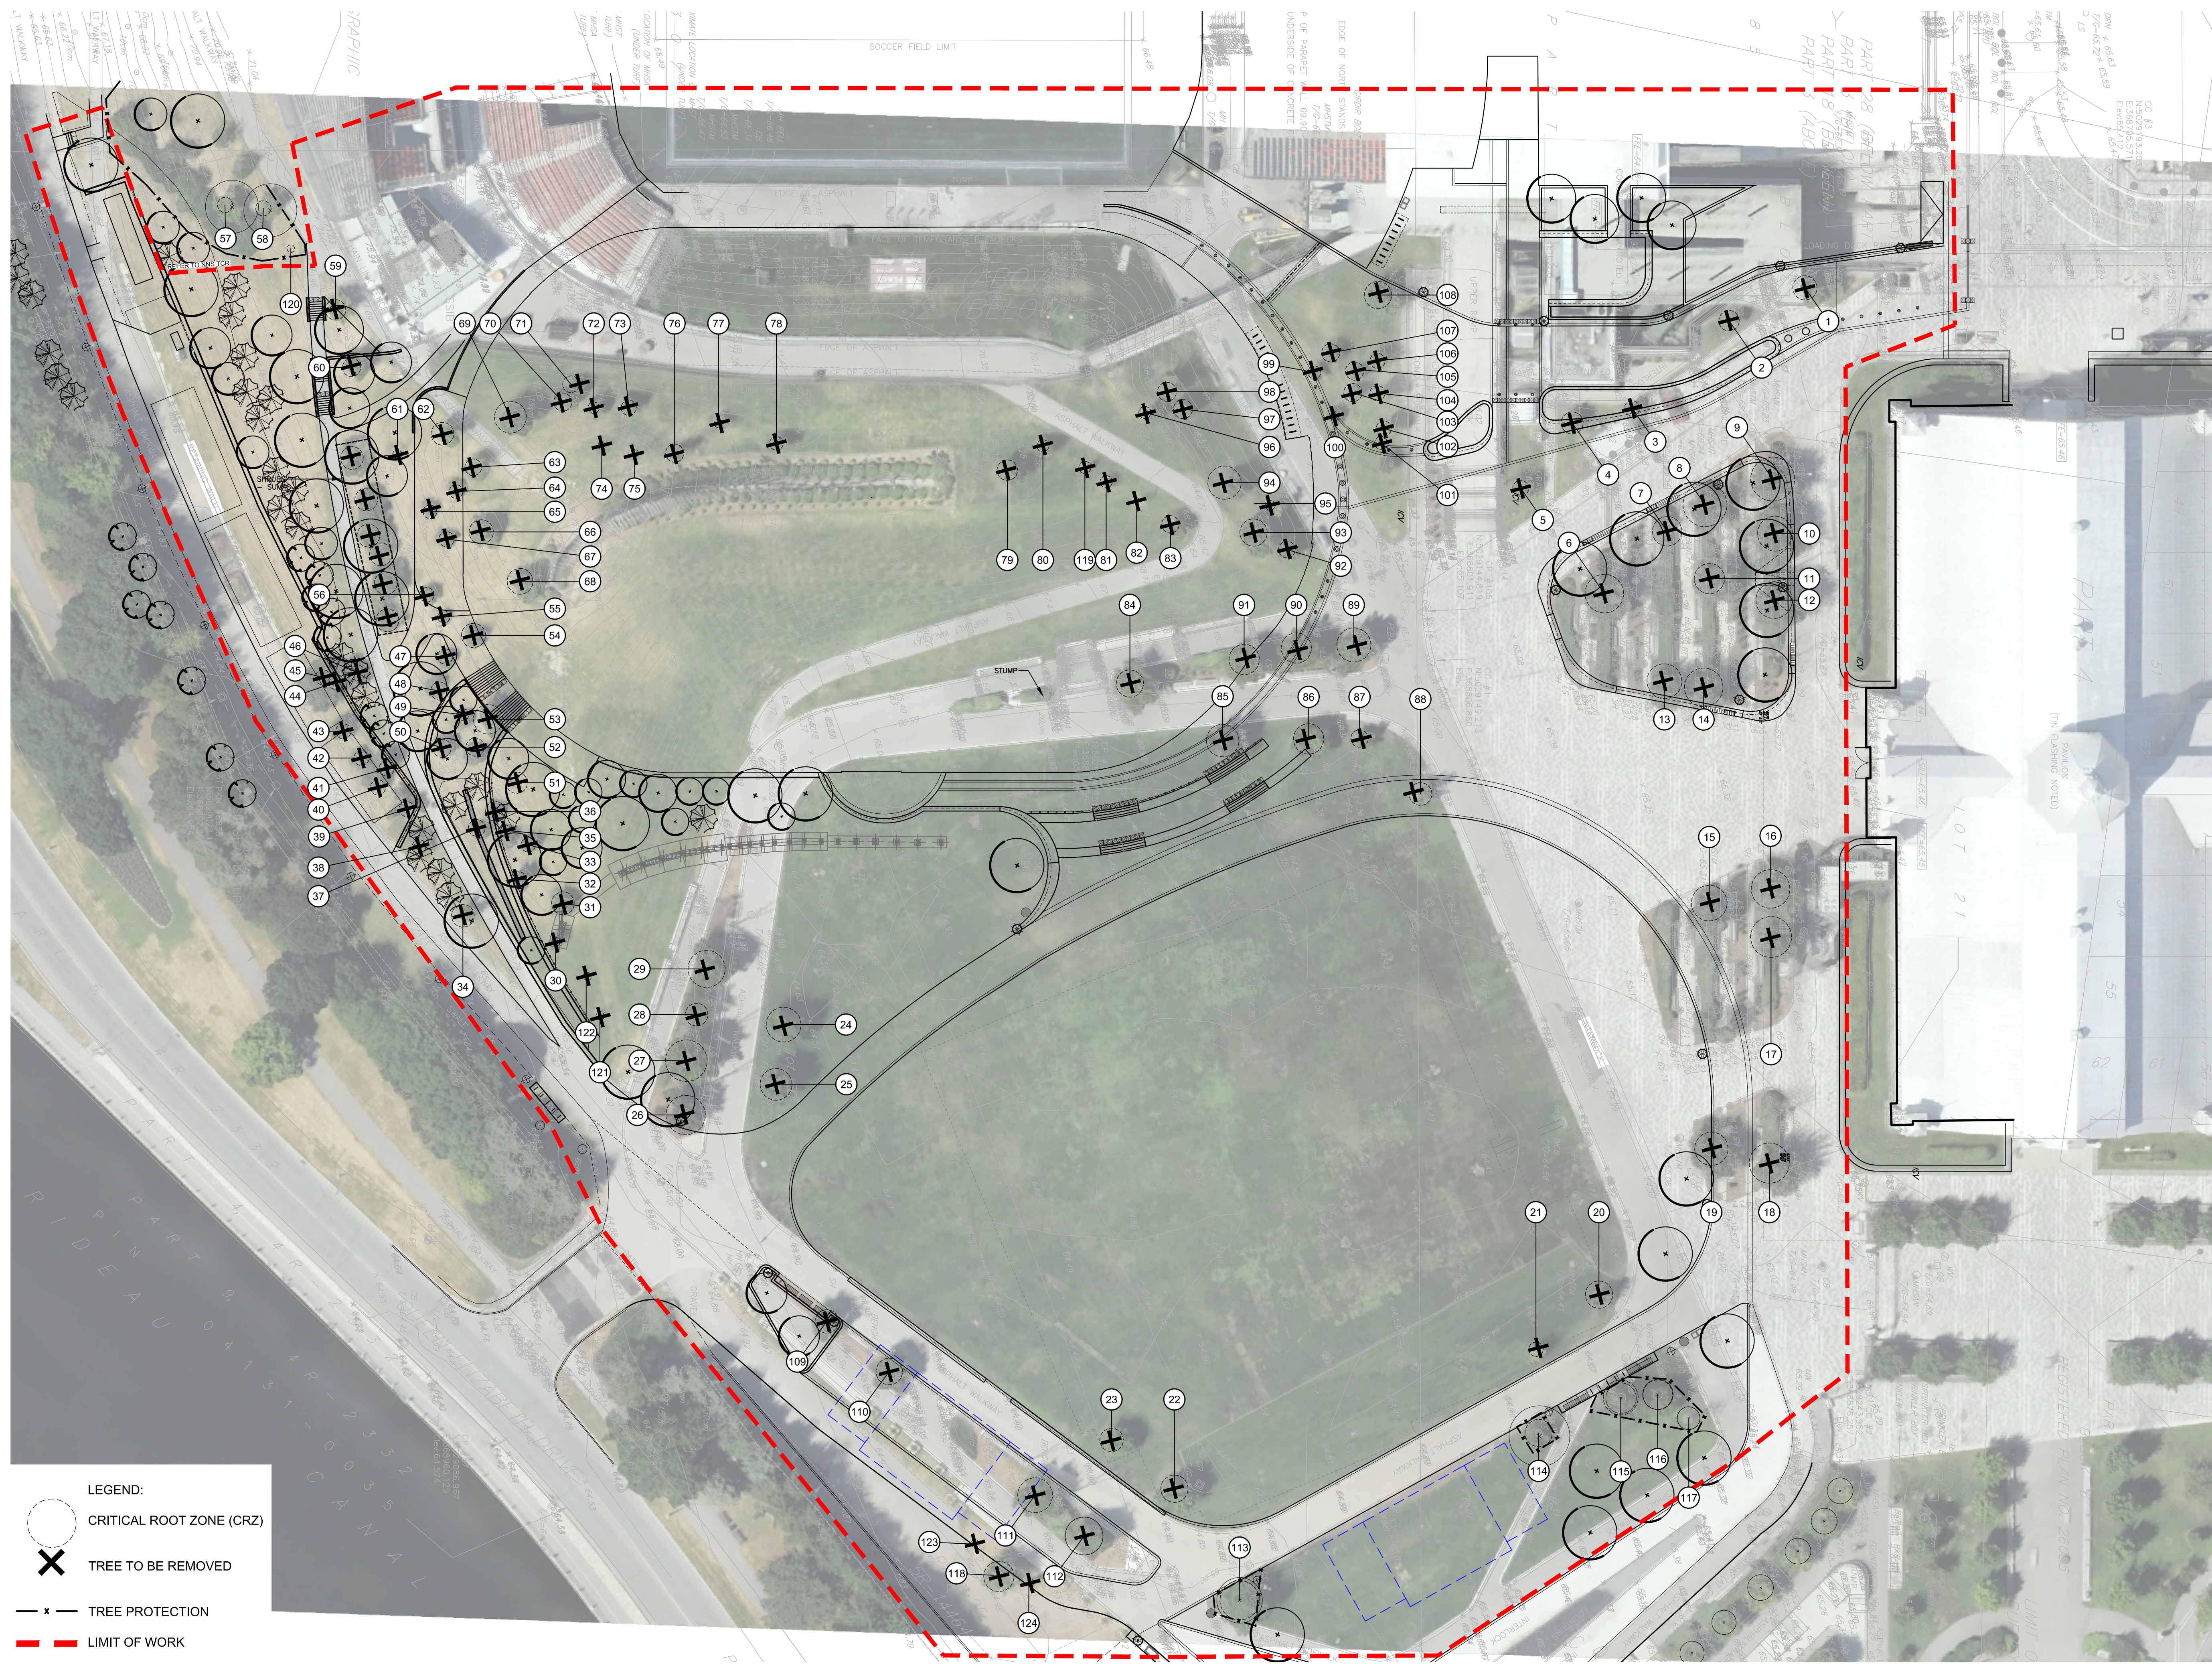
1 : 400
 PROJ. NO. CSW #1766-12
 DWG. NO. EC-TCR 1.1
 FILE NO. D07-24-0082
 PLAN # 19172

- LEGEND:
- CRITICAL ROOT ZONE (CRZ)
 - TREE TO BE REMOVED
 - TREE PROTECTION
 - LIMIT OF WORK

NOTE: SOME TREES MAY BE SUITABLE FOR TRANSPLANTING, (TO BE REVIEWED THROUGH DETAILED DESIGN DEVELOPMENT)
