Landslide Hazard Assessment

Proposed Self-Storage Facility

1015 & 1045 Dairy Drive
Ottawa, Ontario

Report PG6498-2 dated June 10, 2024

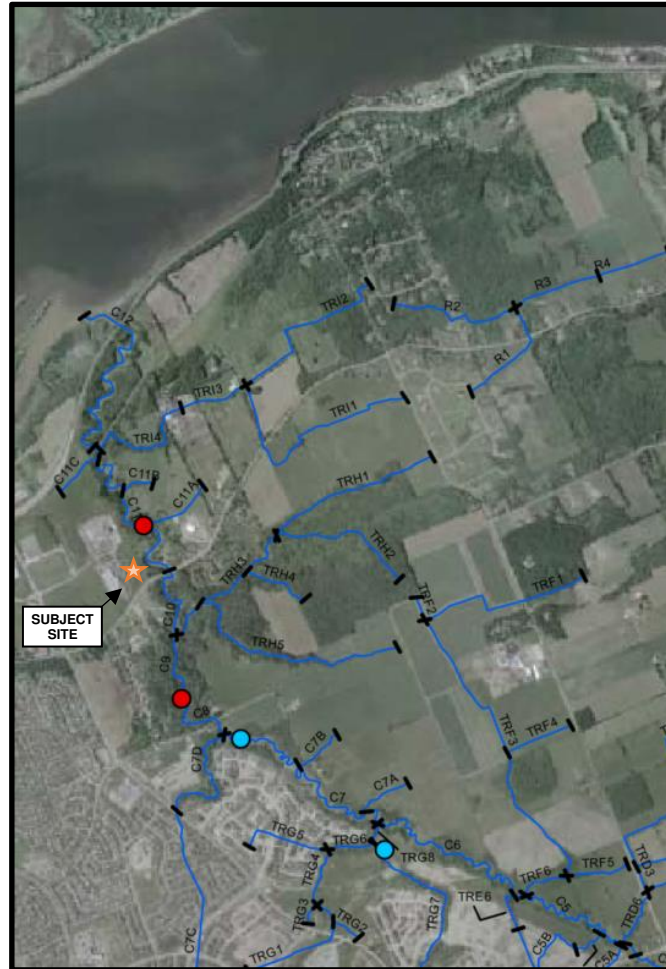
Figure 1 - Cardinal Creek Subwatershed (Geomorphic Solutions, 2007)

A geomorphic study was undertaken by Geomorphic Solutions in 2007 for the Cardinal Creek watershed. Figure 1 depicts the enumeration of the corresponding reaches of the watershed close to the subject area. The study indicated that Reach C11, which neighbors the subject site, is considered to be a stream order 4, with a sinuosity of 1.39, which would correspond to a low to moderate risk of landslides.
