Landslide Hazard Assessment

Proposed Residential Development

2983, 3053 and 3079 Navan Road Ottawa, Ontario

Prepared for EXP Services Inc. (c/o 12714001 Canada Inc.)

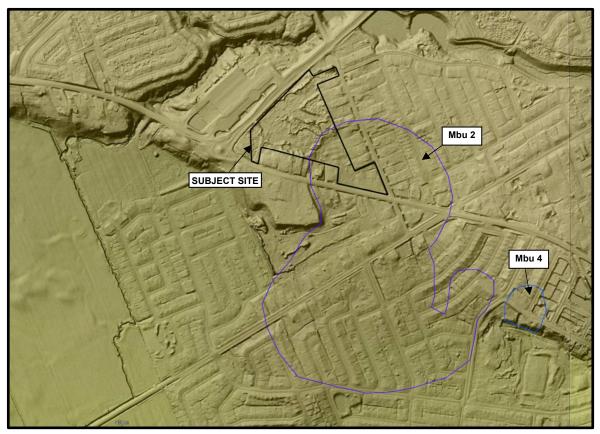
Figure 1 – LiDAR Image of Subject Site and closest documented landslides.

Landslide Mbu2 is located throughout the footprint of the subject site and extending to the south and east covering the footprint of existing residential dwelling structures throughout the neighboring developments. The location of the subject site in relation to Mbu2 and a smaller landslide, Mbu4, located approximately 350 m from the subject site, is depicted in Figure 1, for reference.

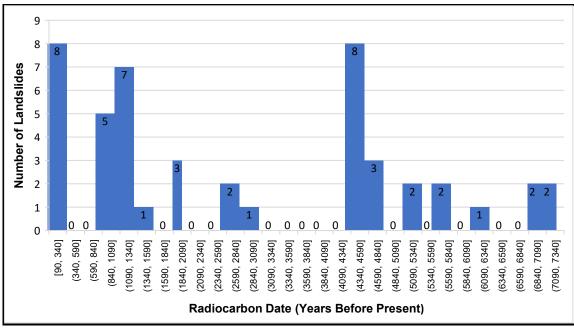
Figure 2 - Summary of Carbon-dated Landslides (GSC OF7432)

The results from the study and approximations provided by OF8600, neglecting the potential deviation and range of uncertainty, are summarized in Figure 2 below.

Temporal factors such as periods of increased earthquakes and climatic factors affecting these frequencies have been explored by others. Based on the above, more than half of the carbon dated landslides have occurred within the past 3,090 years, and over a quarter within the past 1,090 years.

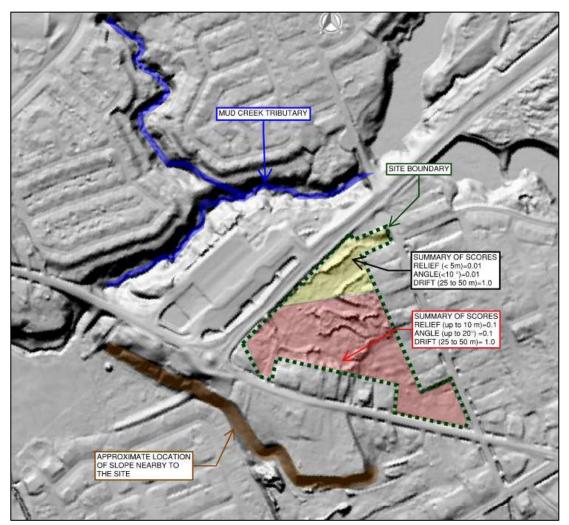
Figure 3 - Summary of Drift Thickness, Surface Relief, and Slope Angle Weight Factors

Considering these factors, the subject site may be divided into two areas with distinct attributes as depicted in Figure 3 included in the following page.

It should be noted that since the portion of the subject site identified in yellow on Figure 3 may be subject to active toe erosion, a modified probability has been considered including a toe erosion factor of 1.85, rather than 1 as discussed in Section 4.2.3. This would result in a $P_{\text{Modified for Toe Erosion}} = 5.5 \times 10^{-3} \text{ or 1 in 184}$.

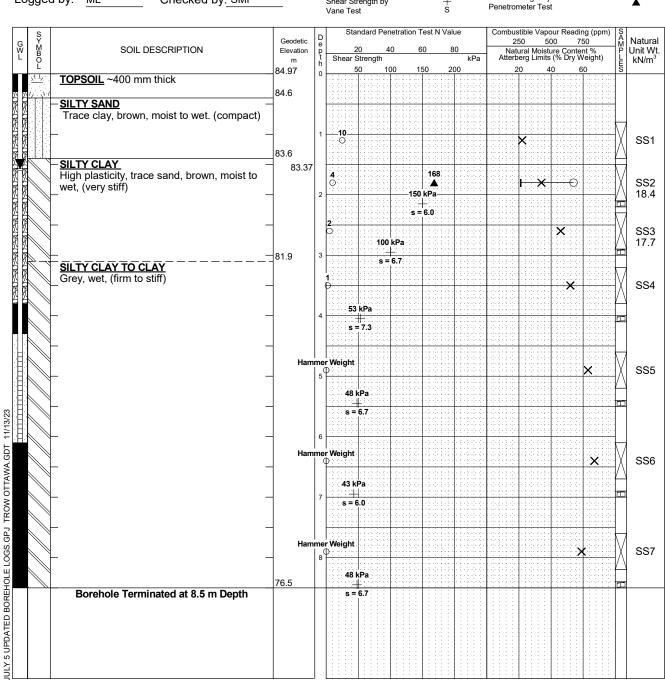
Log of Doi	CHOIC DIT O		$\leftarrow x$
Project No:	OTT-21004743-B0			
Project:	Proposed Residential Development		Figure No3_	
_ocation:	2983, 3053 and 3079 Navan Road, Ottawa, Ontar	Page. <u>1</u> of <u>1</u>	-	
Date Drilled:	'April 29, 2021	Split Spoon Sample	Combustible Vapour Reading	
Orill Type:	CME-850 Track Mounted Drill Rig	Auger Sample	Natural Moisture Content	X
onii Type.	CIVIE-050 Track Mounted Drill Rig	SPT (N) Value	Atterberg Limits	\longrightarrow
Datum:	Geodetic Elevation	Dynamic Cone Test	Undrained Triaxial at	\oplus
		Shelby Tube	% Strain at Failure	•
ogged by:	ML Checked by: SMP	Shear Strength by +	Shear Strength by	•

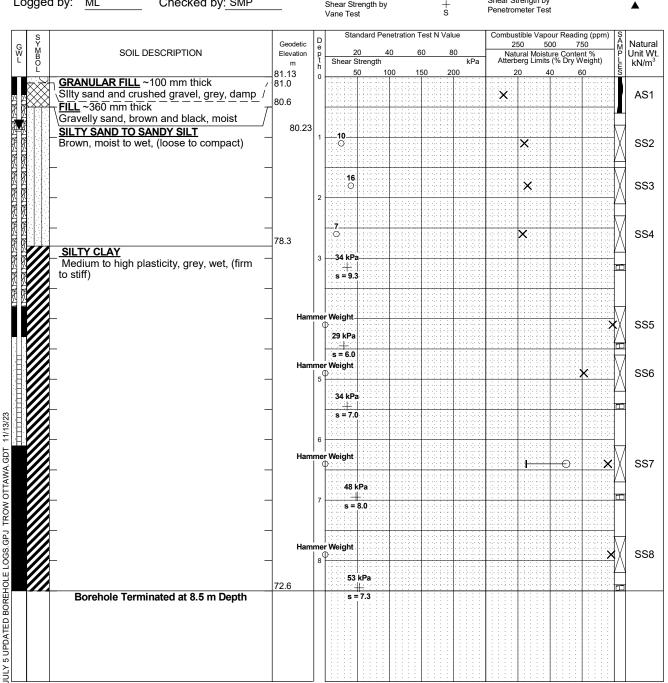
<u> </u>	<u> </u>		-x
Project No:	OTT-21004743-B0				
Project:	Proposed Residential Development	Figure No. 4			
Location:	2983, 3053 and 3079 Navan Road, Ottawa		Page. <u>1</u> of <u>1</u>	-	
Date Drilled:	'April 28, 2021	Split Spoon Sample	\boxtimes	Combustible Vapour Reading	
Drill Type:	CME-850 Track Mounted Drill Rig	Auger Sample SPT (N) Value	Ⅱ	Natural Moisture Content Atterberg Limits	× ⊷
Datum:	Geodetic Elevation	Dynamic Cone Test Shelby Tube	_	Undrained Triaxial at % Strain at Failure	\oplus
I oaged by.	MI Checked by: SMP	Shoor Strongth by	_	Shear Strength by

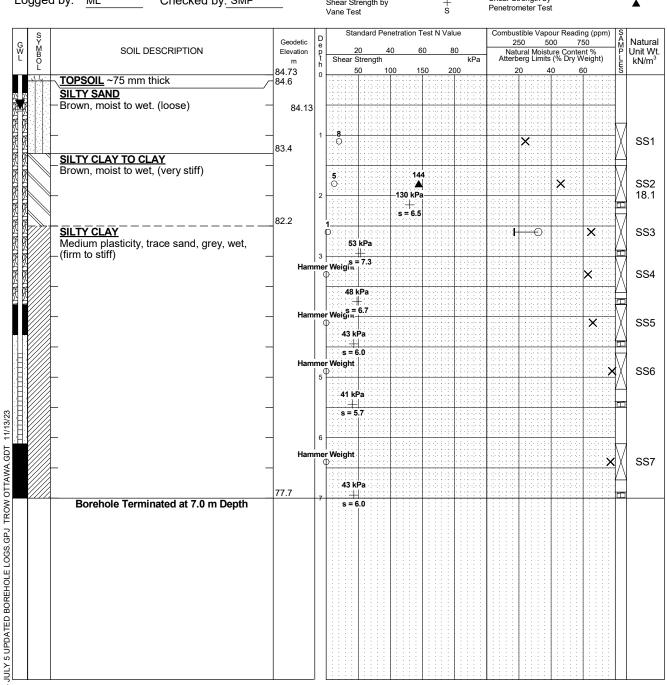
_09 0	<u> </u>	, , , , , , , , , , , , , , , , , , , 	<u> </u>	-x
Project No:	OTT-2100474	13-B0				
Project:	Proposed Re	sidential Development	Figure No5_			
Location:	2983, 3053 a	nd 3079 Navan Road, Ottawa		Page. <u>1</u> of <u>1</u>	_	
Date Drilled:	'April 29, 202	1	Split Spoon Sample	\boxtimes	Combustible Vapour Reading	
Drill Type:	CME-850 Tra	ck Mounted Drill Rig	Auger Sample SPT (N) Value	■	Natural Moisture Content Atterberg Limits	X ——⊕
Datum:	Geodetic Elevation		Dynamic Cone Test Shelby Tube	_	Undrained Triaxial at % Strain at Failure	\oplus
Logged by:	ML	Checked by: SMP	Shear Strength by	+	Shear Strength by	•

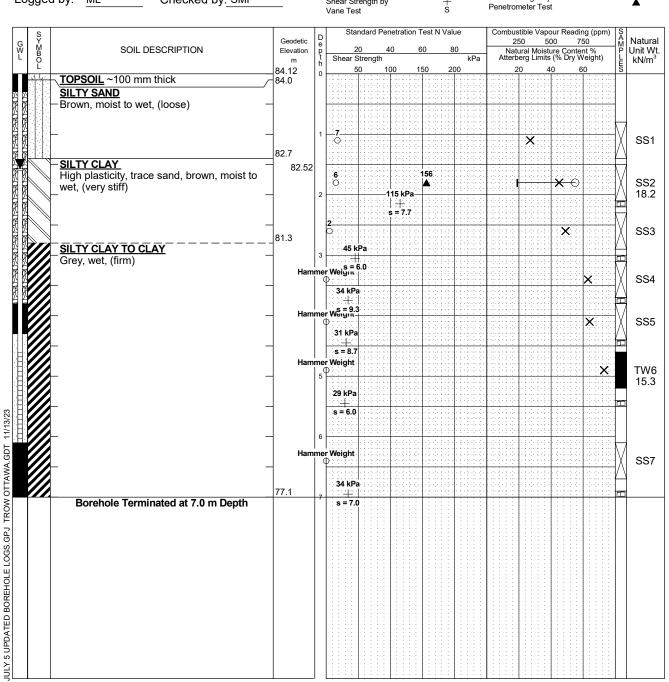
Log of D	or crioic <u>b</u>	<u> </u>	_	\leftarrow	Х
Project No:	OTT-21004743-B0					/ \
Project:	Proposed Residential Development			Figure No. 9		
Location:	2983, 3053 and 3079 Navan Road, Ottawa, O	ntario		Page. <u>1</u> of <u>1</u>	_	
Date Drilled:	'April 30, 2021	Split Spoon Sample	\boxtimes	Combustible Vapour Reading		
Orill Type:	CME-850 Track Mounted Drill Rig	Auger Sample — SPT (N) Value	Ⅲ ○	Natural Moisture Content Atterberg Limits	—	X ⊕
Datum:	Geodetic Elevation	Dynamic Cone Test Shelby Tube	_	Undrained Triaxial at % Strain at Failure		\oplus
oaged by:	MI Checked by: SMP	Shear Strength by		Shear Strength by

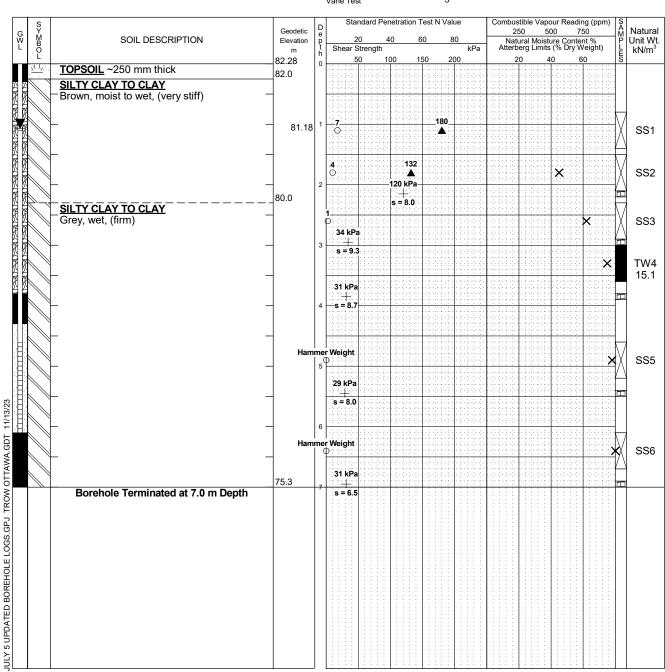
Log of Doi	CHOIC DIT	<u> </u>		$\leftarrow x$
Project No:	OTT-21004743-B0			10	
Project:	Proposed Residential Development		F	igure No10_	
Location:	2983, 3053 and 3079 Navan Road, Ottawa, Ontar	io		Page. <u>1</u> of <u>1</u>	-
Date Drilled:	'April 29, 2021	Split Spoon Sample	1	Combustible Vapour Reading	
Drill Type:	CME-850 Track Mounted Drill Rig	Auger Sample SPT (N) Value O		Natural Moisture Content Atterberg Limits	× ⊢—≎
Datum:	Geodetic Elevation	Dynamic Cone Test Shelby Tube		Undrained Triaxial at % Strain at Failure	\oplus
Logged by:	ML Checked by: SMP	Shear Strength by Vane Test S		Shear Strength by Penetrometer Test	A

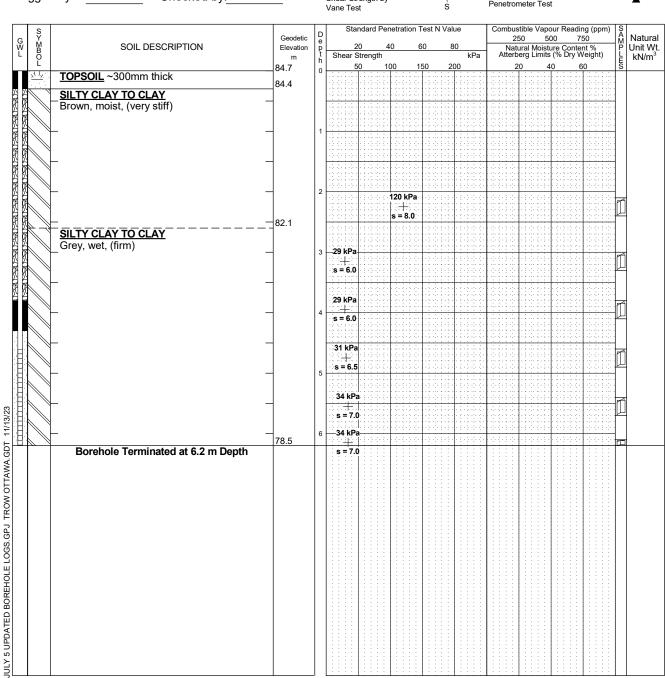
Log of Do	I CITOIC DIT	<u>00</u>	\leftarrow x
Project No:	OTT-21004743-B0			
Project:	Proposed Residential Development		Figure No11	
Location:	2983, 3053 and 3079 Navan Road, Ottawa, Onta	rio		_
Date Drilled:	'April 30, 2021	Split Spoon Sample	Combustible Vapour Reading	
Drill Type:	CME-850 Track Mounted Drill Rig	Auger Sample SPT (N) Value	Natural Moisture Content Atterberg Limits	× ⊢—⊖
Datum:	Geodetic Elevation	Dynamic Cone Test Shelby Tube	Undrained Triaxial at % Strain at Failure	\oplus
Logged by:	ML Checked by: SMP	Shear Strength by + Vane Test S	Shear Strength by Penetrometer Test	A

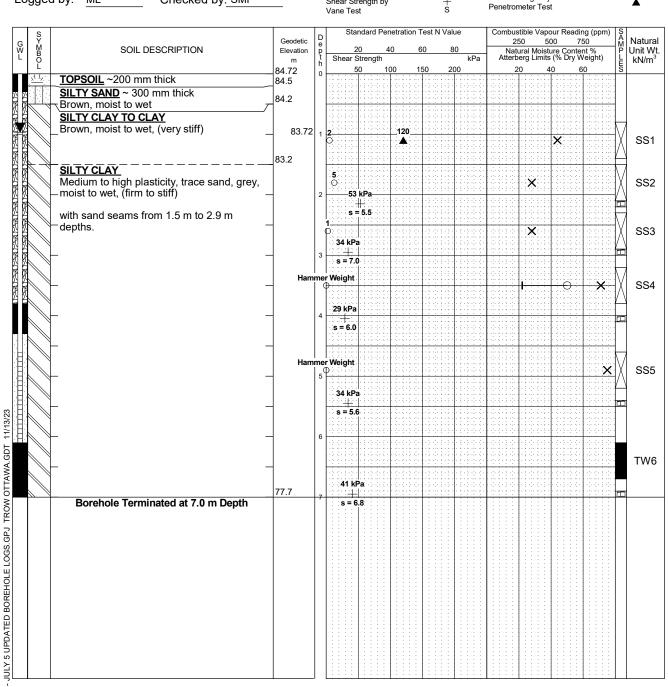
_09 0	<u> </u>	<u> </u>	<u>U</u>	-x
Project No:	OTT-21004743-B0				
Project:	Proposed Residential Development			Figure No. 12	
Location:	2983, 3053 and 3079 Navan Road, Ottawa,	Ontario		Page. <u>1</u> of <u>1</u>	_
Date Drilled:	'April 29, 2021	Split Spoon Sample	\boxtimes	Combustible Vapour Reading	
Drill Type:	CME-850 Track Mounted Drill Rig	Auger Sample SPT (N) Value	I	Natural Moisture Content Atterberg Limits	× ⊖
Datum:	Geodetic Elevation	Dynamic Cone Test Shelby Tube	_	Undrained Triaxial at % Strain at Failure	\oplus
Logged by:	ML Checked by: SMP	Shear Strength by	<u>_</u>	Shear Strength by

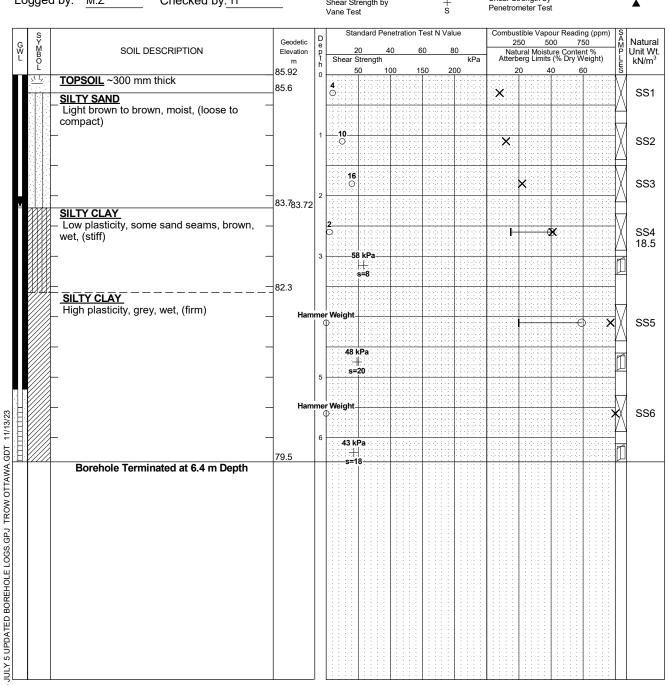
Log of Do	CHOIC DIT				Χ÷
Project No:	OTT-21004743-B0		_	:: 12	\sim	// \
Project:	Proposed Residential Development		F	igure No13_		
Location:	2983, 3053 and 3079 Navan Road, Ottawa, Ontak	rio		Page. <u>1</u> of <u>1</u>	-	
Date Drilled:	'September 12, 2023	Split Spoon Sample	\boxtimes	Combustible Vapour Reading		
Drill Type:	CME-55 Track Mounted Drill Rig	Auger Sample [SPT (N) Value		Natural Moisture Content Atterberg Limits	⊢	X →
Datum:	Geodetic Elevation	Dynamic Cone Test Shelby Tube	- -	Undrained Triaxial at % Strain at Failure	-	\oplus
Logged by:	M.Z Checked by: IT	Shear Strength by Vane Test	+ s	Shear Strength by Penetrometer Test		•

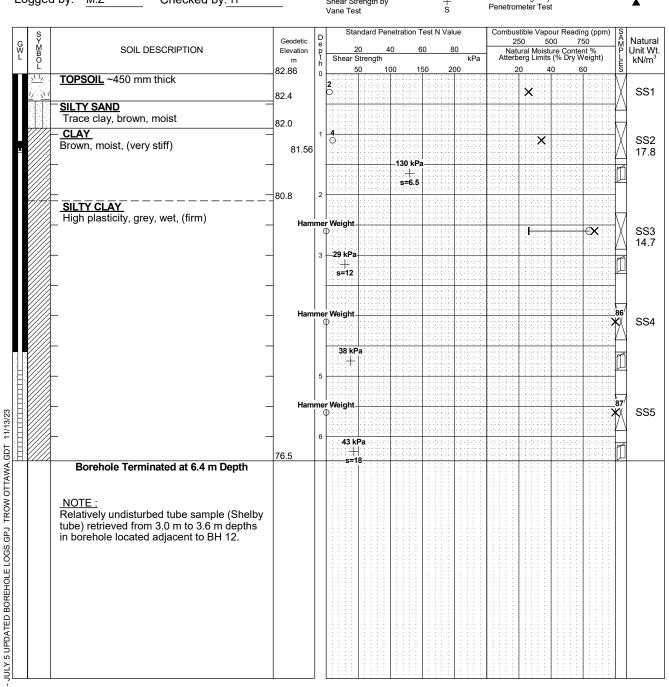
<u> </u>	<u> </u>		-x
Project No:	OTT-21004743-B0				
Project:	Proposed Residential Development			Figure No14	
Location:	2983, 3053 and 3079 Navan Road, Ottawa, C	ntario		Page1_ of _1_	-
Date Drilled:	September 12, 2023	Split Spoon Sample	\boxtimes	Combustible Vapour Reading	
Drill Type:	CME-55 Track Mounted Drill Rig	Auger Sample —— SPT (N) Value	■	Natural Moisture Content Atterberg Limits	× ⊖
Datum:	Geodetic Elevation	Dynamic Cone Test Shelby Tube	_	Undrained Triaxial at % Strain at Failure	\oplus
Logged by:	M.Z Checked by: IT	Shear Strength by	+	Shear Strength by	•

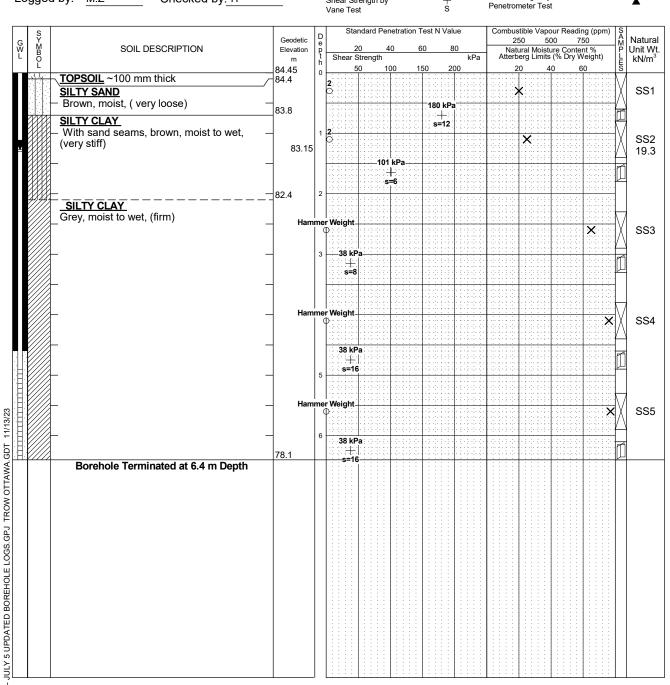
Log of Do	TOTOLO DIT	<u>10</u>	\leftarrow x
Project No:	OTT-21004743-B0			
Project:	Proposed Residential Development		Figure No15_	
Location:	2983, 3053 and 3079 Navan Road, Ottawa, Ont	ario	Page. <u>1</u> of <u>1</u> 	_
Date Drilled:	September 12, 2023	_ Split Spoon Sample ∑	Combustible Vapour Reading	
Drill Type:	CME-55 Track Mounted Drill Rig	Auger Sample - SPT (N) Value		× ⊢—⊙
Datum:	Geodetic Elevation	Dynamic Cone Test Shelby Tube	Undrained Triaxial at % Strain at Failure	\oplus
Logged by:	M.Z Checked by: IT	Shear Strength by +	Shear Strength by	•

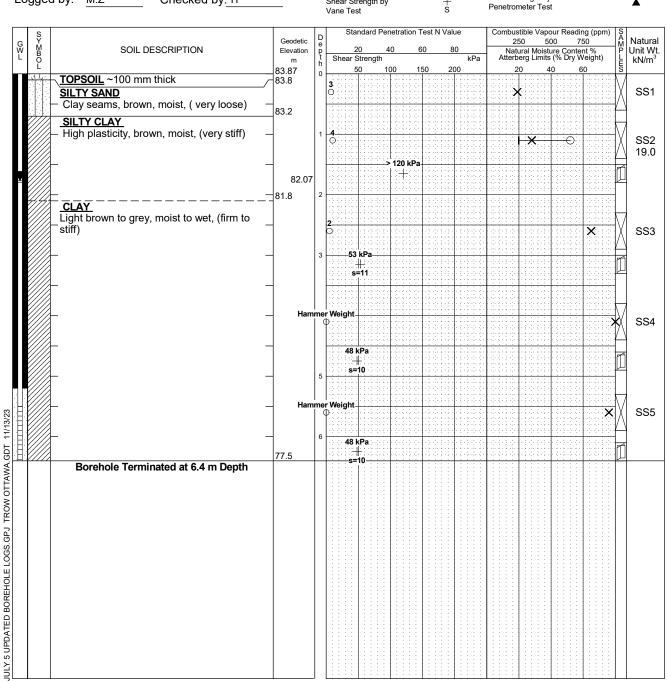
JOI CHOIC <u>E</u>	<u> </u>	<u> </u>	$\leftarrow x$
Project No:	OTT-21004743-B0				
Project:	Proposed Residential Development			Figure No16	
Location:	2983, 3053 and 3079 Navan Road, Ottawa,	Ontario		Page. <u>1</u> of <u>1</u>	_
Date Drilled:	'September 12, 2023	Split Spoon Sample	\boxtimes	Combustible Vapour Reading	
Orill Type:	CME-55 Track Mounted Drill Rig	Auger Sample SPT (N) Value		Natural Moisture Content Atterberg Limits	X _—⊖
Datum:	Geodetic Elevation	Dynamic Cone Test Shelby Tube	_	Undrained Triaxial at % Strain at Failure	\oplus
oaged by.	M.7 Checked by: IT	Shear Strength by		Shear Strength by

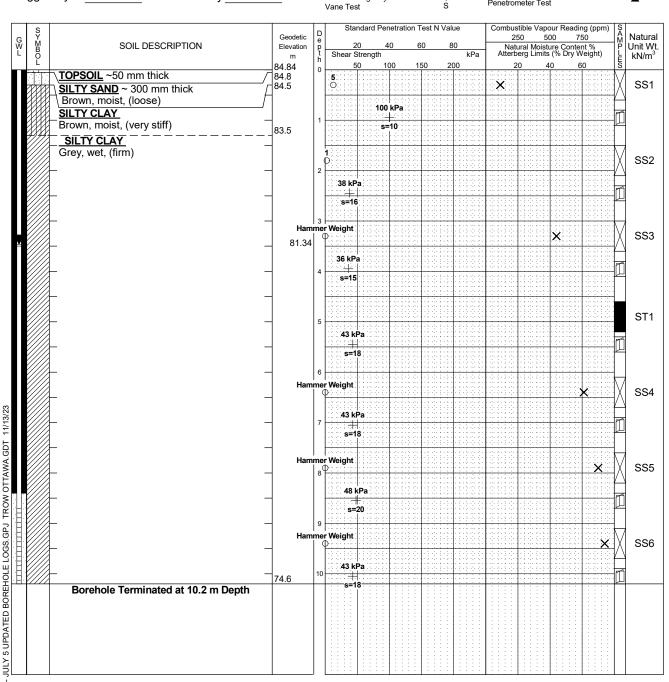
Project No: OTT-21004743-B0 Figure No. Project: Proposed Residential Development Page. 1 of 1 Location: 2983, 3053 and 3079 Navan Road, Ottawa, Ontario Date Drilled: 'September 13, 2023 Split Spoon Sample \boxtimes Combustible Vapour Reading X Auger Sample Natural Moisture Content Drill Type: CME-55 Track Mounted Drill Rig SPT (N) Value 0 0 Atterberg Limits Dynamic Cone Test Datum: Undrained Triaxial at Geodetic Elevation \oplus % Strain at Failure Shelby Tube Shear Strength by Logged by: M.ZChecked by: IT Shear Strength by Penetrometer Test

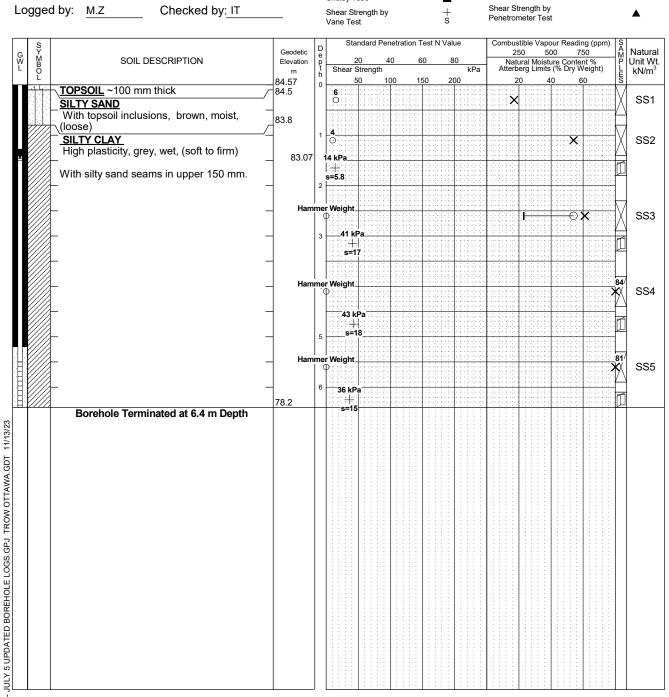
Log of Do	TOTOLO DIT	<u>1 / </u>	$\leftarrow x$
Project No:	OTT-21004743-B0			
Project:	Proposed Residential Development		Figure No19_	
Location:	2983, 3053 and 3079 Navan Road, Ottawa, Ont	ario	Page. <u>1</u> of <u>1</u>	_
Date Drilled:	September 11, 2023	_ Split Spoon Sample 🖂	Combustible Vapour Reading	
Drill Type:	CME-55 Track Mounted Drill Rig	Auger Sample SPT (N) Value	Natural Moisture Content Atterberg Limits	× ⊢—⊙
Datum:	Geodetic Elevation	Dynamic Cone Test Shelby Tube	Undrained Triaxial at % Strain at Failure	\oplus
Logged by:	M.Z Checked by: IT	Shear Strength by +	Shear Strength by	•

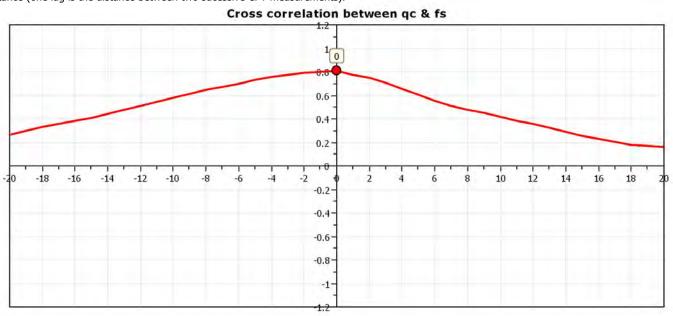
The plot below presents the cross correlation coeficient between the raw qc and fs values (as measured on the field). X axes presents the lag distance (one lag is the distance between two sucessive CPT measurements).

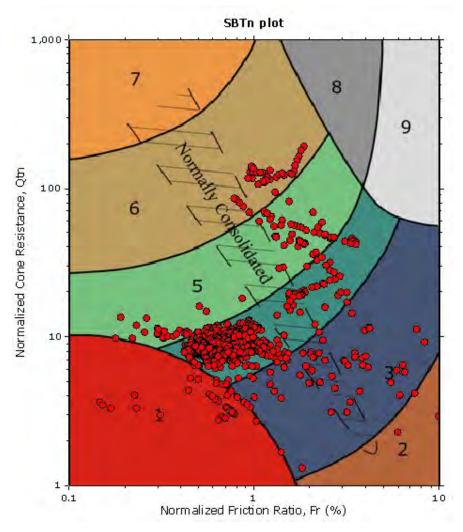
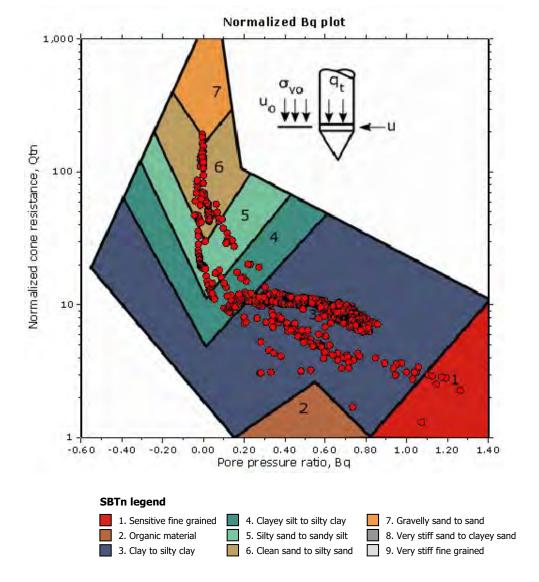
SBT - Bq plots (normalized)

Total depth: 32.51 m Surface Elevation: 84.70 m

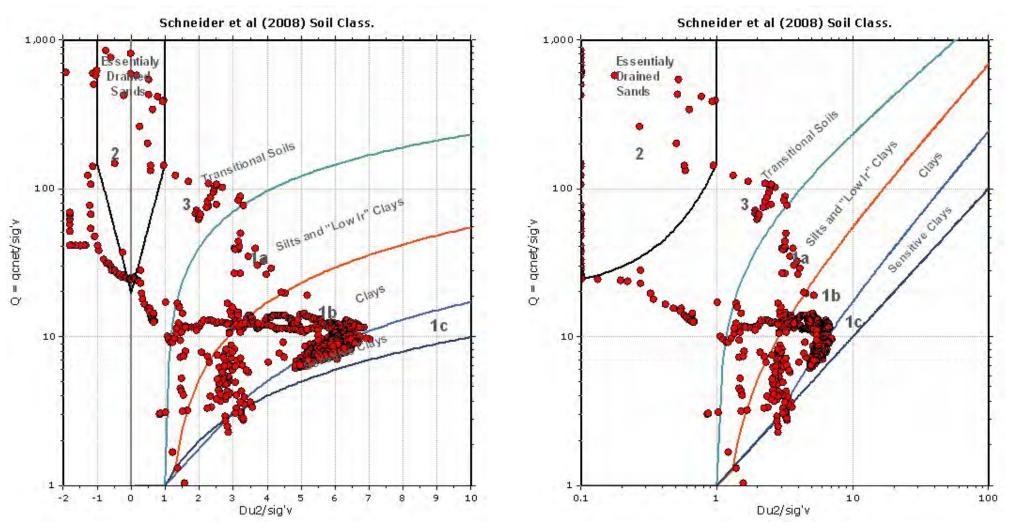
Bq plots (Schneider)

Project: 3053 & 3079 Navan Road Location: Navan / Pagé Roads, Ottawa

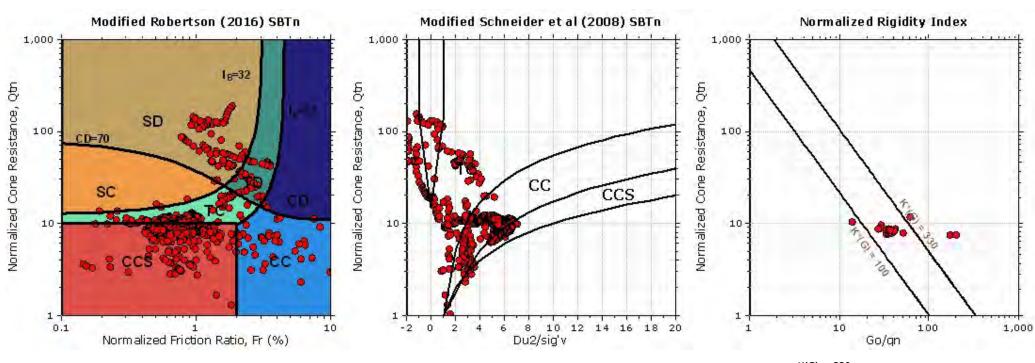
Updated SBTn plots

CCS: Clay-like - Contractive - Sensitive

CC: Clay-like - Contractive CD: Clay-like - Dilative

K(G) > 330: Soils with significant microstructure (e.g. age/cementation)

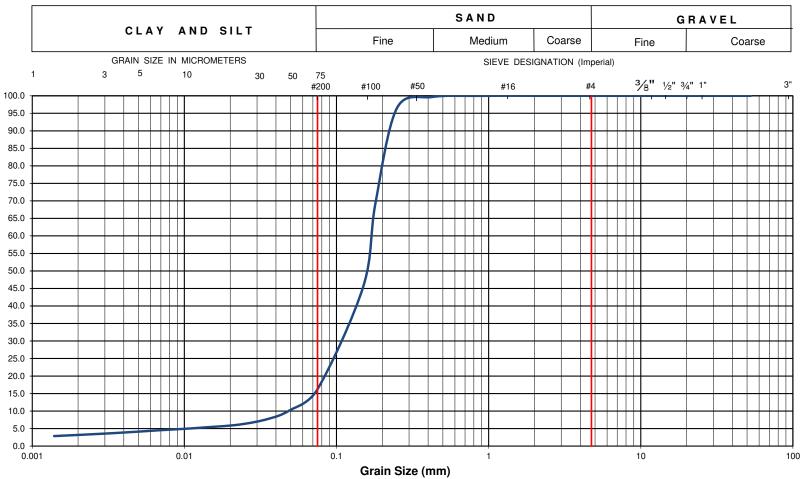
Grain-Size Distribution Curve Method of Test For Particle Size Analysis of Soil ASTM C-136/ASTM D422

EXP Project No.:	OTT-21004743-B0	Project Name :		Proposed Resid	dential D	evelopment				
Client :	12714001 Canada Inc.	Project Location	1:	2983, 3053 & 30	79 Nava	n Road, Otta	wa,	ON		
Date Sampled :	April 29, 2021	Borehole No:		BH 1	San	ple No.:	S1	Depth (m):	0.8-1.4	
Sample Description :		% Silt and Clay	16	% Sand	84	% Gravel		0	-Figure :	22
Sample Description :	imple Description : Silty Sand (SM) - Trace Clay								rigure .	22

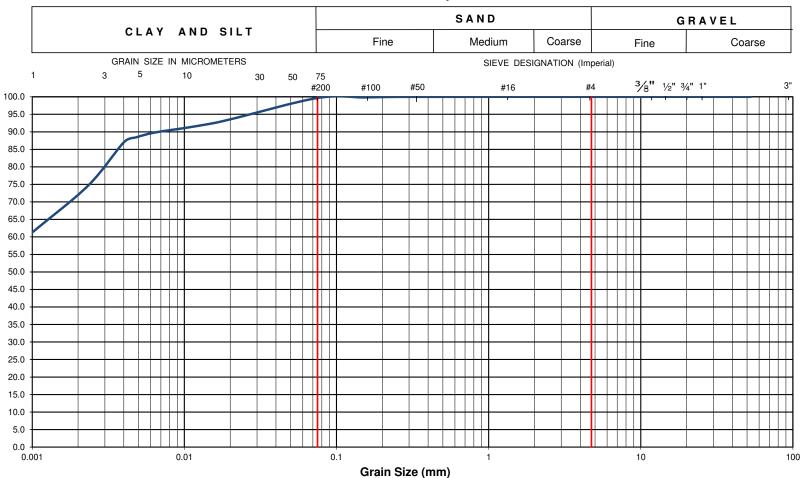
Grain-Size Distribution Curve Method of Test For Particle Size Analysis of Soil ASTM C-136/ASTM D422

EXP Project No.:	OTT-21004743-B0	Project Name :		Proposed Resid	lential D	evelopment				
Client :										
Date Sampled :	April 28, 2021	Borehole No:	: BH 2 Sample No.: SS7 Depth (m):							6.1-6.7
Sample Description :	:	% Silt and Clay	100	% Sand	0	% Gravel		0	Figure :	26
Sample Description :										20

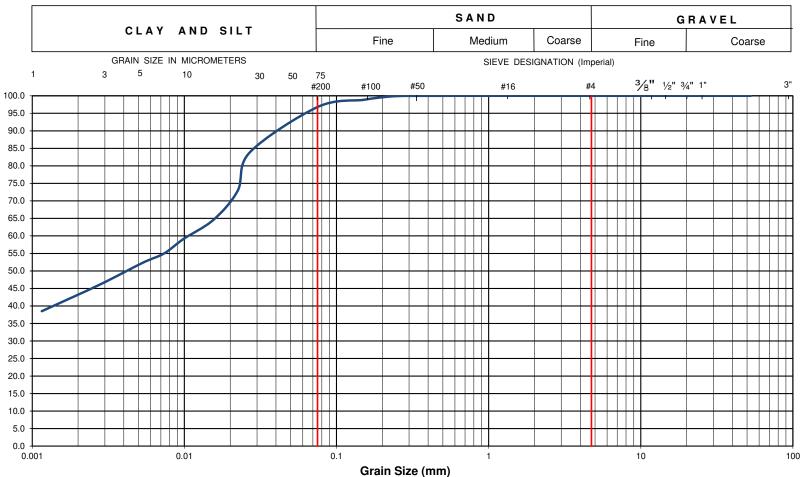
Grain-Size Distribution Curve Method of Test For Particle Size Analysis of Soil ASTM C-136/ASTM D422

EXP Project No.:	OTT-21004743-B0	Project Name :		Proposed Resid	lential D	evelopment				
Client :	12714001 Canada Inc. Project Location: 2983, 3053 & 3079 Navan Road, Ottawa, ON									
Date Sampled :	April 29, 2021	Borehole No:		BH 3	Sam	ple No.:	S3	Depth (m):	2.3-2.9	
Sample Description :		% Silt and Clay	97	% Sand	3	% Gravel		0	Figure :	27
Sample Description :	Figure: 27

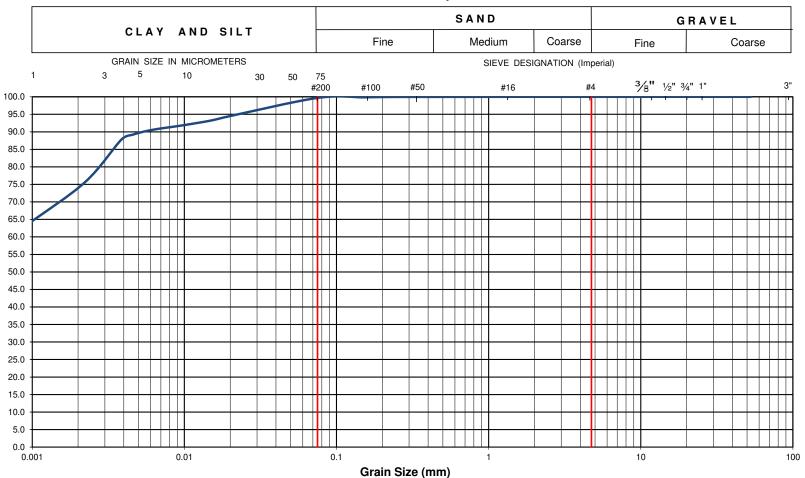
Grain-Size Distribution Curve Method of Test For Particle Size Analysis of Soil ASTM C-136/ASTM D422

EXP Project No.:	OTT-21004743-B0 Project Name: Proposed Residential Development									
Client :	12714001 Canada Inc.	Project Location	1 :	2983, 3053 & 30	79 Nava	ın Road, Otta	awa,	ON		
Date Sampled :	April 28, 2021	Borehole No:		BH 4	San	ple No.:	Depth (m):	4.7-5.3		
Sample Description :		% Silt and Clay	100	% Sand	0	% Gravel		0	Figure :	28
Sample Description :	ample Description : Clay of High Plasticity (CH) -Some Silt								Figure .	20

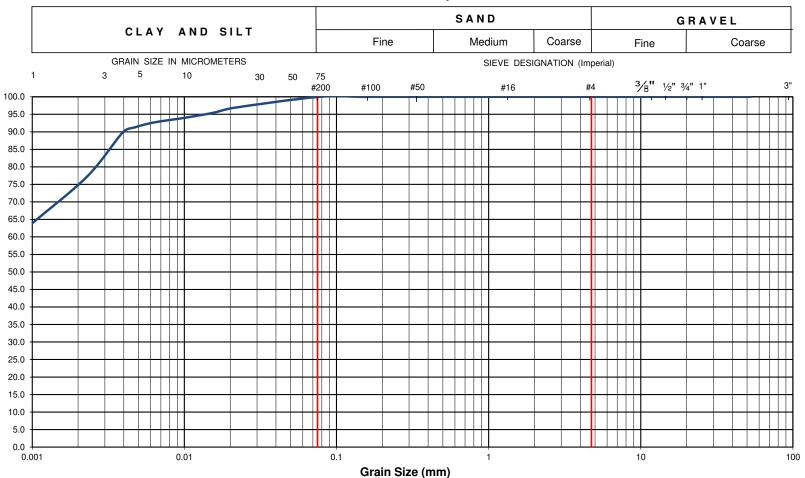
Grain-Size Distribution Curve Method of Test For Particle Size Analysis of Soil ASTM C-136/ASTM D422

EXP Project No.:	OTT-21004743-B0	Project Name :		Proposed Resid	dential D	evelopment				
Client :	Client: 12714001 Canada Inc. Project Location: 2983, 3053 & 3079 Navan Road, Ottawa, ON									
Date Sampled :	April 28, 2021	Borehole No:		BH 6	Sam	ple No.:	S8	Depth (m):	9.1-9.7	
Sample Description :		% Silt and Clay	100	% Sand	0	% Gravel		0	Figure :	29
Sample Description : Silty Clay of Medium Plasticity (CI)									Tigule .	29

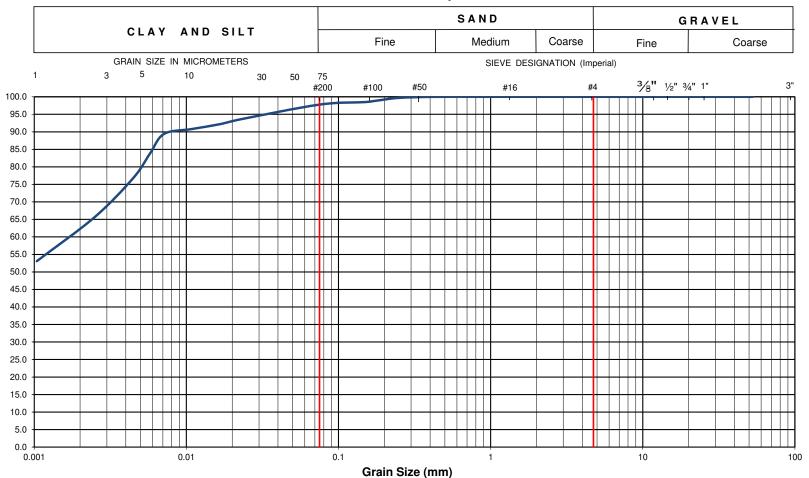
Grain-Size Distribution Curve Method of Test For Particle Size Analysis of Soil ASTM C-136/ASTM D422

EXP Project No.:	OTT-21004743-B0	Project Name :		Proposed Resid	dential D	evelopment				
Client :	12714001 Canada Inc.	Inc. Project Location: 2983, 3053 & 3079 Navan Road, Ottawa, ON								
Date Sampled :	April 29, 2021	Borehole No:		BH 10	Sam	ple No.:	Depth (m):	3.2-3.8		
Sample Description :		% Silt and Clay	98	% Sand	2	% Gravel		0	Figure :	30
Sample Description :	Silty	Clay of Medium to High	Plastic	city (CI and CH) -	Trace Sa	and			Figure :	30

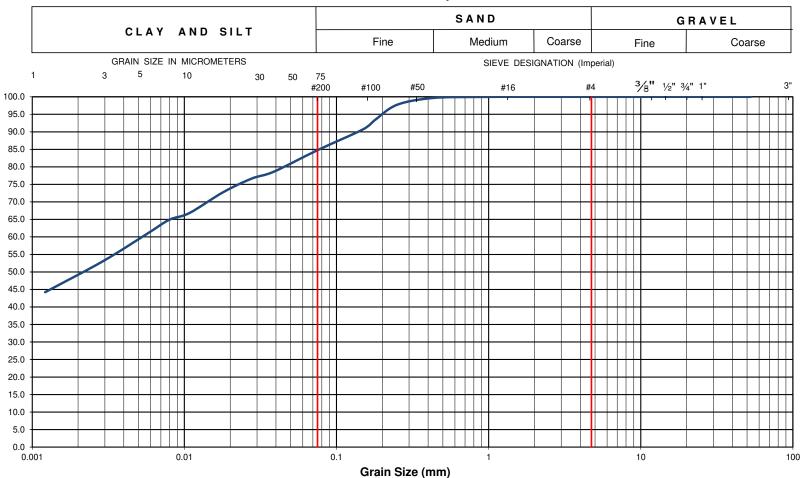
Grain-Size Distribution Curve Method of Test For Particle Size Analysis of Soil ASTM C-136/ASTM D422

EXP Project No.:	OTT-21004743-A0	Project Name :		Proposed Resid	dential D	evelopment				
Client :	12714001 Canada Inc.	Project Location	1:	2983, 3053 & 30	79 Nava	ın Road, Otta	wa,	ON		
Date Sampled :	September 12, 2023	Borehole No:		BH 11	San	ple No.:	Depth (m):	2.3-2.9		
Sample Description :		% Silt and Clay	85	% Sand	15	% Gravel		0	Figure :	24
Sample Description :	S	ilty Clay of Low P	lasticity	y (CL) - Some Sai	nd				rigure .	24

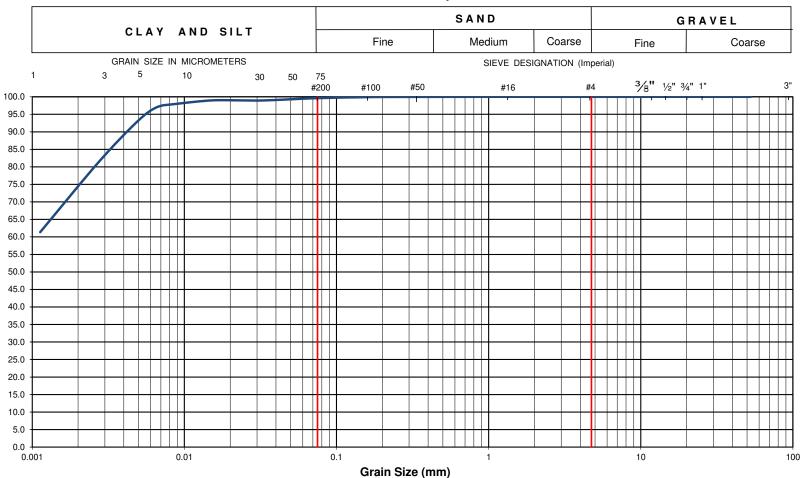
Grain-Size Distribution Curve Method of Test For Particle Size Analysis of Soil ASTM C-136/ASTM D422

EXP Project No.:	OTT-21004743-A0	Project Name :		Proposed Resid	dential D	evelopment				
Client :	t: 12714001 Canada Inc. Project Location: 2983, 3053 & 3079 Navan Road, Ottawa, ON									
Date Sampled :	September 12, 2023	Borehole No:		BH 11	Sam	ple No.:	S5	Depth (m):	3.8-4.4	
Sample Description :		% Silt and Clay	100	% Sand	0	% Gravel		0	Figure :	31
Sample Description :		Silty Clay of	High Pl	lasticity (CH)					rigure .	31

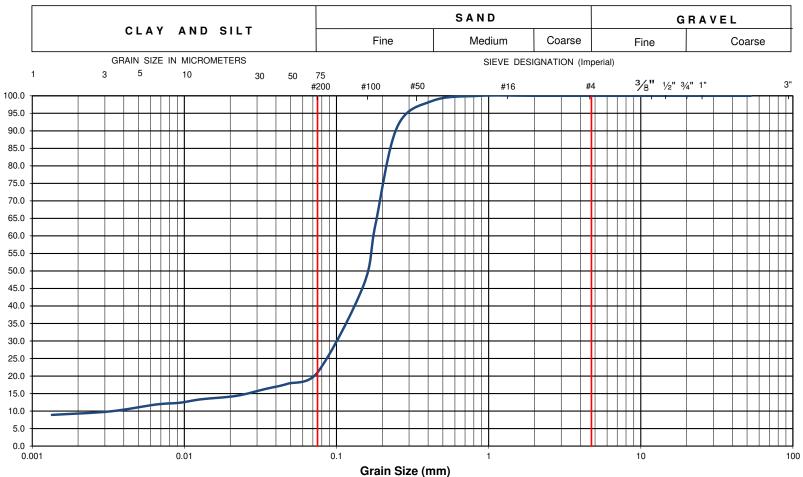
Grain-Size Distribution Curve Method of Test For Particle Size Analysis of Soil ASTM C-136/ASTM D422

EXP Project No.:	OTT-21004743-A0	Project Name :		Proposed Resid	dential D	evelopment			
Client :	12714001 Canada Inc.	Project Location	ı :	2983, 3053 & 30	79 Nava	n Road, Ottawa	a, ON		
Date Sampled :	September 12, 2023	Borehole No: BH 12 Sample No.: SS1 & SS2 De						Depth (m):	0-1.4
Sample Description :		% Silt and Clay	21	% Sand	79	% Gravel	0	Figure :	23
Sample Description :		Silty Sand	Figure :						23

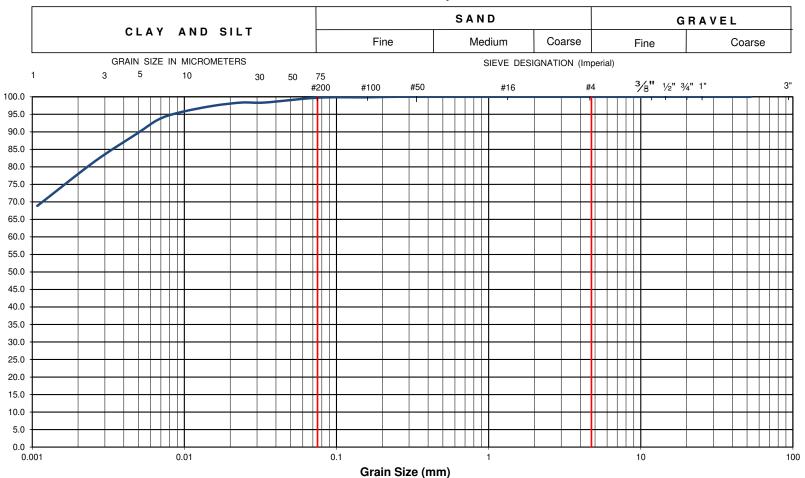
Grain-Size Distribution Curve Method of Test For Particle Size Analysis of Soil ASTM C-136/ASTM D422

EXP Project No.:	OTT-21004743-A0	Project Name :		Proposed Resid	dential D	evelopment					
Client :	lient: 12714001 Canada Inc. Project Location: 2983, 3053 & 3079 Navan Road, Ottawa, ON										
Date Sampled :	September 12, 2023	Borehole No:		BH 12	BH 12 Sample No.: SS3 Depth (m						
Sample Description :	:	% Silt and Clay	100	% Sand	0	% Gravel		0	Figure :	32	
Sample Description :	:	Silty Clay of	High P	lasticity (CH)					rigure :	32

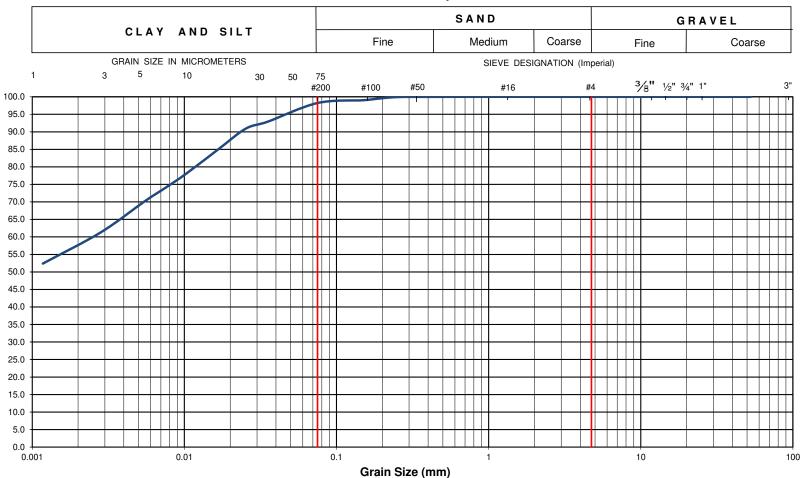
Grain-Size Distribution Curve Method of Test For Particle Size Analysis of Soil ASTM C-136/ASTM D422

EXP Project No.:	OTT-21004743-A0	Project Name :	roject Name : Proposed Residential Development							
Client :	: 12714001 Canada Inc. Project Location : 2983, 3053 & 3079 Navan Road, Ottawa, ON									
Date Sampled :	September 12, 2023	Borehole No:	Borehole No:		Sample No.:		SS2		Depth (m):	0.8-1.4
Sample Description :	% Silt and Clay	98	% Sand 2 % Gravel		0	Figure :	25			
Sample Description : Silty Clay of High Plasticity (CH) - Trace Sand										25

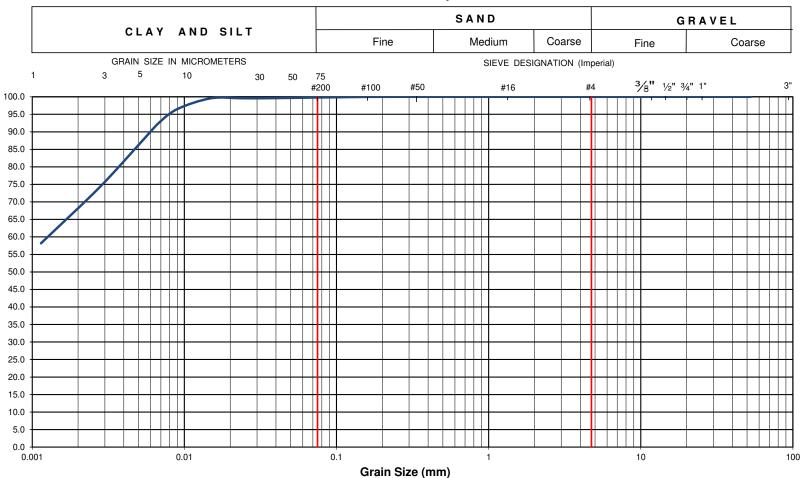
Grain-Size Distribution Curve Method of Test For Particle Size Analysis of Soil ASTM C-136/ASTM D422

EXP Project No.:	OTT-21004743-A0 Project Name : Proposed Residential Development										
Client :	12714001 Canada Inc. Project Location: 2983, 3053 & 3079 Navan Road, Ottawa, ON										
Date Sampled :	September 11, 2023	Borehole No:		BH 17	Sample No.:		SS3		Depth (m):	2.3-2.9	
Sample Description :	Sample Description :		100	% Sand	0 % Gravel 0			0	Figure :	33	
Sample Description : Silty Clay of High Plasticity (CH)

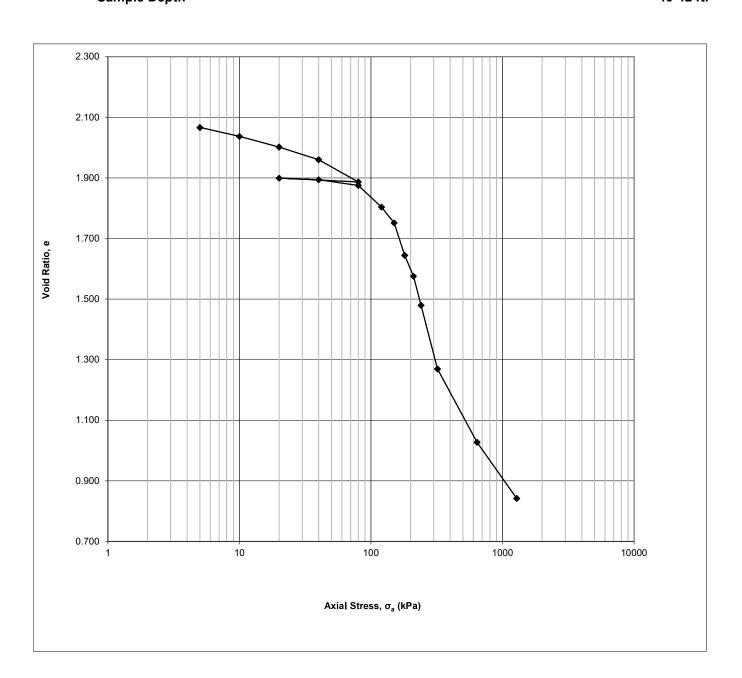
One-Dimensional Consolidation Properties of Soils Using Incremental Loading ASTM D2435/D2435M - 11(2020)

Project Project No. Borehole No. Sample No. Sample Depth Exp, File# OTT21004743-B0 121623683 BH 6 TW10 40-42 ft.

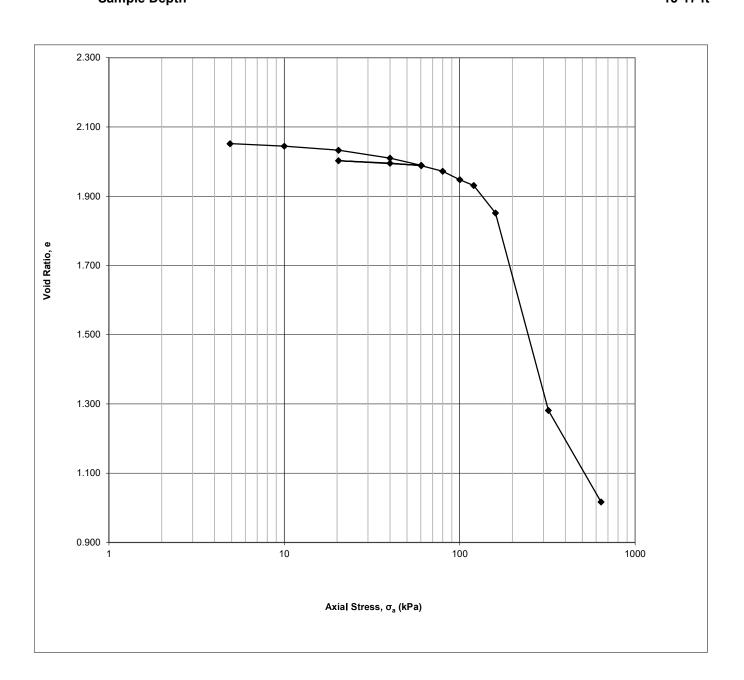
One-Dimensional Consolidation Properties of Soils Using Incremental Loading ASTM D2435/D2435M - 11(2020)

Exp, File# OTT21004743-B0 121623683 BH 7 TW6 15-17 ft

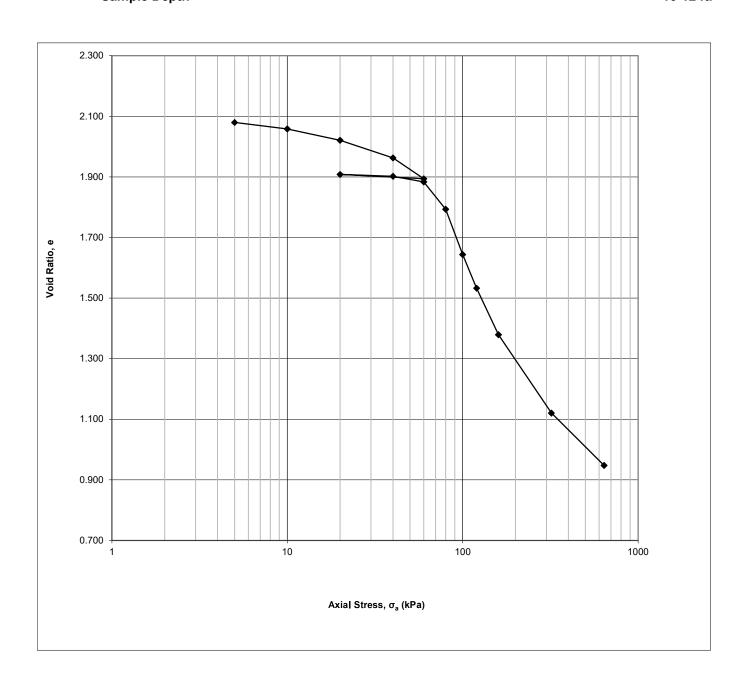
One-Dimensional Consolidation Properties of Soils Using Incremental Loading ASTM D2435/D2435M - 11(2020)

Exp, File# OTT21004743-B0 121623683 BH 8 TW4 10-12 ft.

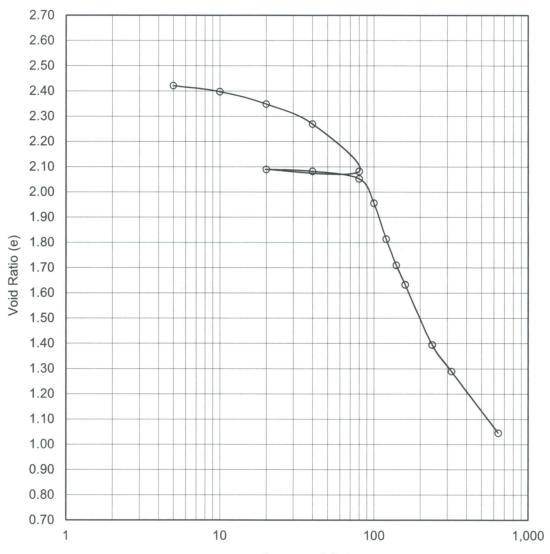
Void Ratio vs Pressure

Soil Type: Silty clay, grey, fraible, very wet

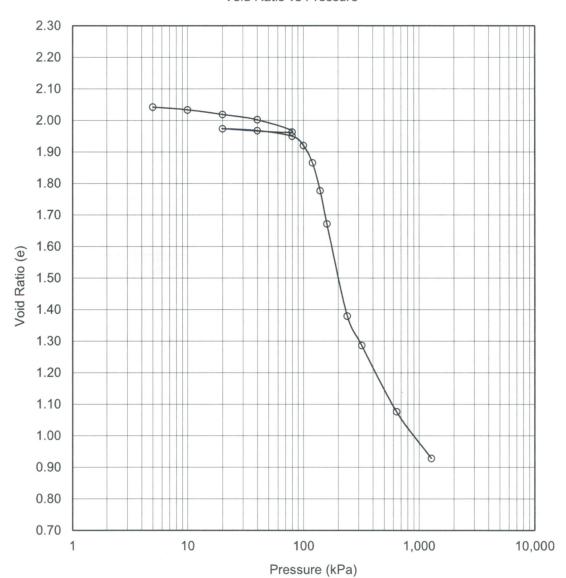
Void Ratio vs Pressure

Exp, File# OTT-21004743-B0 BH 15, ST2

Silty clay, grey, fraible, very wet Soil Type: e_o = 2.054 $\omega_L =$ N/A $\sigma_{v0}' =$ XX kPa $\sigma_P' =$ ω = 73.70 % $\omega_P =$ N/A XX kPa 15.3 kN/m³ PI = N/A $\gamma =$

Gs = 2.75

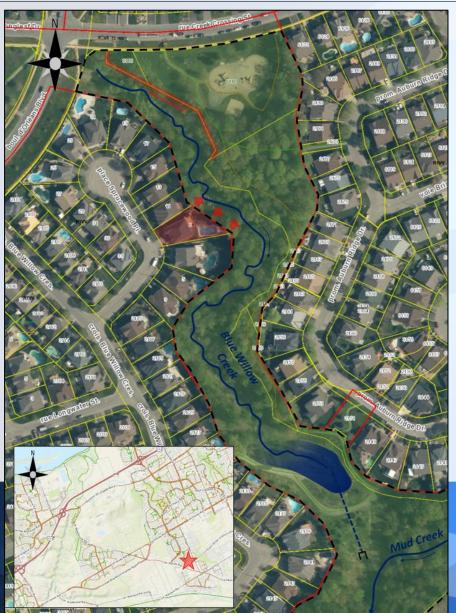
2. Project Background / Contexte du projet

- Study Area:
 - Blue Willow Creek,
 tributary to Mud Creek
 - On-line Blue Willow SWM facility
- Uncontrolled runoff from 106 ha of existing residential development
- Excessive erosion, widening and movement of the channel and slope failures

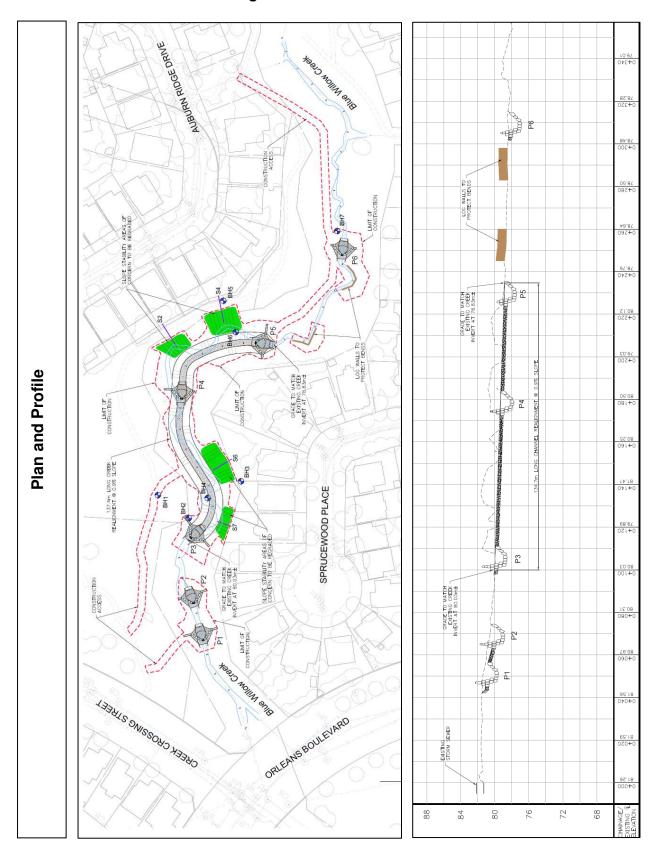
Document 3 – Functional Design

- the construction of six weir-pool structures along the channel to dissipate the flow energy and reduce erosion;
- the realignment of the creek over a distance of 135 meters to move the channel away from the slopes of concerns;
- the filling and regrading of four slopes to provide stabilization; and
- the planting of new shrubs and trees to ensure the tree canopy that will be lost due to construction activities will be replaced with a diverse selection of native tree species.

Following the alternative assessment, a functional design was prepared (see Document 3). Detailed design of the recommended measures is expected to start by the end of 2022 with construction starting in late 2023.

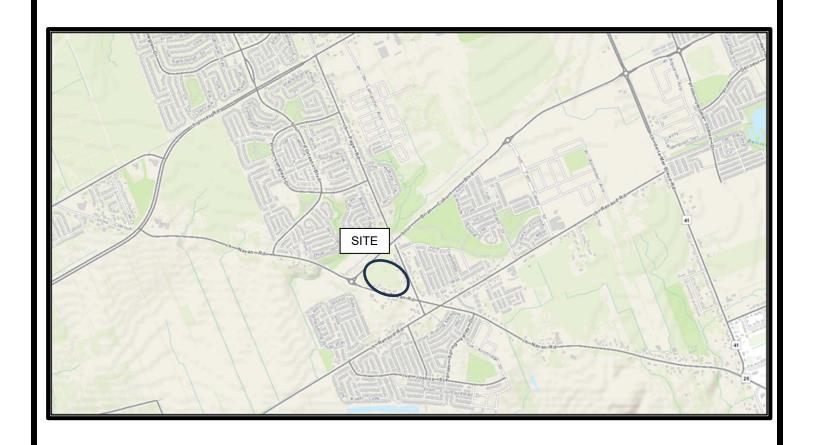
FIGURE 1

KEY PLAN

Paterson Group (Paterson) was commissioned by EXP Services Inc. to prepare a landslide hazard assessment study for the proposed residential development to be located at 2983, 3053 and 3079 Navan Road in the City of Ottawa, Ontario (reference should be made to Figure 1 - Key Plan in Appendix 2 of this report). The study has been prepared in response to the requirement by the Rideau Valley Conservation Authority (RVCA) as part of the Site Plan Approval process for the City of Ottawa for the subject site.
