### CONCEPTUAL SITE MODEL 3610 INNES ROAD, OTTAWA, ON

GLENVIEW HOMES (INNES) LTD.

PROJECT NO.: 17M-01348-00 DATE: FEBRUARY 11, 2021

# 1 PHASE TWO CONCEPTUAL SITE MODEL

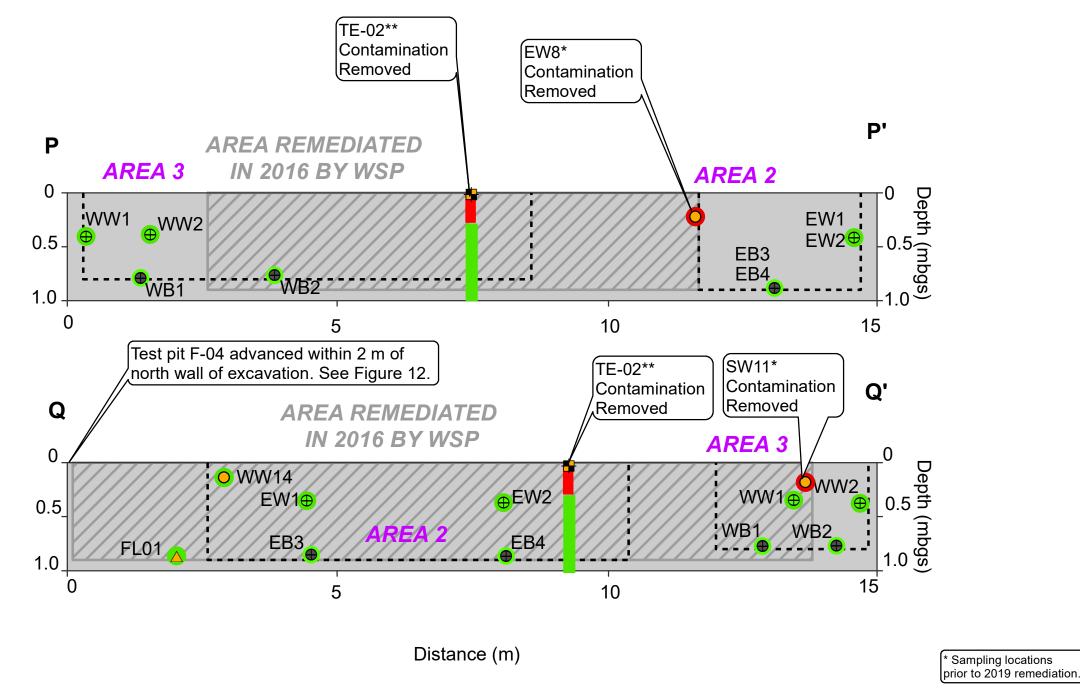
### **AREA 2 AND 3 CROSS SECTIONS**

SCALE: 1:70 (Horizontal) 1:35 (Vertical)

Note: See contaminant concentrations on Figure 12.

Areas 2 and 3 (**Figure 12**) were excavated to remove residual contaminants after the 2016 remediation at TE-02. Concentrations remained that met ICC SCS but exceeded MECP Table 3 SCS for RPI land use. Soil to the depth approximately 0.9 mbgs (**Figure 12-1** shows the cross section) was removed in this area and confirmation sampling (EW1, EW2, EB3, EB4, WW1, WW2, WB1 and WB2) at the locations shown on **Figure 12** and **Figure 12-1** confirmed that PHC impacts did not remain at this location.

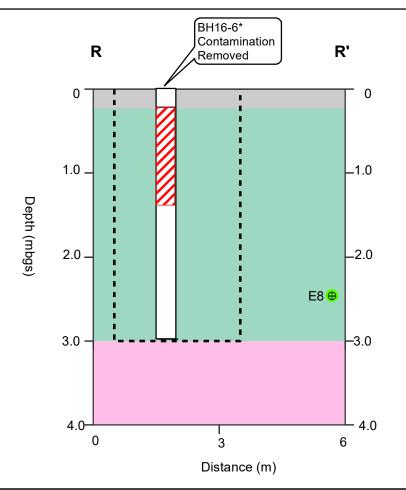
AREA 4 CROSS SECTION

HORIZONTAL SCALE: 1:90 VERTICAL SCALE: 1:45

Areas 4 and 5 were excavated to remove SAR at BH16-8 and EC at BH16-8, prior to identifying that the SAR and EC were related to the application of salt for vehicular or pedestrian safety and was, therefore, exempt from being identified as a contaminant. During excavation in Area 4 (to a depth of 3.0 mbgs), stained and odorous soil was

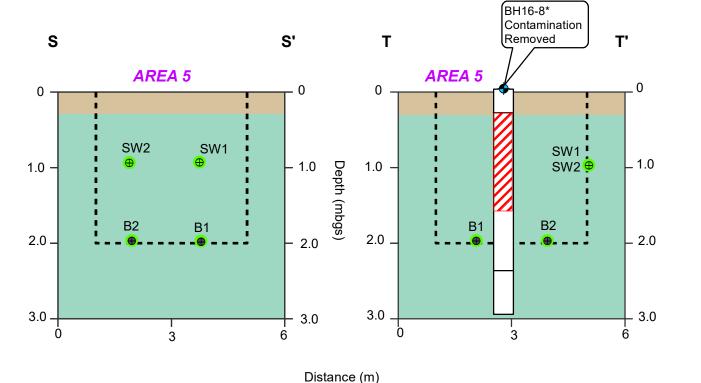
AREA 5 CROSS SECTIONS HORIZONTAL SCALE: 1:100 VERTICAL SCALE: 1:50

\* Sampling locations prior to 2019 remediation.

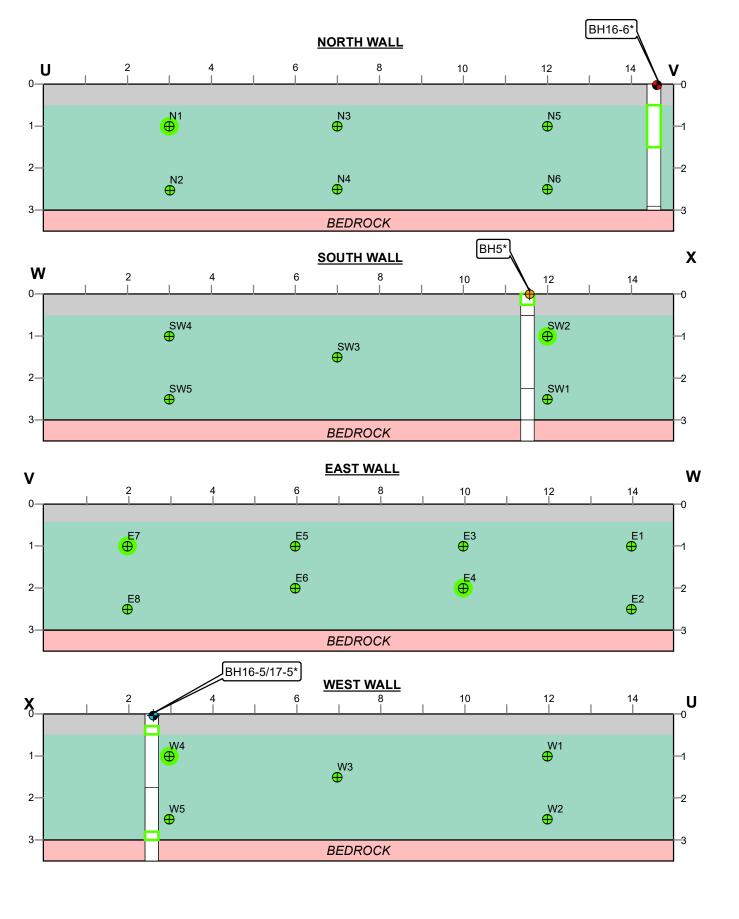
> > FIGURE 14

> **REMEDIATION AREA 6** PHCs & BTEX IN SOIL

Area 6 extended from Area 4, which was initiated to remove SAR impacts (prior to recognizing the exemption) at BH16-6. Stained soil was unearthed at the base of the excavation and was found to extend to the south and west, toward MW17-5. The excavation for Area 6 (**Figure 14**) extended to bedrock, as indicated on the cross section (**Figure 14-1**). Field monitoring was conducted on the sidewalls (N1 to N6, SW1 to SW5, E1 to E8 and W1 to W5) and samples N1, SW2, E4, E7 and W4 were selected as worst-case conditions and submitted for analysis of PHCs F1-F4 and BTEX. Results were in compliance with MECP Table 3 SCS, with only PHC F1 measured at detectable concentrations and these were less than 10 ug/g, compared to the MECP Table 3 SCS of 55 ug/g.
