A CULTURAL HERITAGE IMPACT STATEMENT & CONSERVATION PLAN 168 -174 MURRAY STREET, OTTAWA

Revised V4 June 2022

Commonwealth Historic Resource Management

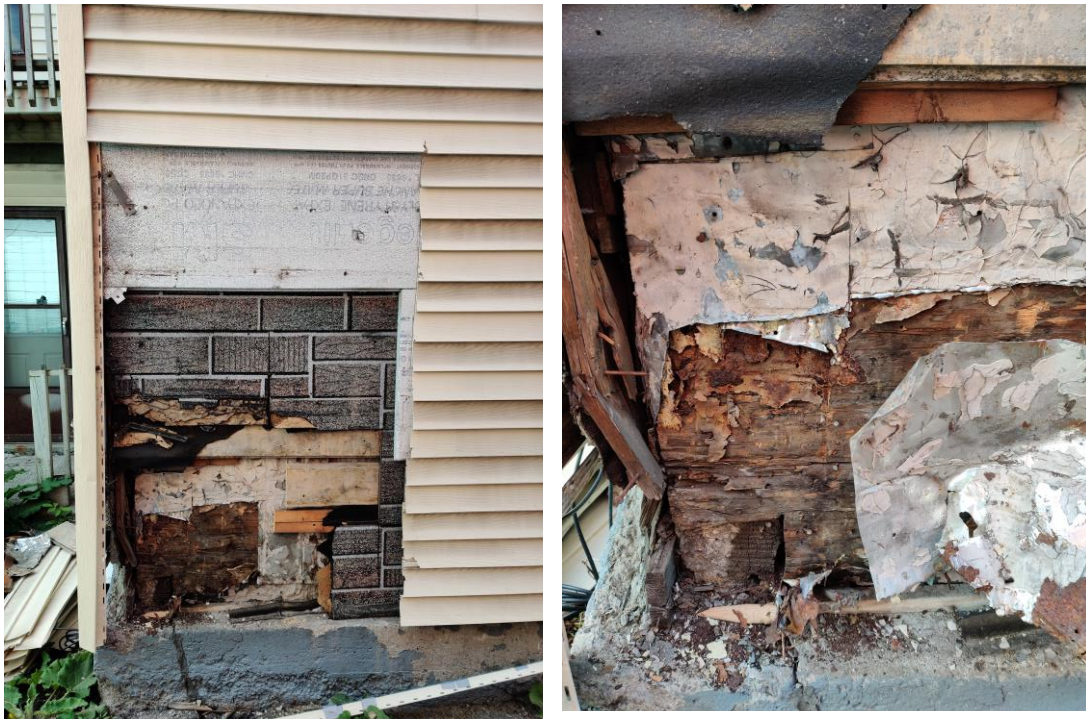
Figure 33: 1861 Census documents the McManus family owned a 66 x.99 lot at 168 Murray and were living in 1.5 storey log house. The Lowertown building inventory recorded that the building was constructed in 1876 based on Fire Insurance plans. The two views illustrate the multiple layers of finishes including squared timber, tin panels insulation, brick, ridged insulation, and vinyl siding. Source David Yoo 2022.
