**Environmental Impact Statement
Phoenix Homes -
Old Montreal Road**

Updated Report

July 17, 2023

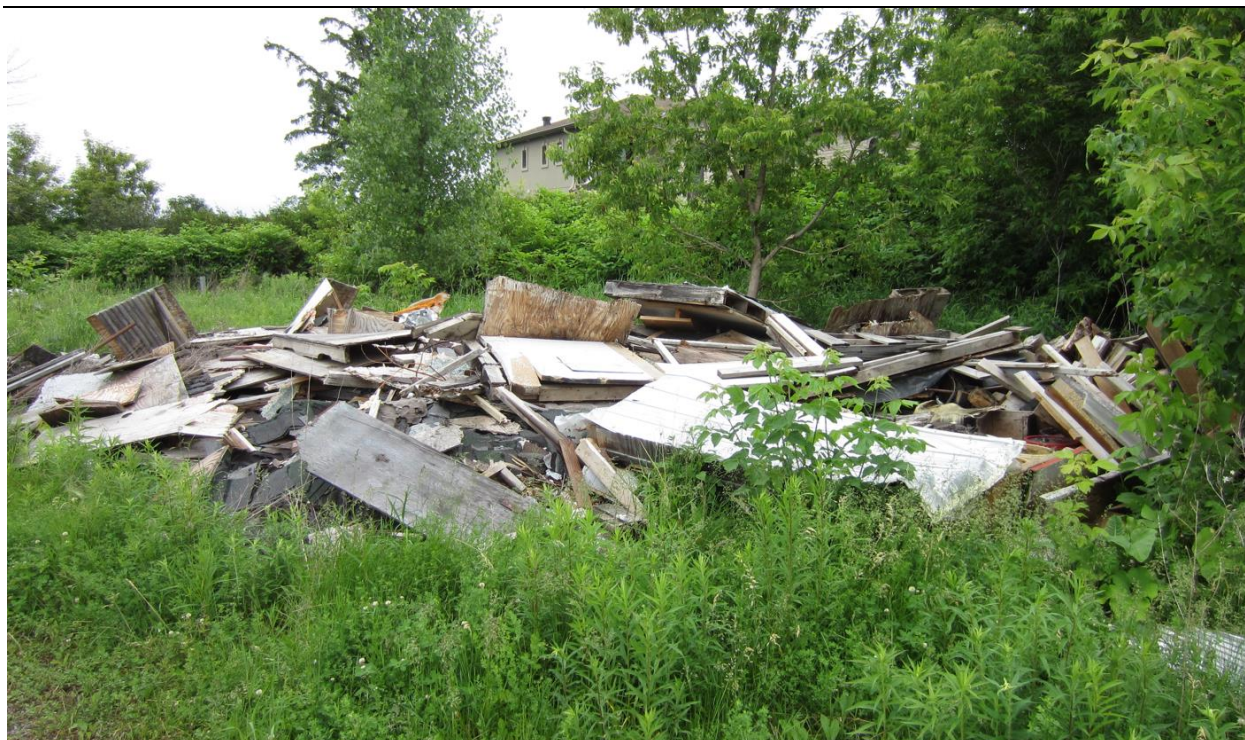
Figure 3. Collapsed farm building, spring 2018

The initial exploratory Site visit on November 13, 2017 noted remnants of mud nest cups in two dilapidated farm buildings (KAL, 2017), which was considered at the time to be possible evidence of former Barn Swallow nests. By the spring of 2018, however, both structures were found to be collapsed (Figure 3). All traces of the buildings had been removed prior to the 2021 field season. As such, prior use of structures on the site by Barn Swallow cannot be confirmed. Subsequent field studies describe conditions as observed in 2021.

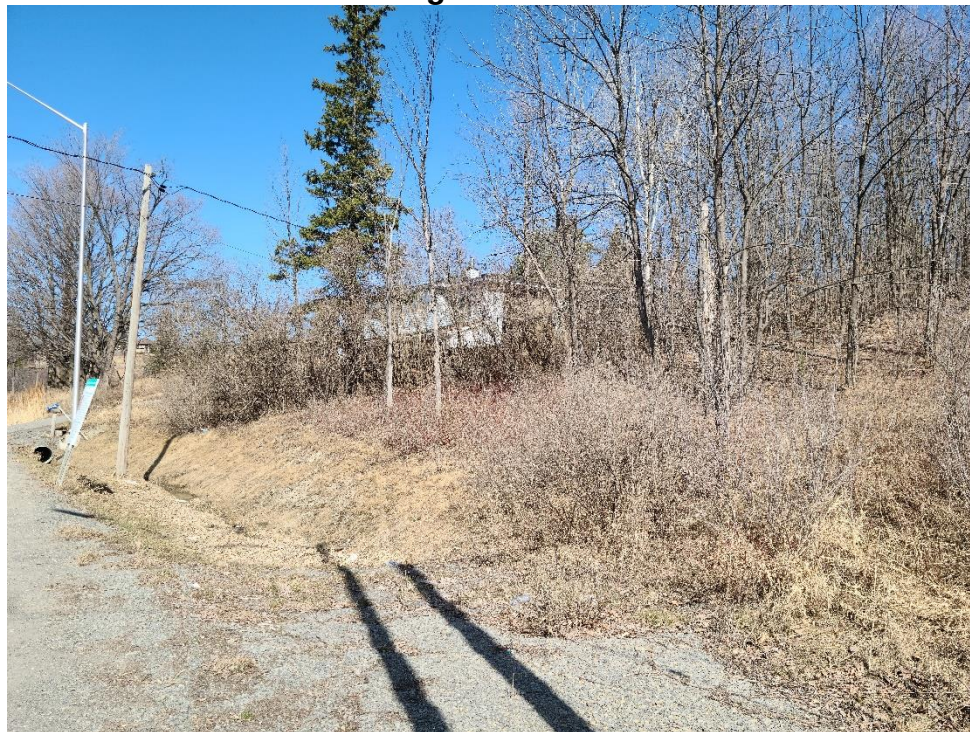
HDF1 - Roadside ditch along Old Montreal Road

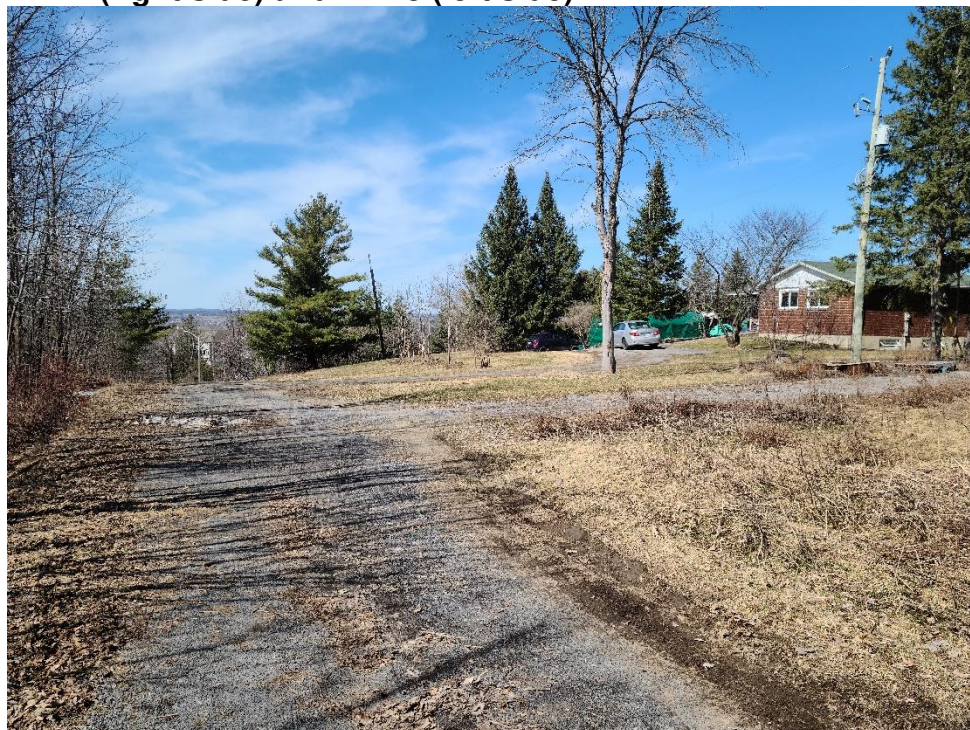
HDF2 (right side) and HDF3 (left side)
