Hintonburg Pumphouse

Conservation and
Redevelopment Project

Final Technical Report

Revision 3
October 5, 2023

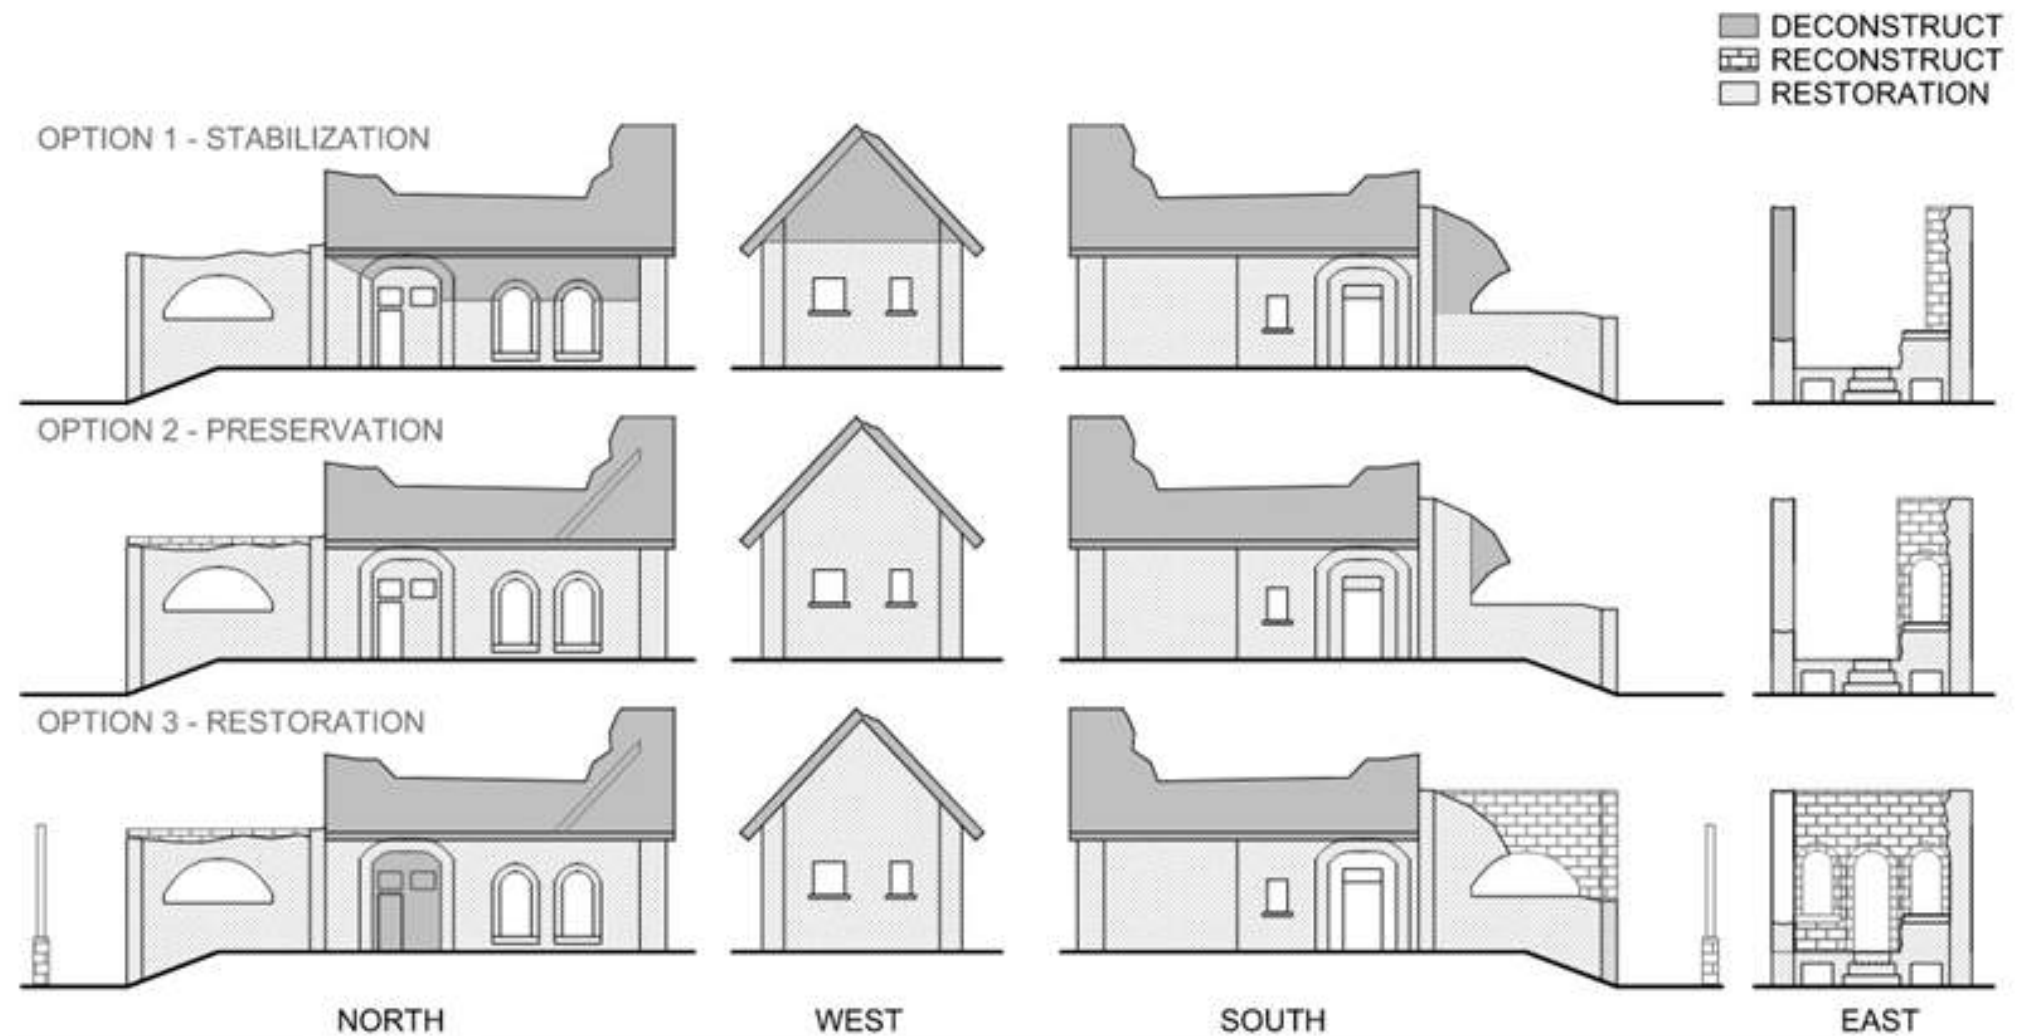
Image 1.9 Illustrations of stabilization options - Source: J.G. Cooke, 2021

In 2021, John G. Cooke and Associates Consulting Engineers were engaged to assess the ruins and identify what options were available for their conservation. The report identifies critical repairs that are necessary to prevent further collapse and deterioration of the remaining structure. The options (Image 1.9) were outlined as follows:

- Option 1 – Stabilization: Remove any masonry in poor condition, restore the remaining masonry walls, and protect by capping skyward facing joints to prevent water infiltration.
- Option 2 – Preservation & Protection: Restore all remaining masonry elements by deep repointing, local dismantling and rebuilding, and core consolidation. Protect the masonry walls by capping skyward facing joints to prevent water infiltration, or by a partial self-supported roof structure.
- Option 3 – Restoration & Reconstruction: Restore all remaining masonry elements by deep repointing, local dismantling and rebuilding, and core consolidation. Reconstruct collapsed masonry elements based on existing physical evidence and historic photos or documentation. Protect the masonry walls by a self-supported roof structure, supported by the verandah posts. (J.G. Cooke, 2021)

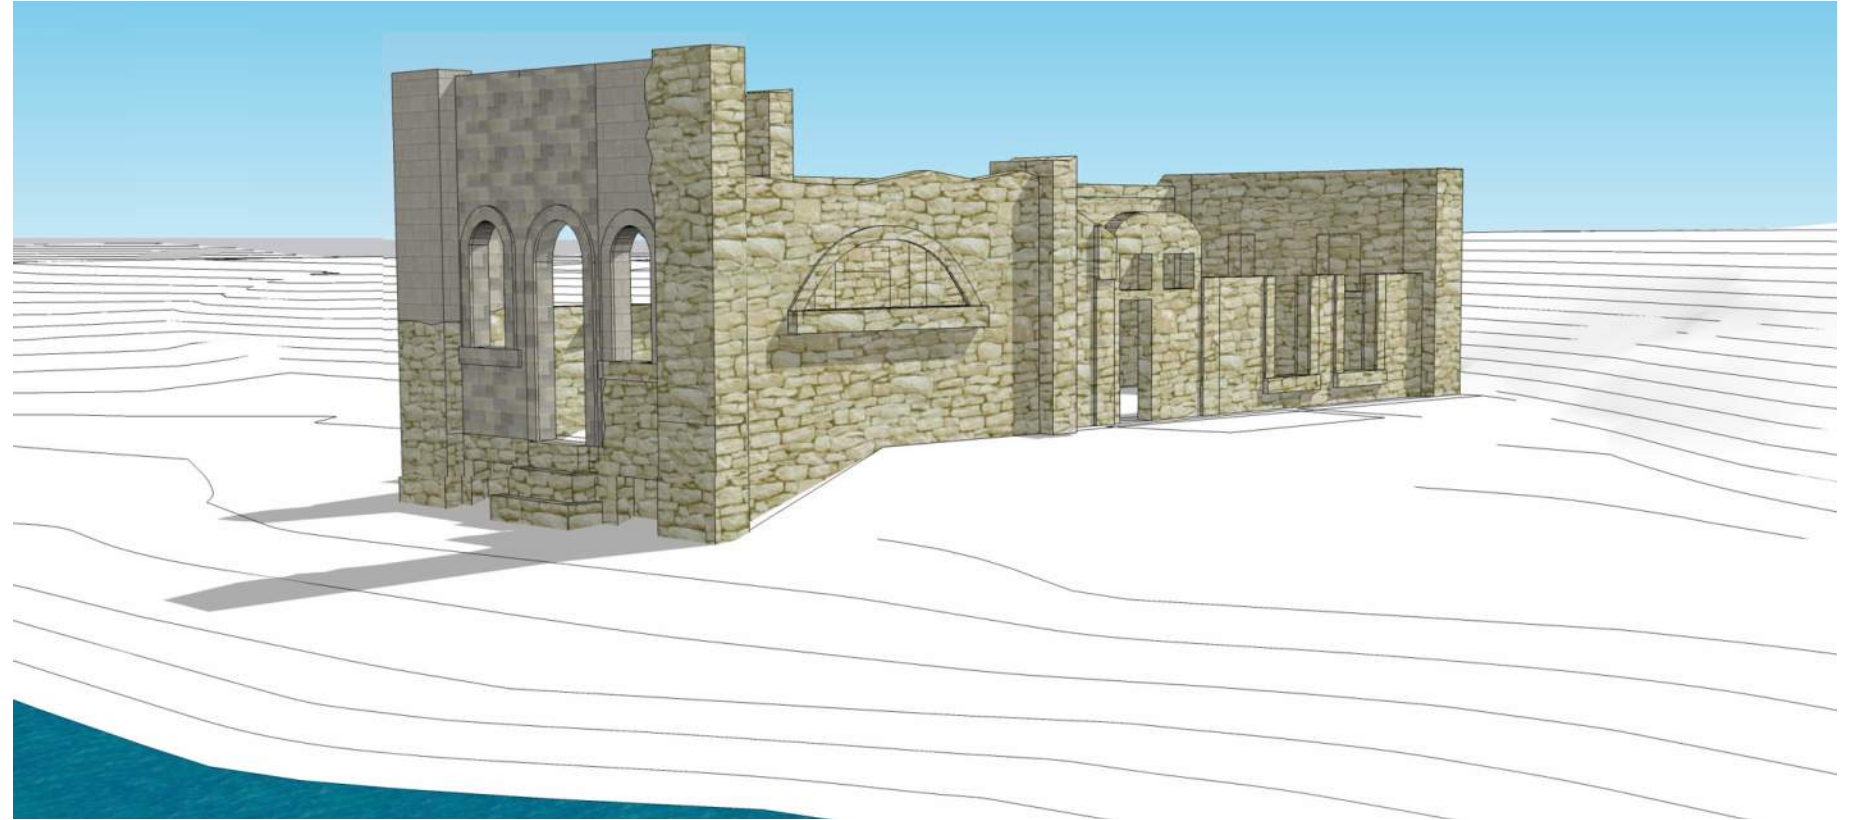
Image 1.10 Option 3 - Restoration

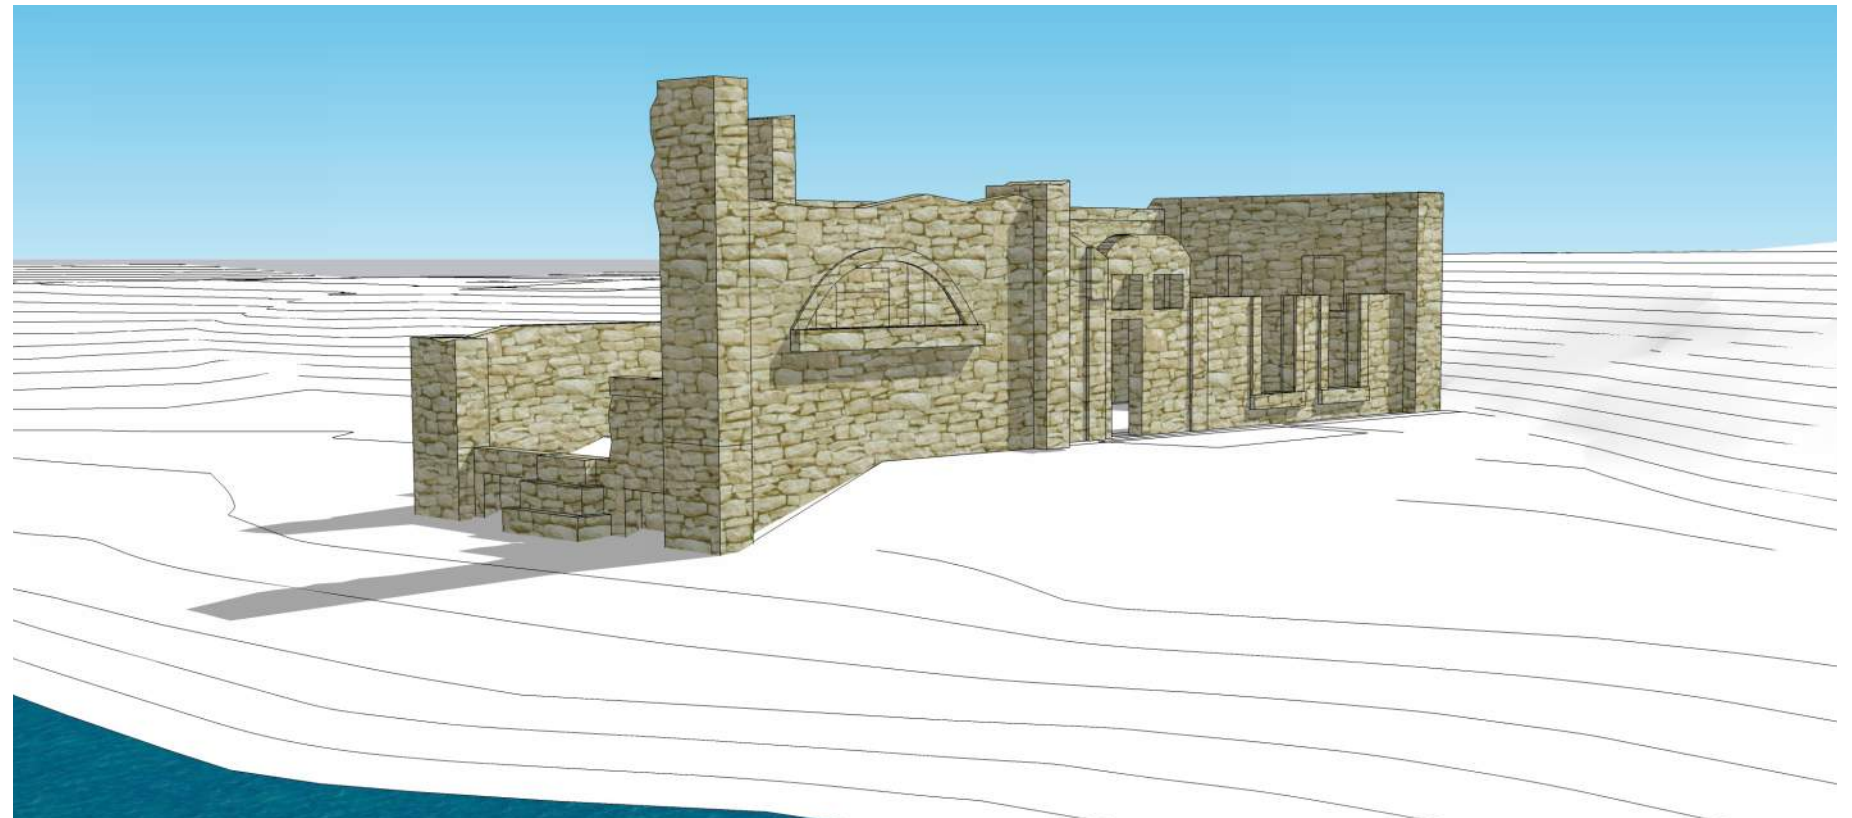
Image 1.11 Option 1 - Stabilization

Through engagement, the final recommendation is to move forward with a modified “Stabilization/Preservation” approach (Image 1.11) as the most appropriate treatment. This approach accepts the events, such as the major fire that changed this former building into a ruin as part of the history of the structure, creating a new heritage character for the structure as a ruin and not a house. However, the ‘Restoration’ of some of the character-defining elements, such as partial restoration of the masonry of the half round windows, could enhance the value of the structure in its current incarnation as a ‘Ruin’.

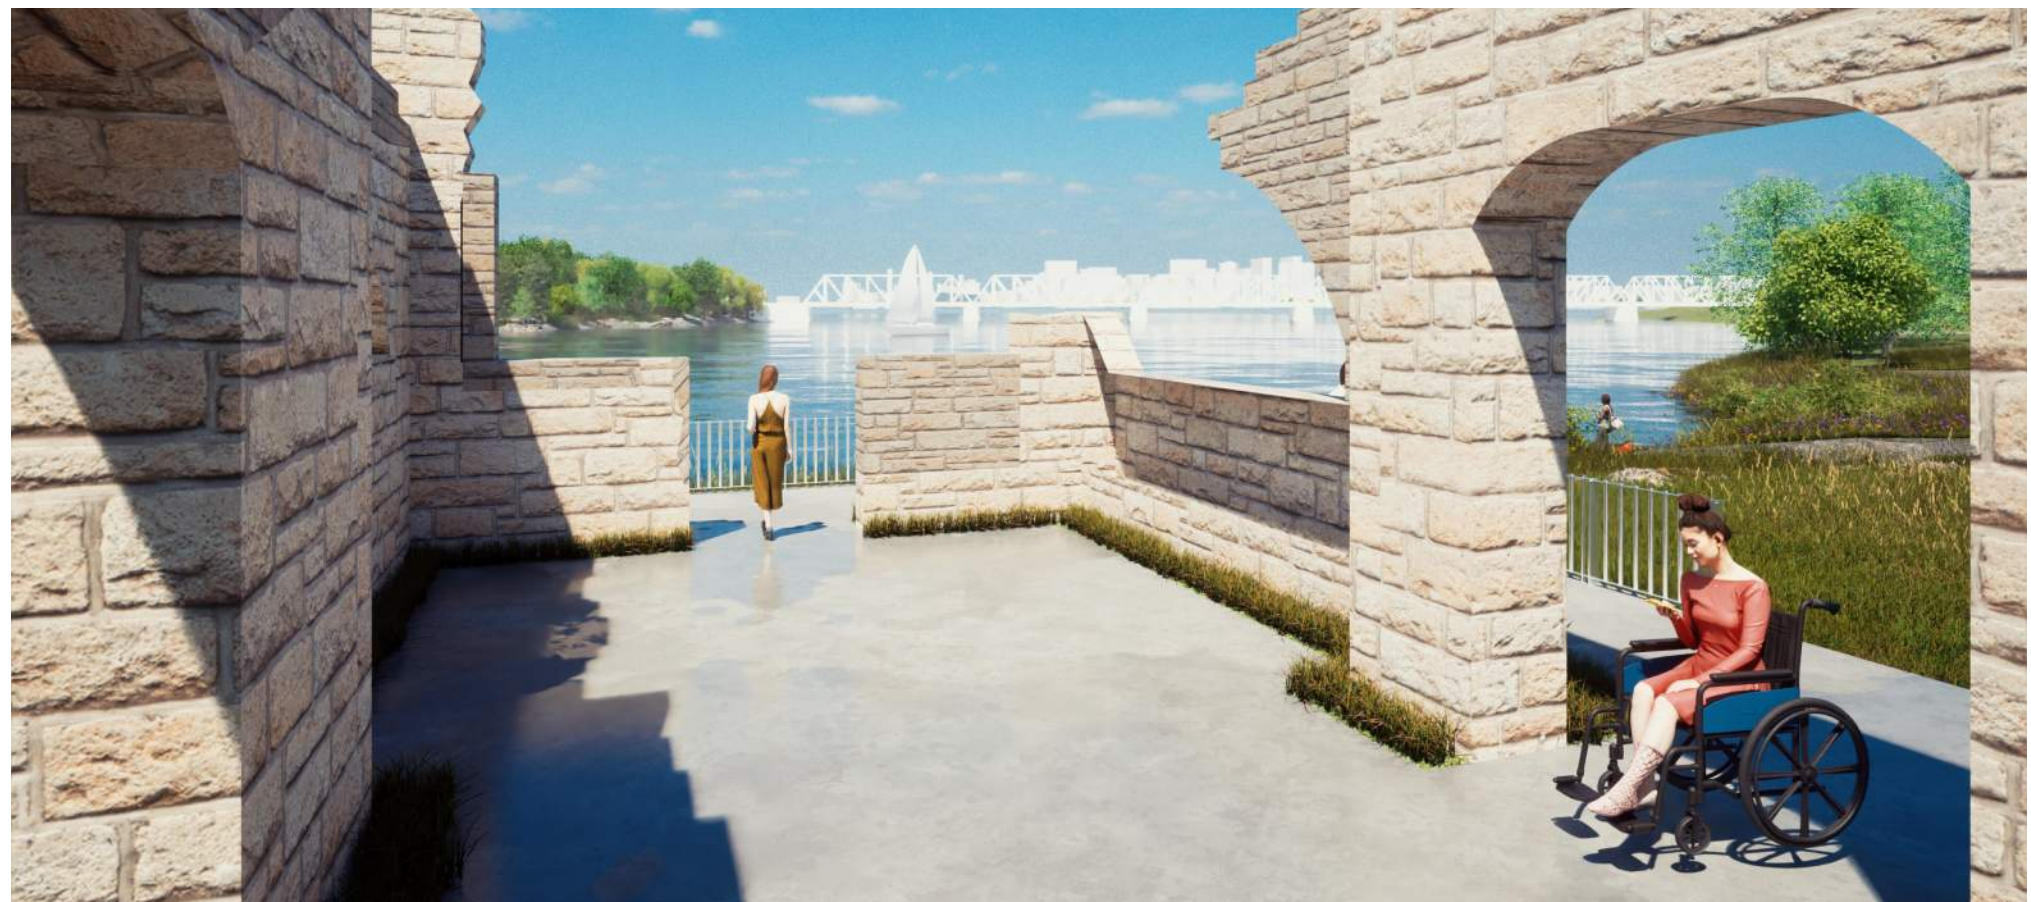
Image 1.13 Proposed interior treatment of the ruin

- Filling the existing sub-floor crawlspace with granular and topping with a smooth concrete floor (Image 1.13) to improve accessibility, reduce ongoing maintenance challenges, and address inundation from flooding due to recent high-water levels in the Ottawa River.

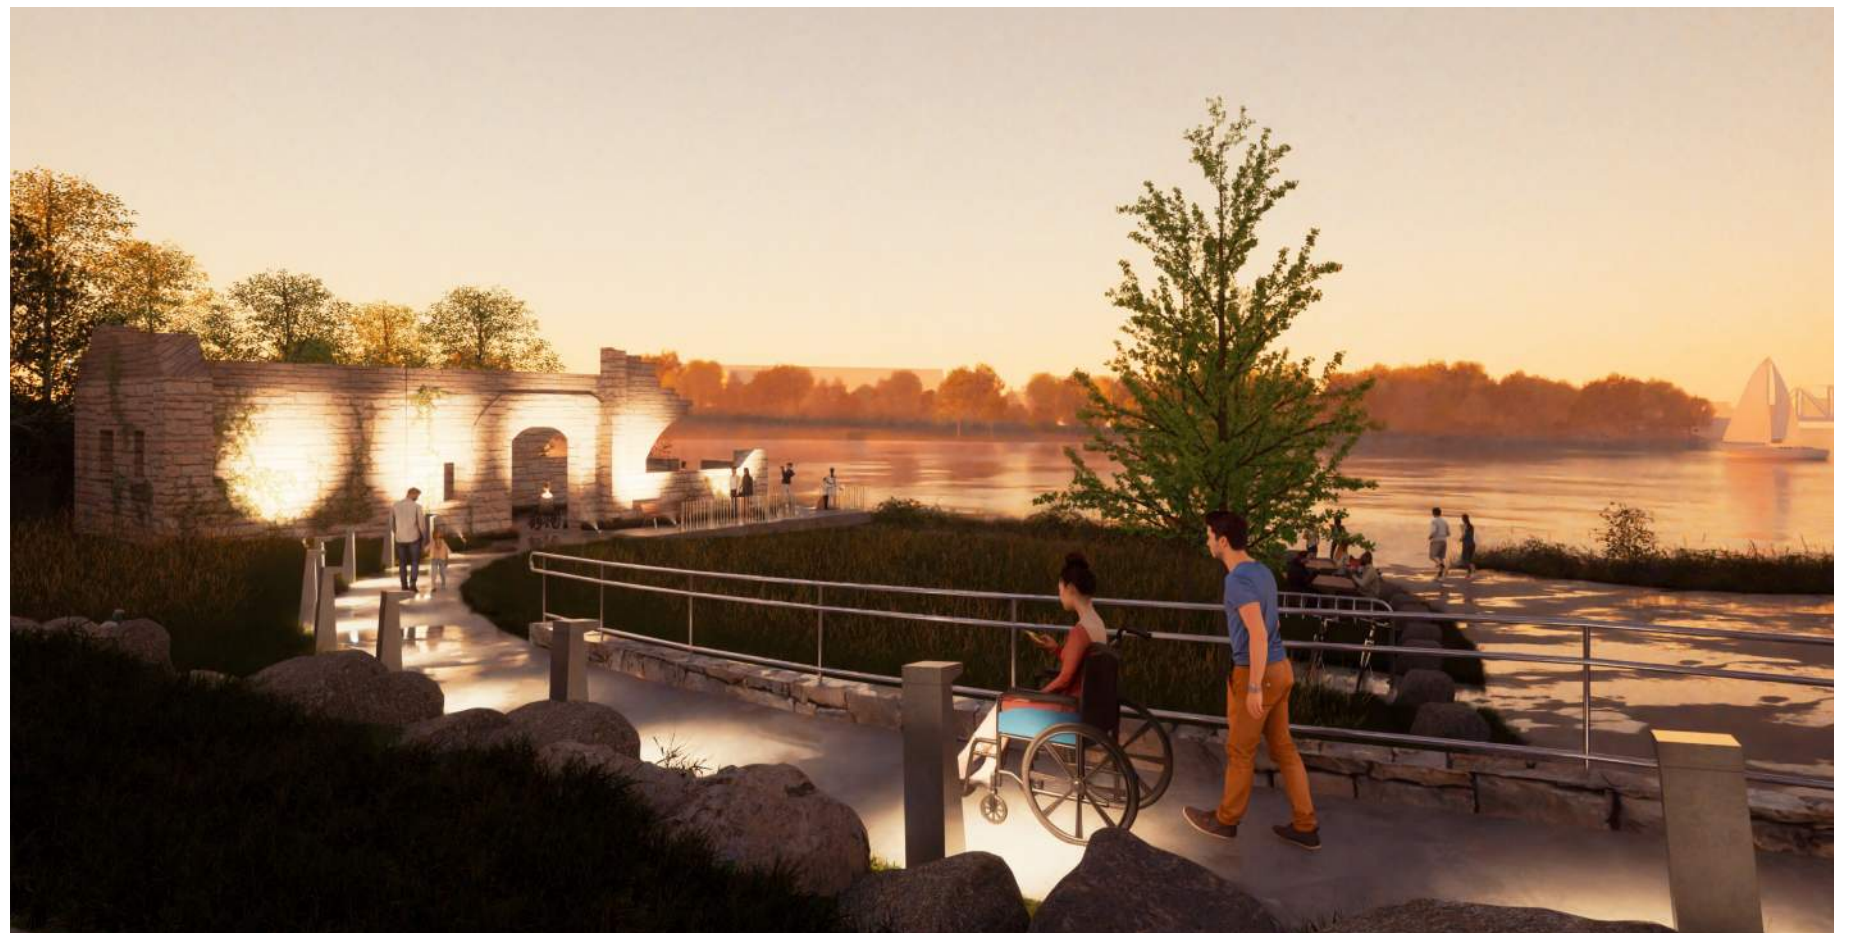
Image 1.20 Proposed lighting of the ruin

Lighting of the site is recommended as it is desirable for accessibility and can enhance the aesthetic experience of the ruin if implemented properly. Some possibilities are uplighting the ruin walls and implementing small low lighting such as pedestrian bollards along the pathway, with consideration given to avoiding negatively affecting wildlife or detracting from the peaceful, quiet character of the ruin (Image 1.20).

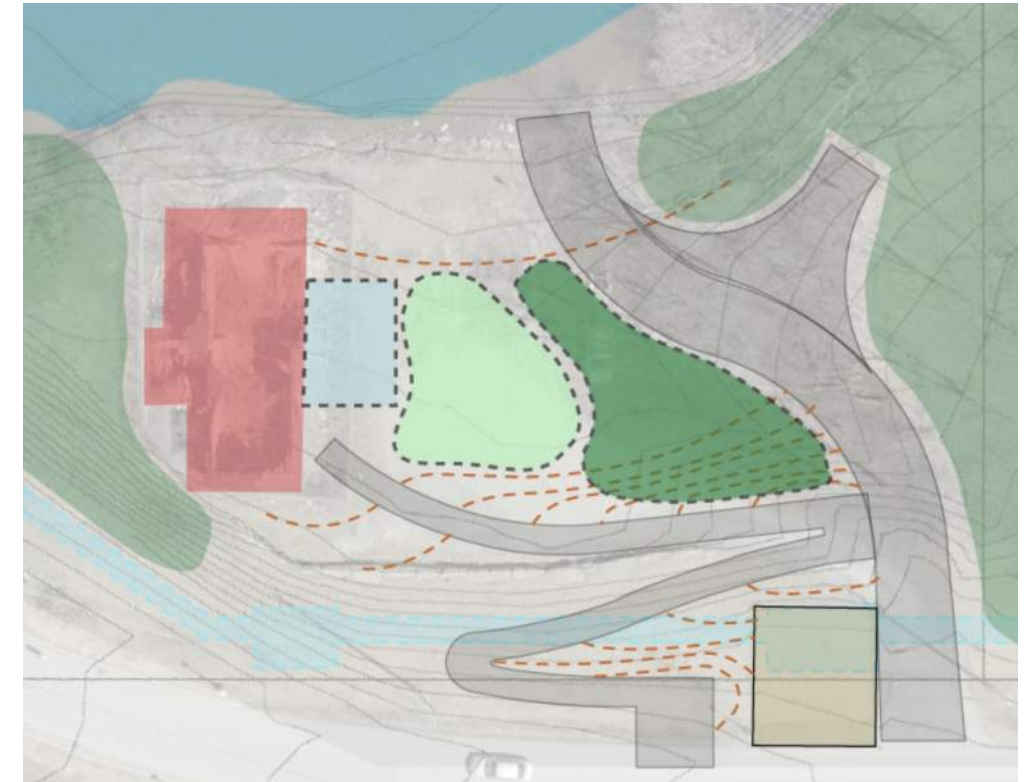
Image 1.22 Site treatment option 2

The second option (Image 1.22) would create a plaza to the west of the vehicular entrance with an accessible pathway to the pumphouse. The pathway would include two switchbacks, which would deposit pedestrians directly adjacent to the pumphouse ruin. This would limit the amount of retaining walls required and the travel distance would be shorter to the pumphouse. However, this option creates additional impervious surfaces adjacent to the vehicular entrance and unit paver pad and has a longer travel distance to the parking lot (Image 1.23).

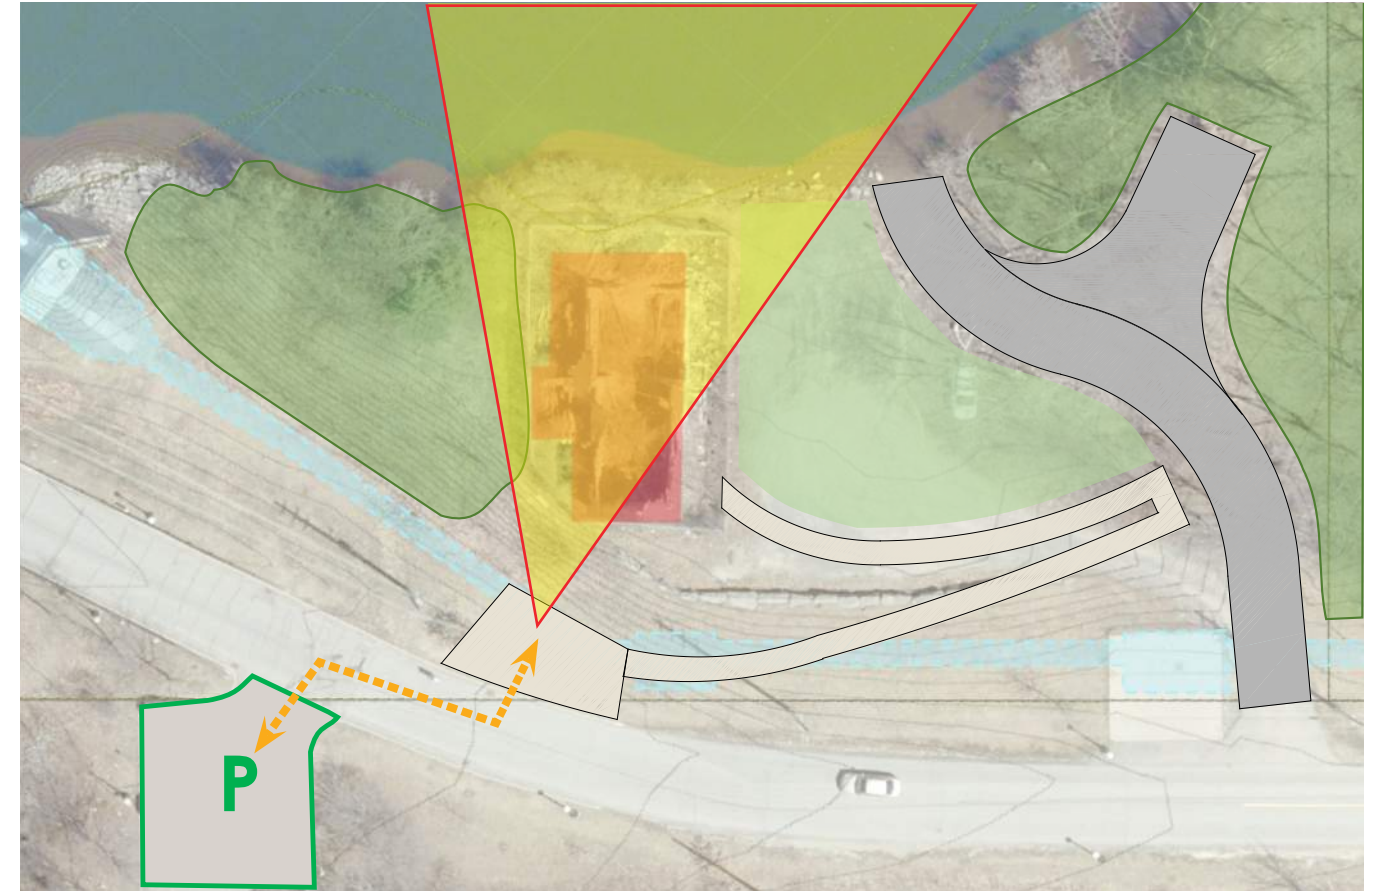
Image 1.24 Preferred site treatment

The preferred concept was developed based on the feedback from the engagement sessions and more in-depth design considerations. In the preferred site treatment plan, the pedestrian pathway is simplified to reduce the number of switchbacks and the entrance was moved to the north so that it has a direct connection to the parking lot (Image 1.24). The pathway entrance from the parking lot also provides a different perspective of the ruin when entering the site (Image 1.25). The pathway then leads the users directly to the pumphouse. The vehicular road and hammerhead are clearly separated from the open space. This will require the removal of some of the vegetated area, which is dominated by non-native invasive plant species and those in decline, while protecting more valuable trees and re-vegetating the area. The open space created is proposed to be treated as picturesque, relaxing, and serve as a contemplative space that enhances the ruin's presence to create a degree of mystery.

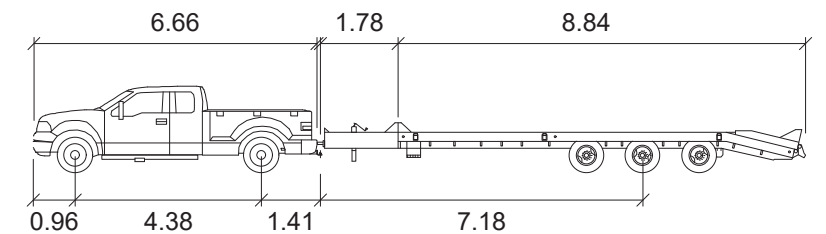
Big Tex 5XPH-24+5 Heavy Hitch

meters
Car Width	: 2.03
Trailer Width	: 2.59
Car Track	: 2.41
Trailer Track	: 2.59
Lock to Lock Time	: 6.0
Steering Angle	: 34.2
Articulating Angle	: 70.0

Image 1.32 Vehicle with trailer used for AutoTURN analysis

The boat launch and access road have been modified since the community consultation after reviewing multiple possible travel route options. The Ottawa River Rafter's use a large van and 28' trailer to launch their boats (Image 1.31). Using the AutoTURN software, we tested a large truck with a trailer with a similar axle length as the van and boat trailer (Image 1.32). It became apparent that the vehicle would need much more room than the small hammerhead illustrated in the preferred site treatment option, and it would still be quite difficult (Figure 1.33). We assessed their current process, however it uses a good portion of the open space adjacent to the pumphouse and would reduce the open space for leisure and public use (Figure 1.34). Therefore, we explored an alternative that proposed the vehicle would continue from the entrance straight down to the river, through the vegetated area, and around some trees that are slated to be preserved (Figure 1.35). This allows for the vehicles to turn around the preserved trees and naturalized space and back into the boat launch (Figure 1.36). Parking for extra vehicles is provided to ensure safe coordination of the boat launch when there are multiple users (Figure 1.37). This parking could also serve as potential parking for the school bus if necessary. The access road was designed to accommodate the turning radius of the large vehicle and trailer, but modifications to slim down the extents of paved area can be reviewed during detail design. Potential locations for temporary bathroom/change facilities for the Ottawa River Rafter's could be accommodated within the central naturalized area, or by the parking (Figure 1.37).

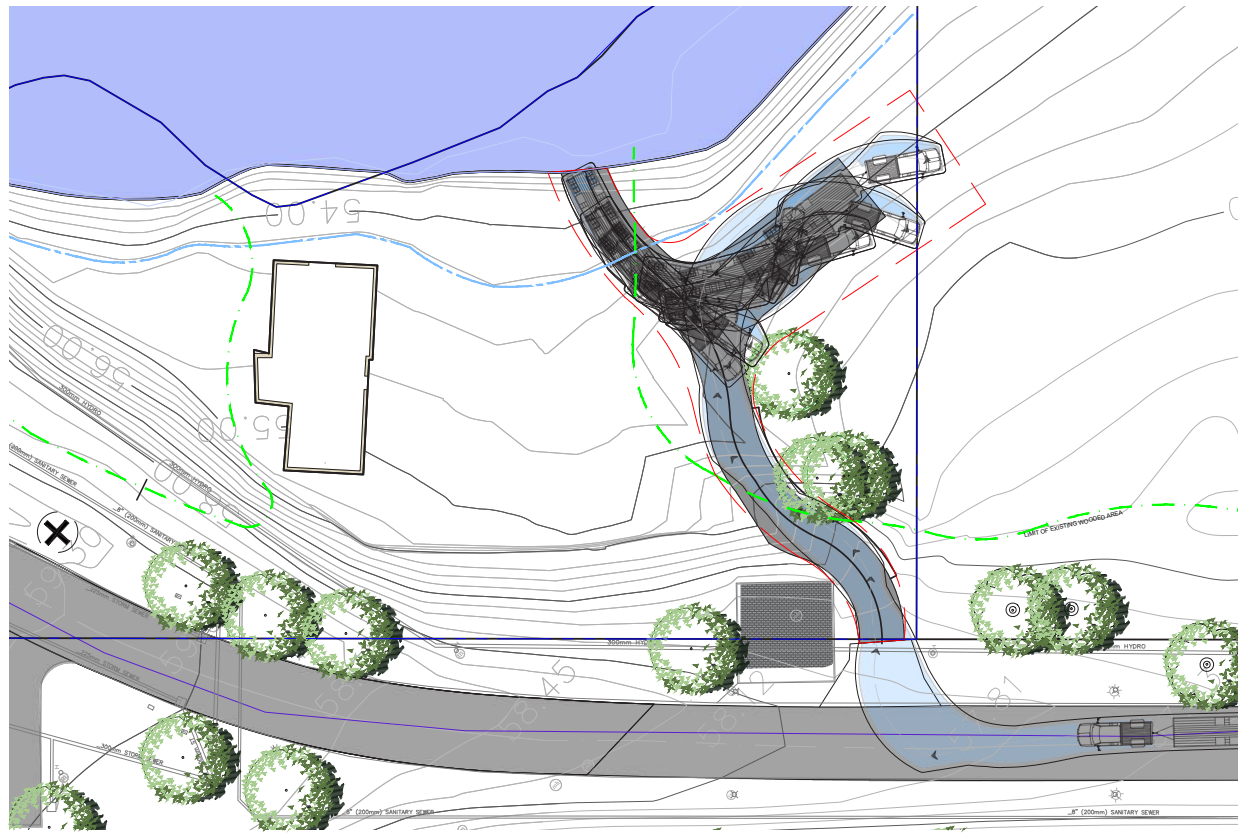
Figure 1.33 Proposed turn around hammerhead analysis

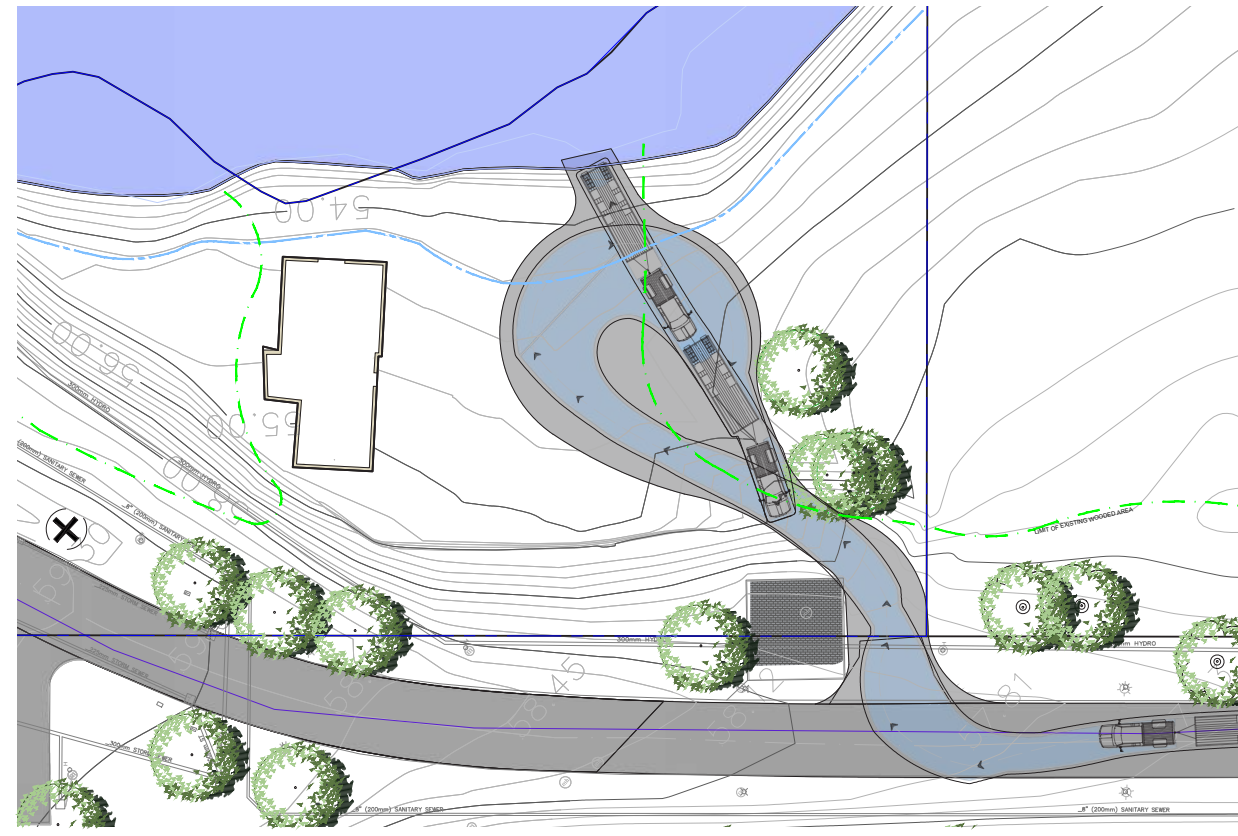
Figure 1.34 Optional turn around proposal

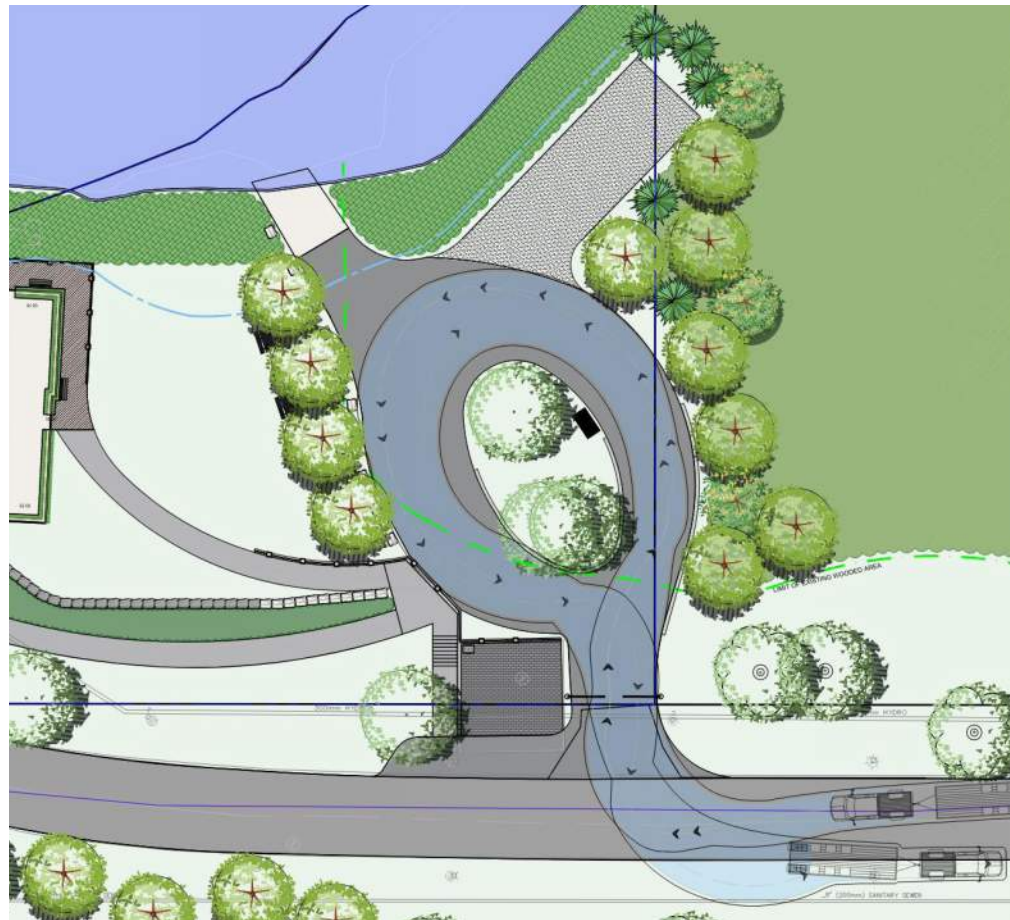
Figure 1.35 Proposed vehicular circulation through the site

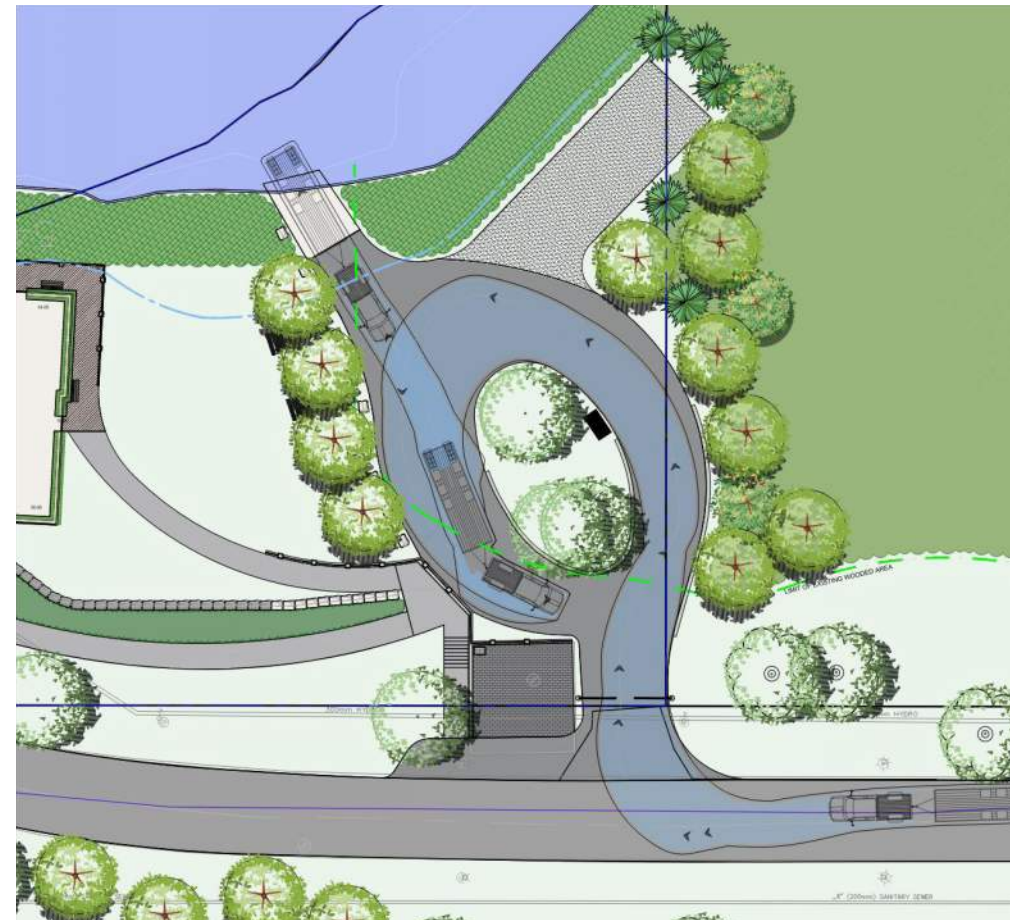
Figure 1.36 Proposed vehicular circulation using the boat launch

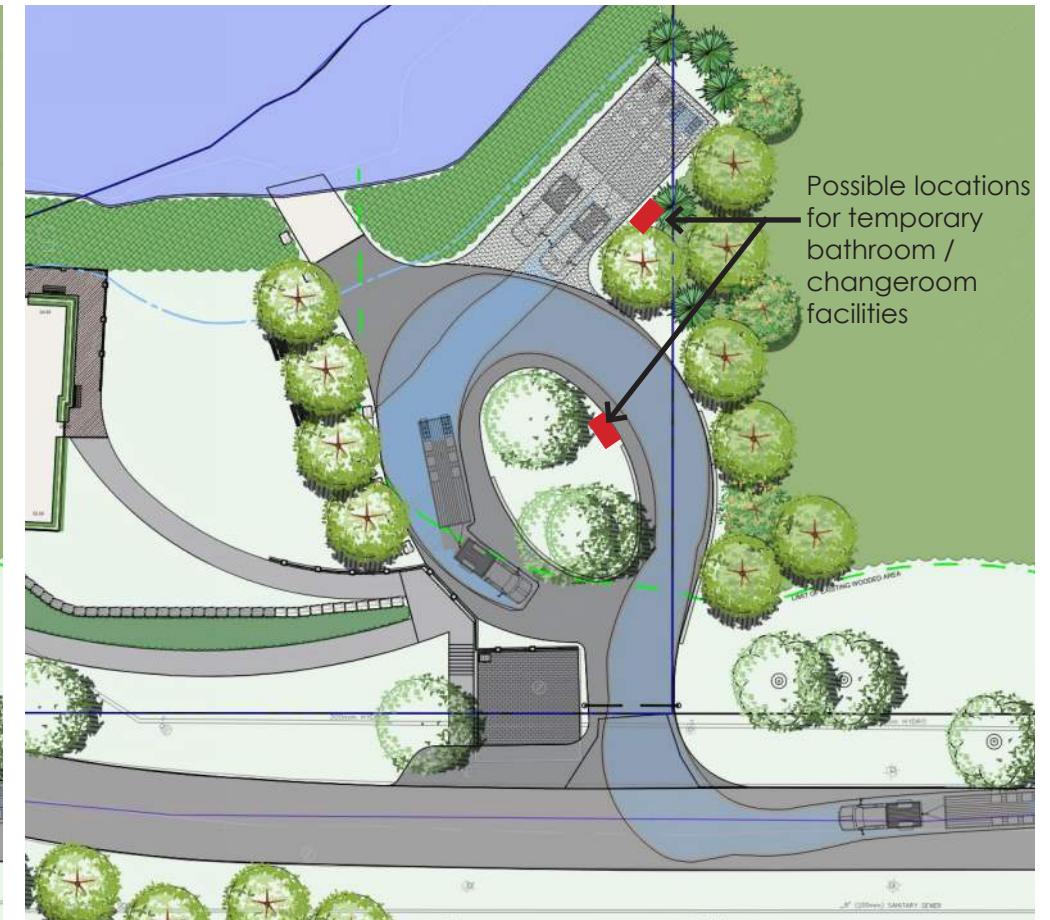
Figure 1.37 Proposed vehicular circulation using the parking area

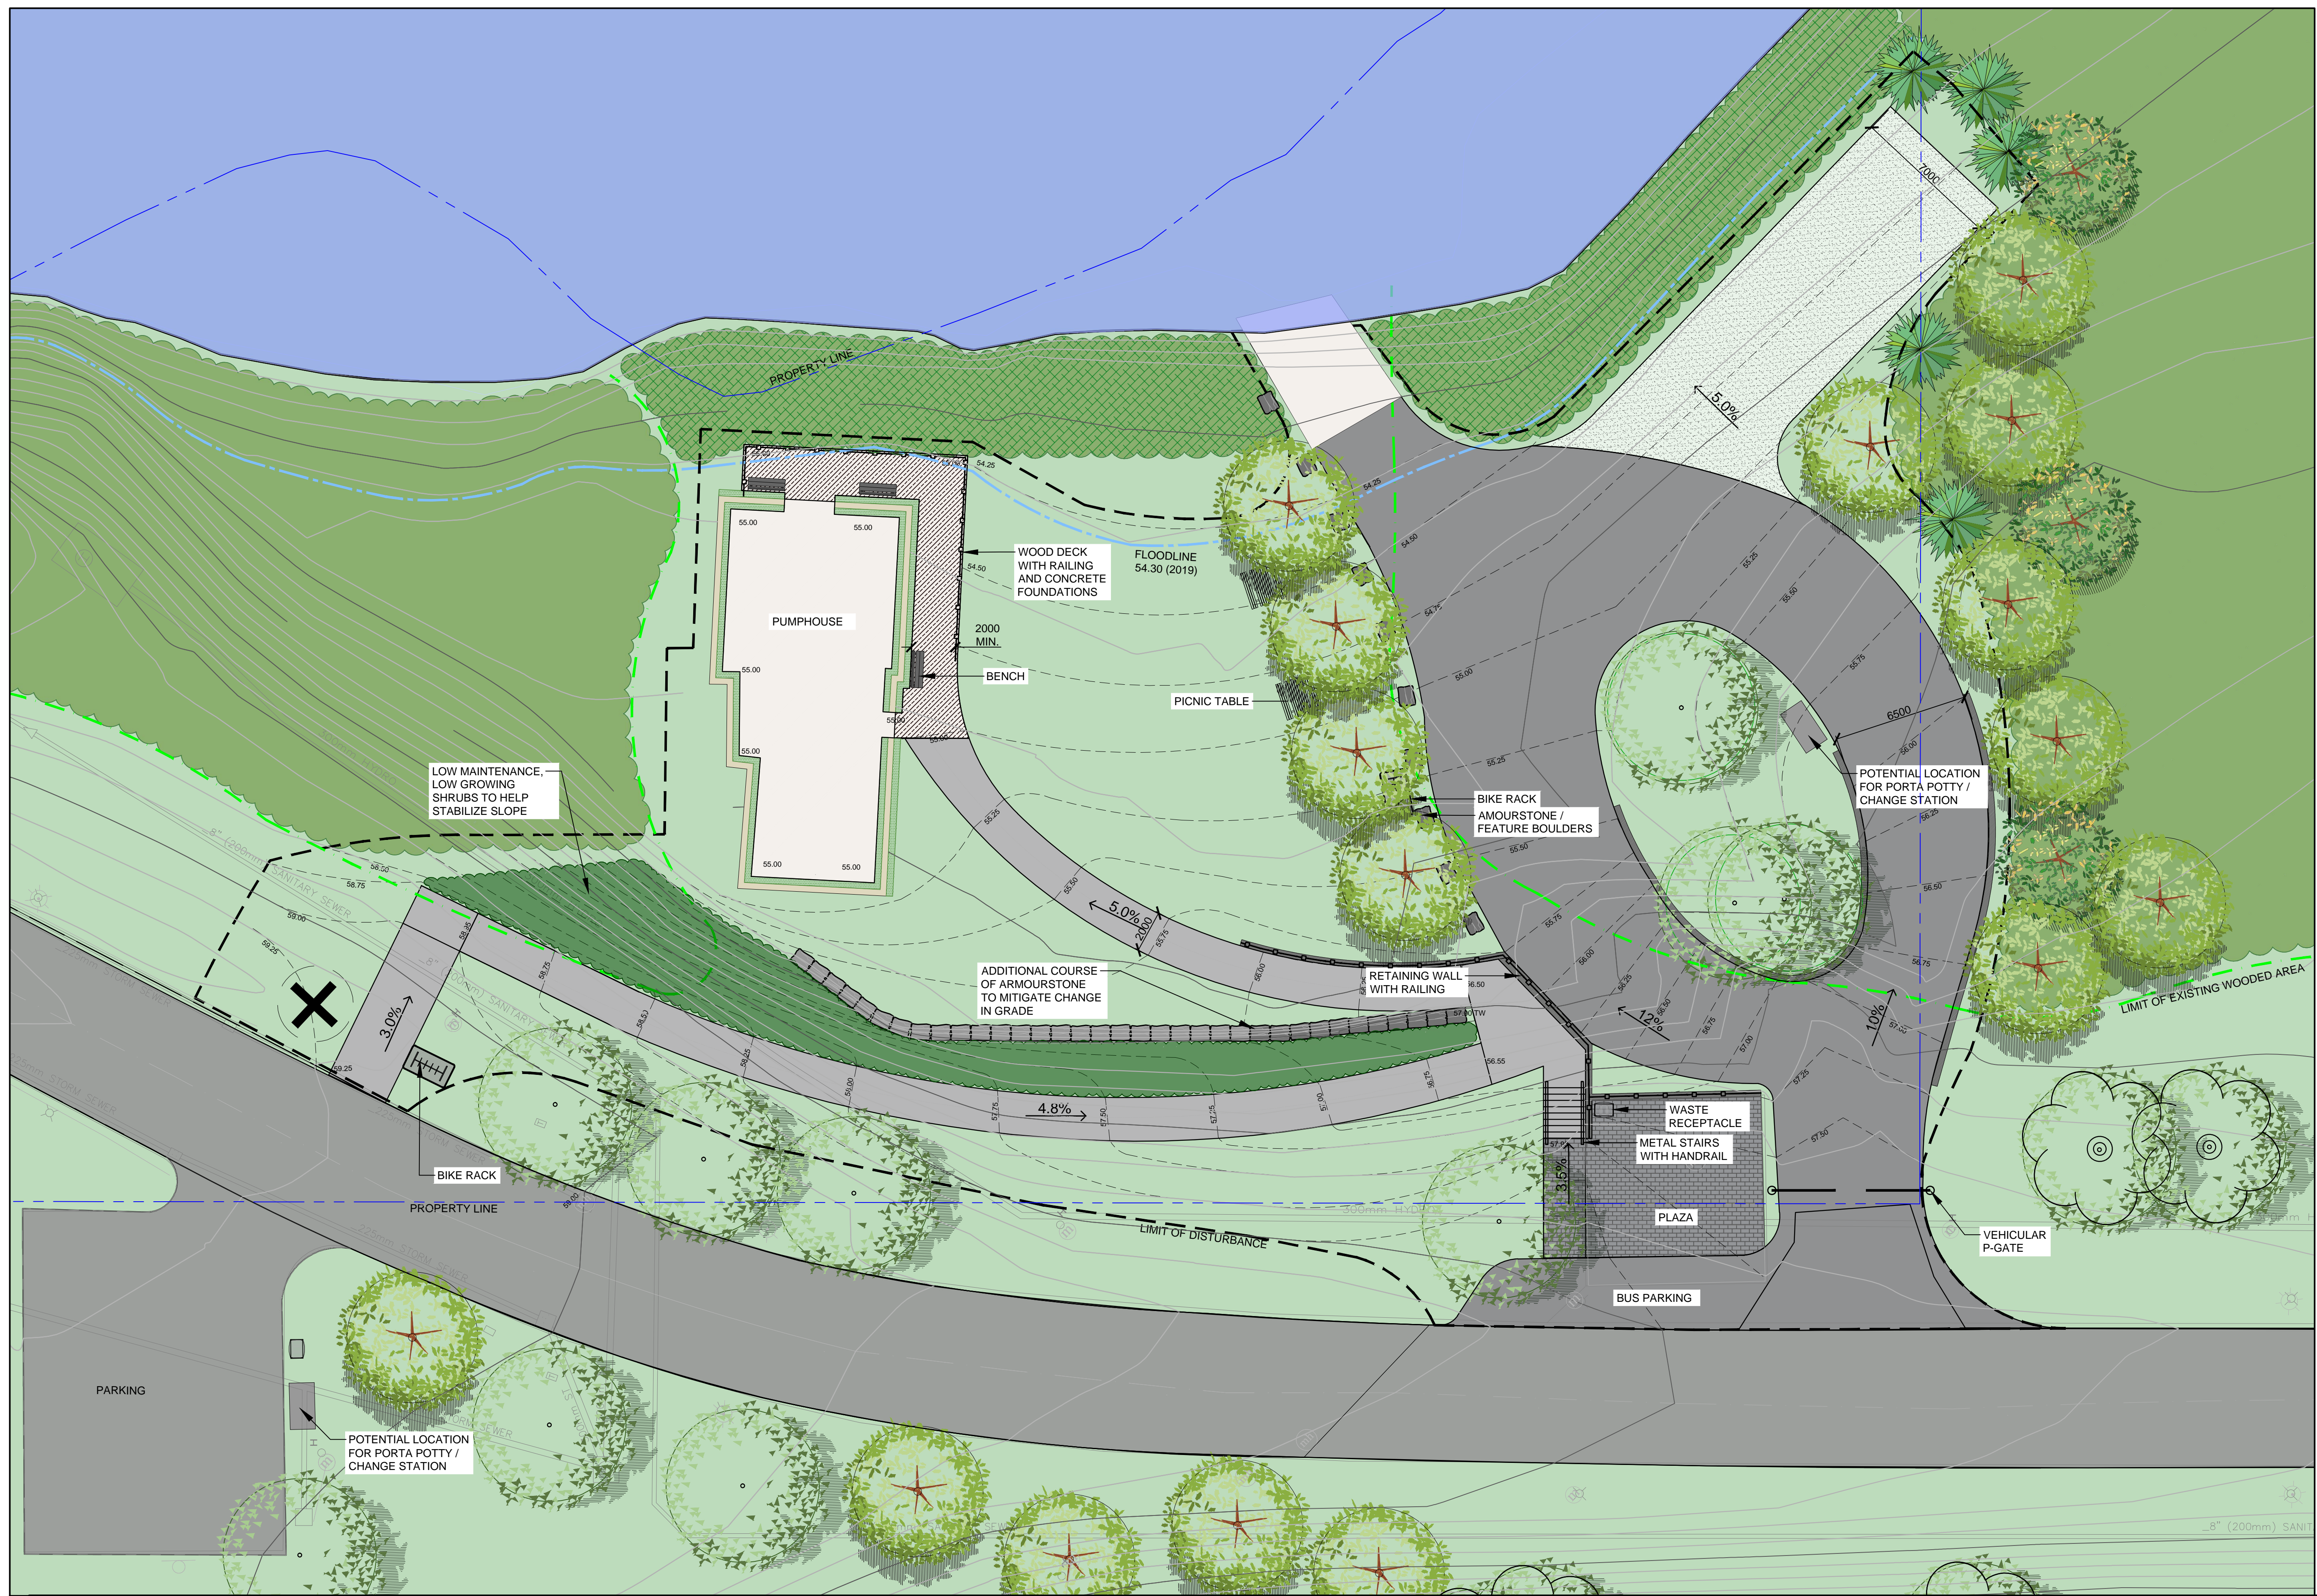
HINTONBURG PUMPHOUSE - PREFERRED CONCEPT PLAN CONSERVATION AND REDEVELOPMENT PROJECT

SCALE 1:150
