April 14, 2022 File: PE4215-LET.02

Subject: Phase I - Environmental Site Assessment Update 3996 and 3998 Innes Road Ottawa, Ontario

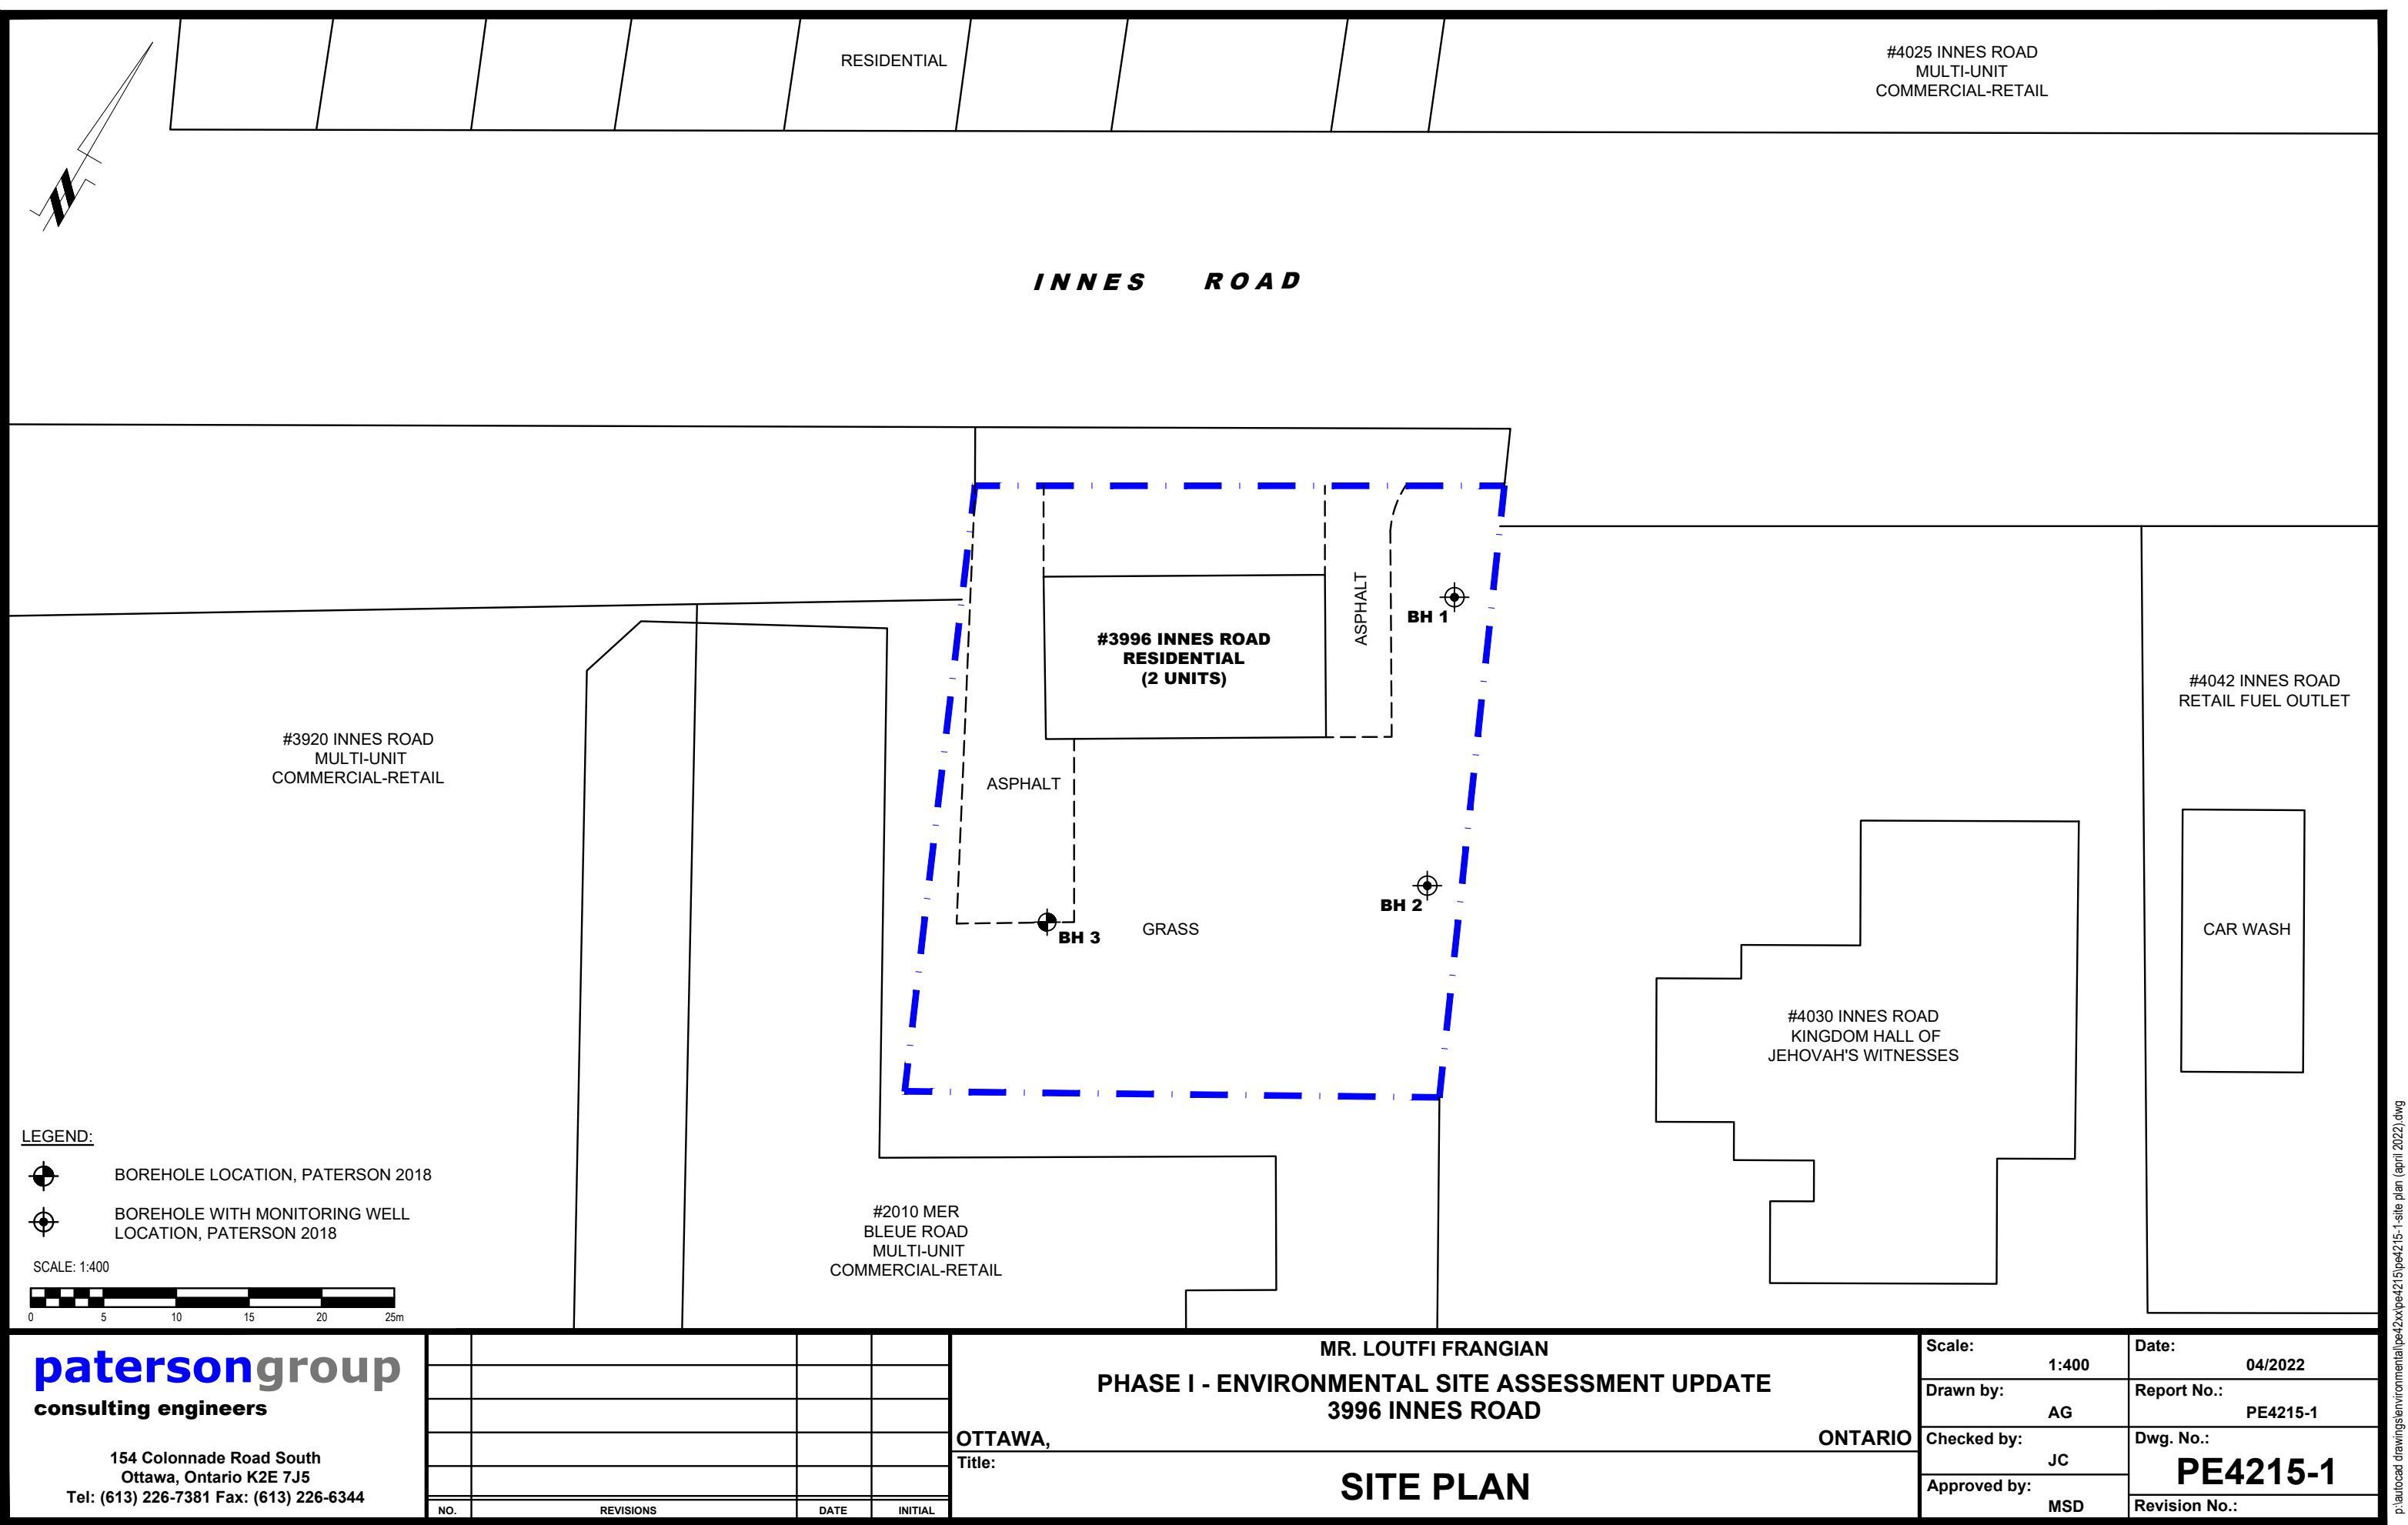
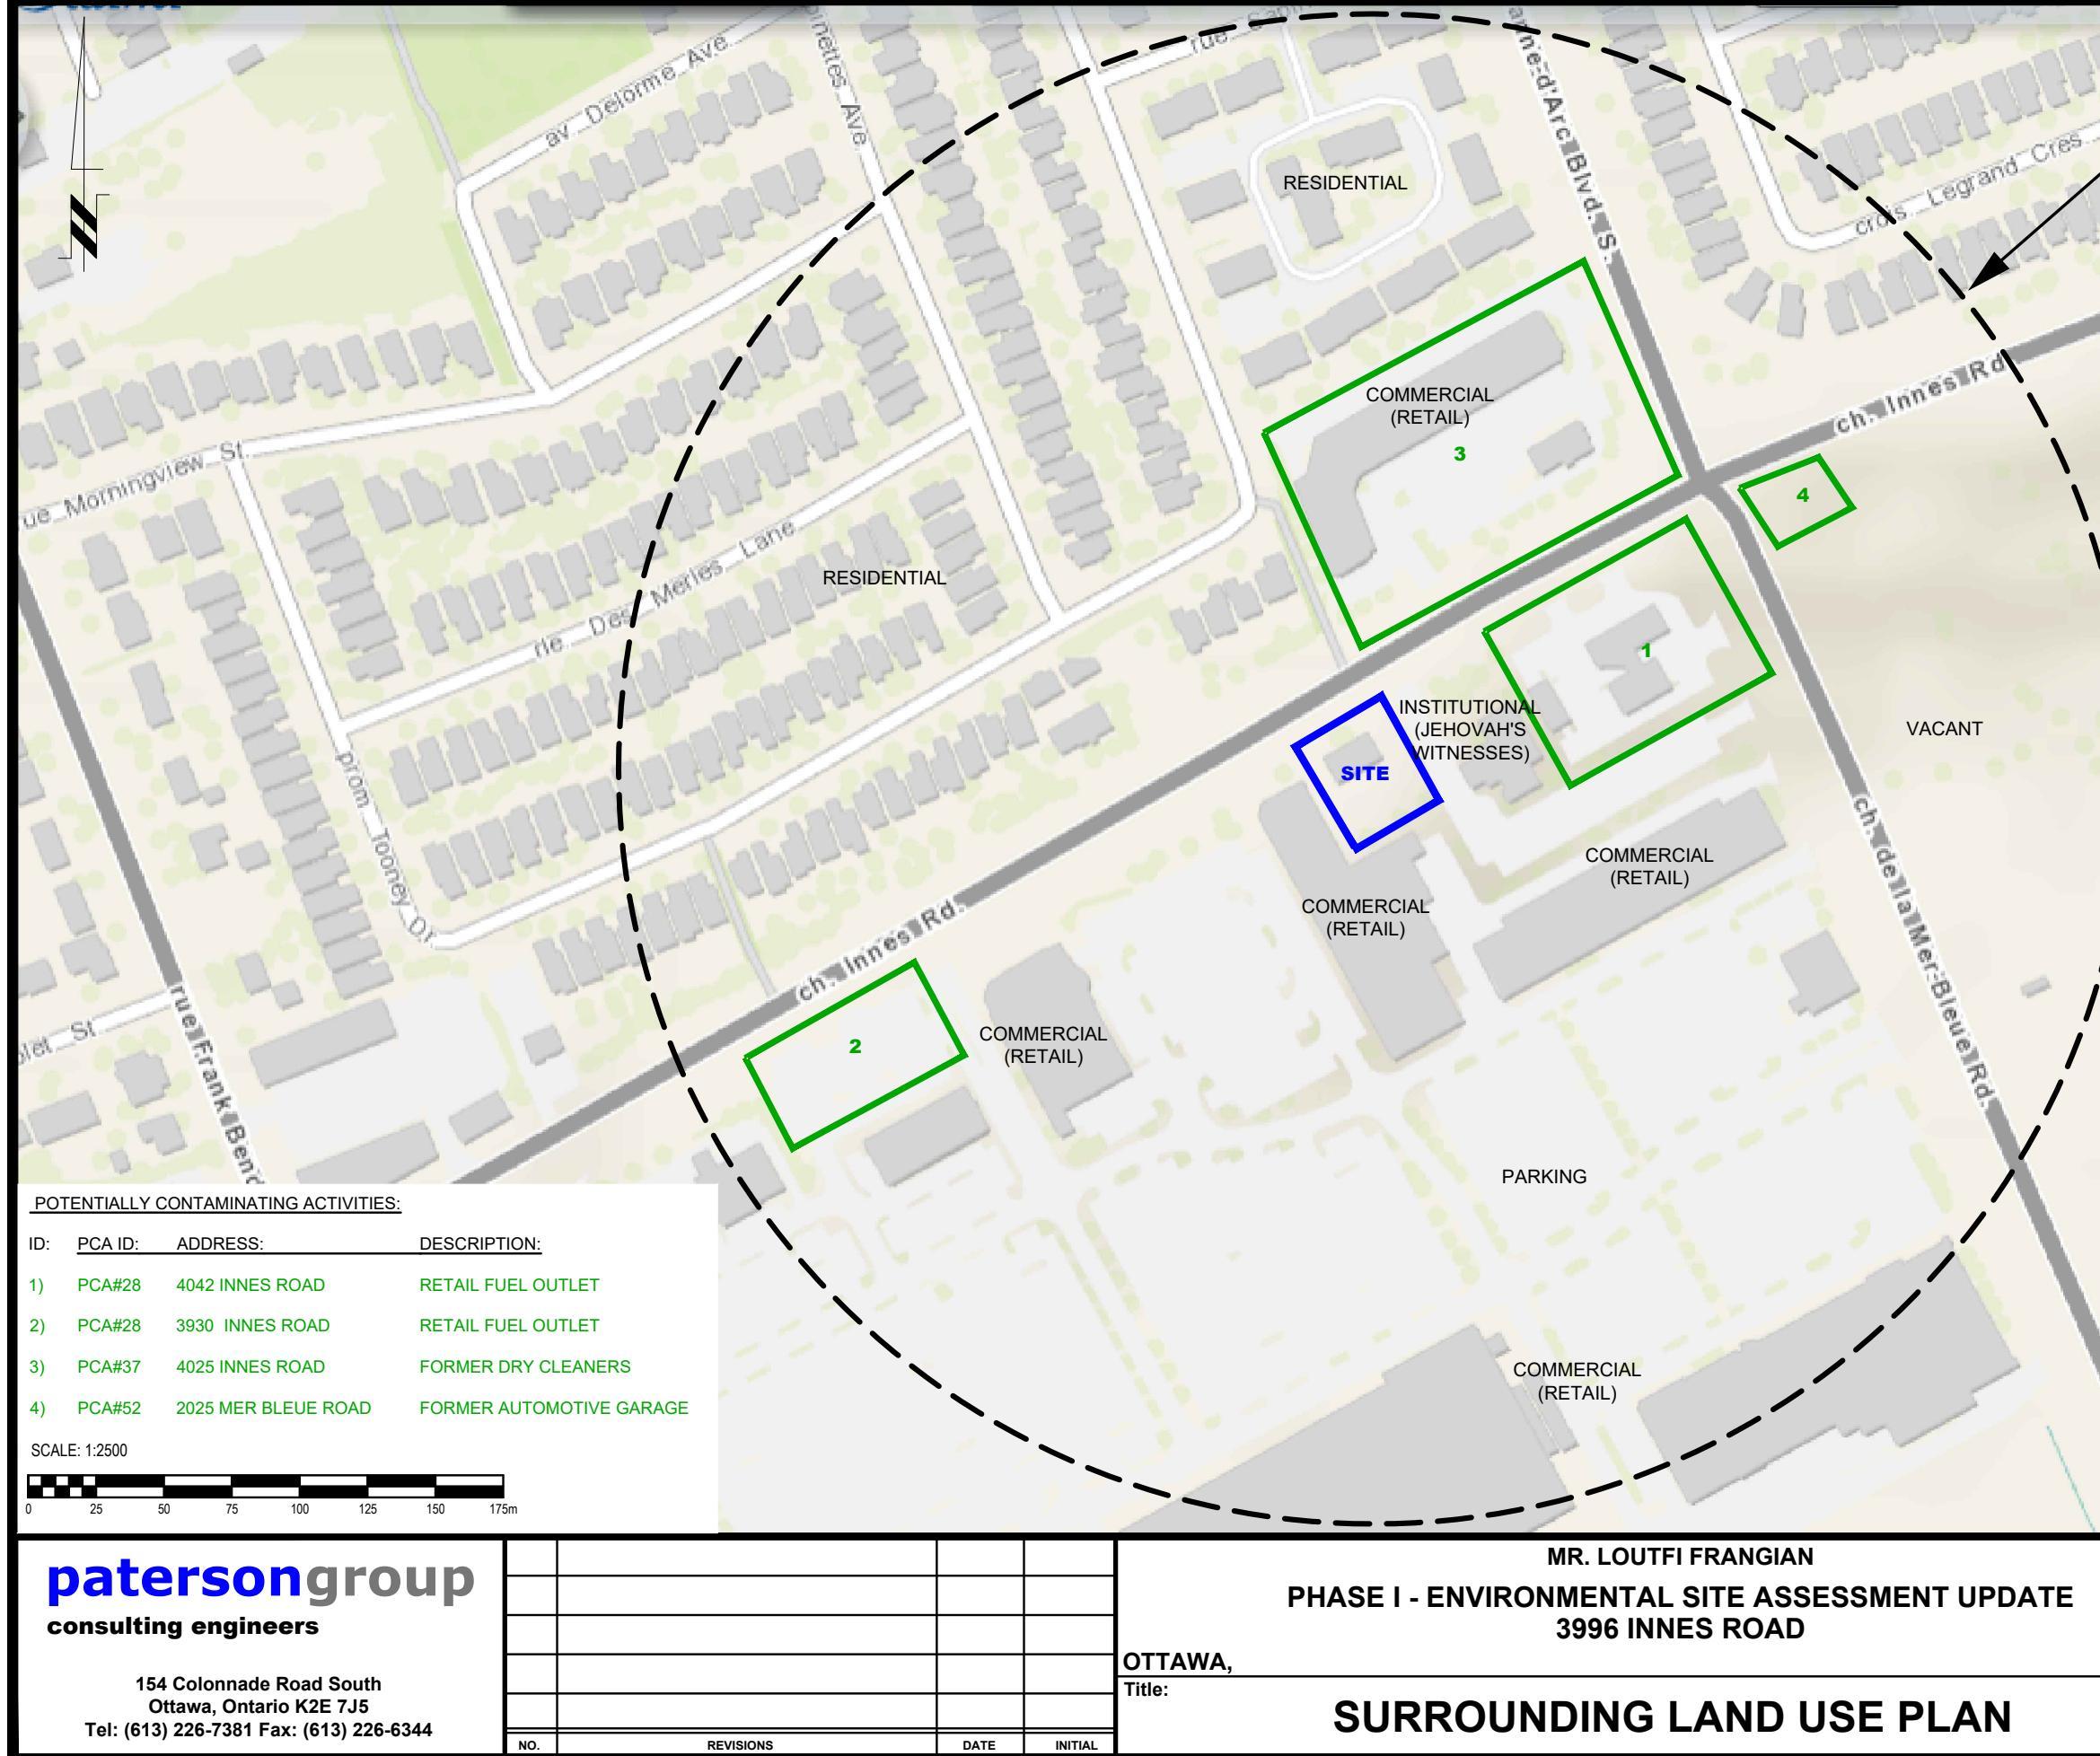
PHASE ASSES	I ENVI SMENT	RONMEN STUDY	ITAL SITE AREA
		/		
i /				λ.
1				
	\sim			
	Scale:	1:2500	Date:	04/2022
	Drawn by:	AG	Report No.:	PE4215-1
ONTARIO	Checked by:	JC	Dwg. No.:	
	Approved by:	MSD	PE Revision No.	4215-2

The Phase I Property is shown on Drawing PE4215-1 – Site Plan.

On the southwest portion of the subject building, a re-surfaced area was noted and considered to be the likely location of former vent and fill pipes. No odours or staining were noted at the time of the site visit.

The above-noted site features are shown on Drawing PE4215-1 - Site Plan.
