Phase I-Environmental Site Assessment

829 Carling Avenue
Ottawa, Ontario

Claridge Homes

Report: PE5197-1

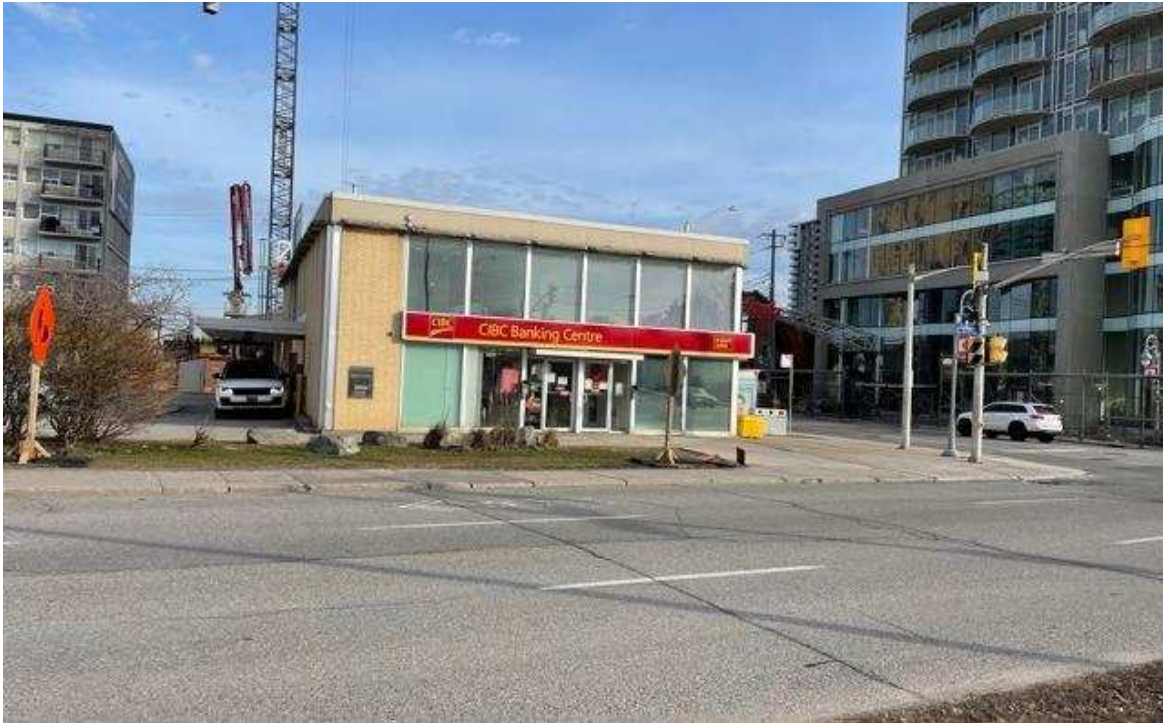
Photograph 1: View of the eastern half of the Phase I Property. Photograph taken from Carling Avenue.

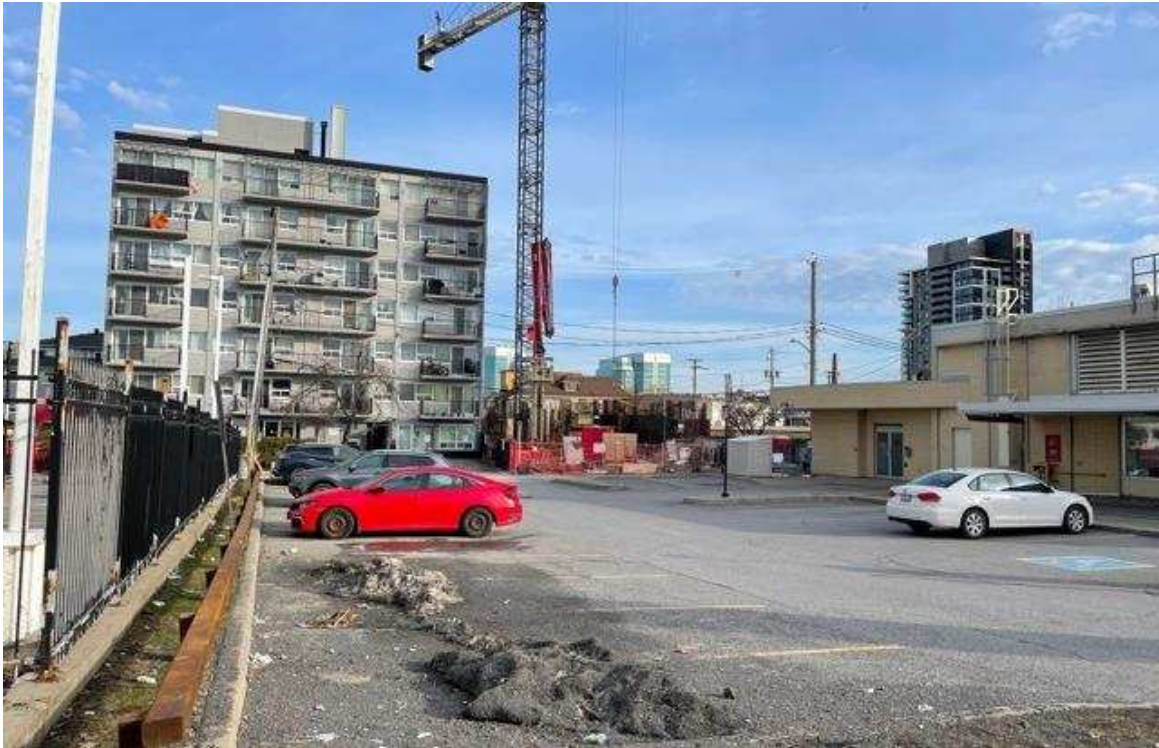
Photograph 2: View of the western half of the Phase I Property. Photograph taken from Carling Avenue.

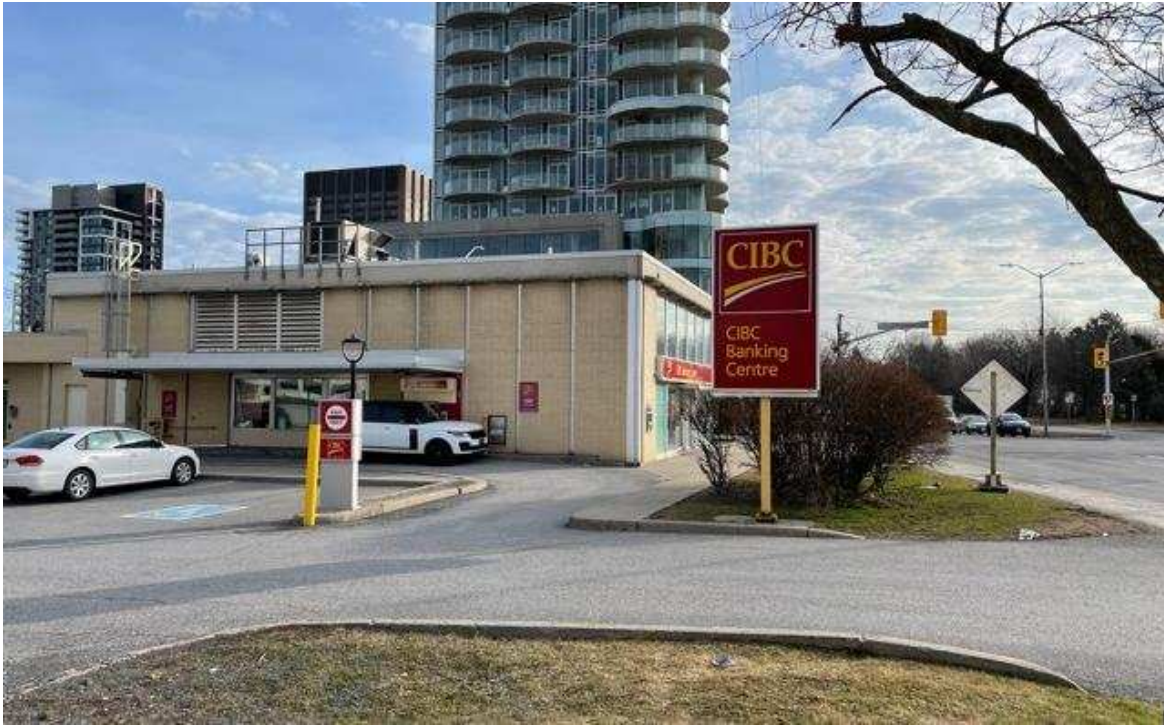
Photograph 3: View of the western side of the subject building. Photograph taken from Carling Avenue, looking east towards Preston Street.

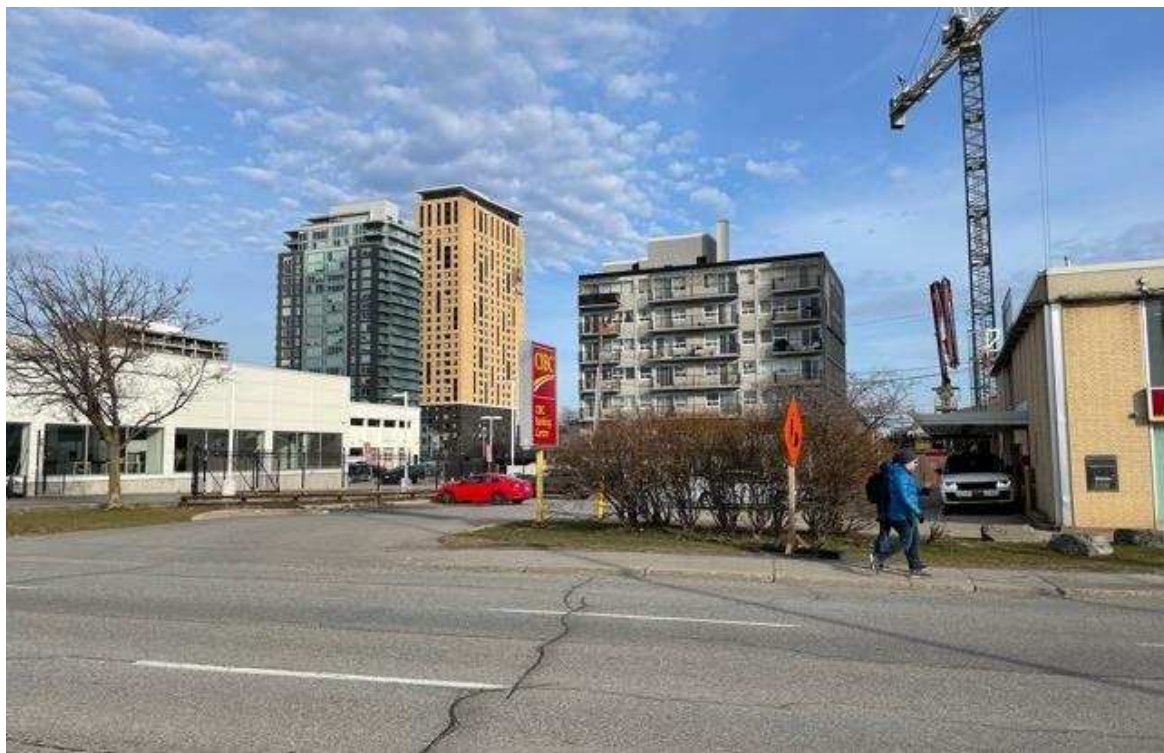
Photograph 4: View of the southern side of the Phase I Property. Photograph taken from Carling Avenue.
