**Functional Site Servicing and
Stormwater Management Report
Rev.03 – 1987 Robertson Road
(Stillwater Station)**

Stantec Job #160401686

Prepared for:

February 28, 2024

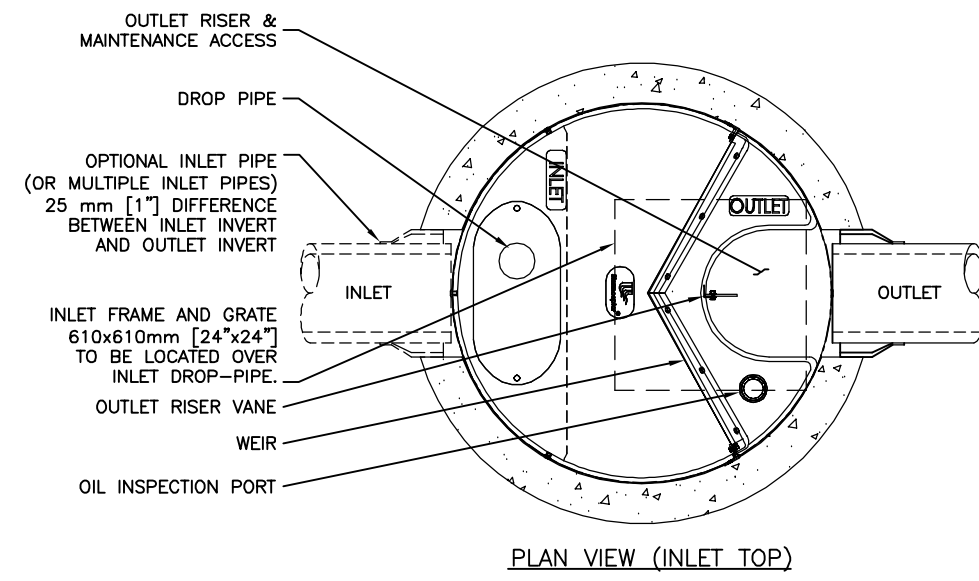
FOR SITE SPECIFIC DRAWINGS PLEASE CONTACT YOUR LOCAL STORMCEPTOR REPRESENTATIVE. SITE SPECIFIC DRAWINGS ARE BASED ON THE BEST AVAILABLE INFORMATION AT THE TIME. SOME FIELD REVISIONS TO THE SYSTEM LOCATION OR CONNECTION PIPING MAY BE NECESSARY BASED ON AVAILABLE SPACE OR SITE CONFIGURATION REVISIONS. ELEVATIONS SHOULD BE MAINTAINED EXCEPT WHERE NOTED ON BYPASS STRUCTURE (IF REQUIRED).

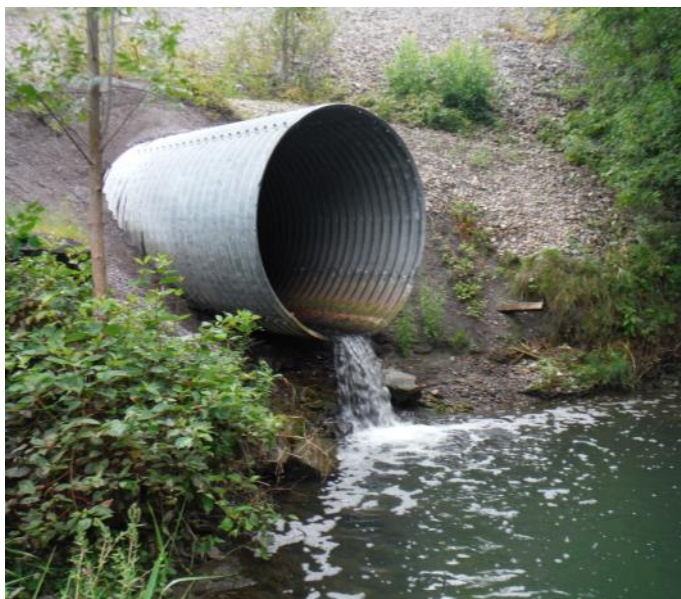
A perched culvert observed along a tributary of Stillwater Creek

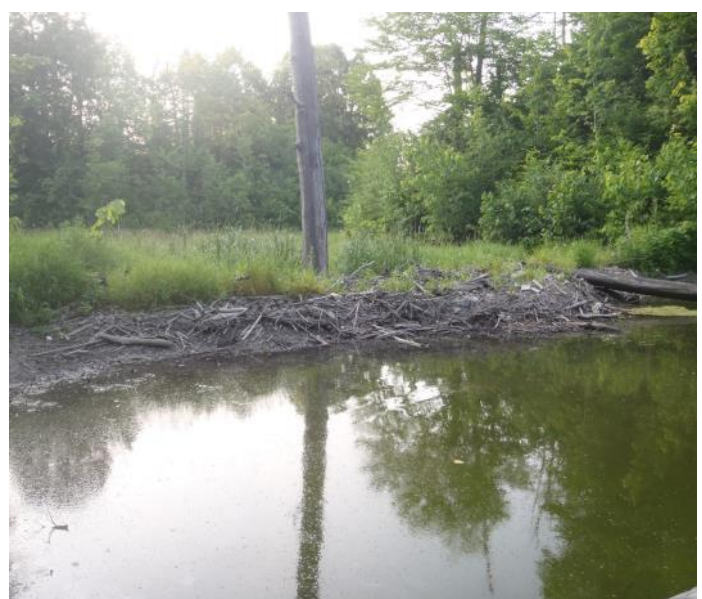
A large beaver dam observed on Stillwater Creek
