**Functional Site Servicing and
Stormwater Management Report
Rev.03 – 1987 Robertson Road
(Stillwater Station)**

Stantec Job #160401686
City of Ottawa File Numbers:
D01-01-21-0021
D02-02-21-0120

Prepared for:
The Properties Group Management Ltd.

Prepared by:
Stantec Consulting Ltd.
300 - 1331 Clyde Avenue
Ottawa ON K2C 3G4

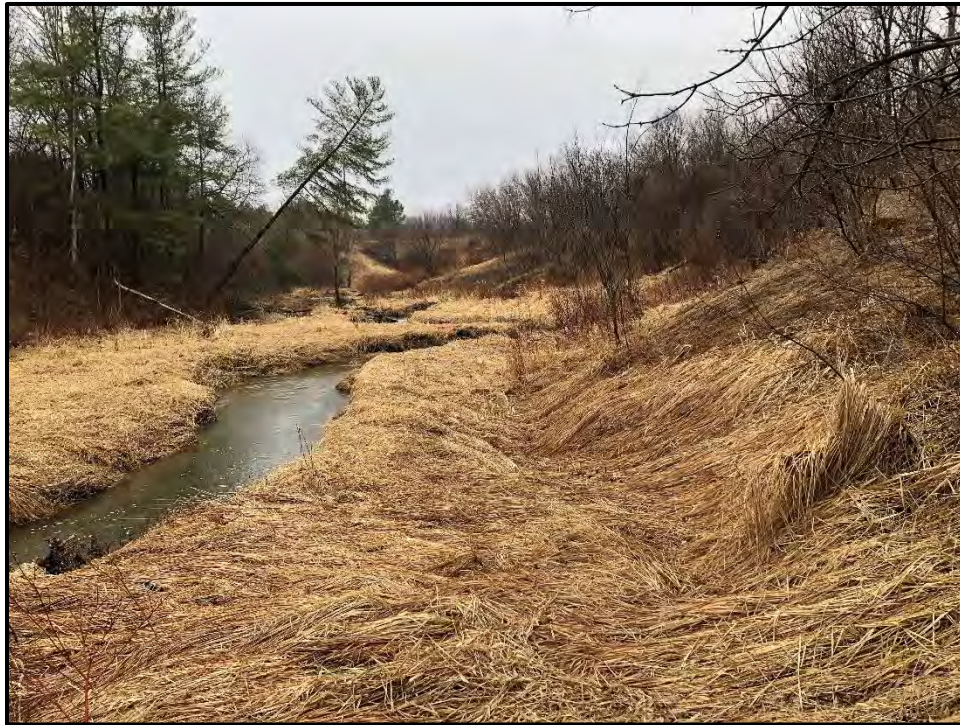
Photo 2: Photograph of Stillwater Creek and toe of slope taken at the west portion of the site towards the north illustrating grass covered side slopes, minor toe erosion was observed.
