**Functional Site Servicing and
Stormwater Management
Report – 1987 Robertson Road
(Stillwater Station)**

Job #160401686

Prepared for:
The Properties Group
Management Ltd.

Prepared by:
Stantec Consulting Ltd.
1331 Clyde Avenue
Ottawa, Ontario
K2C 3G4

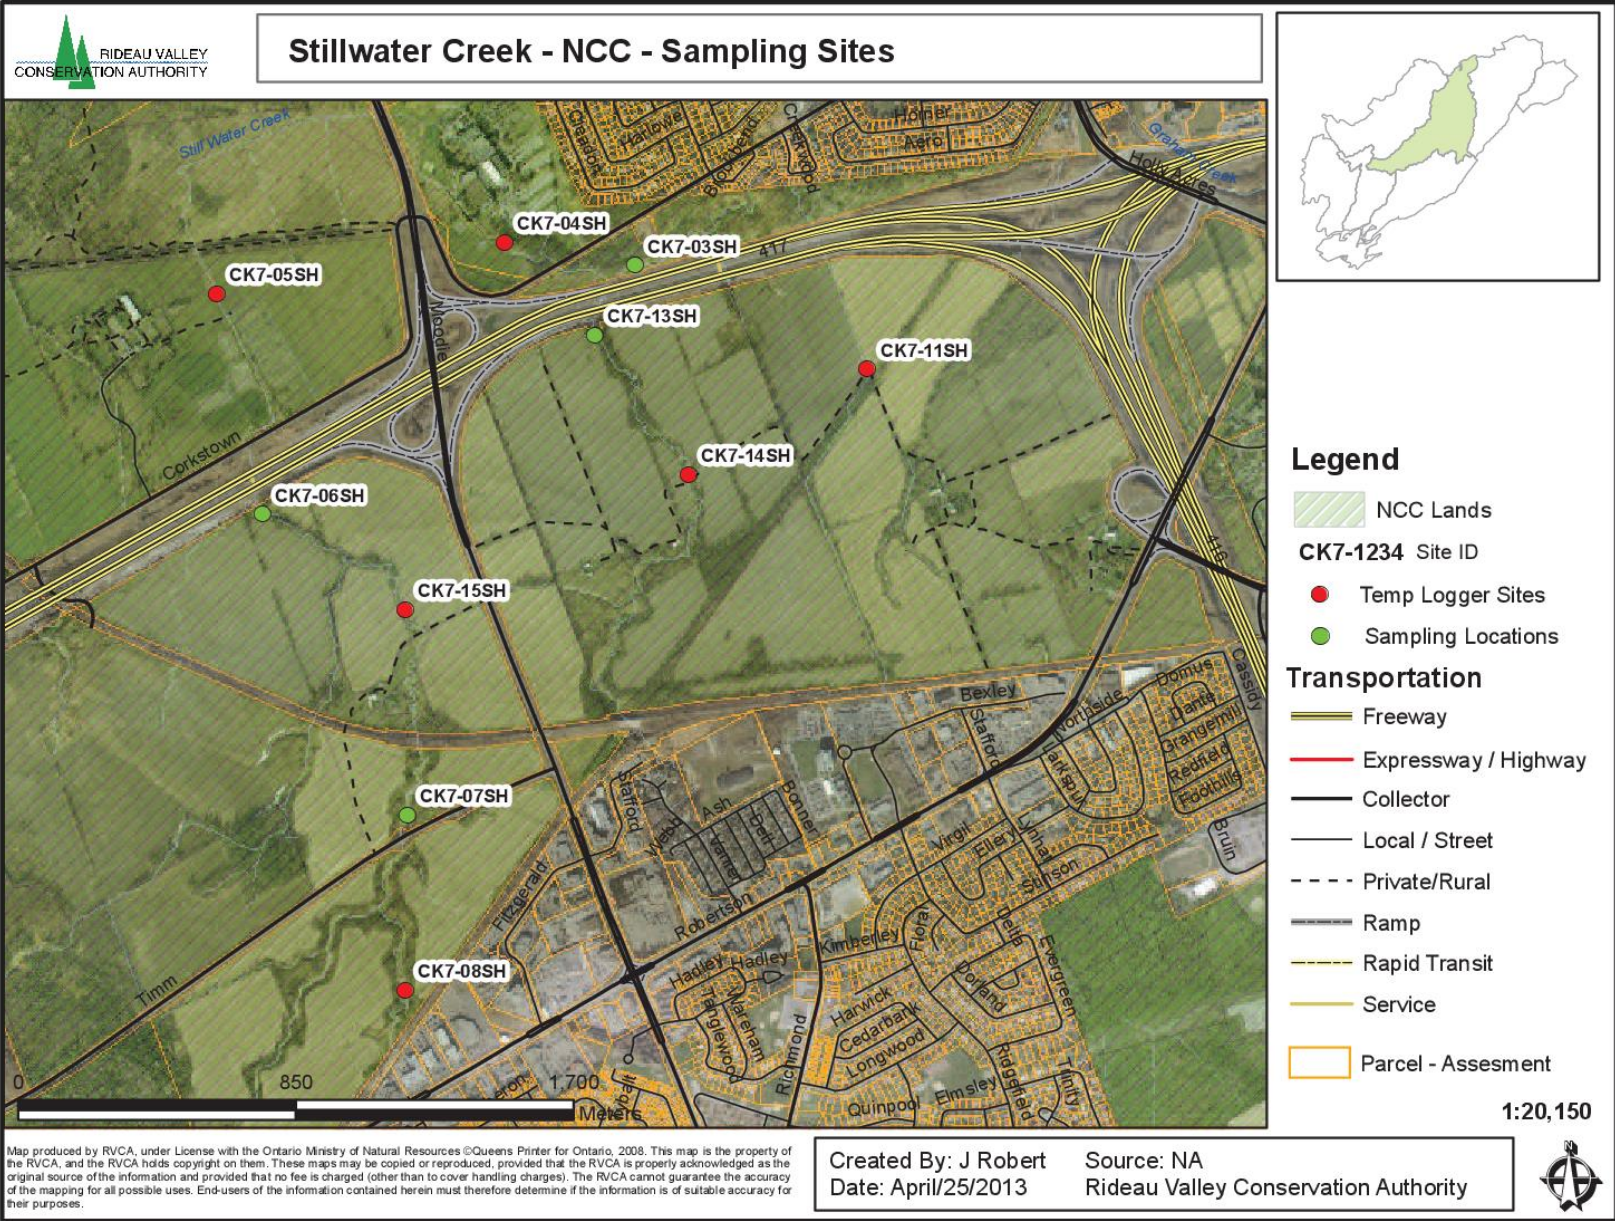
Figure 1. Stillwater Creek OSAP sampling and thermal classification sites.

Previous monitoring efforts conducted by our organization indicate that approximately 46% of the system remains in a natural state, while the remainder has been altered to varying extents (*City Stream Watch*, 2009). Recent efforts have been undertaken to improve the current conditions and to mitigate against further damage. This has been accomplished through extensive riparian planting, habitat enhancement/creation and invasive species removal.

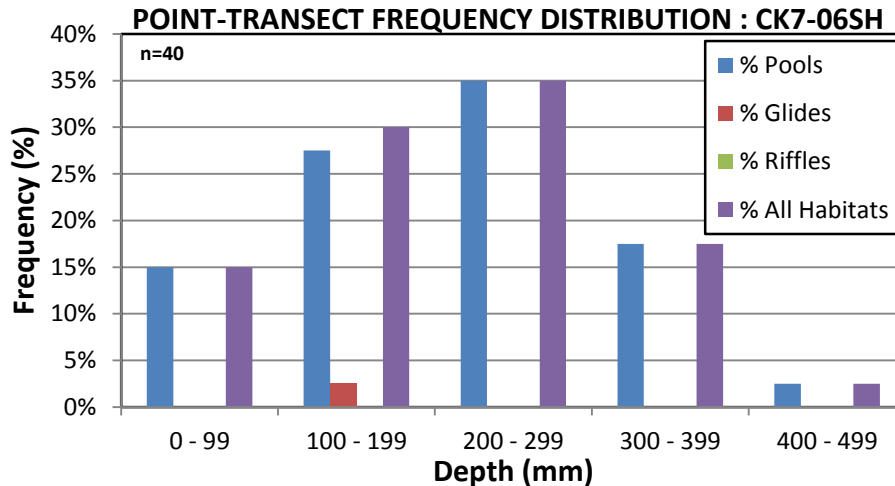
Figure 9. Frequency distribution of habitat types/stream velocities at 100mm intervals for site CK7-06SH

The results of the habitat assessment for site CK7-06SH are summarized in Figure 9. The analysis revealed a total habitat area of approximately 56.9m², consisting of 97% pool habitat, and 3% glides. Embedded cover was observed over approximately 5% of the site, and consisted solely of macrophytes. Unembedded cover included primarily macrophytes and wood, and was observed over approximately 68% of the site (Appendix IV).

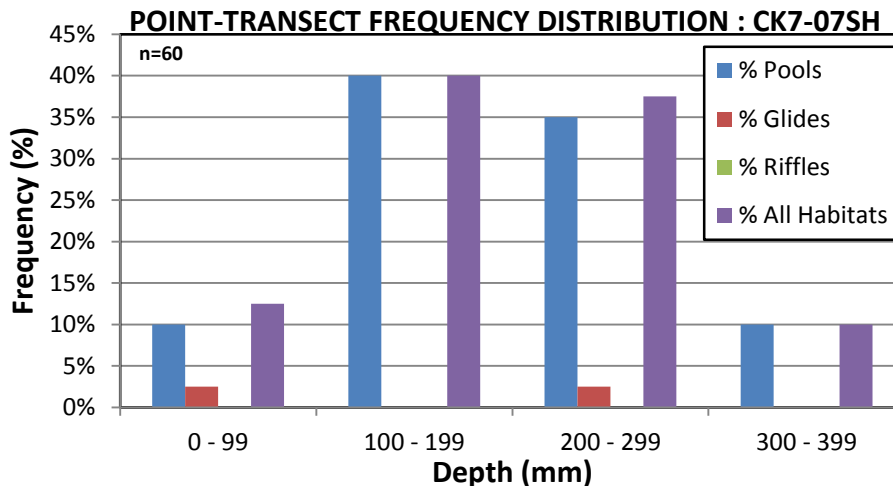
Figure 10. Frequency distribution of habitat types/stream velocities at 100mm intervals for site CK7-07SH

The results of the habitat assessment for site CK7-07SH are summarized in Figure 10.

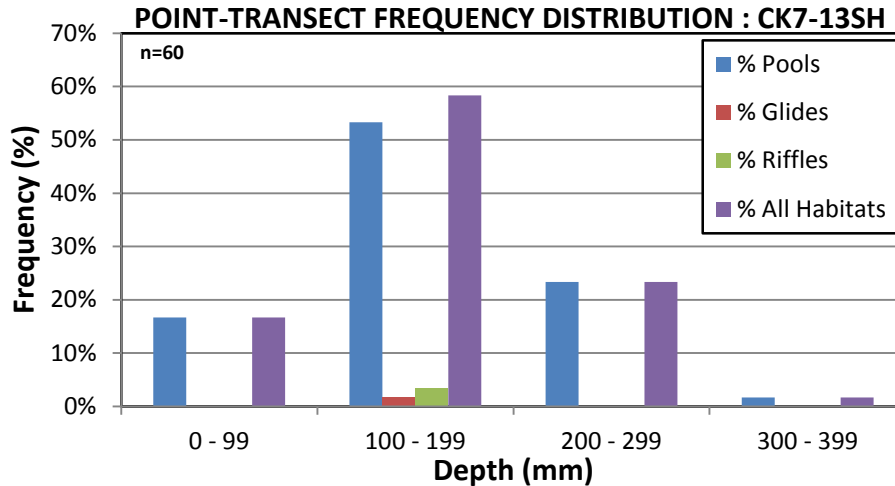
Figure 13. Frequency distribution of habitat types/stream velocities at 100mm intervals for site CK7-13SH

The results of the habitat assessment for site CK7-13SH are summarized in Figure 13. The analysis revealed a total habitat area of approximately 131.6m², consisting of 95% pool habitat, 2% glides and 3% riffles. Embedded cover was observed over approximately 12% of the site, and consisted solely of rock materials. Unembedded cover included flat and round rock, and was observed over approximately 57% of the site (Appendix IV).

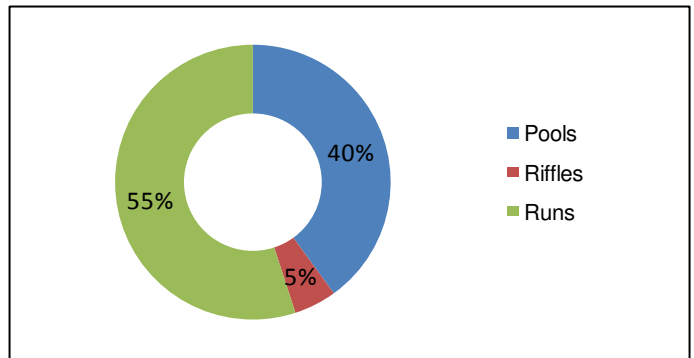
Figure 14 Instream morphology along Stillwater Creek

Figure 14 shows that Stillwater Creek has good variability in instream morphology; 55 percent consists of runs, 40 percent consists of pools and five percent consists of riffles. Figure 15 shows where areas of riffle habitat was observed in Stillwater Creek. Although the riffle habitat was only five percent it was dispersed well across most of the creek.

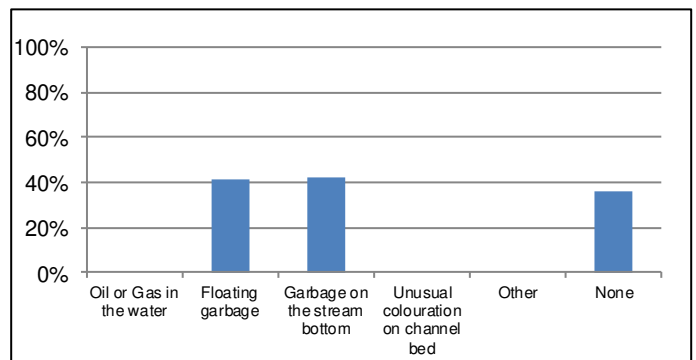
Figure 21 Pollution observed along Stillwater Creek

Figure 21 demonstrates the incidence of pollution/garbage in Stillwater Creek. Thirty six percent of the sections surveyed did not have any observable garbage. Forty two percent had garbage on the stream bottom and 41 percent had floating garbage. Many of the sections had both garbage on the stream bottom and floating garbage. These areas were located near road crossings or in the developed areas near Robertson Road and Corkstown Road.

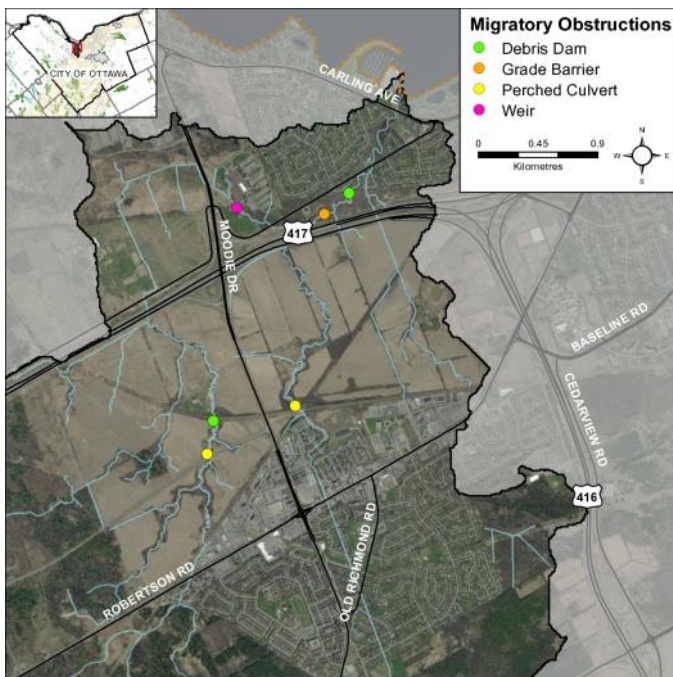
Figure 29 Stillwater Creek migratory obstructions

It is important to know locations of migratory obstructions because these can prevent fish from accessing important spawning and rearing habitat. Migratory obstructions can be natural or manmade, and they can be permanent or seasonal. Figure 29 shows that along Stillwater Creek, two perched culverts, two debris dams, one grade barrier and one weir were observed. Fish migration is currently being impacted by the weir near Moodie Drive and the perched culverts identified on the main channel of the creek at Timm Drive and the tributary east of Moodie Drive at the old railway line.

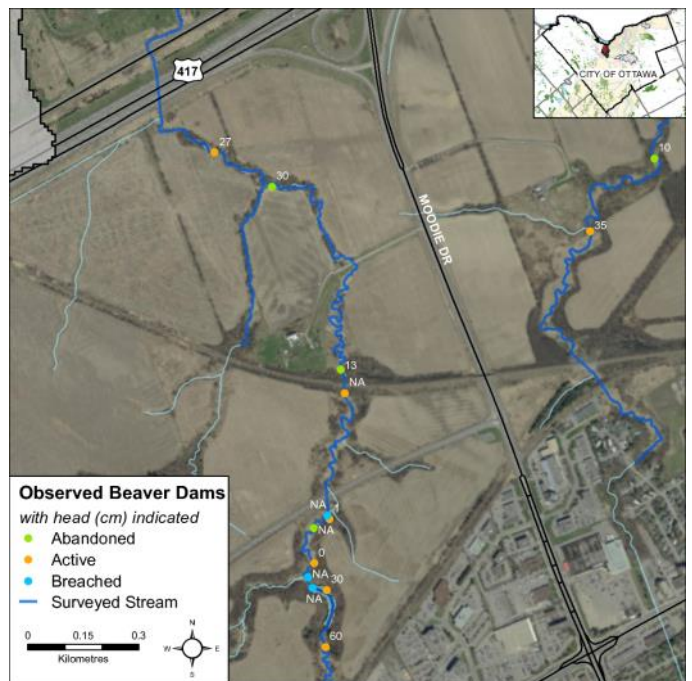
Figure 30 Beaver dams observed on Stillwater Creek

Beaver dams can also act as obstructions to fish migration. Figure 30 shows that a number of active, abandoned and breached beaver dams were observed on Stillwater Creek. Most of the beaver activity was observed between Highway 417 and Robertson Road as well as on the tributary east of Moodie Drive. The head, or difference between the water level up and down stream, of the beaver dams ranged from 0 cm to 60 cm.

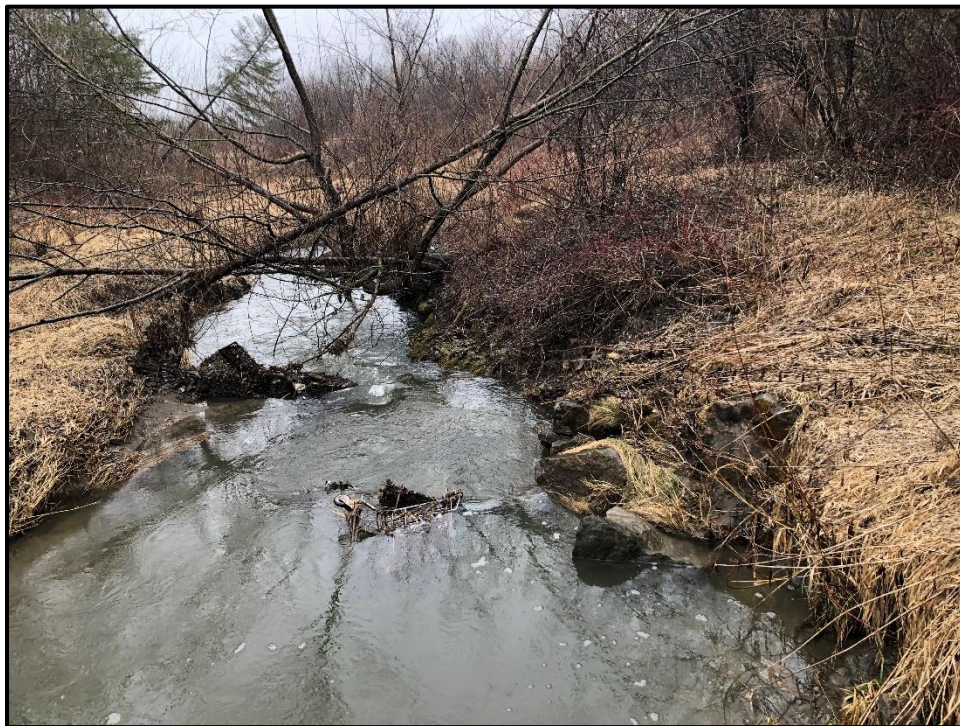
Photo 2: Photograph of Stillwater Creek and toe of slope taken at the west portion of the site towards the north illustrating grass covered side slopes, minor toe erosion was observed.
