Phase Two Environmental Site Assessment

30 Cleary Avenue, Ottawa Ontario

CA0008376.9447-Rev0

November 2023

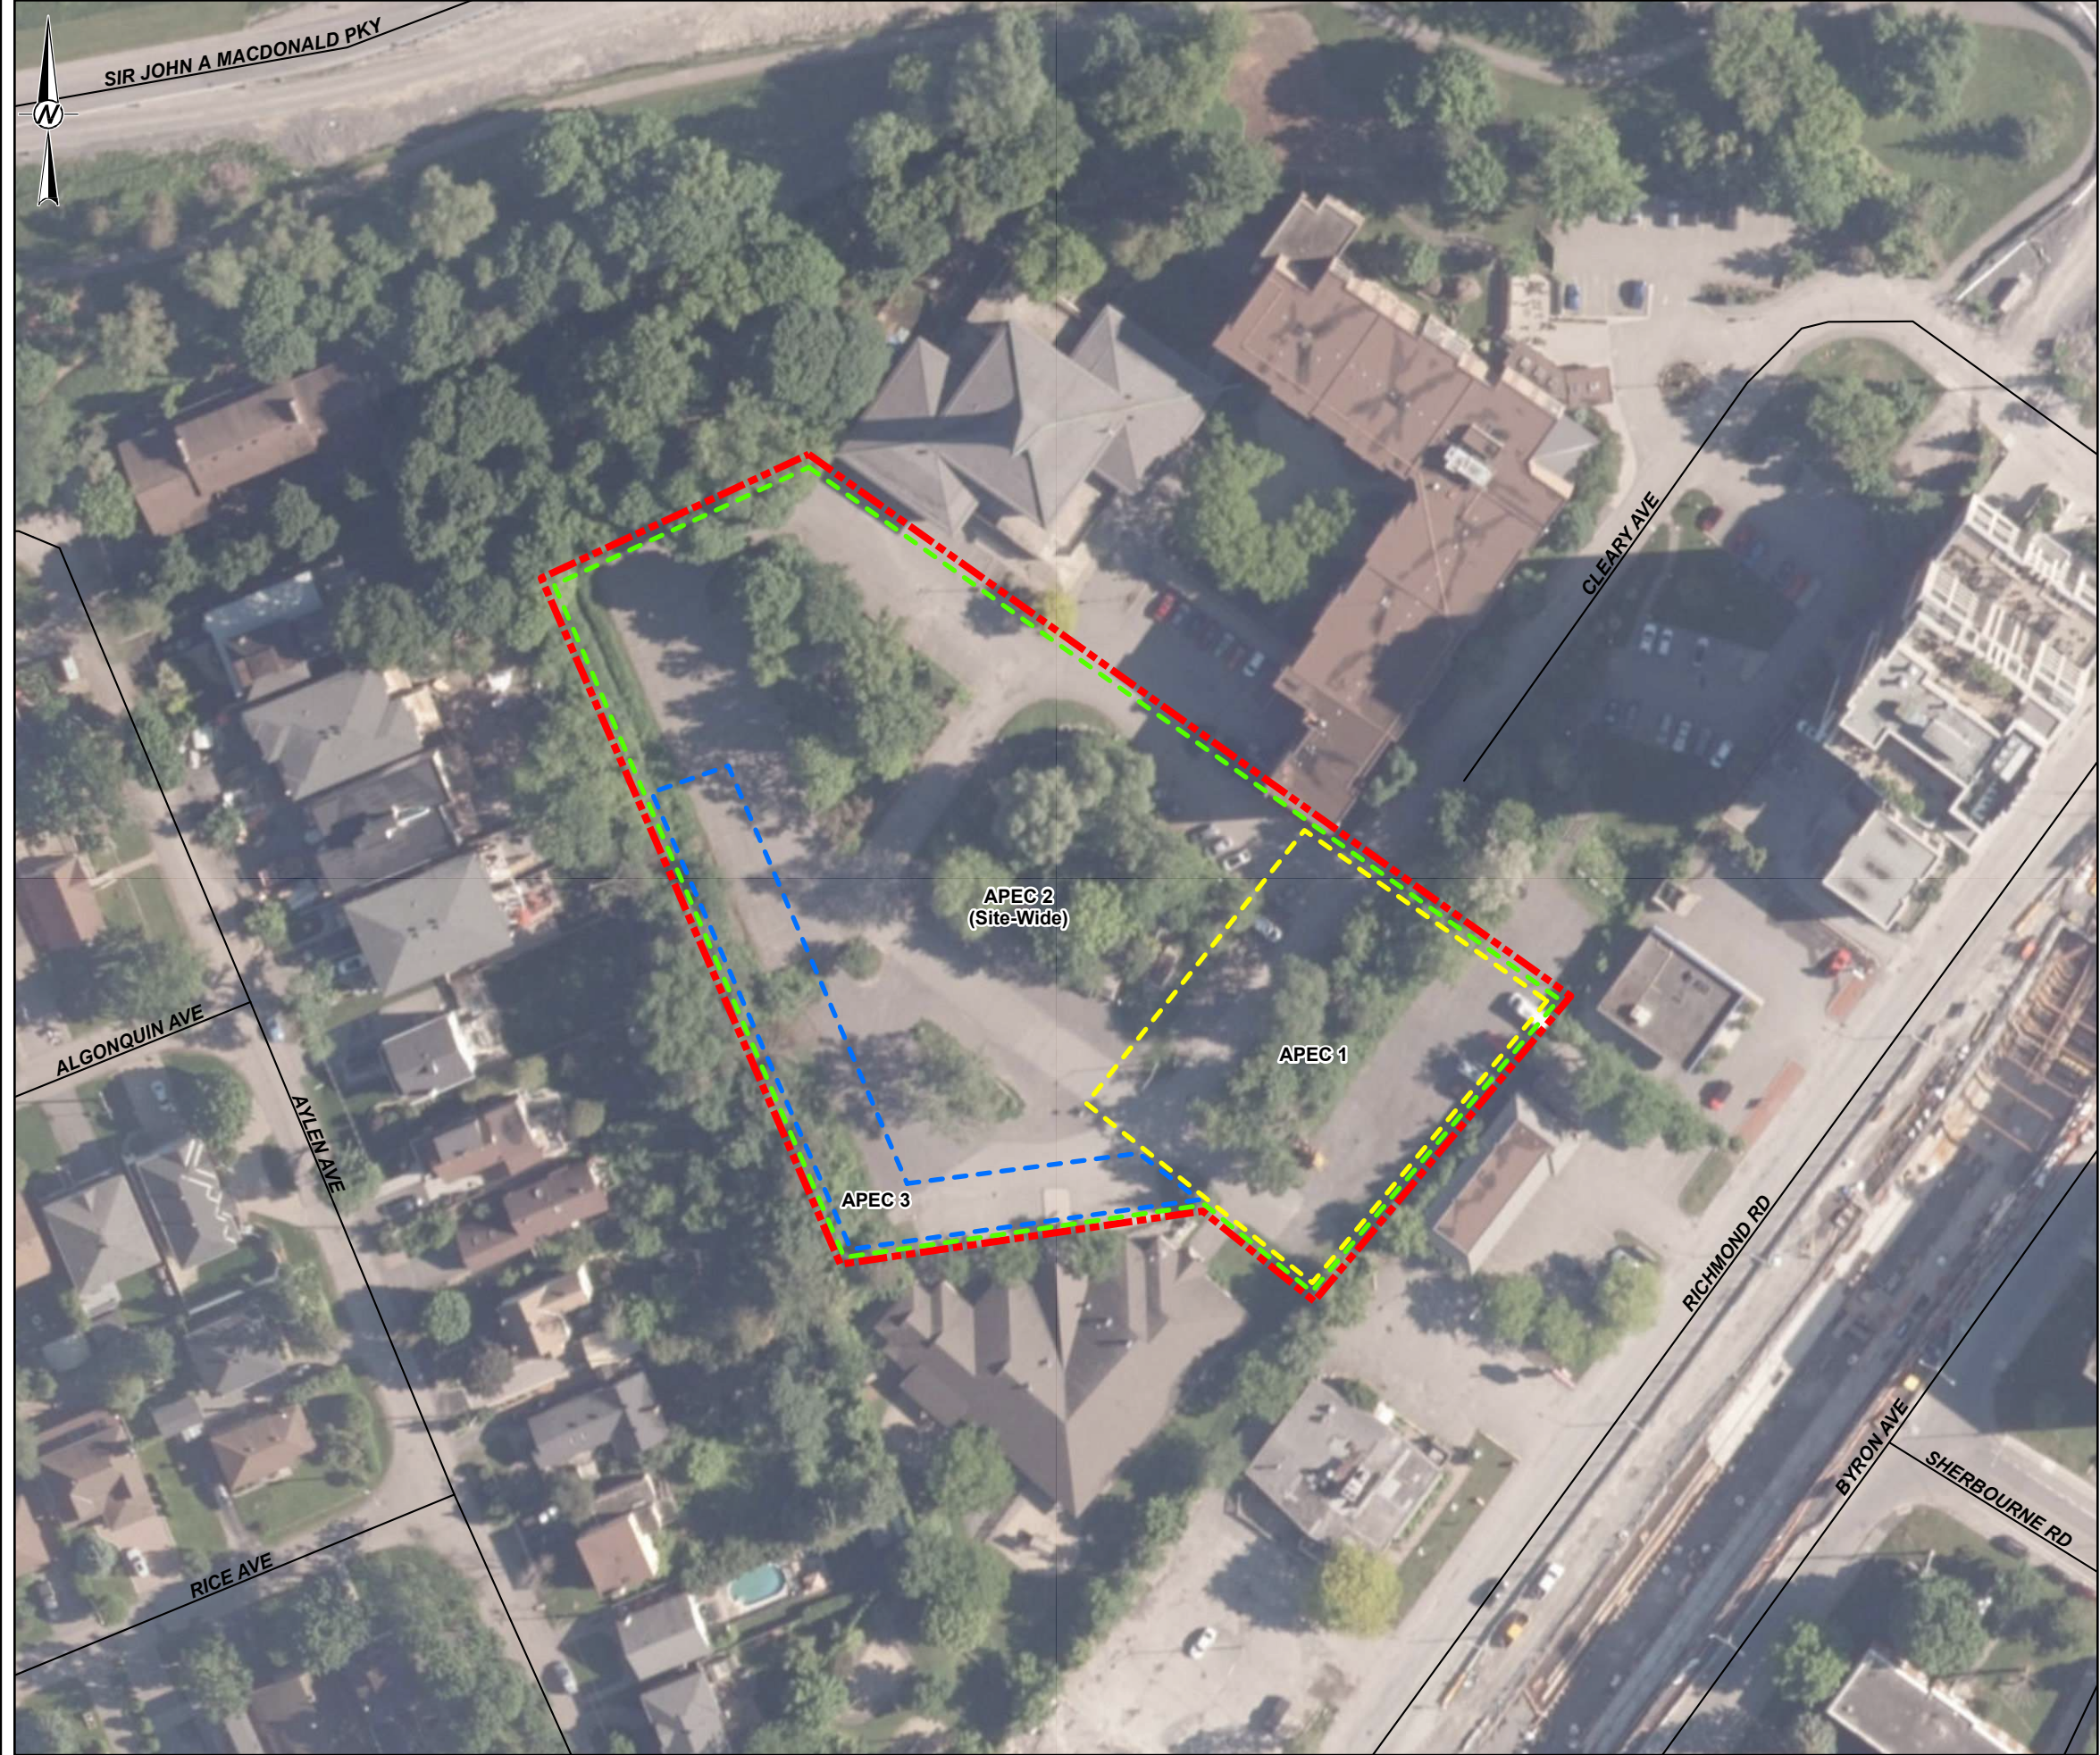
APEC ID	PCA Category	Description of PCAs attributing to APEC
APEC 1	10, 28, 46	PCA 1: Former railway on-site PCA 3, 6, 8: Multiple gasoline service stations and USTs/ASTs PCA 4: Auto repair shop off-site
APEC 2	30	PCA 2: Fill material of unknown quality
APEC 3	28	PCA 9, 10: Multiple gasoline service stations and USTs/ASTs

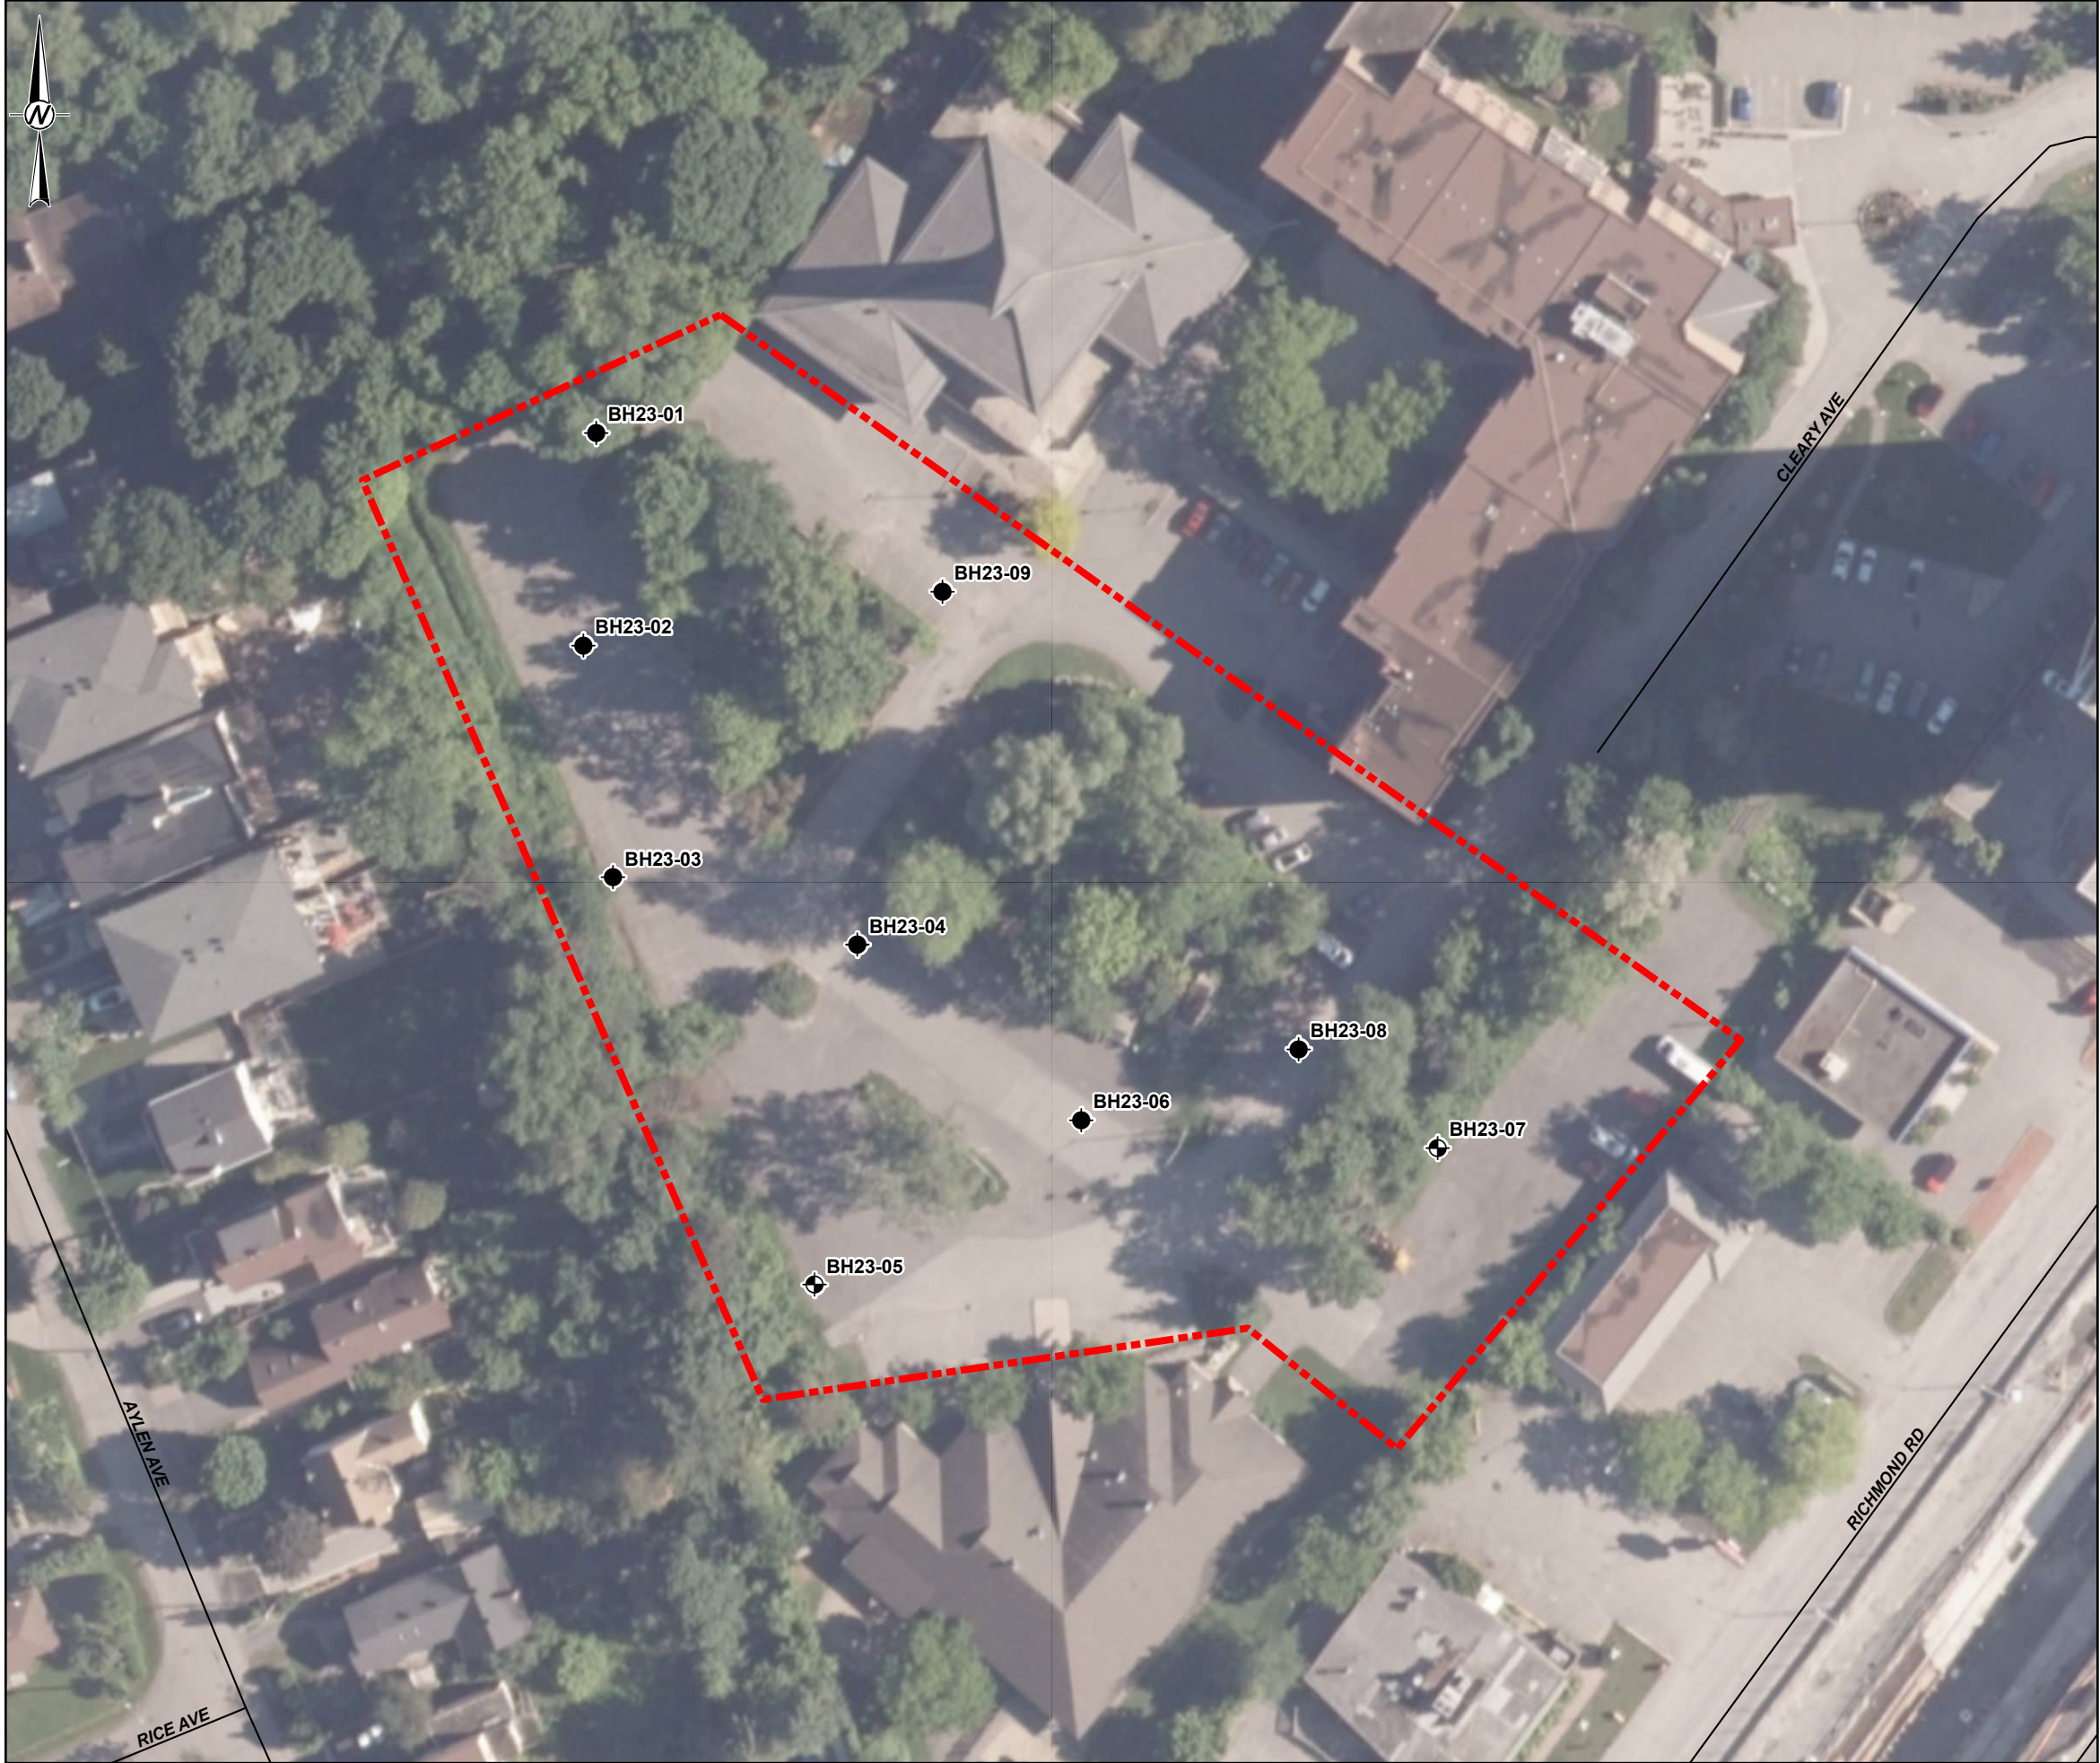
Figure 5 – Investigation Locations

APEC 2 – The investigation included the collection of six soil samples and two groundwater samples from APEC 2. The reported concentrations of all COPCs met the applicable site condition standards with the exception of the reported barium concentration at BH23-01.

- BOREHOLE LOCATION
- BOREHOLE/MONITORING WELL LOCATION
- ROADWAY
- PHASE TWO SITE
