Geotechnical Investigation Proposed Walkley Centre Development 1820-1846 Bank Street, Ottawa, Ontario

FINAL REPORT Revision 1

OTT-23002538-B0

October 3, 2024

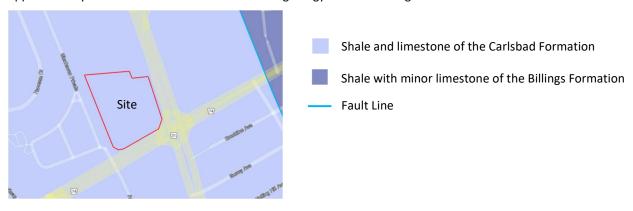
Image 2 - Bedrock Geology

Based on a review of the bedrock geology map (Map P. 2716, Paleozoic Geology of the Ottawa Area, Southern Ontario 1984), the bedrock at the site consists of the Carlsbad formation that consists of a shale and limestone. The shale of the Carlsbad formation is an expansive type of shale. East of the site shale of the Billings formation is present which is also an expansive type of shale. Special procedures will have to be followed during the excavation of the Carlsbad shale. A fault line is noted approximately 230 m east of the site. The bedrock geology is show in Image 2 below.

The bedrock at the site is shale bedrock of the Carlsbad formation which is a type of shale that is prone to deterioration when exposed to the elements. It also heaves due to a complex mechanism caused in part from the bio-oxidation of the sulphides in the rock, which then react with calcite seams to form expanding gypsum. This occurs when oxygen is permitted to enter the rock, usually by exposure or lowering of the water table and is accelerated by the presence of heat.

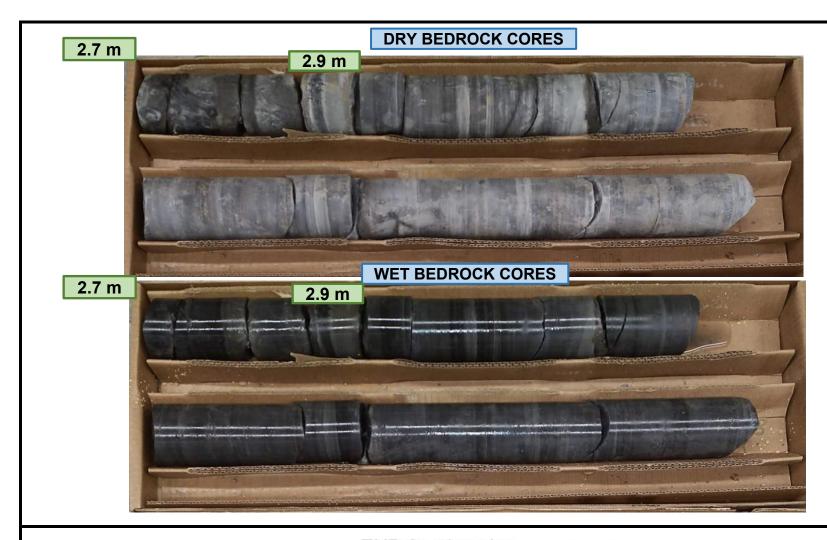
Core Runs Run 2: 2.9 m to 4.5 m Run 3: 4.5 m to 5.9 m	Geotechnical Investigation - Walkley Centre Development	Project N0: OTT-23008400-A0
Date Cored 10/26/2023		Rock Core Photographs	A-2

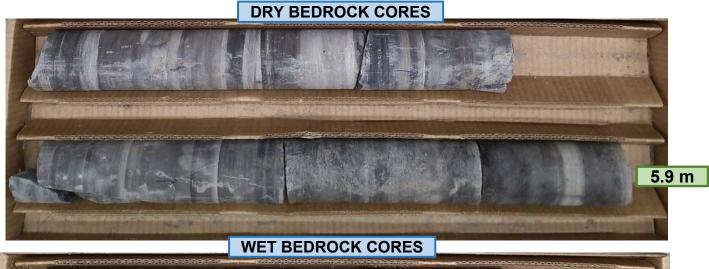
Core Runs Run 2: 2.9 m to 4.5 m Run 3: 4.5 m to 5.9 m	Geotechnical Investigation - Walkley Centre Development	Project N0: OTT-23008400-A0
Date Cored 10/26/2023		Rock Core Photographs	A-3

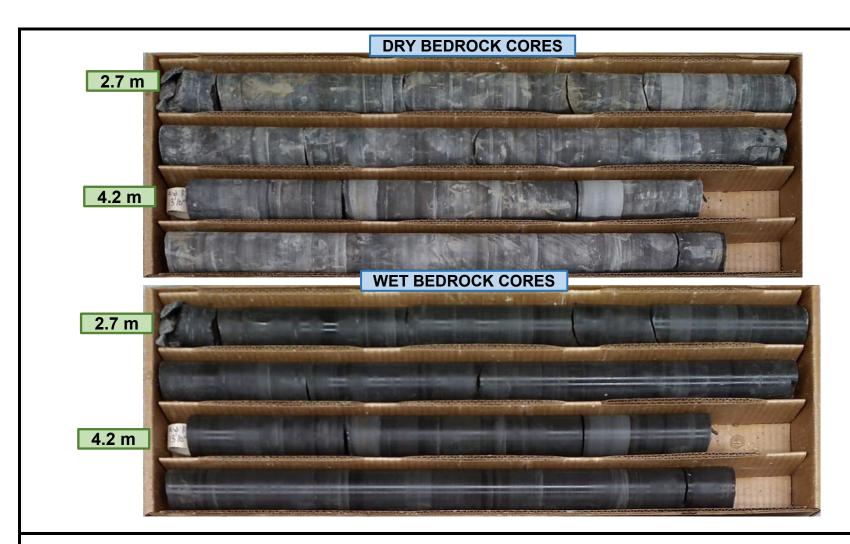
Core Runs Run 1: 2.7 m to 4.2 m Run 2: 4.2 m to 5.6 m	Geotechnical Investigation - Walkley Centre Development	Project N0: OTT-23008400-A0
Date Cored 10/30/2023		Rock Core Photographs	A-4

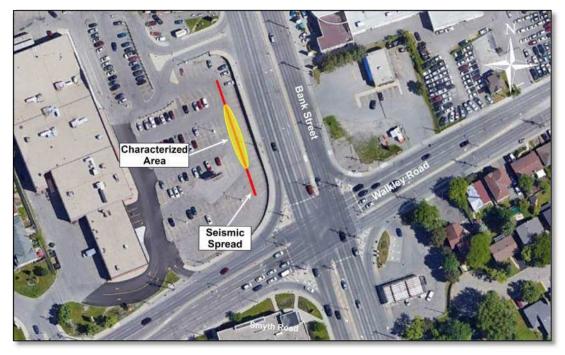
FIGURE 2 Location of borehole 23-01
