BGO Bank & Walkley
Ottawa, ON

Title
TREE CONSERVATION REPORT

TCR 02

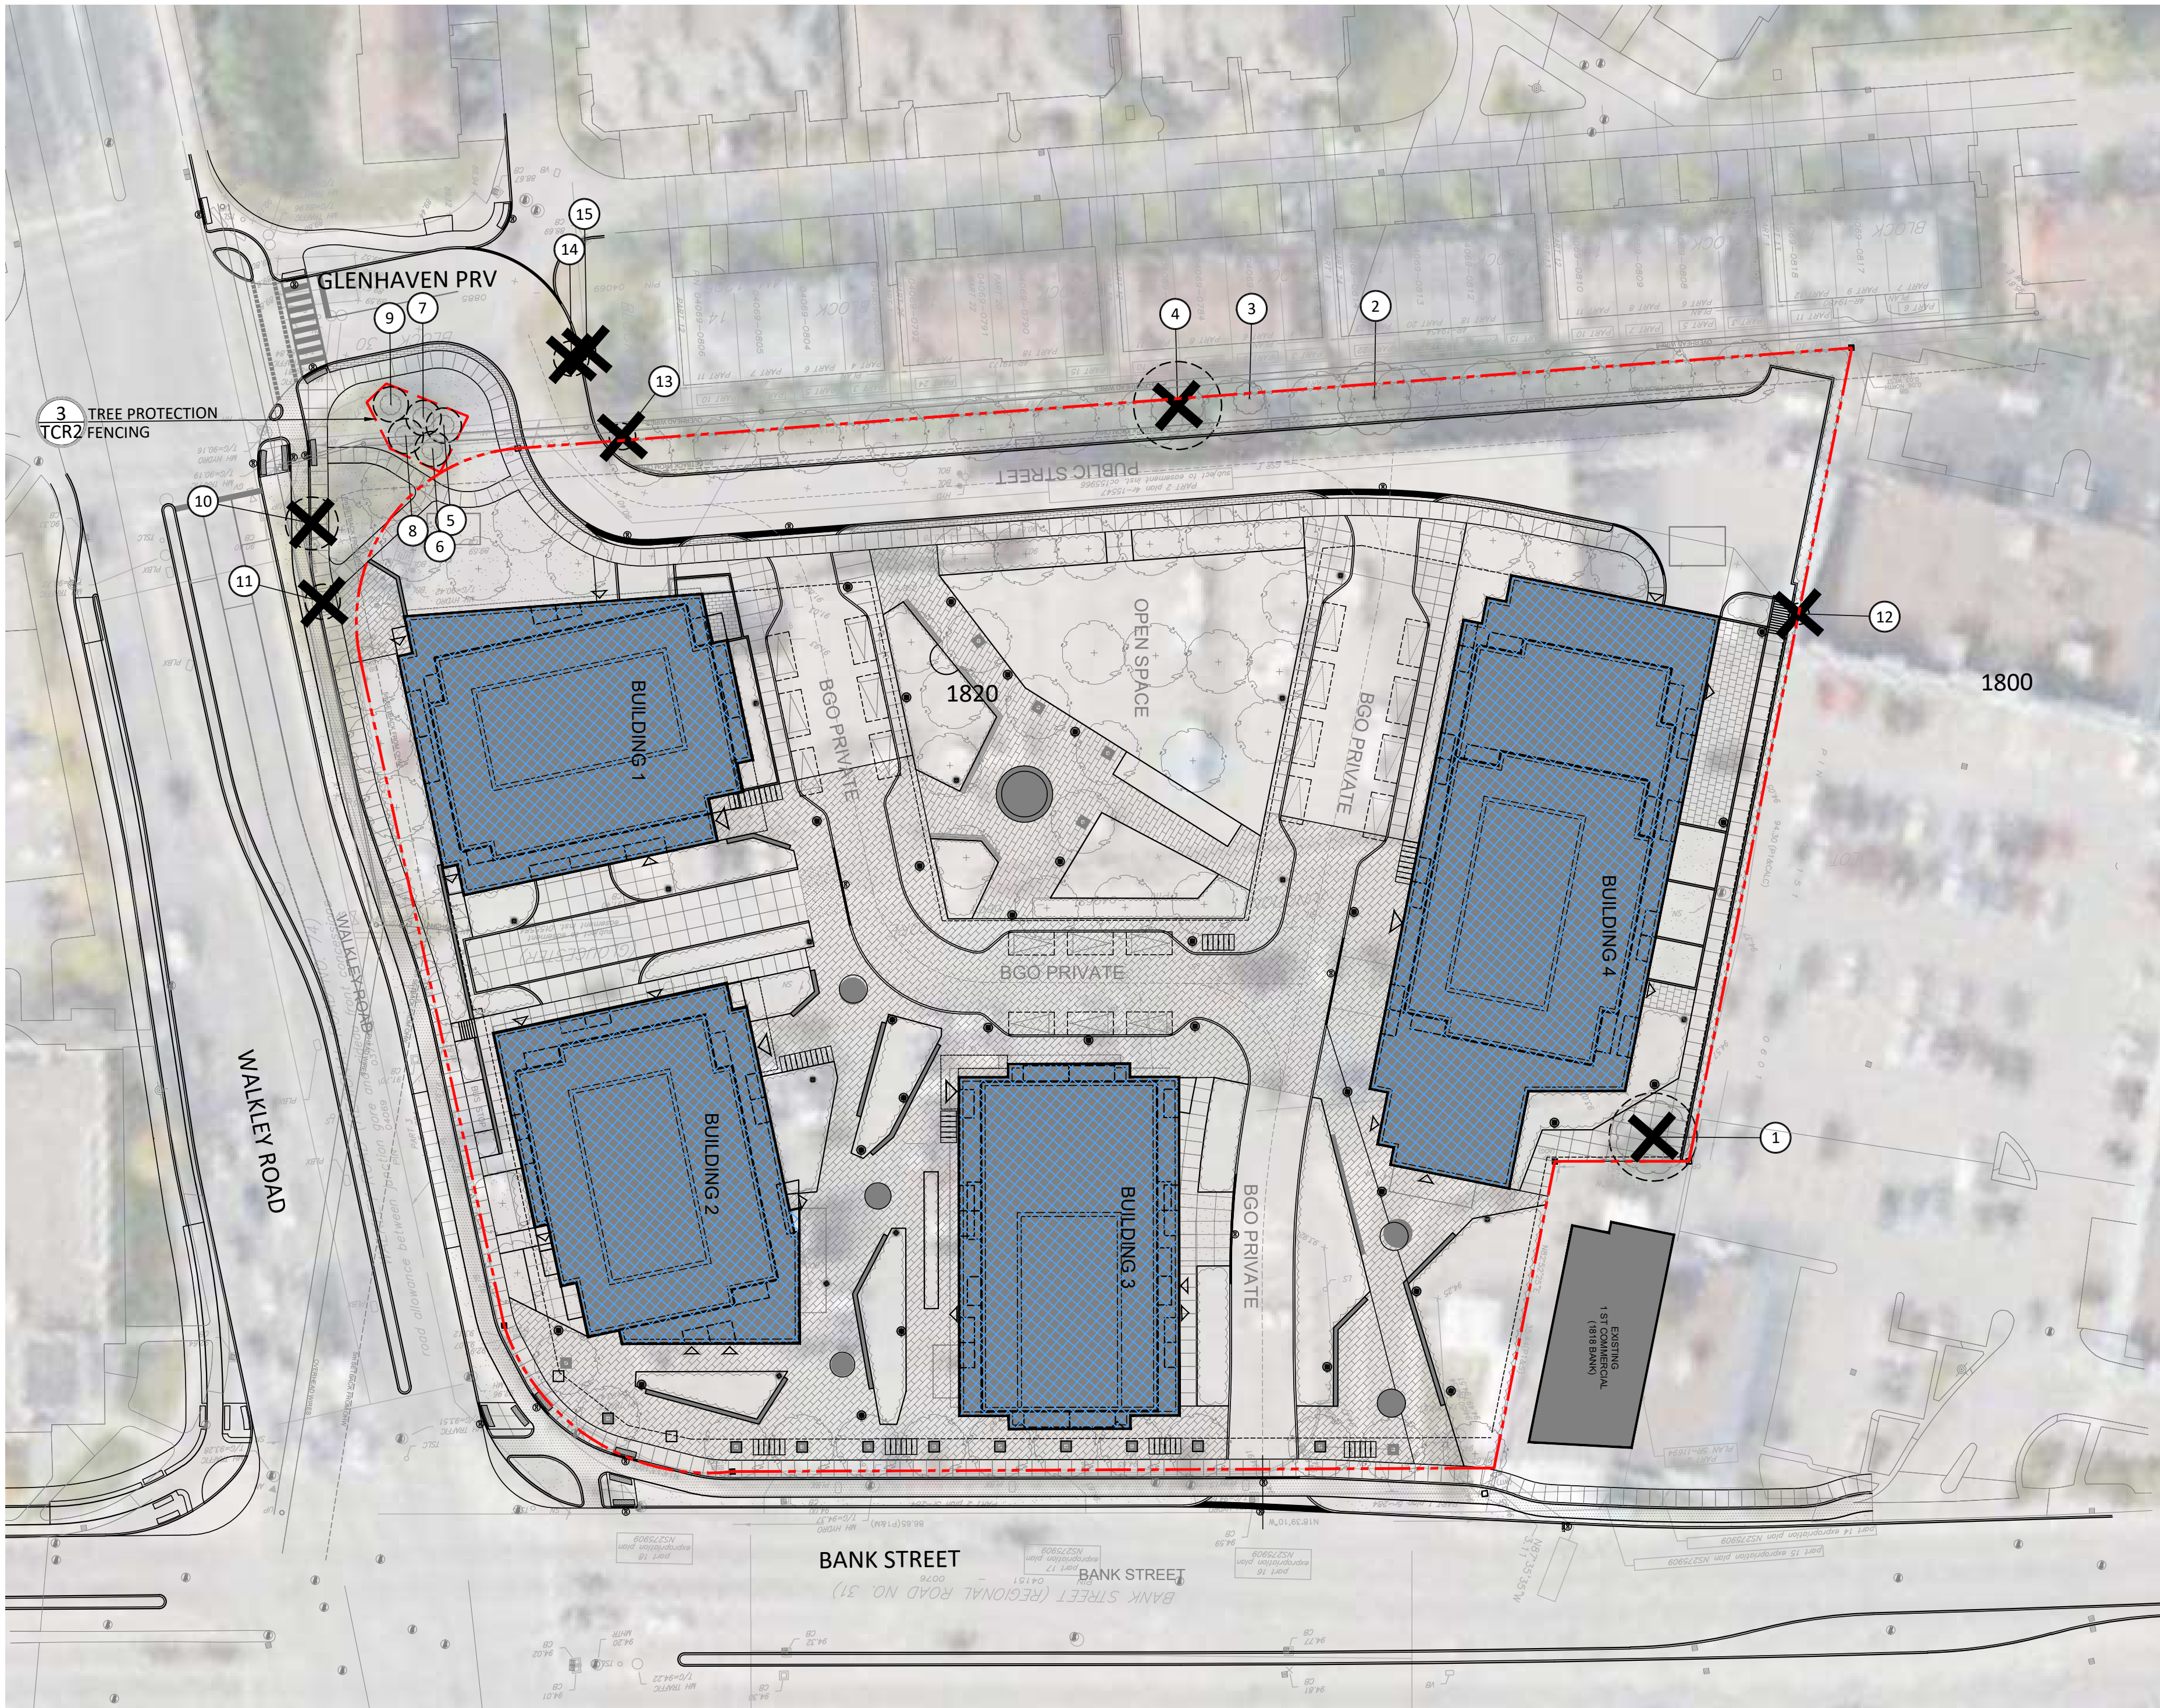
2 PROPOSED DEVELOPMENT Scale: 1:500

Tree #	Botanical Name	Common Name	DBH (cm)	Ownership		Condition	NOTES	To Be Preserved	Reason for Removal
1	Acer platanoides	Norway Maple	50	Private	1822 Bank St	Moderate	Asymmetrical canopy, Dieback ~15% @ canopy, Broken limbs, Single stem, Bark rot @ limbs, Girdled roots	NO	Tree location in conflict with proposed site construction
2						Missing	Tree Removed	N/A	
3						Missing	Tree Removed	N/A	
4	Ulmus spp.	Elm	50	Private	1822 Bank St	Moderate	Asymmetrical canopy, Dieback ~10% @ limbs, Pruned @ O.H., Poor branch union, Multi-stem w/ 3	NO	Heavily pruned tree and conflict with site construction activities
5	Acer platanoides	Norway Maple	20	Private	ROW Glenhaven Prv	Moderate	Asymmetrical canopy, Dieback ~30% @ Canopy, Pruned limbs, Single stem, Bark rot @ cavities	YES	
6	Acer platanoides	Norway Maple	20	Private	ROW Glenhaven Prv	Moderate	Asymmetrical canopy, Broken limbs, Single stem, Pruned branches, Heart rot @ limbs, Girdled trunk from staking	YES

7	Acer platanoides	Norway Maple	20	Private	ROW Glenhaven Prv	Moderate	Asymmetrical canopy, Dieback ~10% @ canopy, Single stem, Included bark, Girdled roots	YES	
8	Acer platanoides	Norway Maple	20	Private	ROW Glenhaven Prv	Good	Asymmetrical canopy, Pruned branches @ O.H., Single stem	YES	
9	Acer platanoides	Norway Maple	20	Private	ROW Glenhaven Prv	Good	Asymmetrical canopy, Dieback ~10% @ canopy, Single stem, Girdled roots	YES	
10	Acer platanoides	Norway Maple	30	City		Moderate	Symmetrical canopy, Dieback ~15% @ canopy, Single stem, Girdled roots	NO	Tree location in conflict with proposed ROW construction
11	Acer platanoides	Norway Maple	20	City		Good	Symmetrical canopy, Single stem	NO	Tree location in conflict with proposed ROW construction
12	Ulmus spp.	Elm	12	Boundary	1822 Bank St/1800 Bank St	Moderate	Asymmetrical canopy, Broken limbs, Single stem, (2) Leaders @ 2m above grade, Included bark, Grown into C.L. fence	NO	Tree location in conflict with proposed site construction

13	Celtis occidentalis	Hackberry	15	Private	ROW Glenhaven Prv	Moderate	Symmetrical canopy, Single stem, Grown btwn 2 privacy fences	NO	Tree location in conflict with proposed site construction
14	Acer platanoides 'Crimson King'	Norway Maple	20	Private	ROW Glenhaven Prv	Moderate	Symmetrical canopy, Single stem, (3) Leaders @ 2m above grade, Large crack on trunk	NO	Tree location in conflict with proposed site construction
15	Picea pungens var. 'Glauca'	Colorado Blue Spruce	10	Private	ROW Glenhaven Prv	Poor	Asymmetrical canopy, Dieback ~80% @ canopy, Single stem	NO	Tree location in conflict with proposed site construction

- TREES IDENTIFIED FOR RETENTION ARE IN MODERATE TO GOOD CONDITION AND CAN BE REASONABLY PROTECTED FROM CONSTRUCTION ACTIVITIES, GIVEN ADEQUATE TREE PROTECTION MEASURES AS DESCRIBED ARE TAKEN.

- THE AREAS WITHIN THE TREE PROTECTION ZONE MUST REMAIN UNDISTURBED AT ALL TIMES. NO WORK OR MATERIAL STORAGE IS PERMITTED WITHIN THE TREE PROTECTION ZONE.

- TREES THAT HAVE DIED OR HAVE BEEN DAMAGED BEYOND REPAIR WILL BE REMOVED AND REPLACED WITH TREES OF AN EQUIVALENT SIZE AND SPECIES AS APPROVED BY THE LANDSCAPE ARCHITECT OR CITY OF OTTAWA.

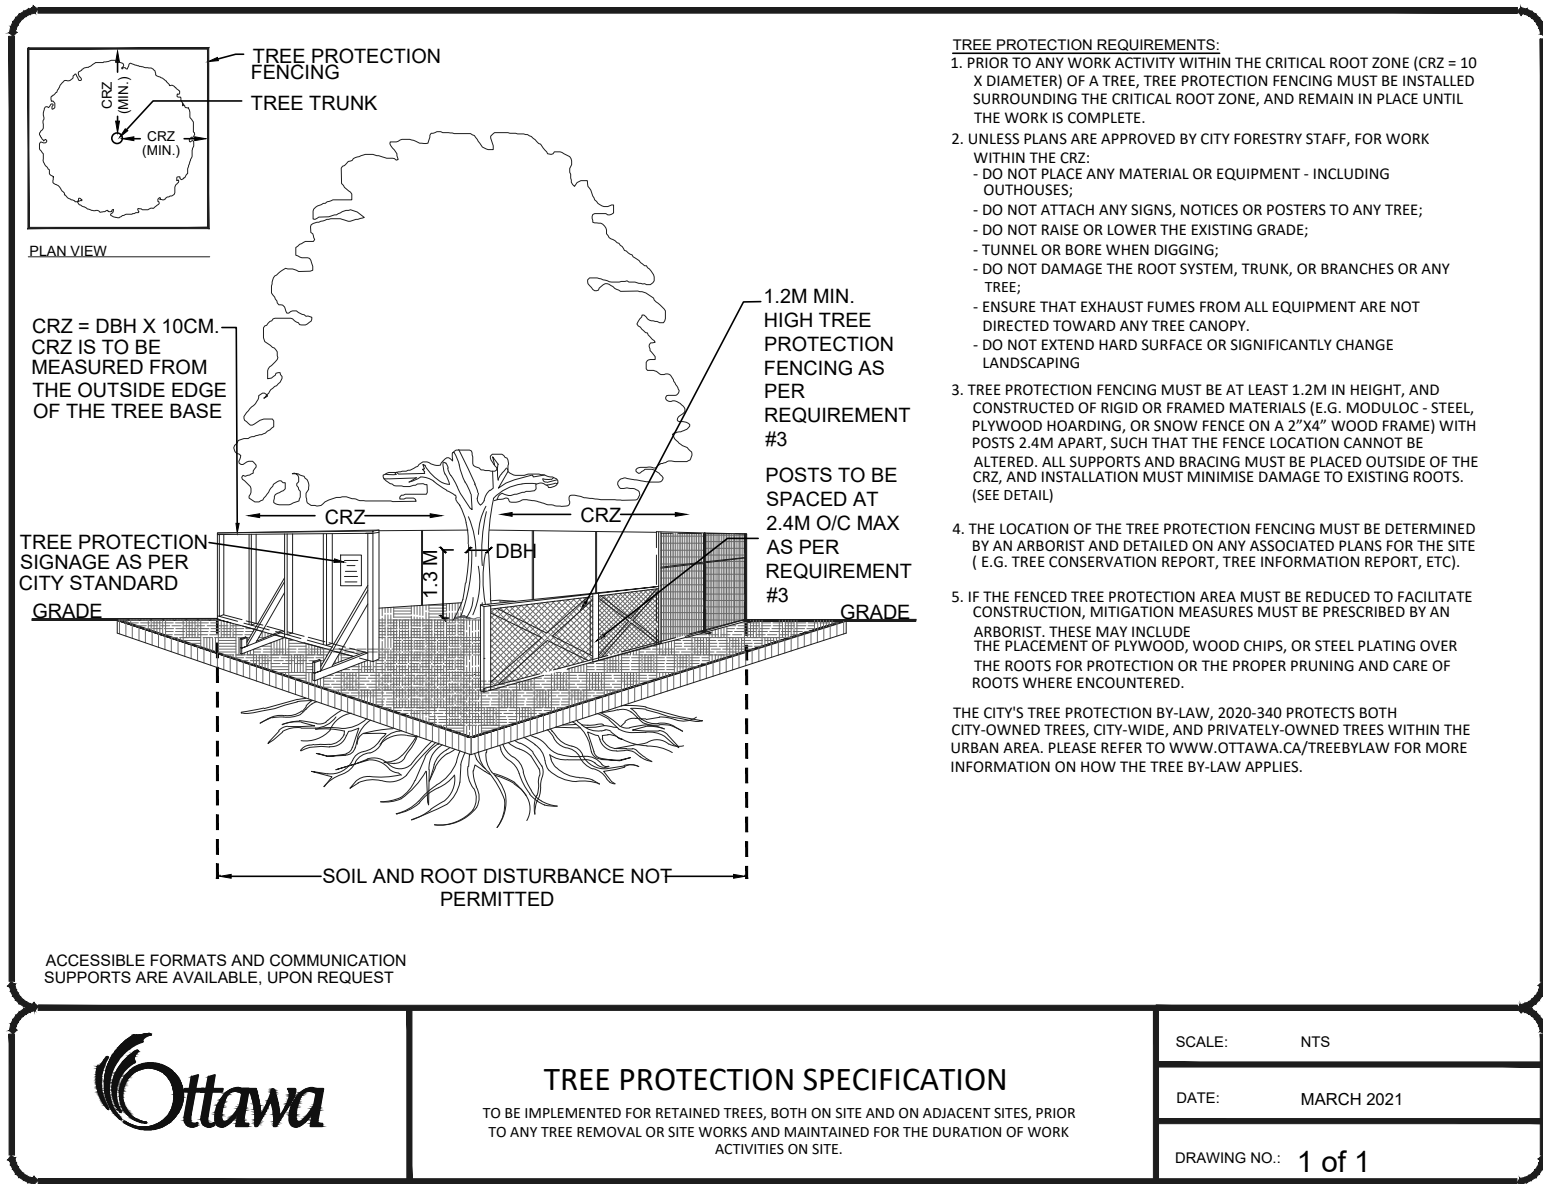
3 TREE PROTECTION FENCING Scale: N.T.S

- INSTALLATION OF TREE PROTECTION FENCE SHALL BE LOCATED AT THE CRITICAL ROOT ZONE.
CRITICAL ROOT ZONE : 10cm x DIAMETER AT BREAST HEIGHT (DBH)
EXAMPLE: DBH = 30cm; CRZ = 300cm / 3.0m

- TREE PROTECTION FENCE MUST NOT BE REMOVED WITHOUT THE WRITTEN AUTHORIZATION OF THE LANDSCAPE ARCHITECT.
- ALL DISTURBED AREAS TO BE RESTORED TO FINISHED CONDITION WITH 150mm TOPSOIL AND SOD OR SEED AS INDICATED.

- IF CUTTING OF ROOTS OR CHANGING OF GRADES AROUND EXISTING TREES IS SPECIFIED, FOLLOW APPROPRIATE DETAILS AS DIRECTED BY LANDSCAPE ARCHITECT.
- INSTALL TREE PROTECTION FENCE TO SATISFACTION OF THE LANDSCAPE ARCHITECT. TREE PROTECTION SHALL REMAIN UNTIL SUBSTANTIAL PERFORMANCE OF THE PROJECT OR UPON WRITTEN AUTHORIZATION FROM THE LANDSCAPE ARCHITECT.
