Phase I Environmental Site Assessment

4497A & 4497B O'Keefe Court
Ottawa, Ontario

Mattamy Corporation

Report: PE6605-1
August 19, 2024

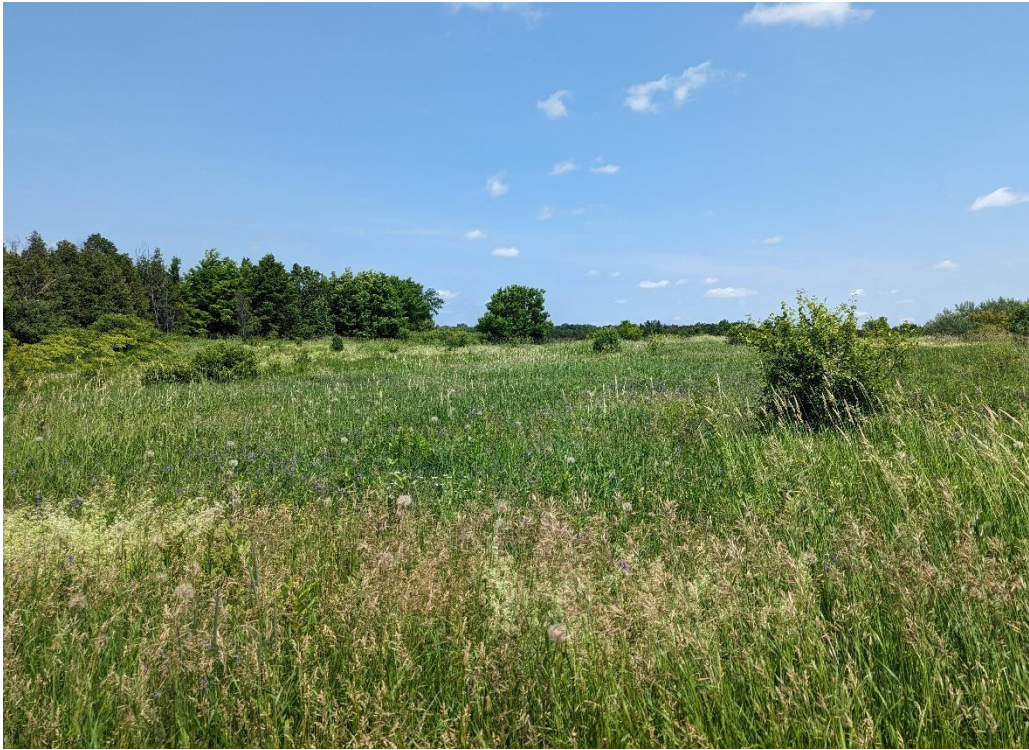
Photograph 1: View looking east at APEC 1 from 4497A O'Keefe Court.

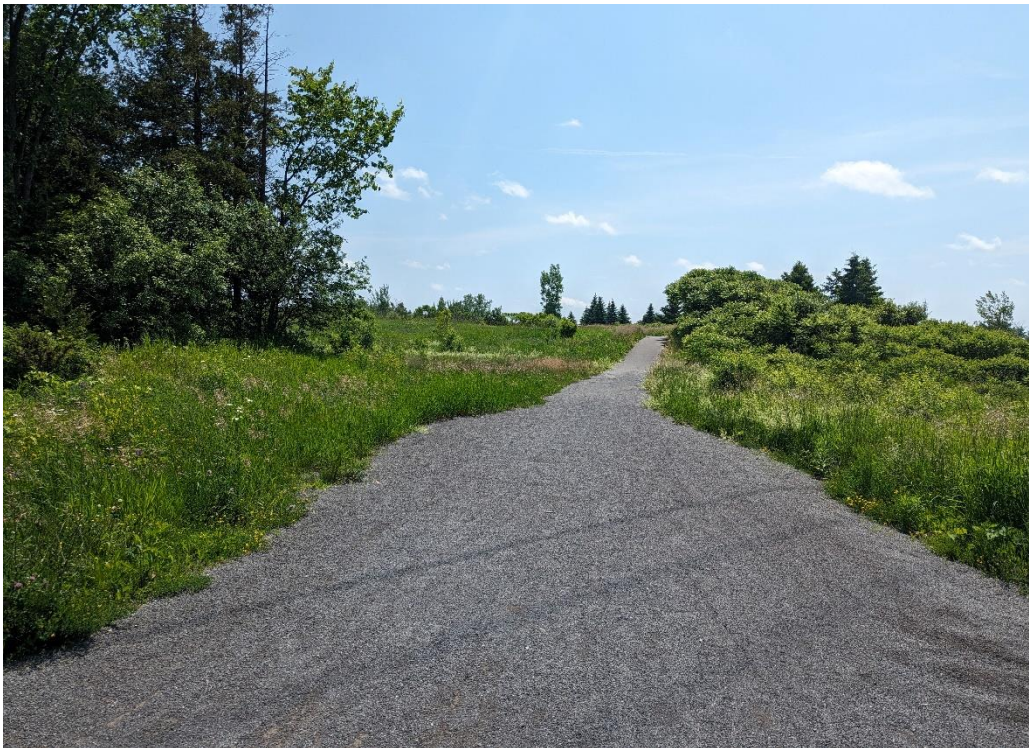
No sheen, film, foam or other evidence of potential contamination was observed in either waterbody. No signs of stressed vegetation, or surficial staining is evident on the Phase I Property. Fill placement was noted on the west side of the Phase I Property south of the hydro electrical corridor.

Photograph 2: View looking south along the west edge of the Phase I Property from the hydroelectric easement.

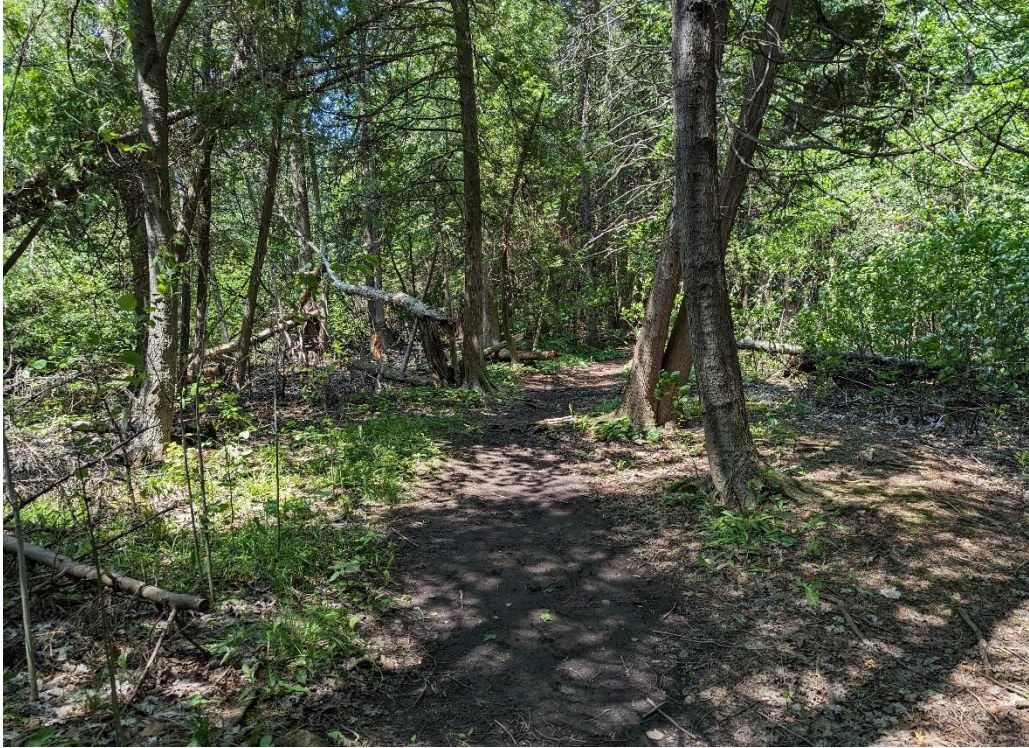
Photograph 3: View looking north at 4497A O'Keefe Court from 4497 A O'Keefe Court.

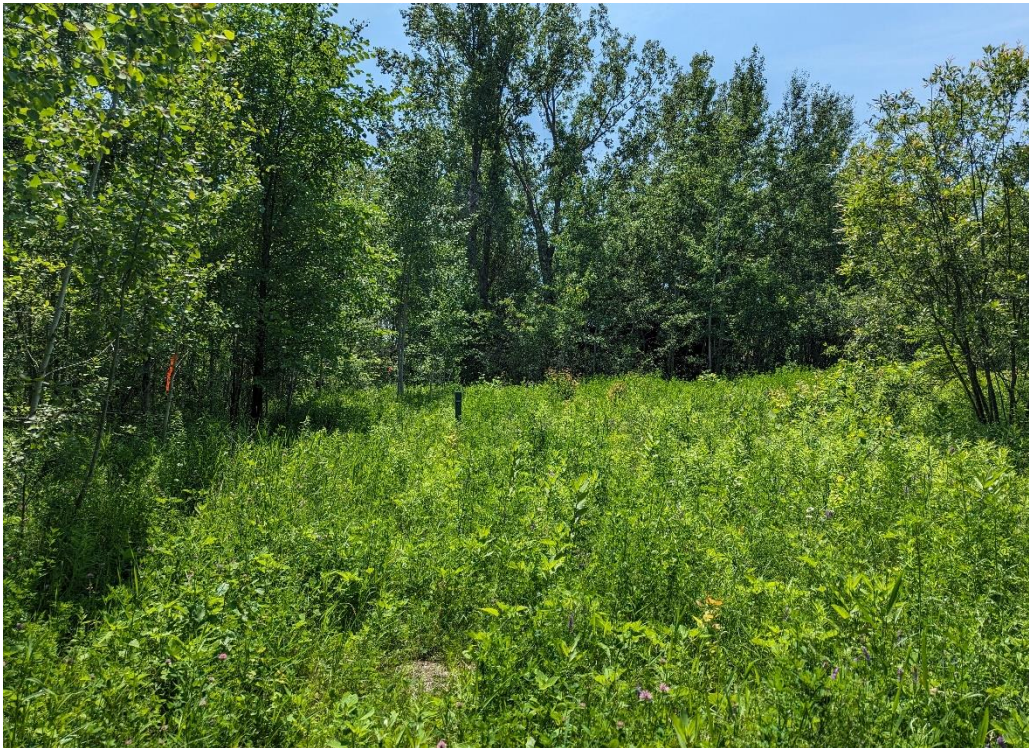
At the time of the site inspection, three monitoring wells were observed on the property addressed 4497B O'Keefe Court. These are consistent with the wells BH6-24, BH7-24, and BH8-24 which were installed in 2024 for long term groundwater monitoring in anticipation of future development needs.

Photograph 4: View looking south, at BH6-24 and the Historical Location of APEC 2 from 4497B O'Keefe Court.

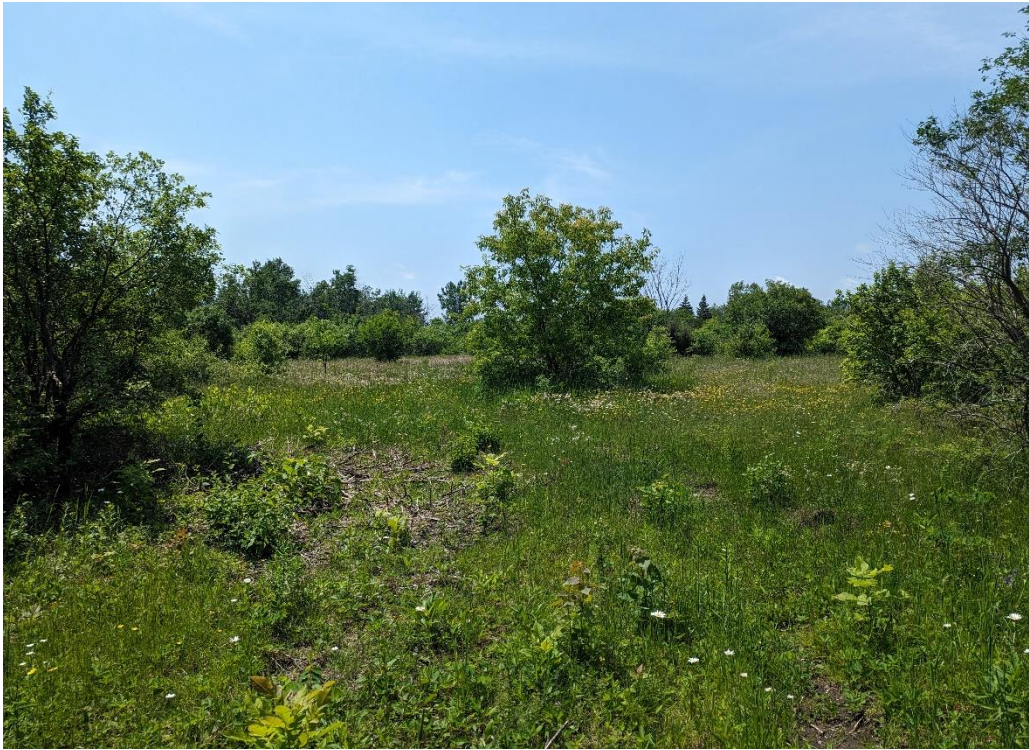
Photograph 5: View looking southwest at 4497B O'Keefe Court from the Phase I Property.

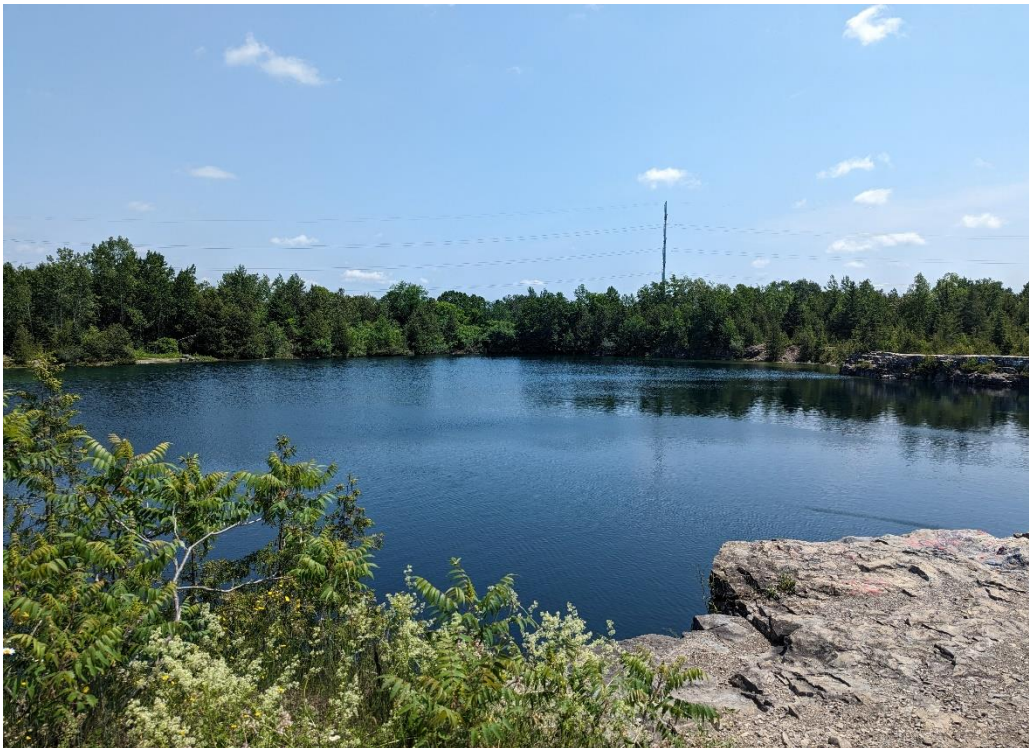
The Phase I Property is made up of two vacant parcels of land bisected by a hydro electrical corridor. The topography of Phase I Property is undulating and drainage occurs through infiltration; the ground surface is covered with a combination of low-lying vegetation, established mature forests, wetland, and some exposed rock outcrops. There are two bodies of water on the Phase I Property, a flooded former quarry and a pond.

Photograph 6: View looking east across the inactive quarry, from the Phase I Property.
