# **Phase I Environmental Site Assessment**

1867 Alta Vista Drive  
Ottawa, Ontario

Prepared for: TCU Development Corporation

Report: PE6971-1  
Date: June 23, 2025

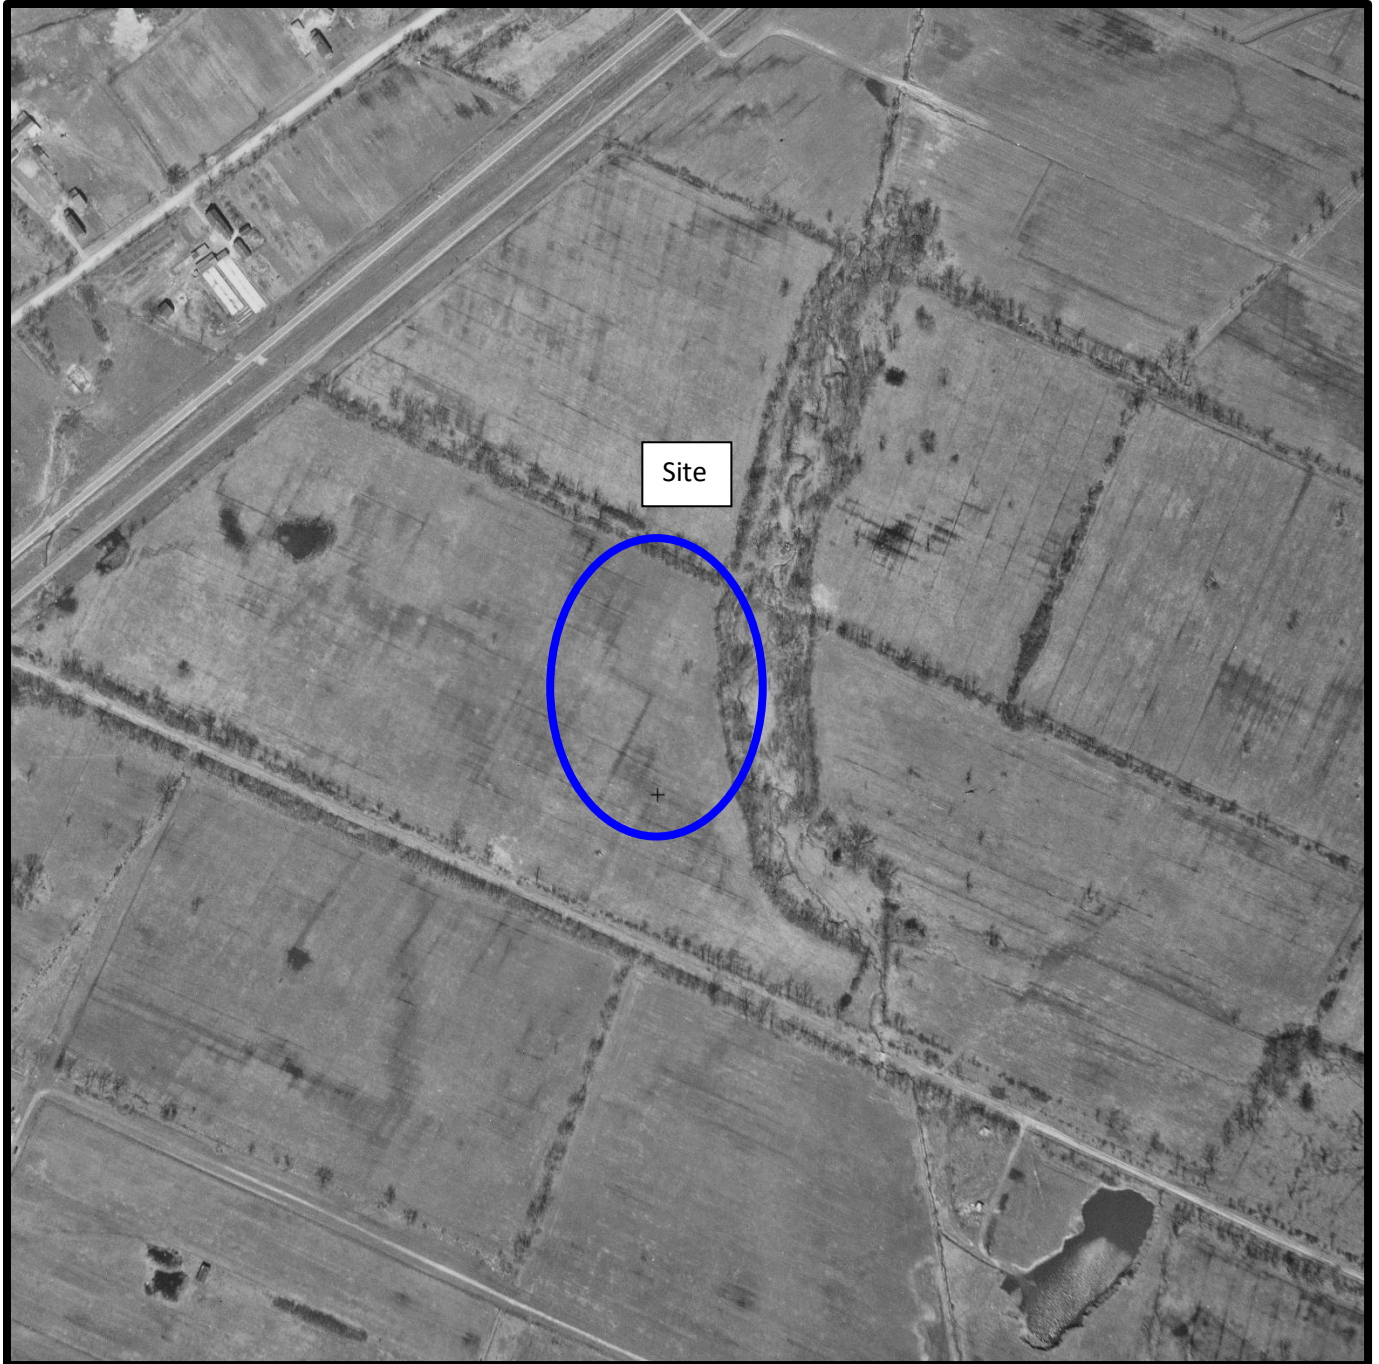
| 1933 | The Phase I Property appears to consist of vacant, undeveloped land. A creek is present to the east of the Phase I Property. The surrounding area primarily consists of vacant and agricultural land. A railway line is observed further west of the Phase I Property, running in a north–south direction. |

AERIAL PHOTOGRAPH  
1933

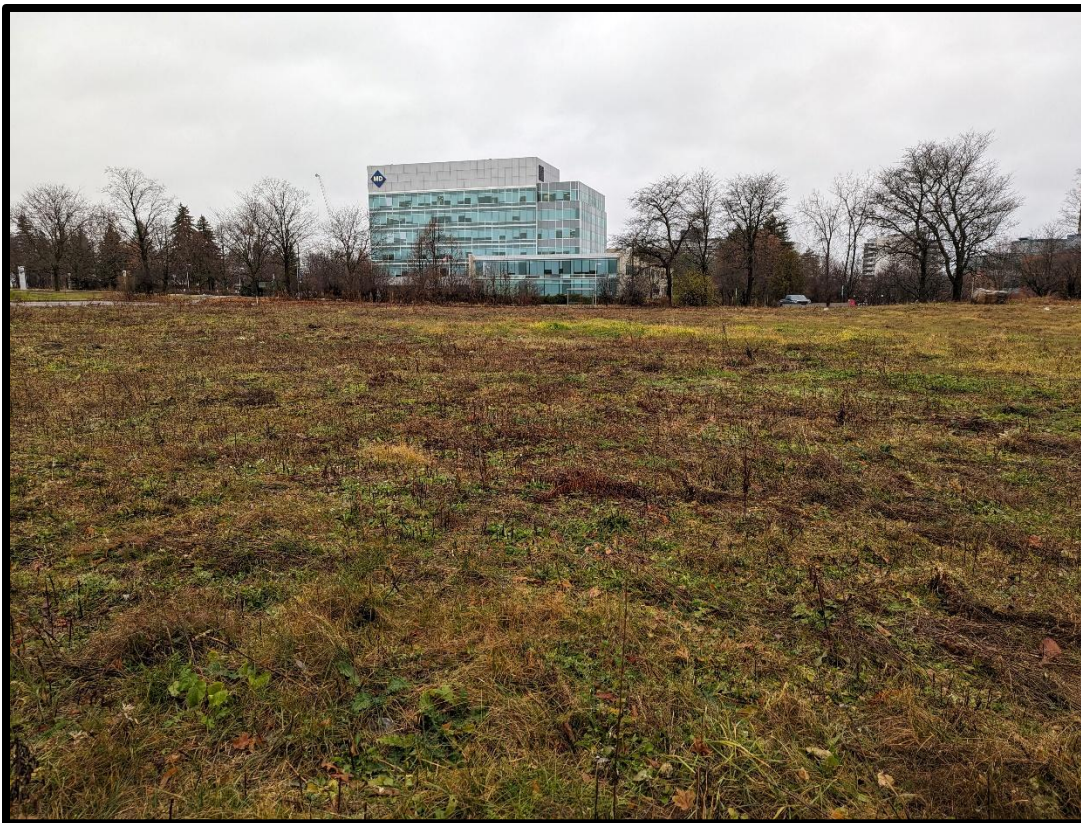
Photograph 4: View of central portion of the Phase I Property, facing west.

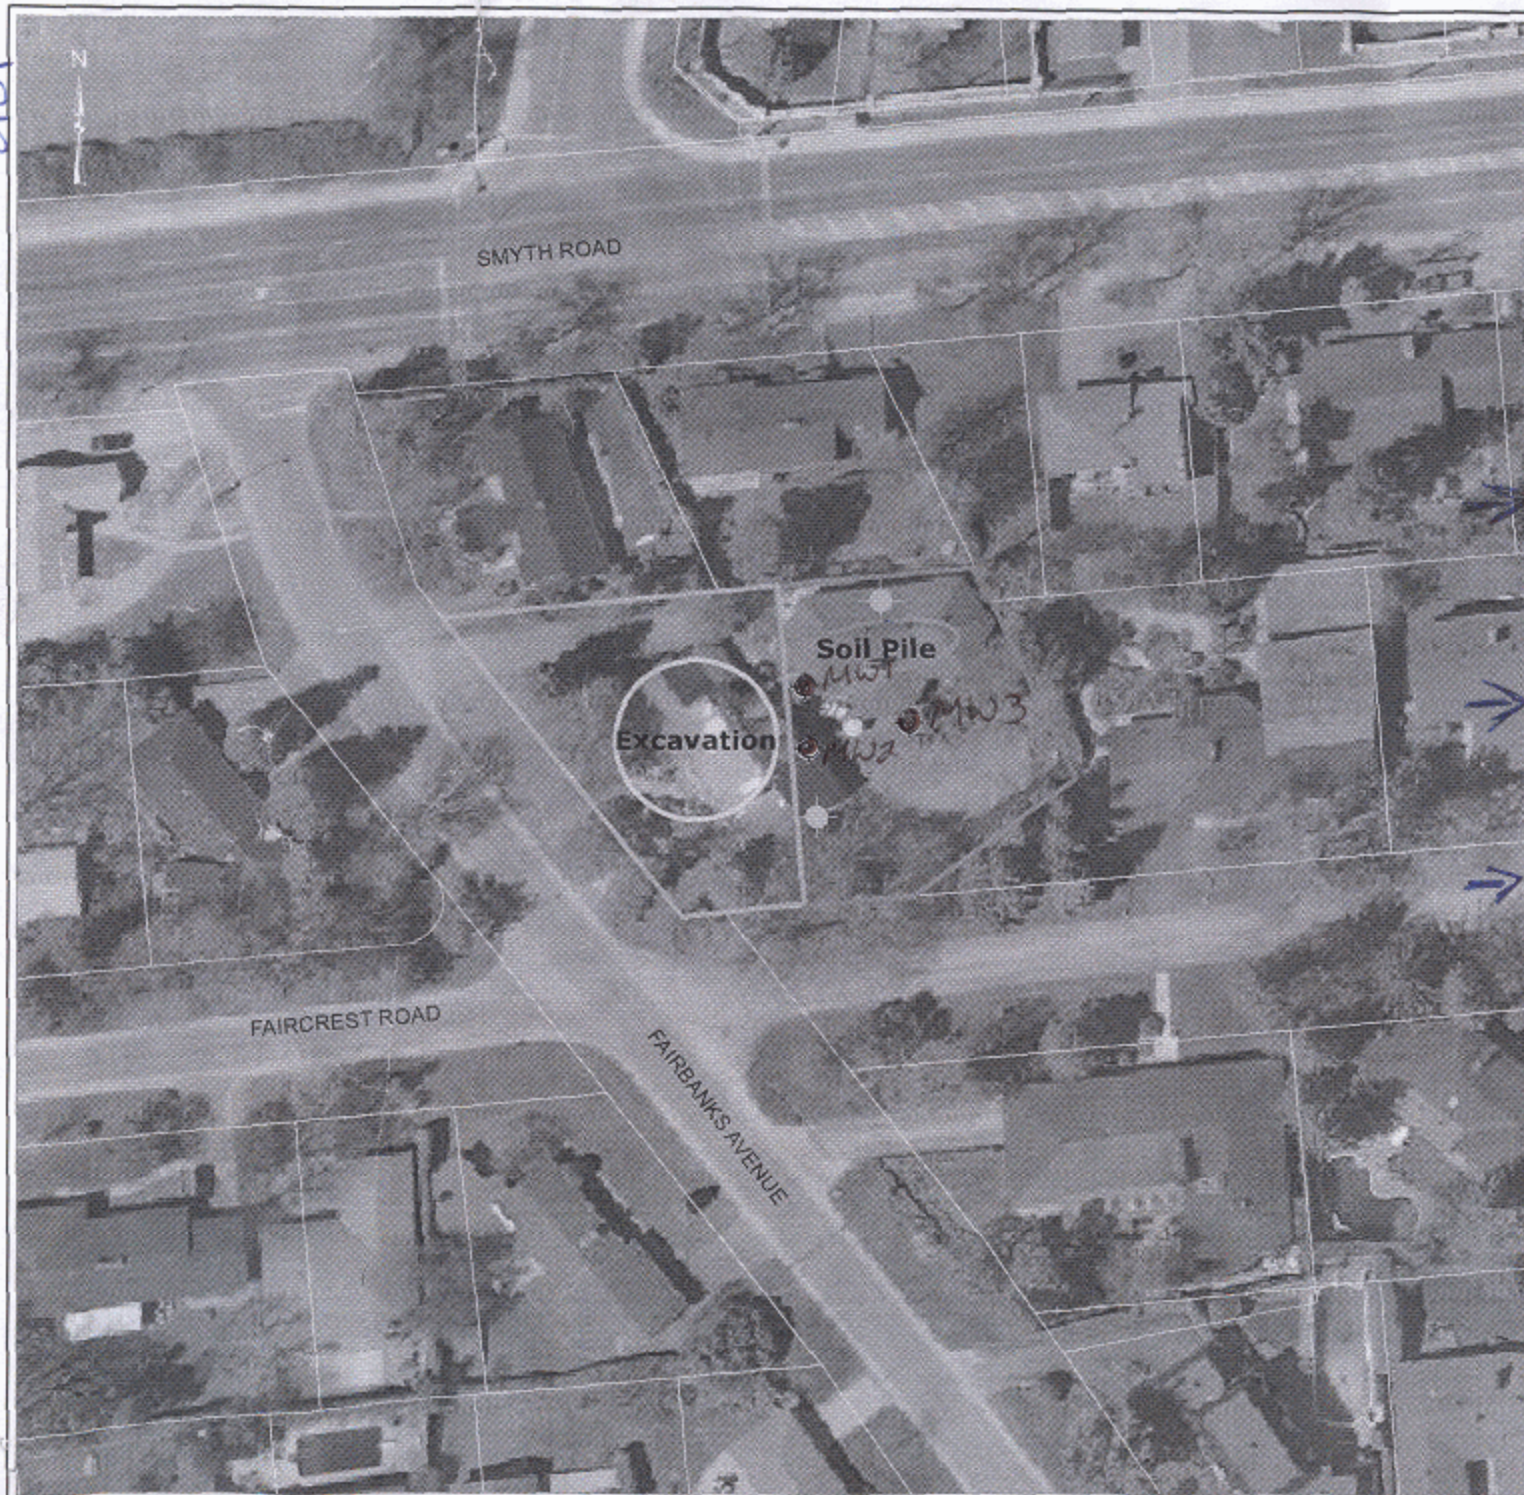
MECP Municipal Coal Gasification Plant Site Inventory, 1991.  
MECP document titled “Waste Disposal Site Inventory in Ontario”.  
MECP Brownfields Environmental Site Registry.  
MNR Areas of Natural Significance.  
MECP Water Well Record Inventory.  
Maps and photographs (Geological Survey of Ontario surficial and subsurface mapping).  
Chapman, L.J., and Putnam, D.F., 1984: ‘The Physiography of Southern Ontario, Third Edition’, Ontario Geological Survey Special Volume 2.

- Approximate Proposed Boreholes with Monitoring Well
- Approximate Proposed Boreholes
- Subject Property (Parts 3 and 4)
- Parts 1 and 2
- Property Boundary
