## Geotechnical Investigation

Proposed Residential Development  
1020 and 1070 March Road  
Ottawa, Ontario

Valecraft Homes Ltd.

Report PG5145-1 Revision 2

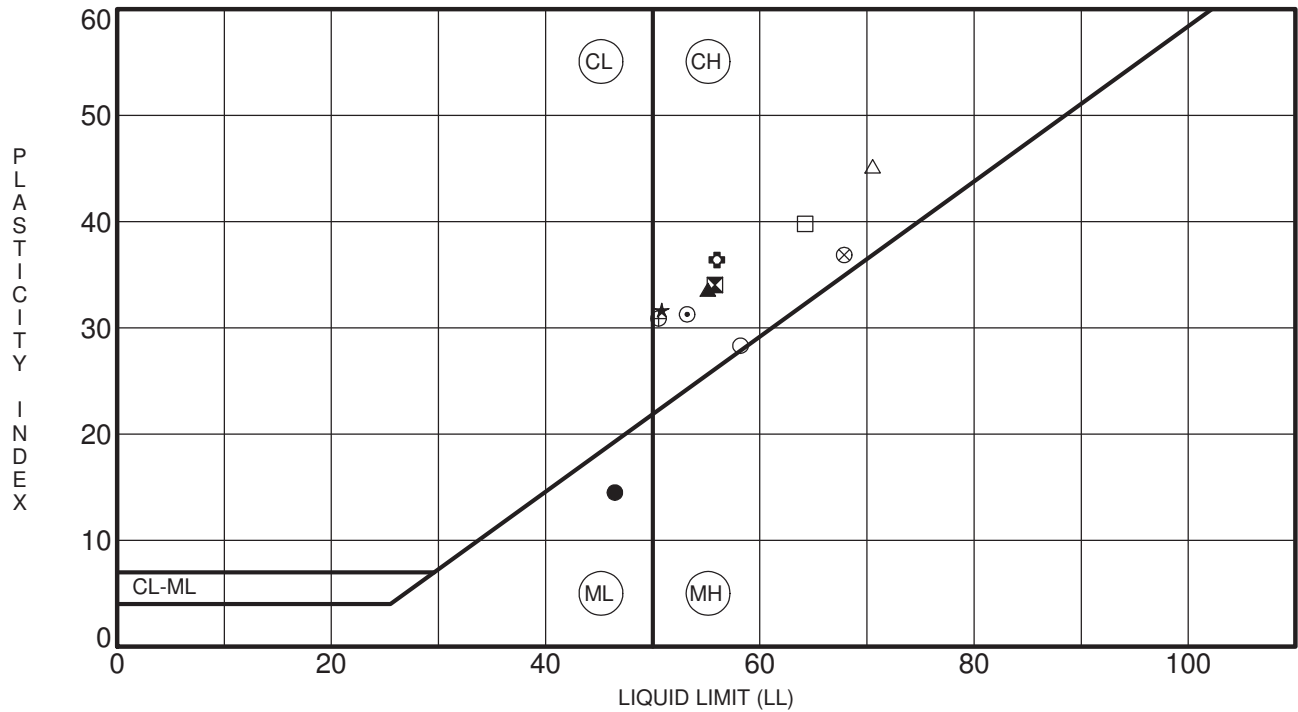
Specimen Identification	LL	PL	PI	Fines	Classification
● TP 1-19 G 3	46	32	14		ML - Inorganic silts of low plasticity
⊠ TP 2-19 G 2	56	22	34		CH - Inorganic clays of high plasticity
▲ TP 3-19 G 2	55	22	34		CH - Inorganic clays of high plasticity
★ TP 4B-19 G 3	51	19	32	99.3	CH - Inorganic clays of high plasticity CH
⊙ TP 5-19 G 3	53	22	31		CH - Inorganic clays of high plasticity
⊕ TP 6-19 G 3	56	20	36		CH - Inorganic clays of high plasticity
○ TP 7-19 G 3	58	30	28		CH - Inorganic clays of high plasticity
△ TP 8-19 G 4	71	25	45	97.8	CH - Inorganic clays of high plasticity CH
⊗ TP 9-19 G 3	68	31	37		CH - Inorganic clays of high plasticity
⊕ TP 10-19 G 3	51	20	31		CH - Inorganic clays of high plasticity
□ TP 12-19 G 4	64	24	40		CH - Inorganic clays of high plasticity

Atterberg limits testing, as well as associated moisture content testing, were completed on the recovered silty clay samples at selected locations throughout the subject site. The results of the Atterberg limits tests are presented in Table 1 and on the Atterberg Limits' Results sheet in Appendix 1.

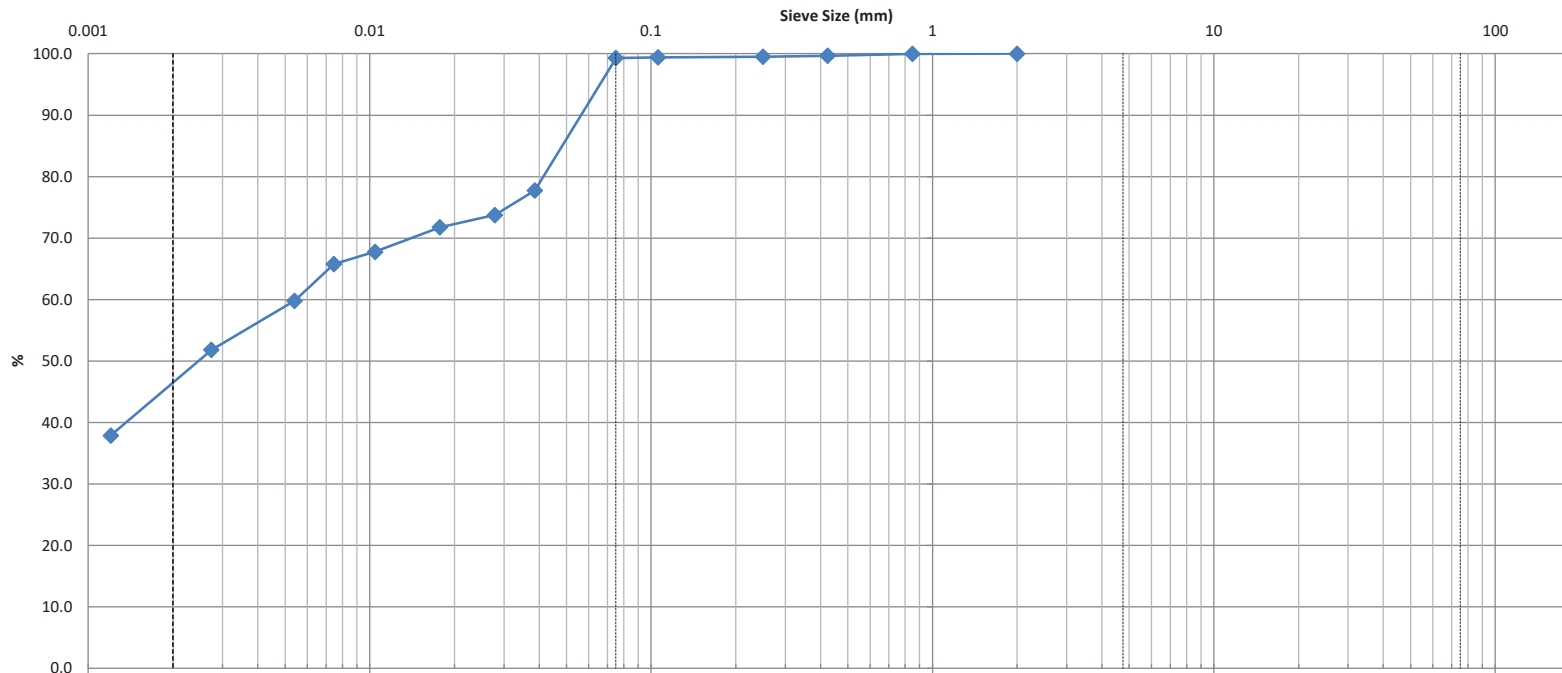
CLIENT:	Valecraft Homes	DEPTH:	1.8 - 1.9m	FILE NO:	PG5145
CONTRACT NO.:		BH OR TP No.:	TP4B - G3	LAB NO:	14615
PROJECT:	1020 to 1070 March Road			DATE RECEIVED:	12-Dec-19
DATE SAMPLED:	6-Dec-19			DATE TESTED:	13-Dec-19
SAMPLED BY:	D.P.			DATE REPORTED:	17-Dec-19
				TESTED BY:	O.M.

Identification	Soil Classification					MC(%)	LL	PL	PI	Cc	Cu
	D100	D60	D30	D10	Gravel (%)	25.4					
					0.0	0.7		52.8		46.5

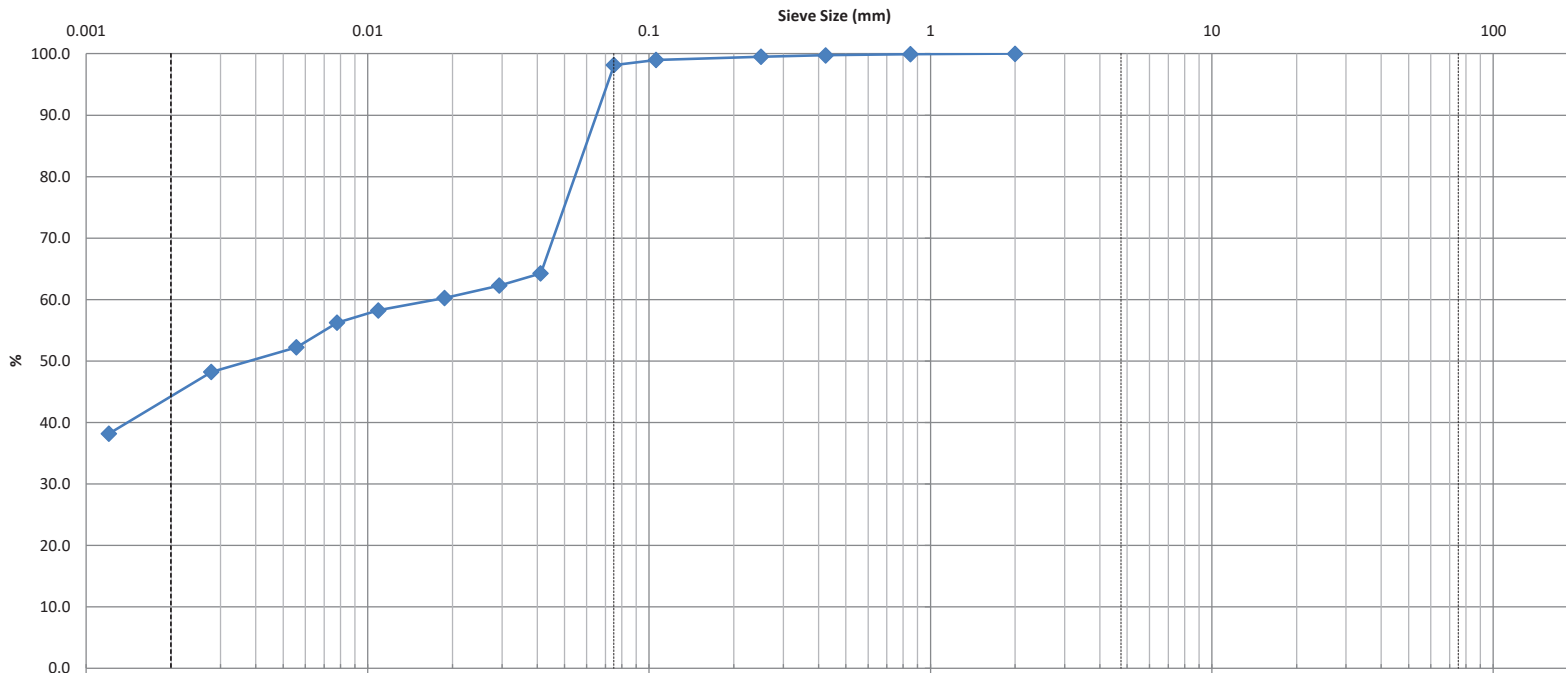
CLIENT:	Valecraft Homes	DEPTH:	1.6 - 1.7m	FILE NO:	PG5145
CONTRACT NO.:		BH OR TP No.:	TP5 - G4	LAB NO:	14616
PROJECT:	1020 to 1070 March Road			DATE RECEIVED:	12-Dec-19
DATE SAMPLED:	6-Dec-19			DATE TESTED:	13-Dec-19
SAMPLED BY:	D.P.			DATE REPORTED:	17-Dec-19
				TESTED BY:	O.M.

Identification	Soil Classification				MC(%)	LL	PL	PI	Cc	Cu
	D100	D60	D30	D10	34.6					
					Gravel (%)	Sand (%)	Silt (%)	Clay (%)		
					0.0	1.8	55.0	43.2

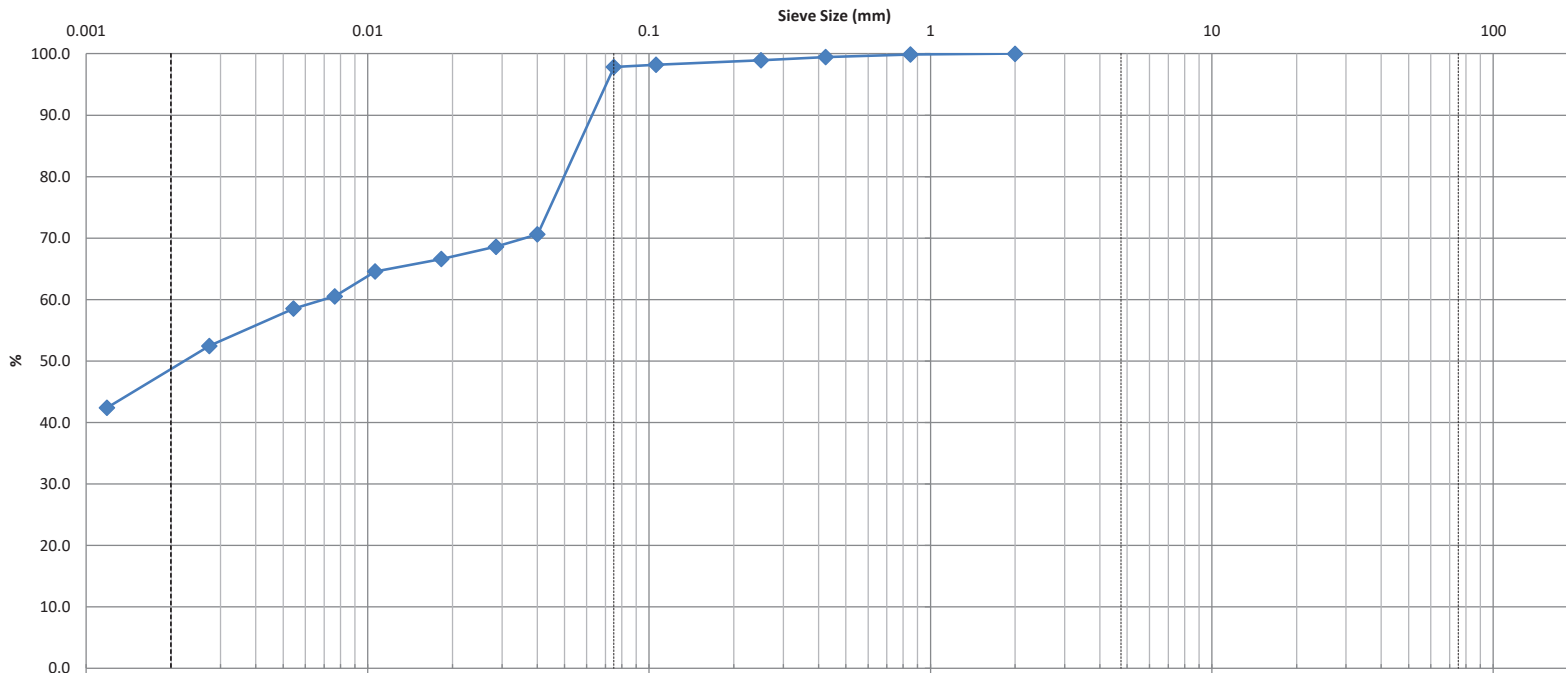
CLIENT:	Valecraft Homes	DEPTH:	1.6 - 1.7m	FILE NO:	PG5145
CONTRACT NO.:		BH OR TP No.:	TP8 - G4	LAB NO:	14617
PROJECT:	1020 to 1070 March Road			DATE RECEIVED:	12-Dec-19
DATE SAMPLED:	6-Dec-19			DATE TESTED:	13-Dec-19
SAMPLED BY:	D.P.			DATE REPORTED:	17-Dec-19
				TESTED BY:	O.M.

Identification	Soil Classification					MC(%)	LL	PL	PI	Cc	Cu
	D100	D60	D30	D10	Gravel (%)	33.0					
					0.0	2.2		49.3		48.5
