## Geotechnical Investigation

Kanata Lakes Golf and Country Club  
7000 Campeau Drive  
Ottawa, Ontario

Minto Communities Inc.  
on behalf of ClubLink Corporation ULC

Report: PG4135-2 Revision 4

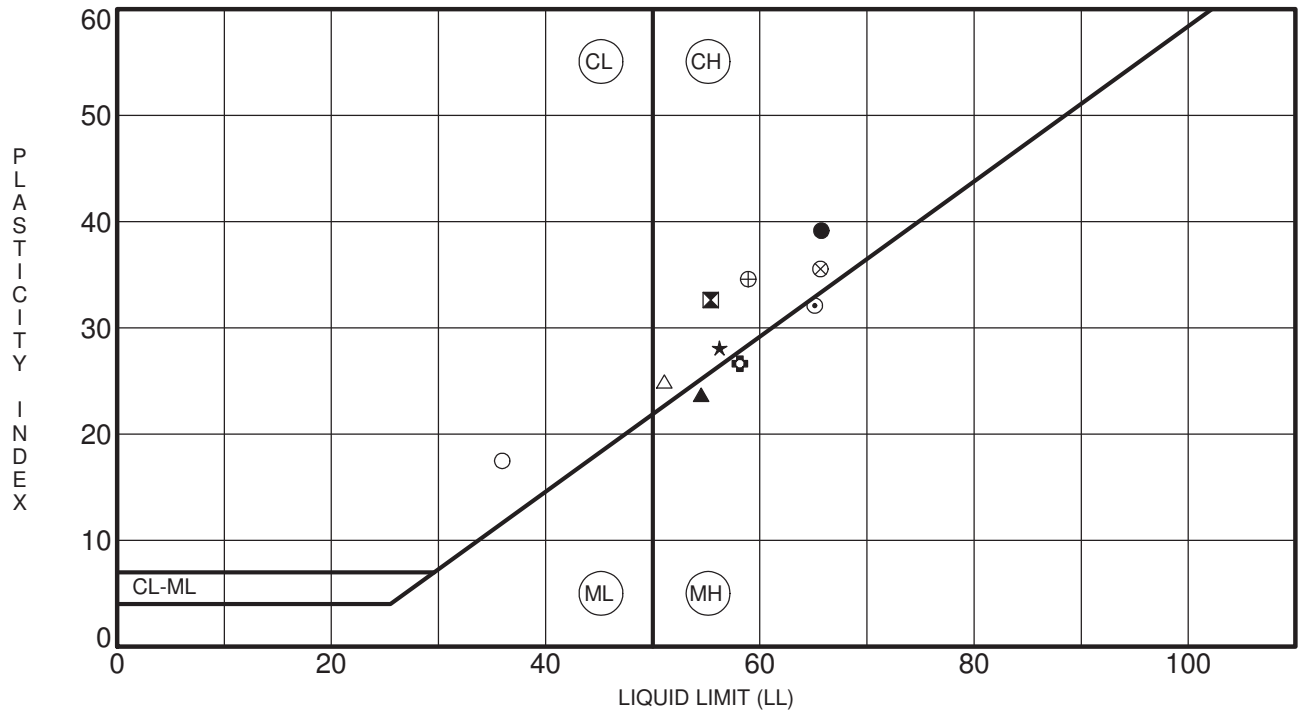
**ATTERBERG LIMITS' RESULTS**

Specimen Identification	LL	PL	PI	Fines	Classification
● BH 6-19 SS 5	66	27	39		CH - Inorganic clays of high plasticity
⊠ BH 7-19 SS 3	55	23	33		CH - Inorganic clays of high plasticity
▲ BH 8-19 SS 3	55	31	24		MH - Inorganic silt of high plasticity
★ BH 9-19 SS 5	56	28	28		CH - Inorganic clays of high plasticity
⊙ BH10-19 SS 5	65	33	32		MH - Inorganic silt of high plasticity
⊛ BH11-19 SS 3	58	32	27		MH - Inorganic silt of high plasticity
○ BH12-19 SS 4	36	18	17		CL - Inorganic clays of low plasticity
△ BH13-19 SS 5	51	26	25		CH - Inorganic clays of high plasticity
⊗ BH14-19 SS 3	66	30	36		CH - Inorganic clays of high plasticity
⊕ BH15-19 SS 4	59	24	35		CH - Inorganic clays of high plasticity

<b>Table 1 - Summary of Atterberg Limits Tests</b>					
<b>Sample</b>	<b>Moisture Content %</b>	<b>Liquid Limit %</b>	<b>Plastic Limit %</b>	<b>Plasticity Index %</b>	<b>Classification</b>
BH 6-19	63.2	66	27	39	CH
BH 7-19	55.9	55	23	33	CH
BH 8-19	51.8	55	31	24	MH
BH 9-19	57.0	56	28	28	CH
BH 10-19	65.2	65	33	32	MH
BH 11-19	57.2	58	32	27	MH
BH 12-19	34.6	36	18	17	CL
BH 13-19	19.1	51	26	25	CH
BH 14-19	64.5	66	30	36	CH
BH 15-19	59.1	59	24	35	CH

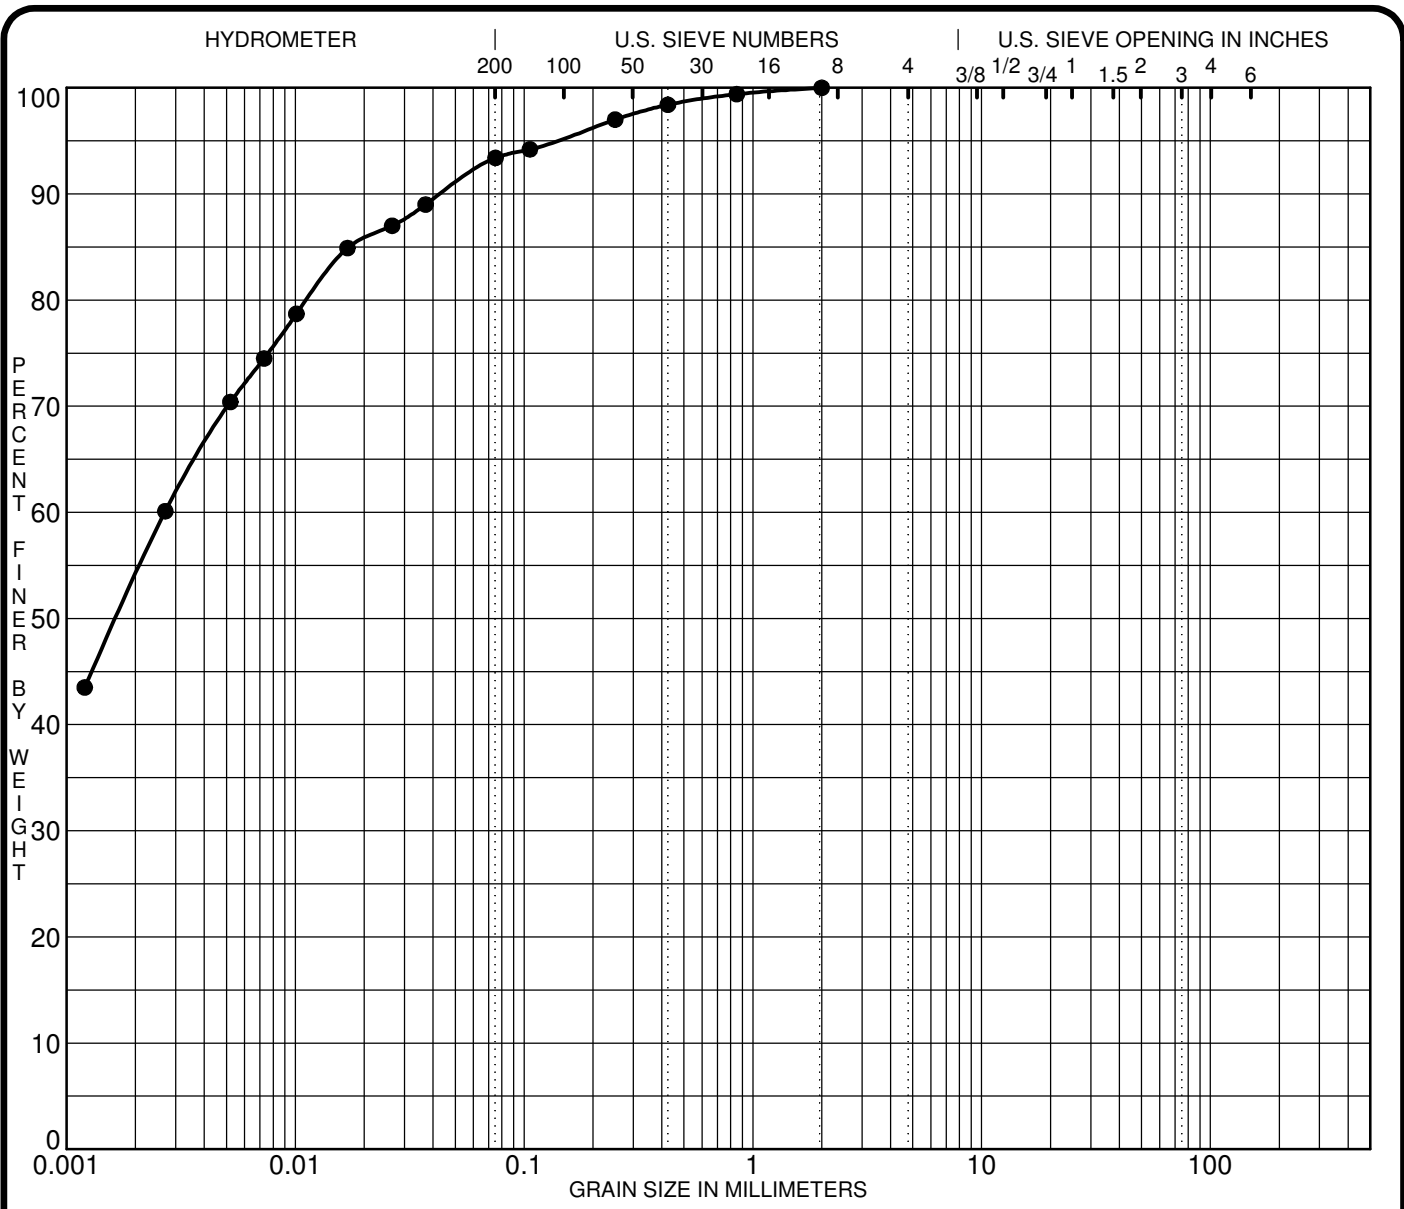
**GRAIN SIZE DISTRIBUTION**

Specimen Identification	Classification	MC%	LL	PL	PI	Cc	Cu
● BH 6-19 SS 4	CH - Inorganic clays of high plasticity

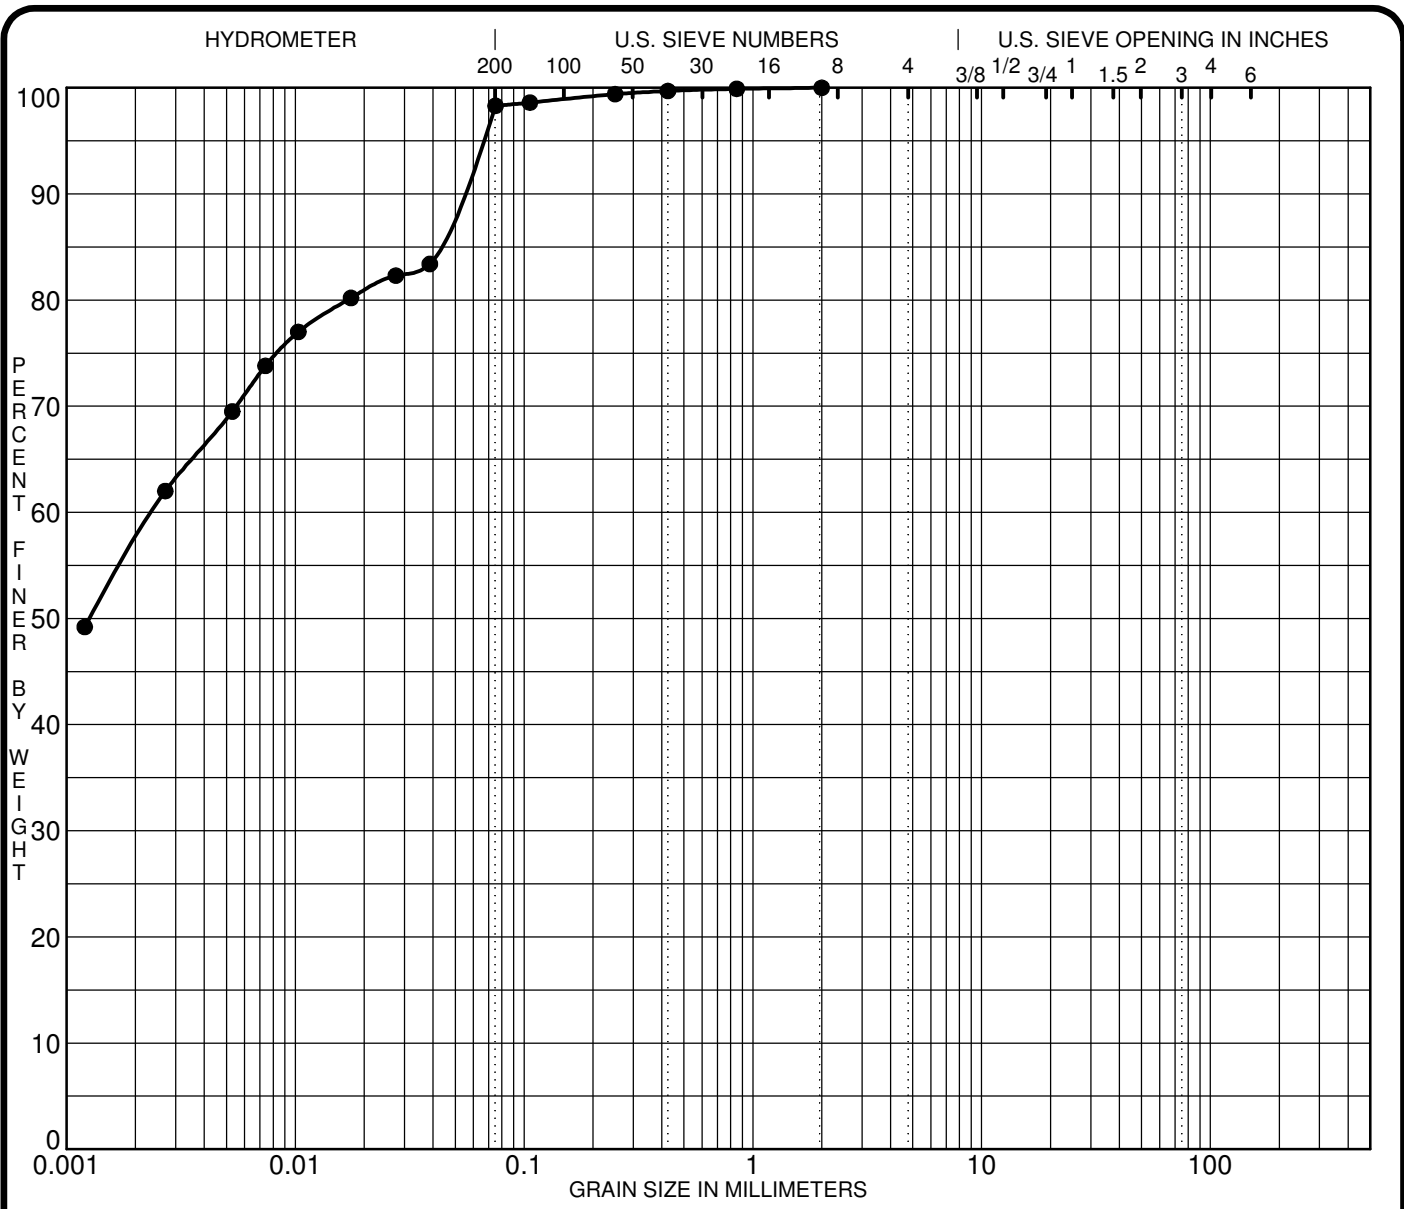
**GRAIN SIZE DISTRIBUTION**

Specimen Identification	Classification					MC%	LL	PL	PI	Cc	Cu
● BH11-19 SS 4	<b>MH - Inorganic silts of high plasticity</b>

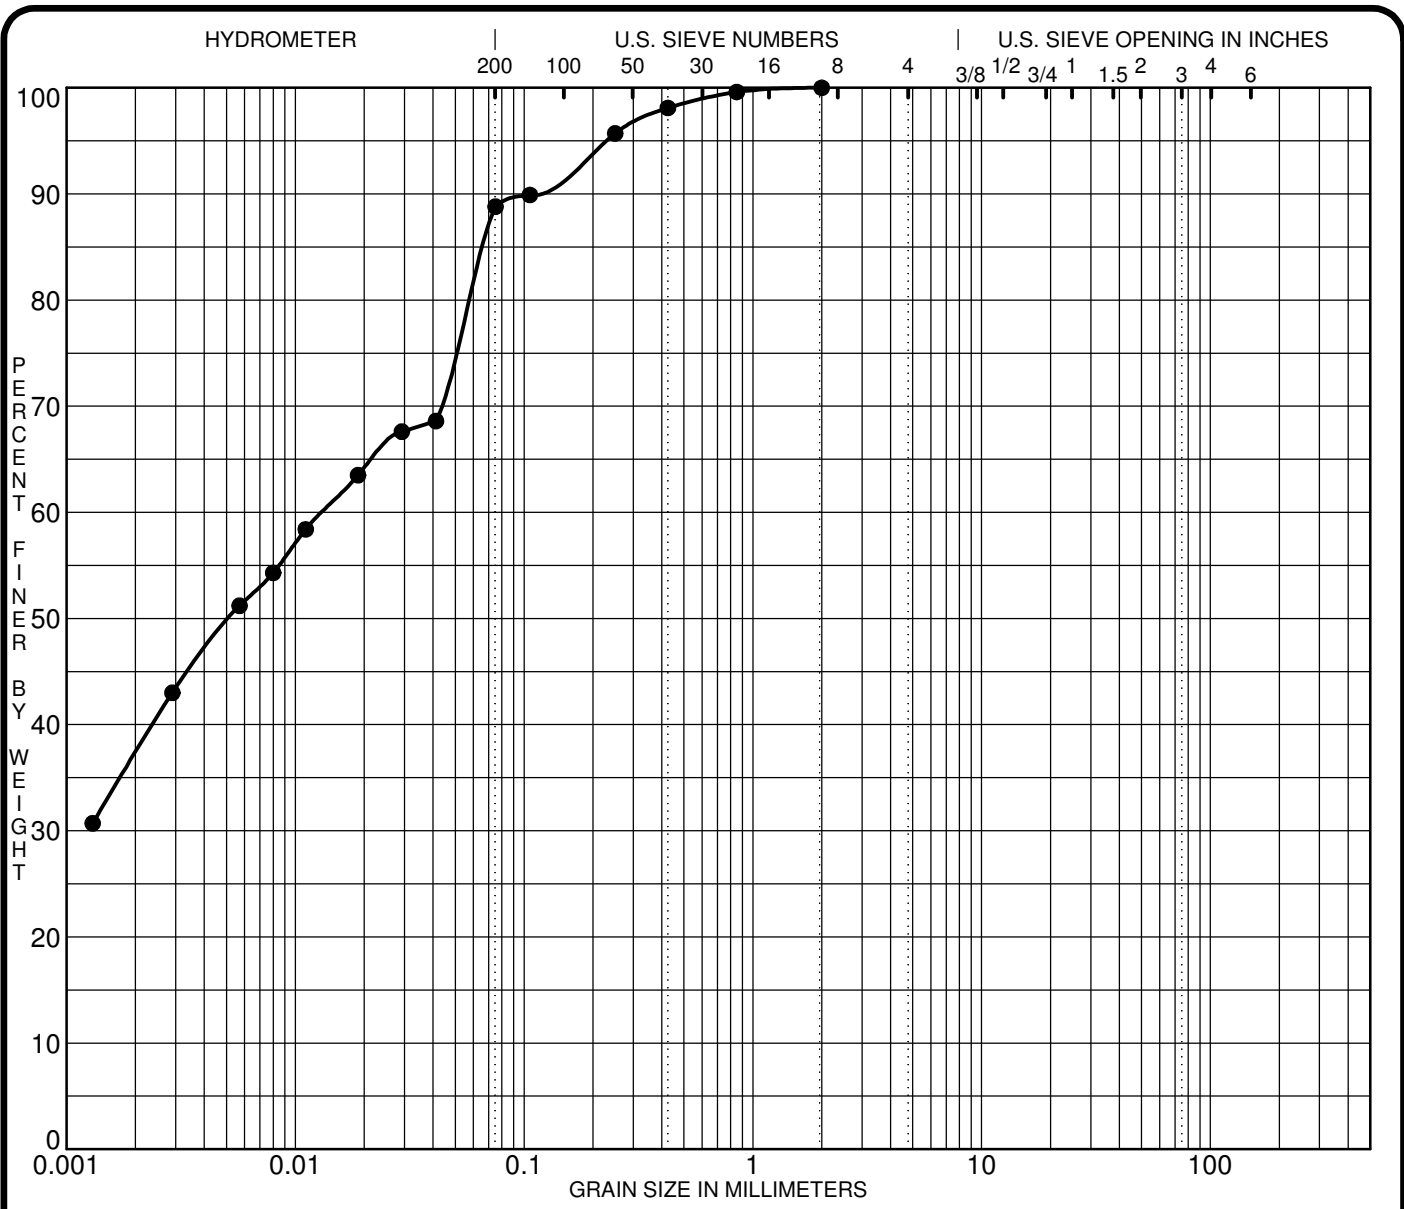
**GRAIN SIZE DISTRIBUTION**

Specimen Identification	Classification	MC%	LL	PL	PI	Cc	Cu
● BH14-19 SS 5	CH - Inorganic clays of high plasticity

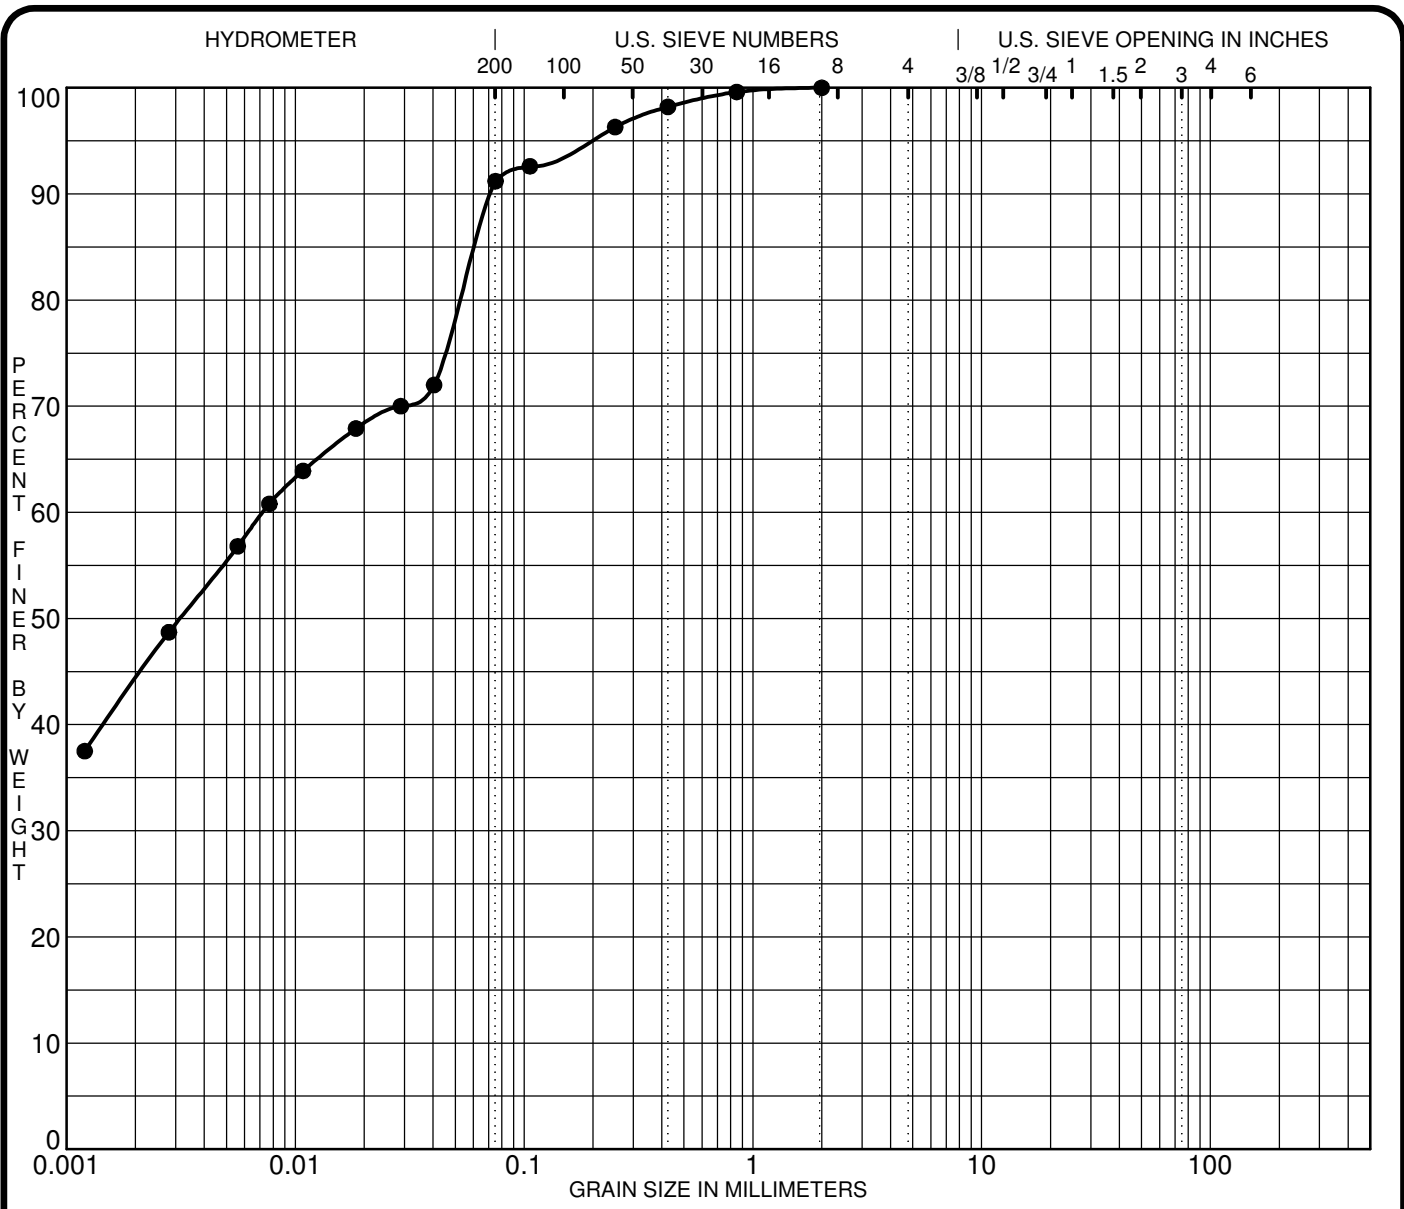
Specimen Identification	Classification	MC%	LL	PL	PI	Cc	Cu
● BH15-19 SS 4	CH - Inorganic clays of high plasticity		59	24	35

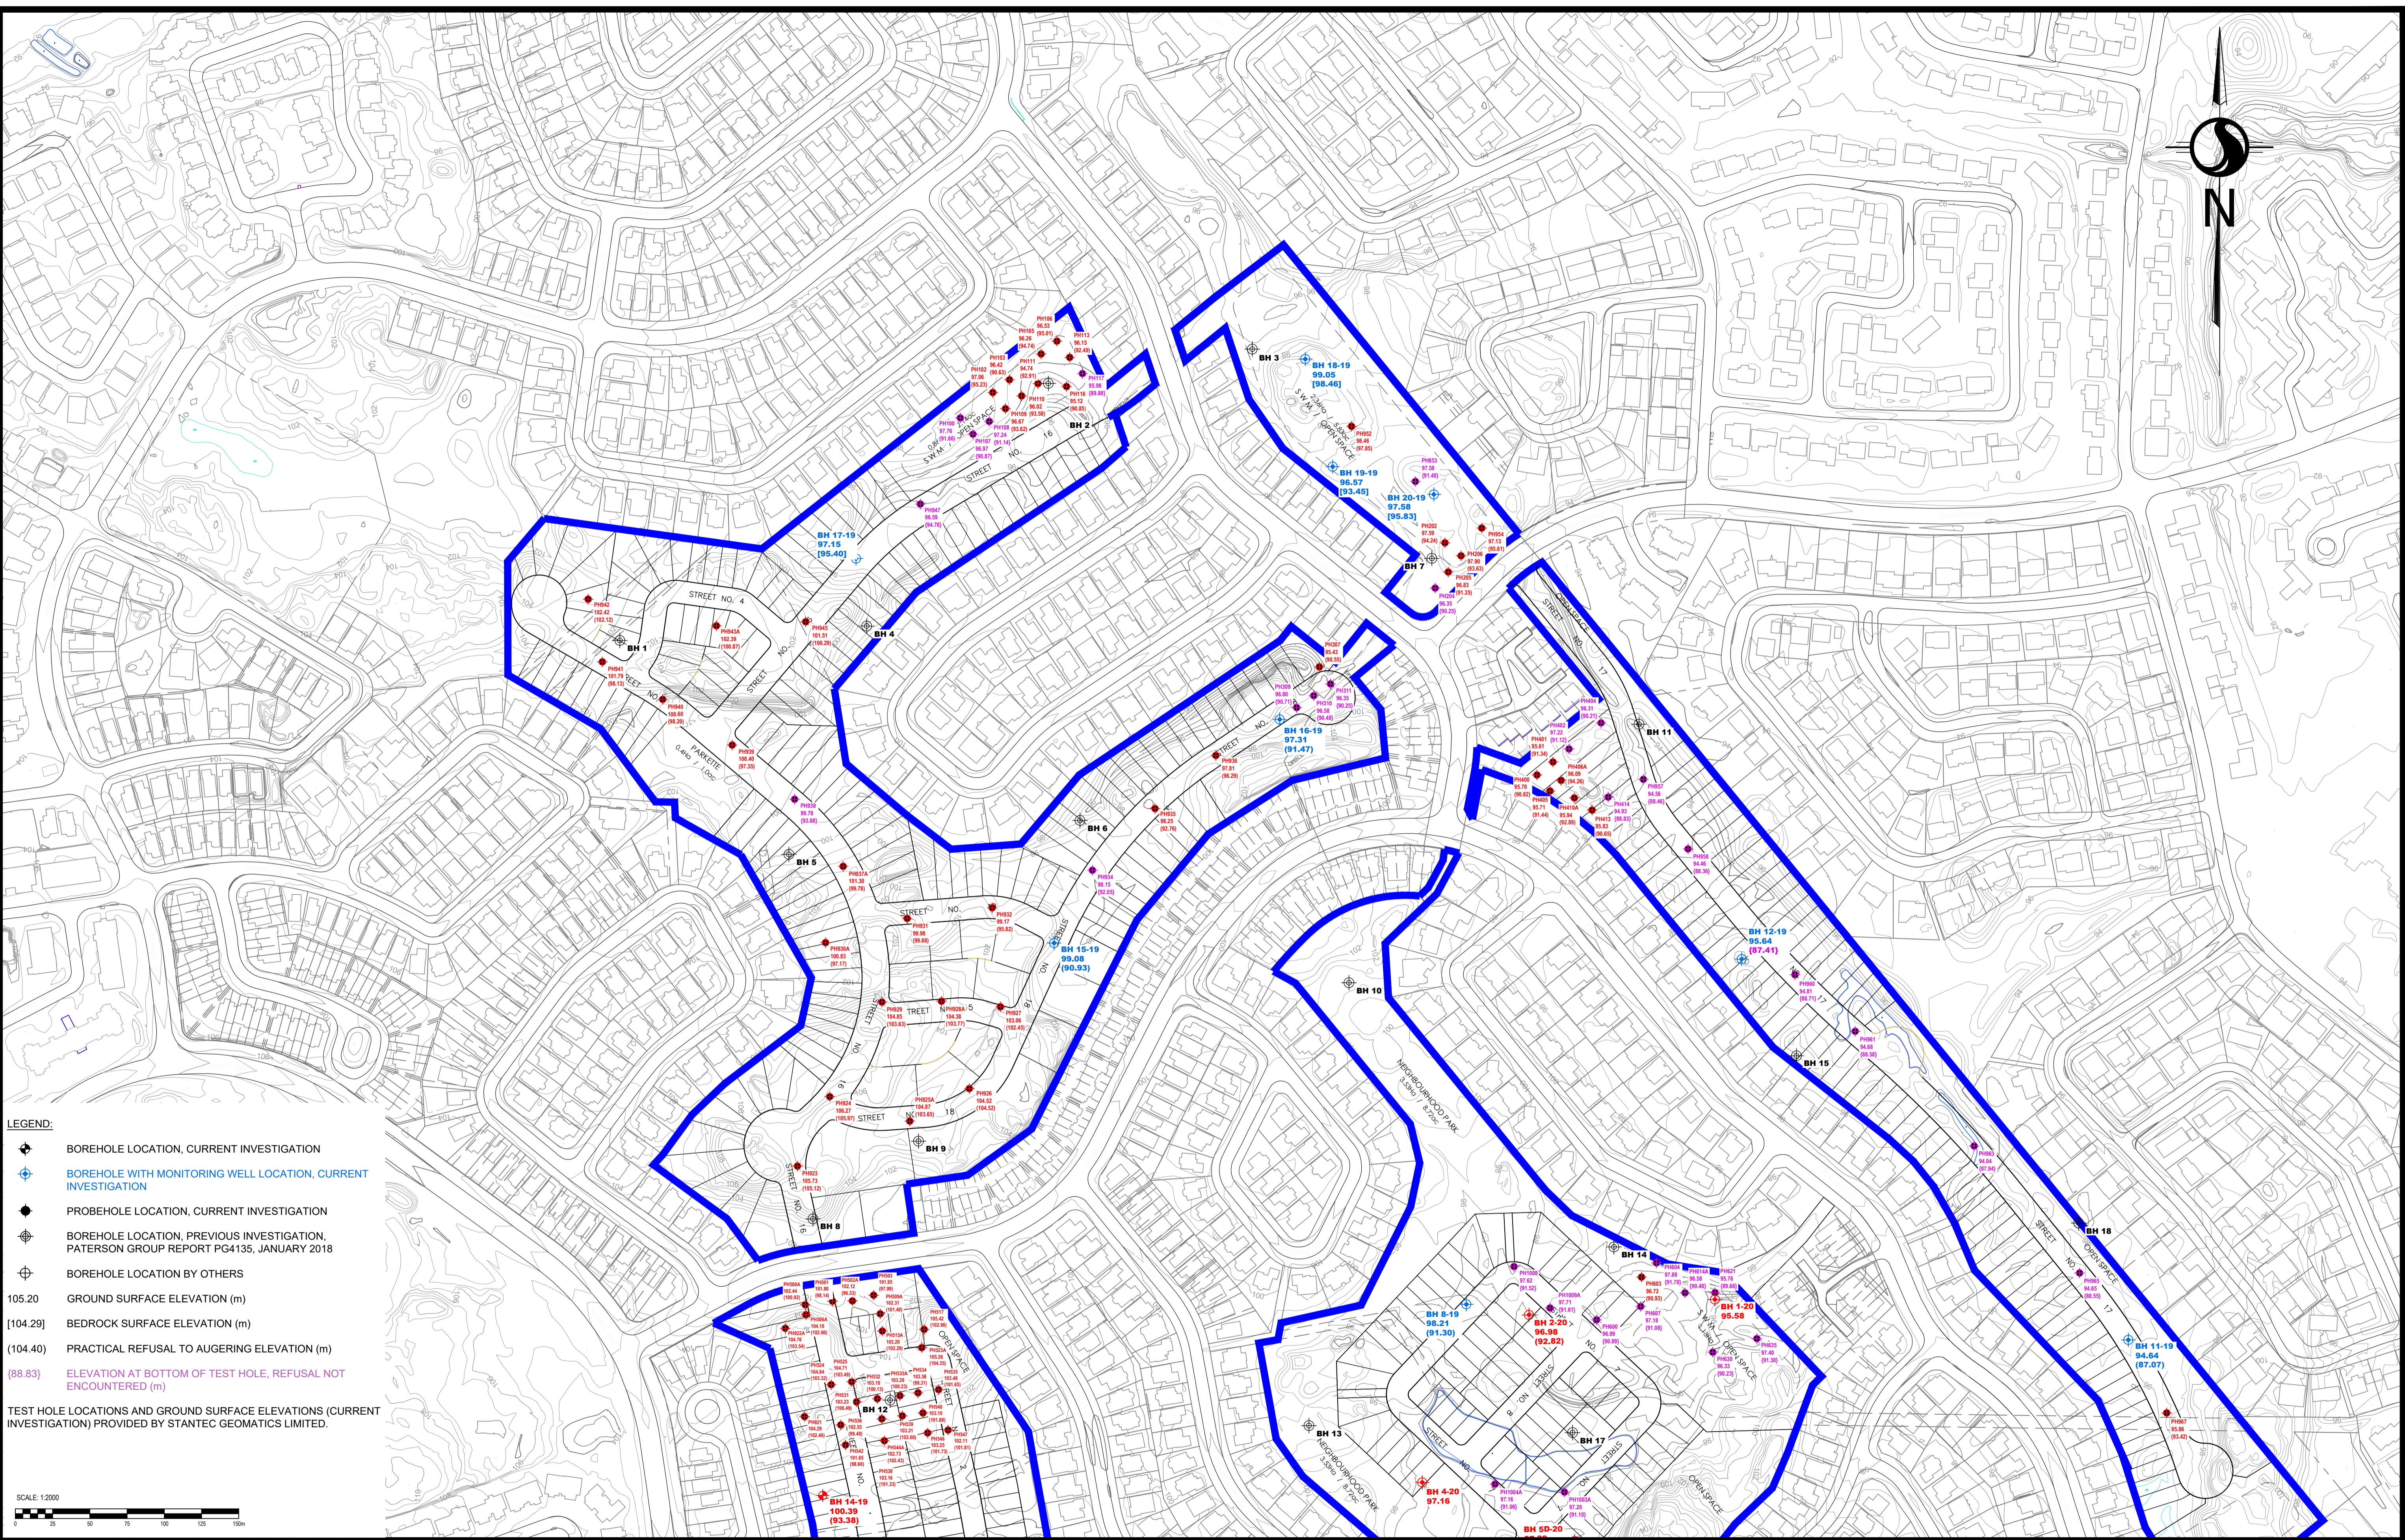
- BOREHOLE LOCATION, CURRENT INVESTIGATION
- BOREHOLE WITH MONITORING WELL LOCATION, CURRENT INVESTIGATION
- PROBEHOLE LOCATION, CURRENT INVESTIGATION
- BOREHOLE LOCATION, PREVIOUS INVESTIGATION, PATERSON GROUP REPORT PG4135, JANUARY 2018
- BOREHOLE LOCATION BY OTHERS
- 105.20 GROUND SURFACE ELEVATION (m)
- {104.29} BEDROCK SURFACE ELEVATION (m)
- {104.40} PRACTICAL REFUSAL TO AUGERING ELEVATION (m)
- {88.83} ELEVATION AT BOTTOM OF TEST HOLE, REFUSAL NOT ENCOUNTERED (m)

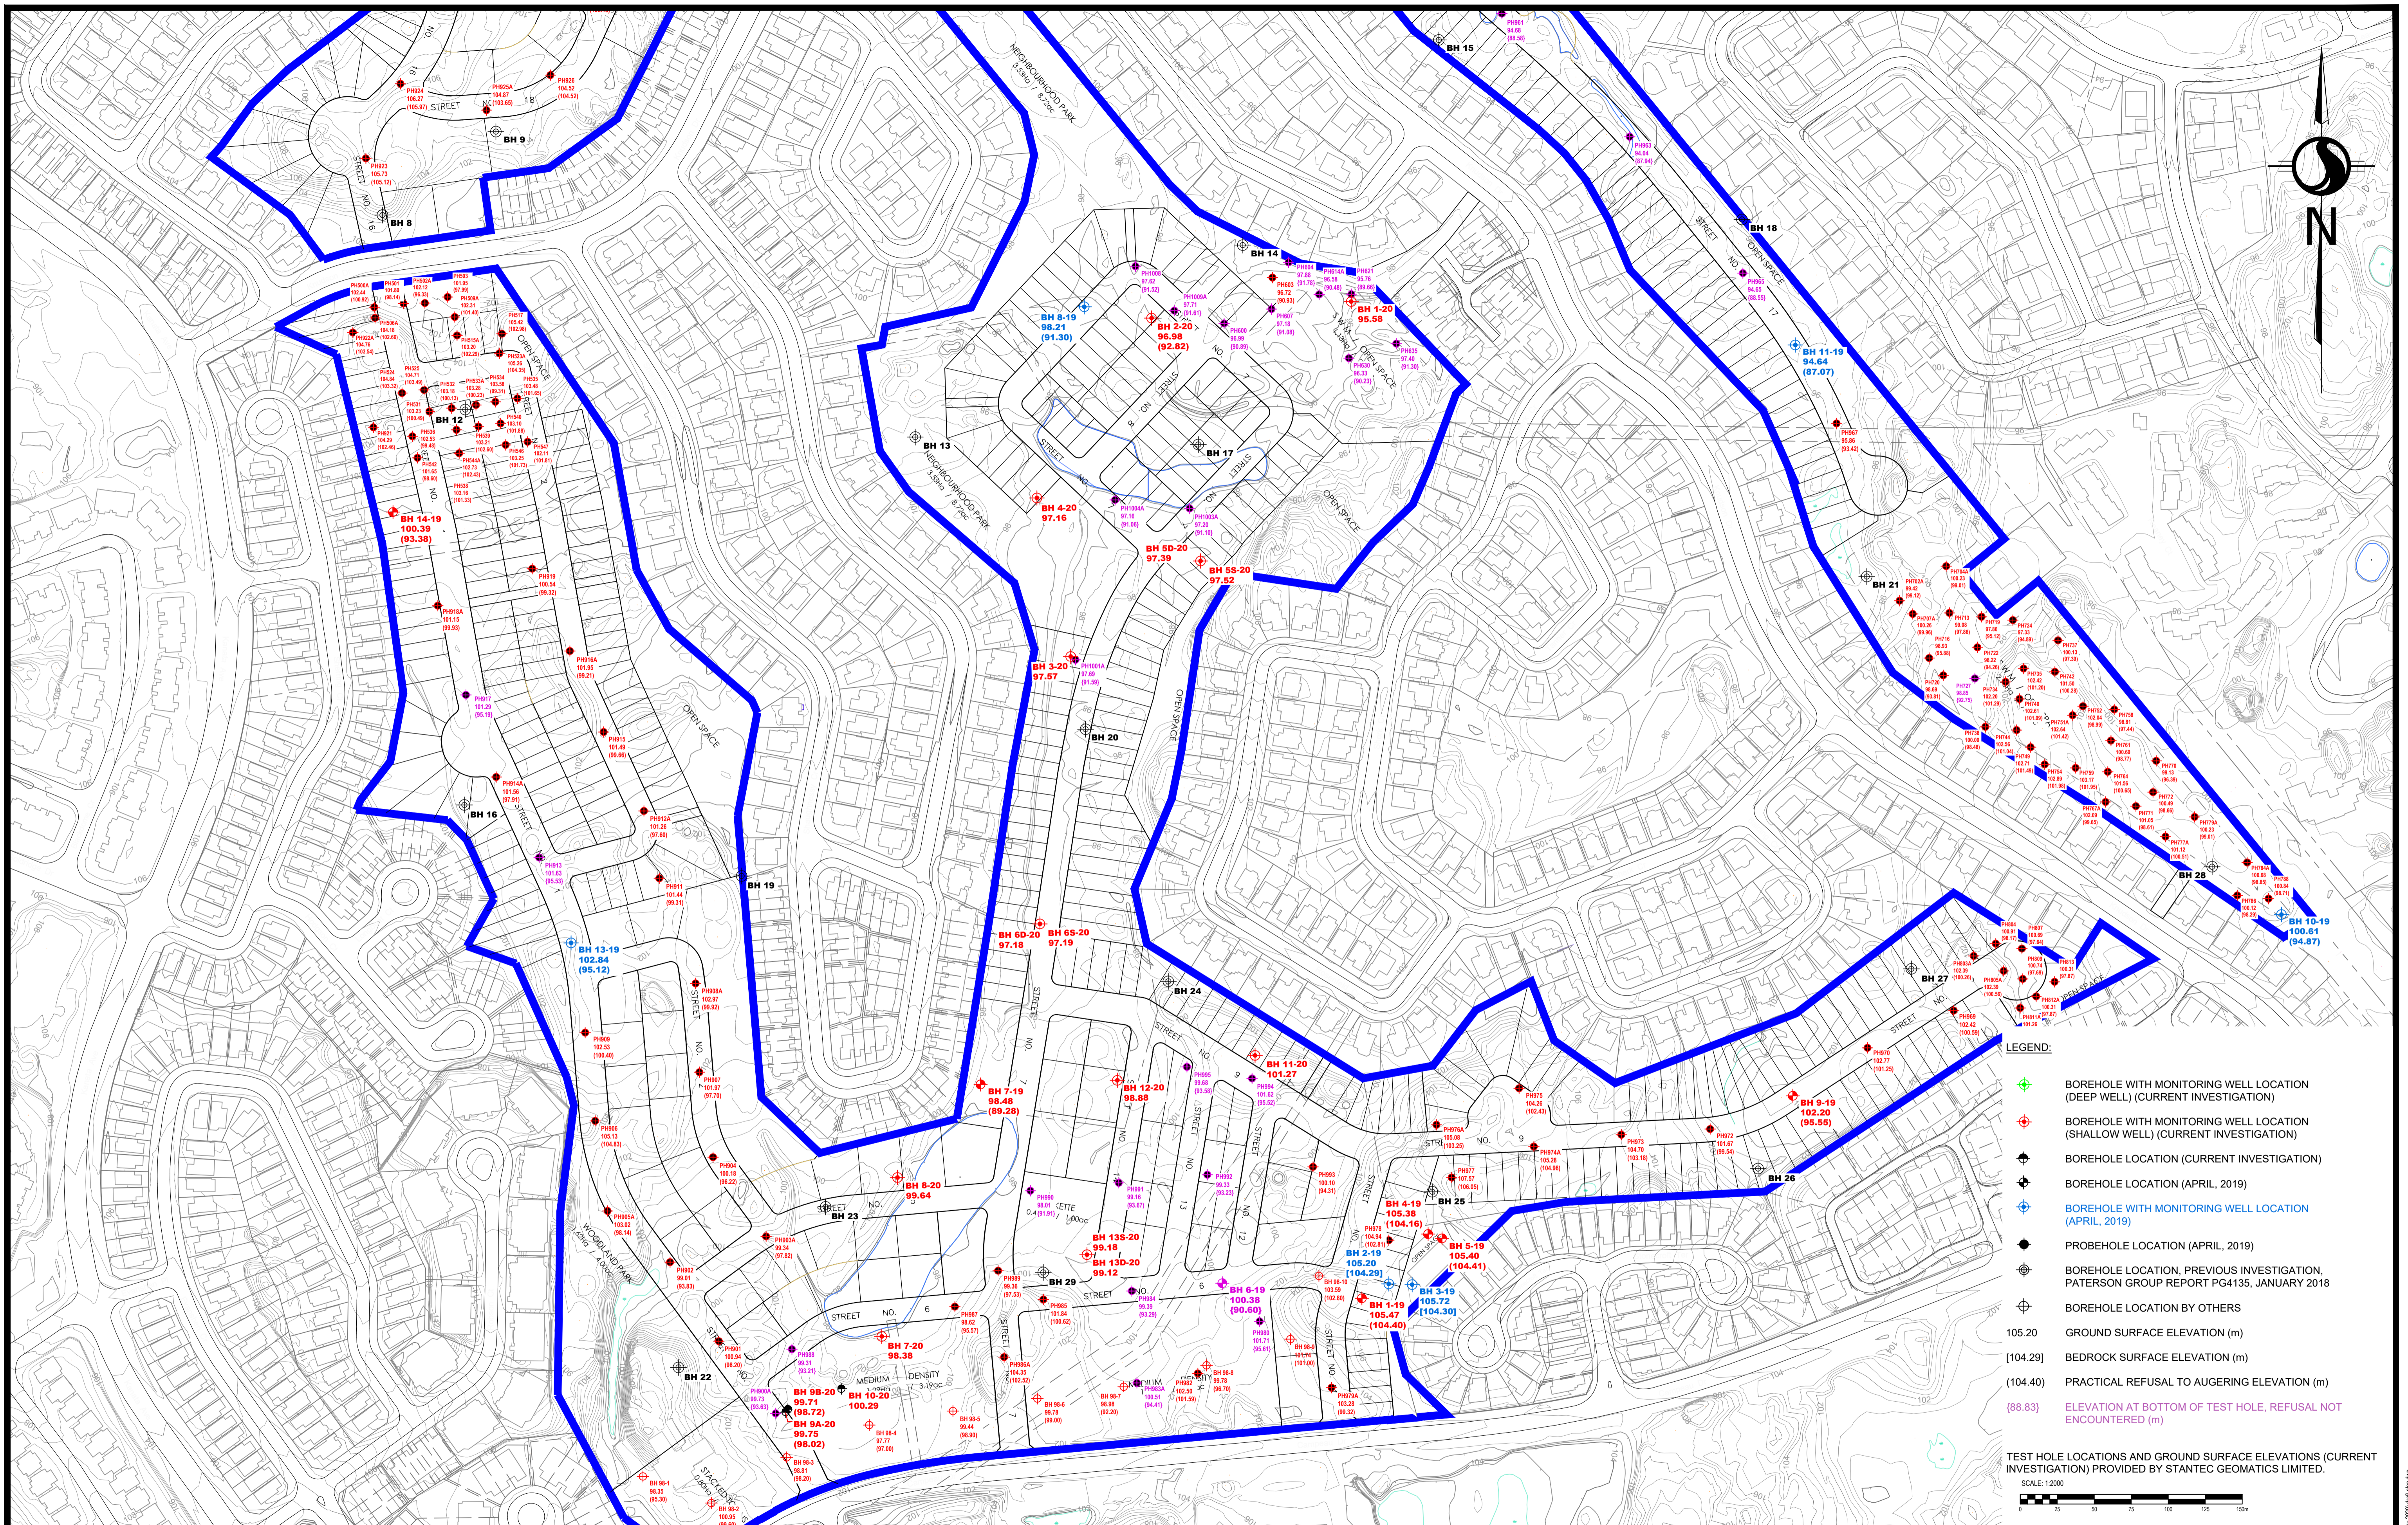
- LEGEND:**
- BOREHOLE WITH MONITORING WELL LOCATION (DEEP WELL) (CURRENT INVESTIGATION)
  - BOREHOLE WITH MONITORING WELL LOCATION (SHALLOW WELL) (CURRENT INVESTIGATION)
  - BOREHOLE LOCATION (CURRENT INVESTIGATION)
  - BOREHOLE LOCATION (APRIL, 2019)
  - BOREHOLE WITH MONITORING WELL LOCATION (APRIL, 2019)
  - PROBEHOLE LOCATION (APRIL, 2019)
  - BOREHOLE LOCATION, PREVIOUS INVESTIGATION, PATERSON GROUP REPORT PG4135, JANUARY 2018
  - BOREHOLE LOCATION BY OTHERS
  - 105.20 GROUND SURFACE ELEVATION (m)
  - [104.29] BEDROCK SURFACE ELEVATION (m)
  - (104.40) PRACTICAL REFUSAL TO AUGERING ELEVATION (m)
  - (88.83) ELEVATION AT BOTTOM OF TEST HOLE, REFUSAL NOT ENCOUNTERED (m)

TEST HOLE LOCATIONS AND GROUND SURFACE ELEVATIONS (CURRENT INVESTIGATION) PROVIDED BY STANTEC GEOMATICS LIMITED.  
 SCALE: 1:2000

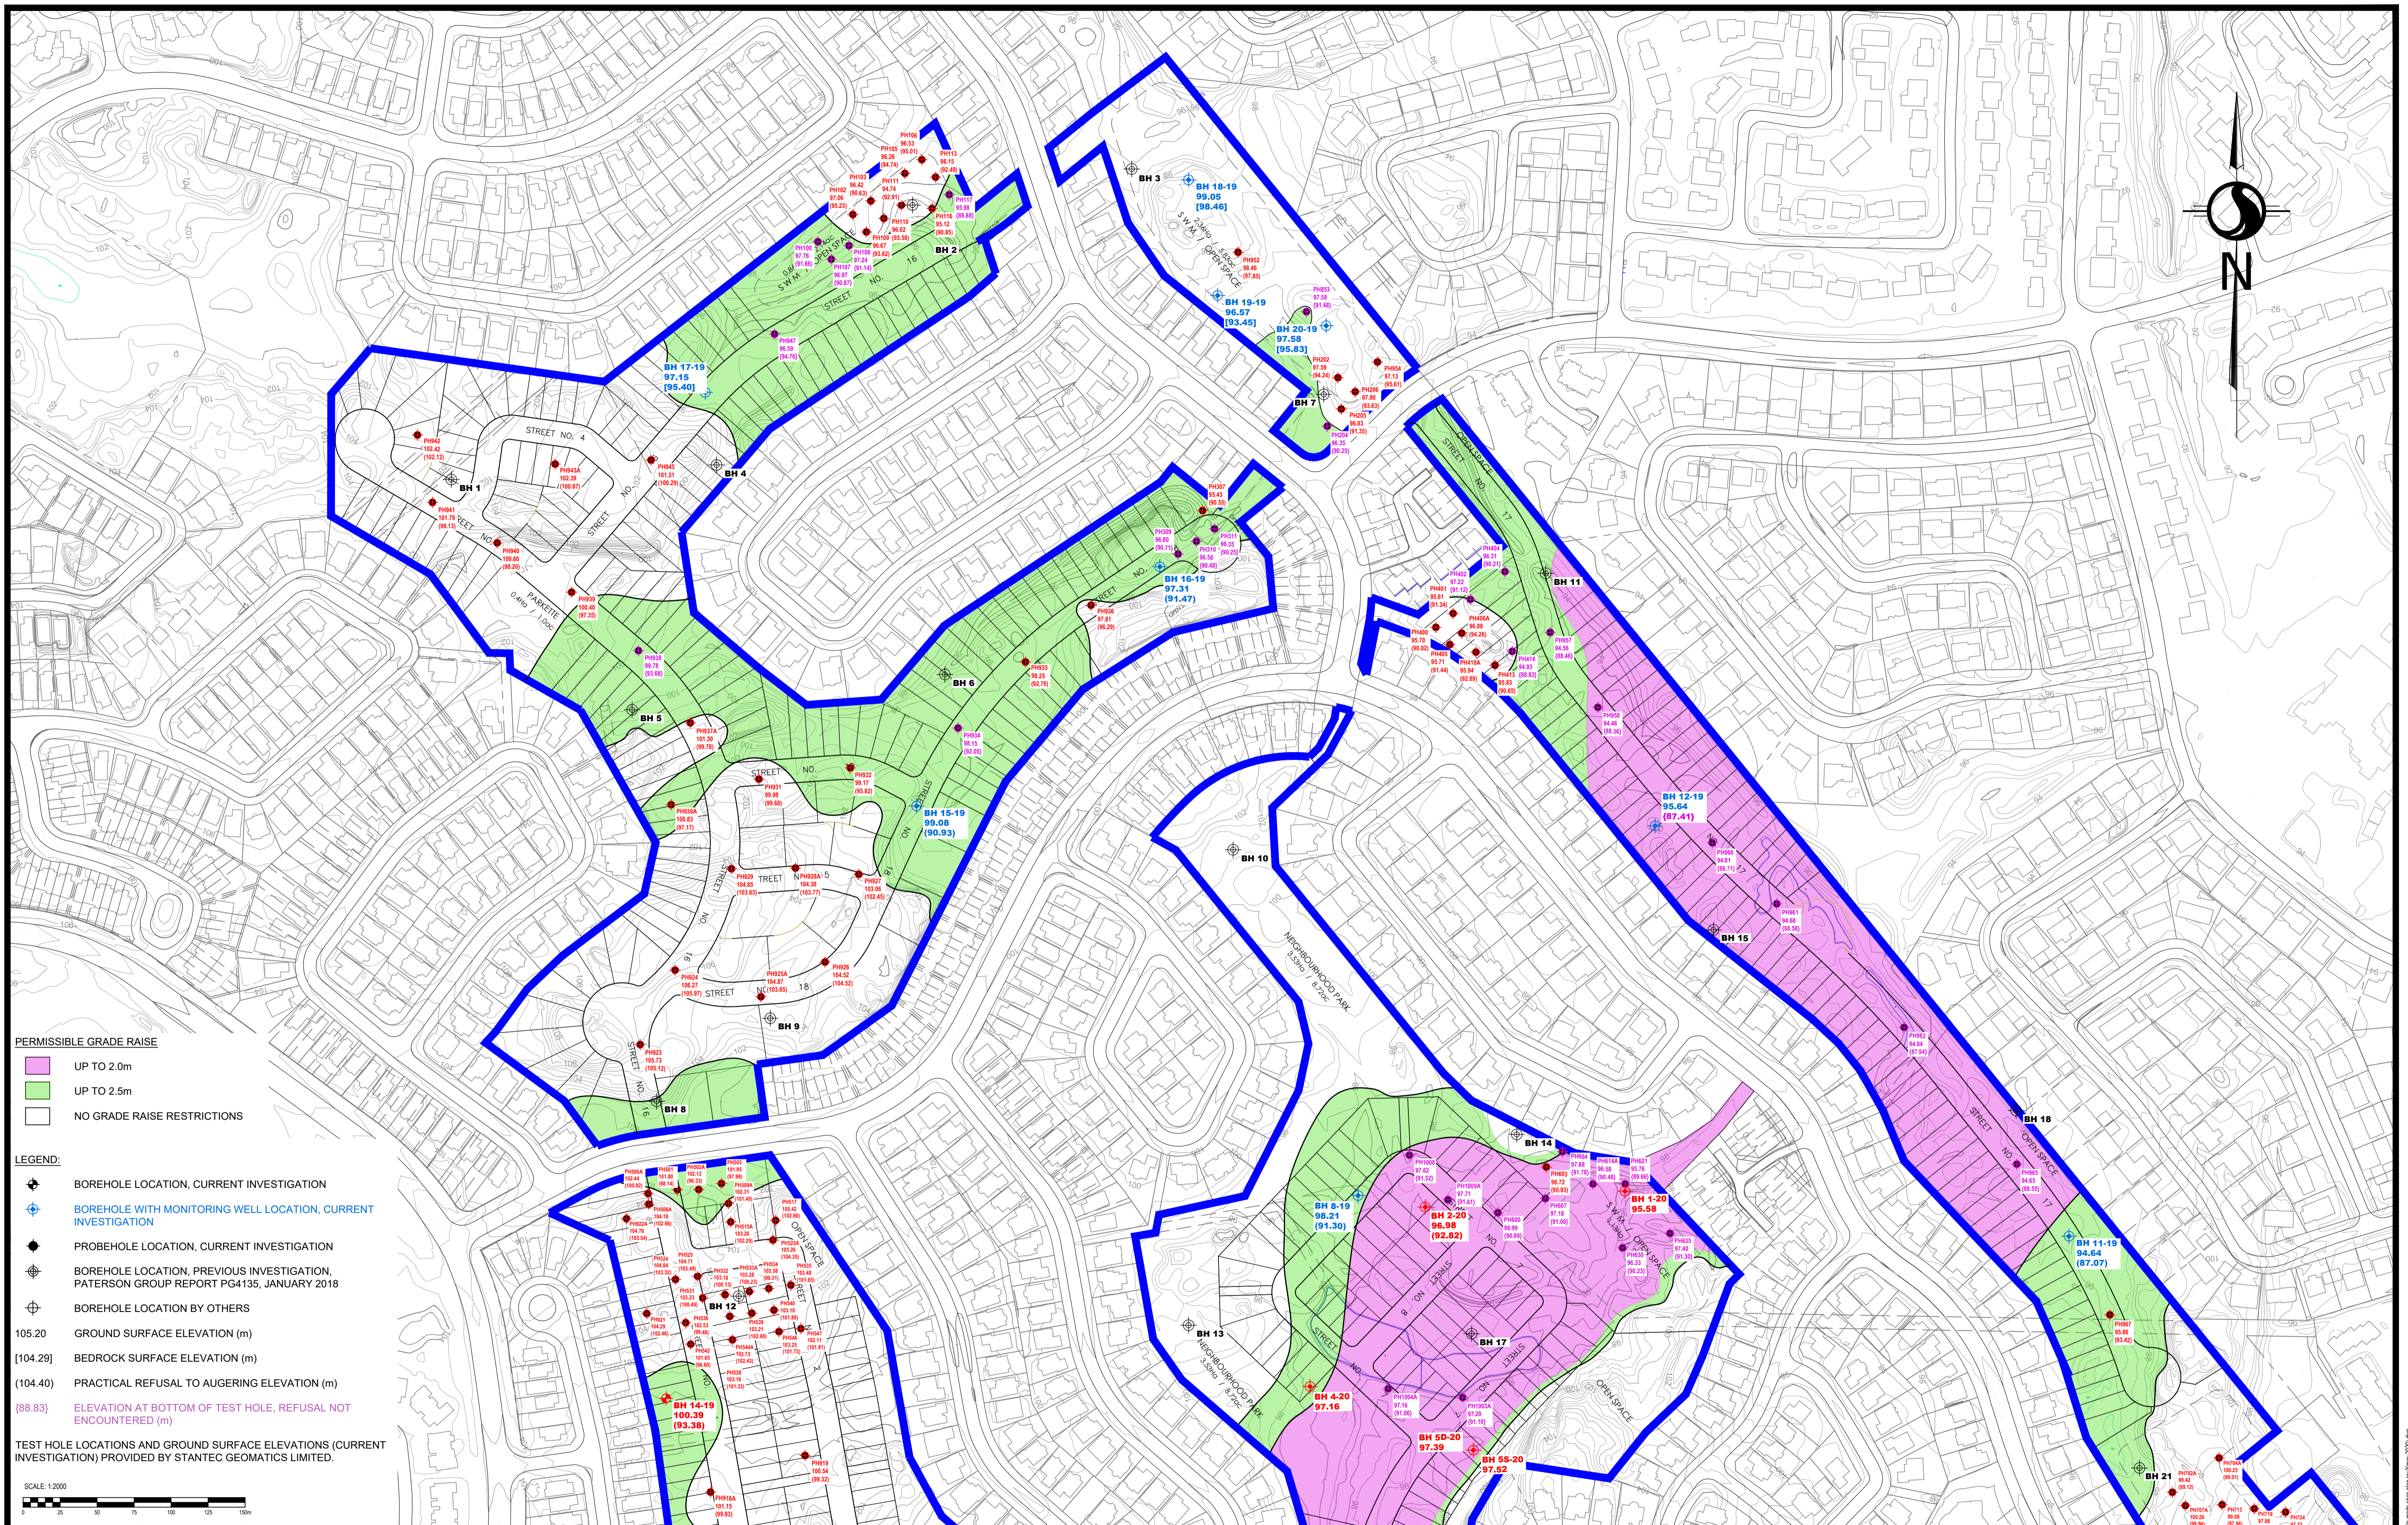
Report No.: **PG4135**  
Drawing No.:  
**PG4135-3**  
Revision No.: 4

**PERMISSIBLE GRADE RAISE**

- UP TO 2.0m
- UP TO 2.5m
- NO GRADE RAISE RESTRICTIONS

From a geotechnical perspective, the subject site is considered suitable for the proposed residential development. However, due to the presence of a silty clay layer, portions of the proposed development will be subjected to grade raise restrictions. Permissible grade raise recommendations are discussed in Subsection 5.3 and permissible grade raise areas are presented in Drawings PG4135-3 and 4 - Permissible Grade Raise Plan in Appendix 2.

Based on the undrained shear strength values, our experience with Ottawa clays and consolidation testing results, permissible grade raise areas have been defined for the proposed development. The recommended permissible grade raise areas are presented in Drawings PG4135-3 and 4 - Permissible Grade Raise Plan in Appendix 2.
