## Geotechnical Investigation

Kanata Lakes Golf and Country Club  
7000 Campeau Drive  
Ottawa, Ontario

Minto Communities Inc.  
on behalf of ClubLink Corporation ULC

Report: PG4135-2 Revision 4

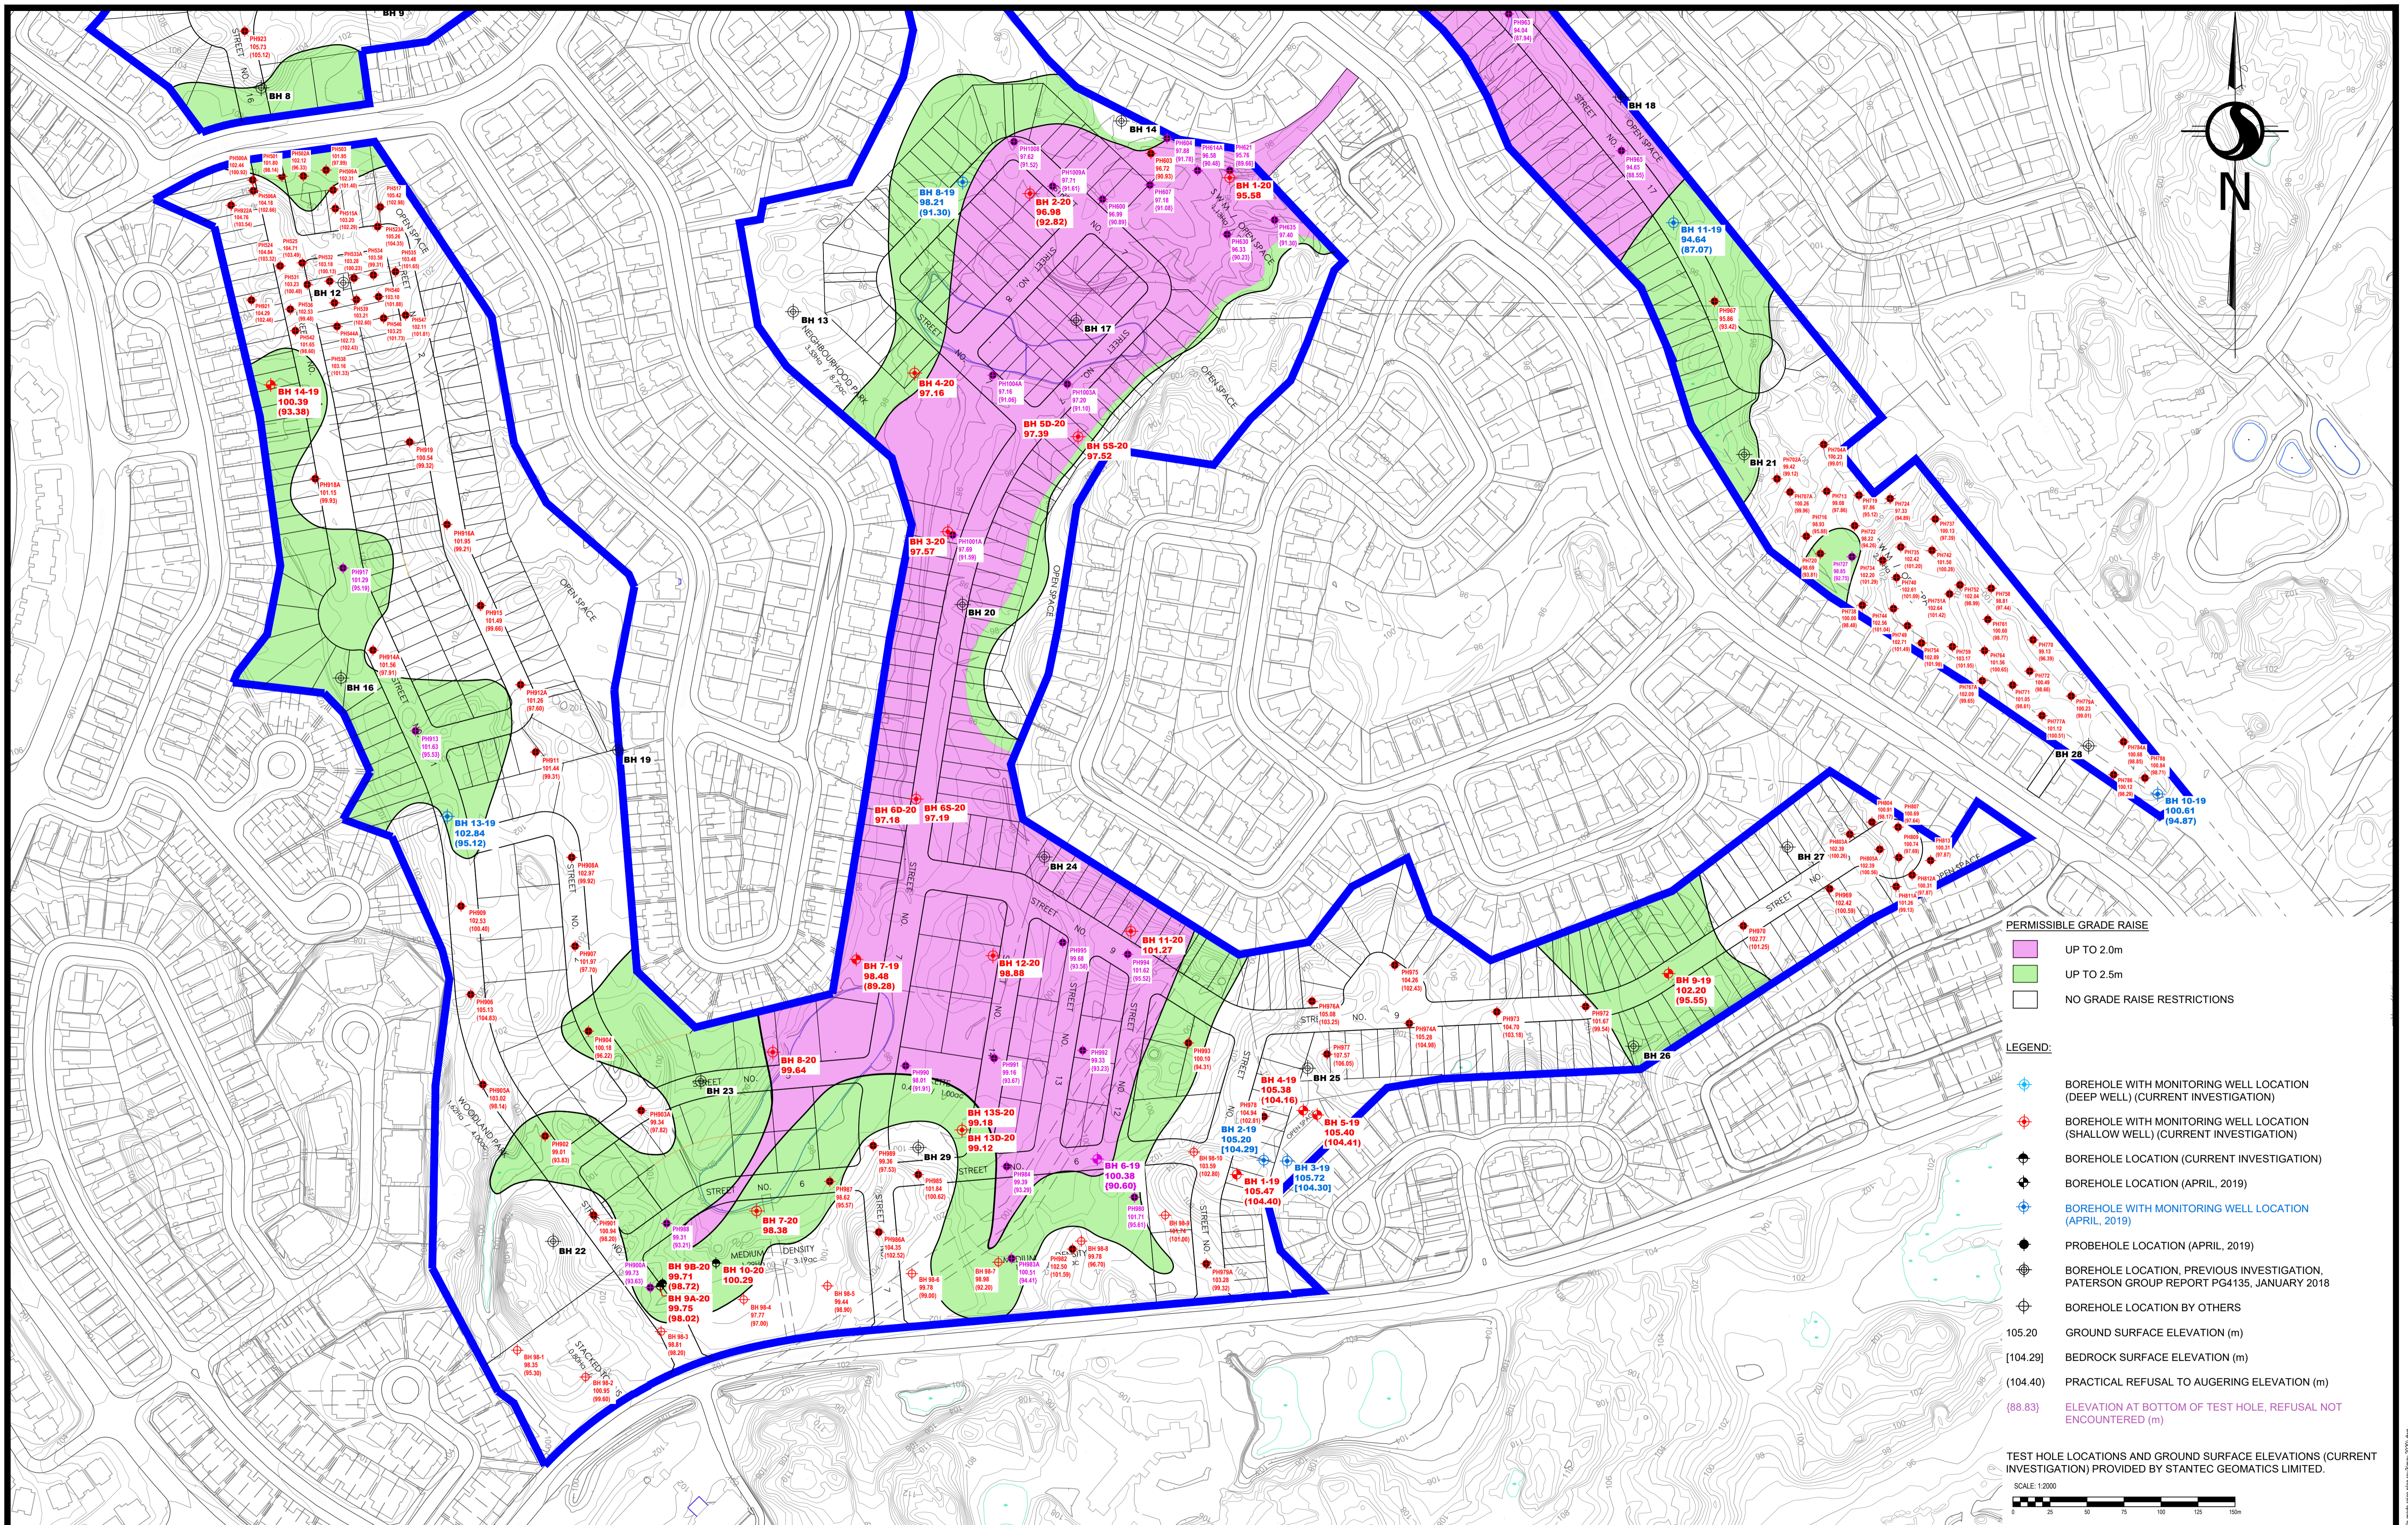
Scale:	1:2000	Report No.:	PG4135
Drawn by:	MPG	Drawing No.:	
Checked by:	RG		
Approved by:	DJG		<b>PG4135-4</b>
Date:	03/2019	Revision No.:	4

- PERMISSIBLE GRADE RAISE**
- UP TO 2.0m
  - UP TO 2.5m
  - NO GRADE RAISE RESTRICTIONS
- LEGEND:**
- BOREHOLE WITH MONITORING WELL LOCATION (DEEP WELL) (CURRENT INVESTIGATION)

From a geotechnical perspective, the subject site is considered suitable for the proposed residential development. However, due to the presence of a silty clay layer, portions of the proposed development will be subjected to grade raise restrictions. Permissible grade raise recommendations are discussed in Subsection 5.3 and permissible grade raise areas are presented in Drawings PG4135-3 and 4 - Permissible Grade Raise Plan in Appendix 2.

Based on the undrained shear strength values, our experience with Ottawa clays and consolidation testing results, permissible grade raise areas have been defined for the proposed development. The recommended permissible grade raise areas are presented in Drawings PG4135-3 and 4 - Permissible Grade Raise Plan in Appendix 2.

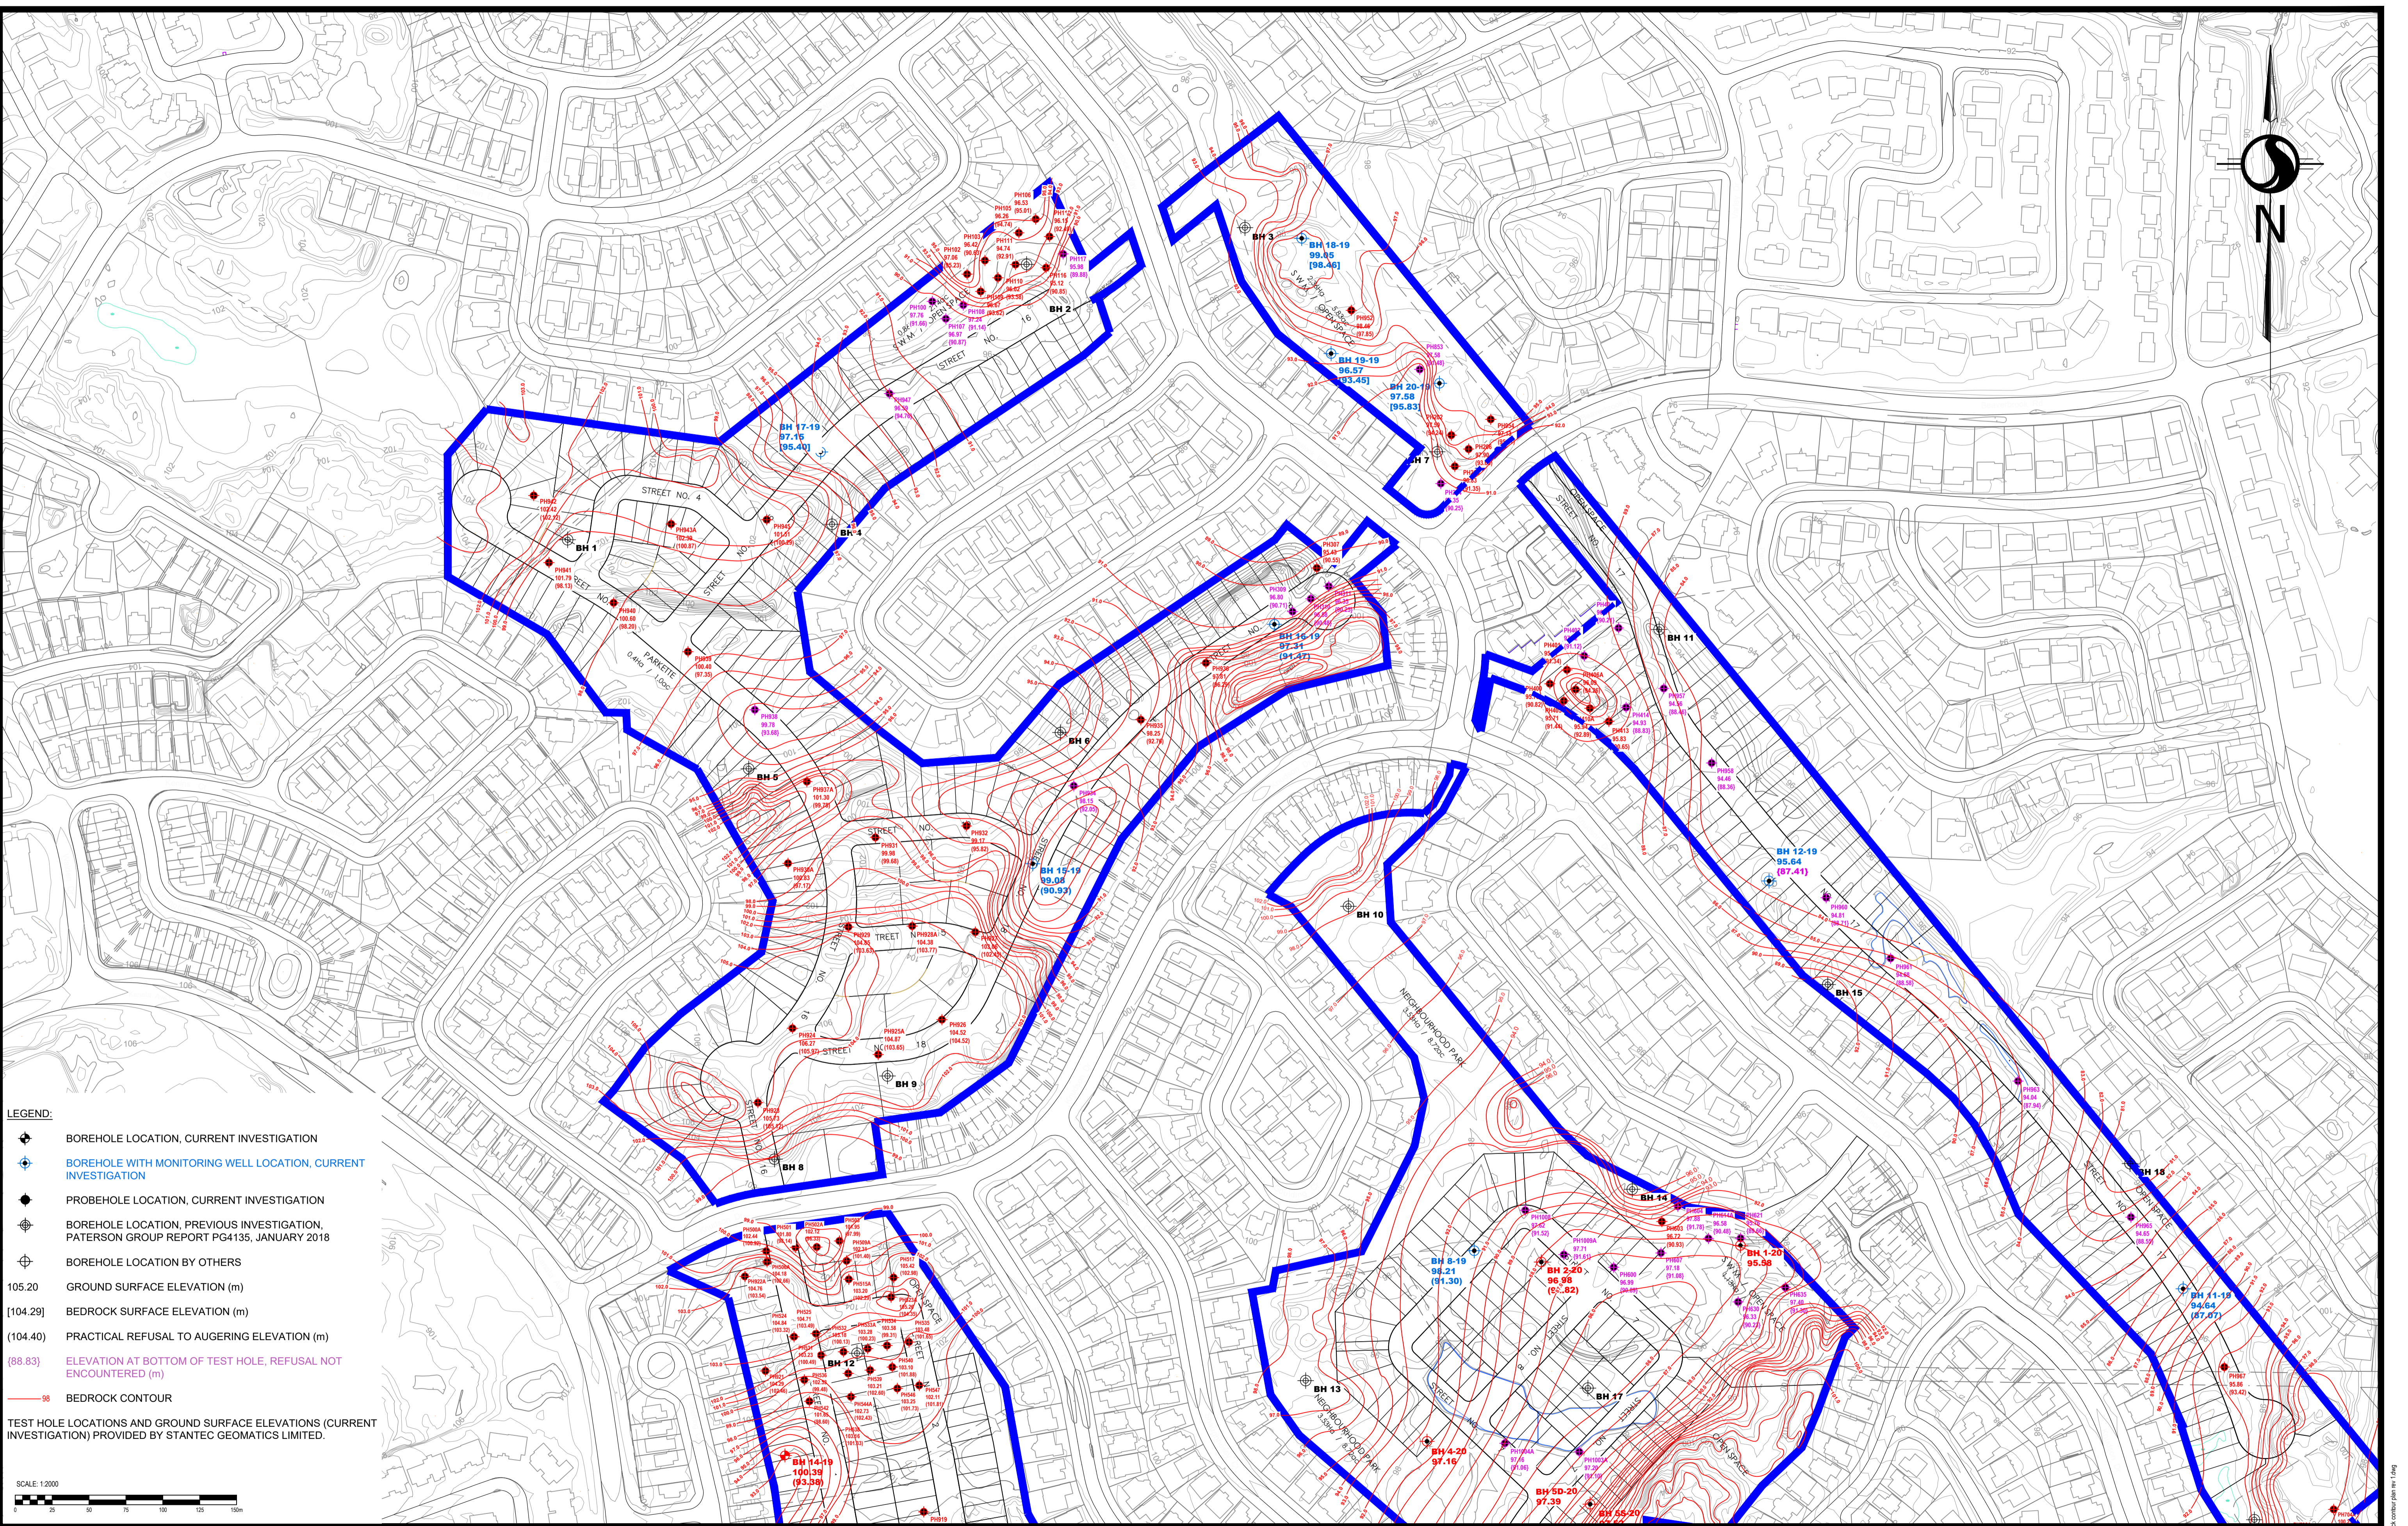
Report No.: **PG4135**  
Drawing No.:  
**PG4135-5**  
Revision No.: 1

- BOREHOLE LOCATION, CURRENT INVESTIGATION
- BOREHOLE WITH MONITORING WELL LOCATION, CURRENT INVESTIGATION
- PROBEHOLE LOCATION, CURRENT INVESTIGATION
- BOREHOLE LOCATION, PREVIOUS INVESTIGATION, PATERSON GROUP REPORT PG4135, JANUARY 2018
- BOREHOLE LOCATION BY OTHERS
- 105.20 GROUND SURFACE ELEVATION (m)
- (104.29) BEDROCK SURFACE ELEVATION (m)
- (104.40) PRACTICAL REFUSAL TO AUGERING ELEVATION (m)
- (88.83) ELEVATION AT BOTTOM OF TEST HOLE, REFUSAL NOT ENCOUNTERED (m)
- BEDROCK CONTOUR
