Geotechnical Investigation

Kanata Lakes Golf and Country Club
7000 Campeau Drive
Ottawa, Ontario

July 30, 2019

Report: PG4135-2 Revision 1

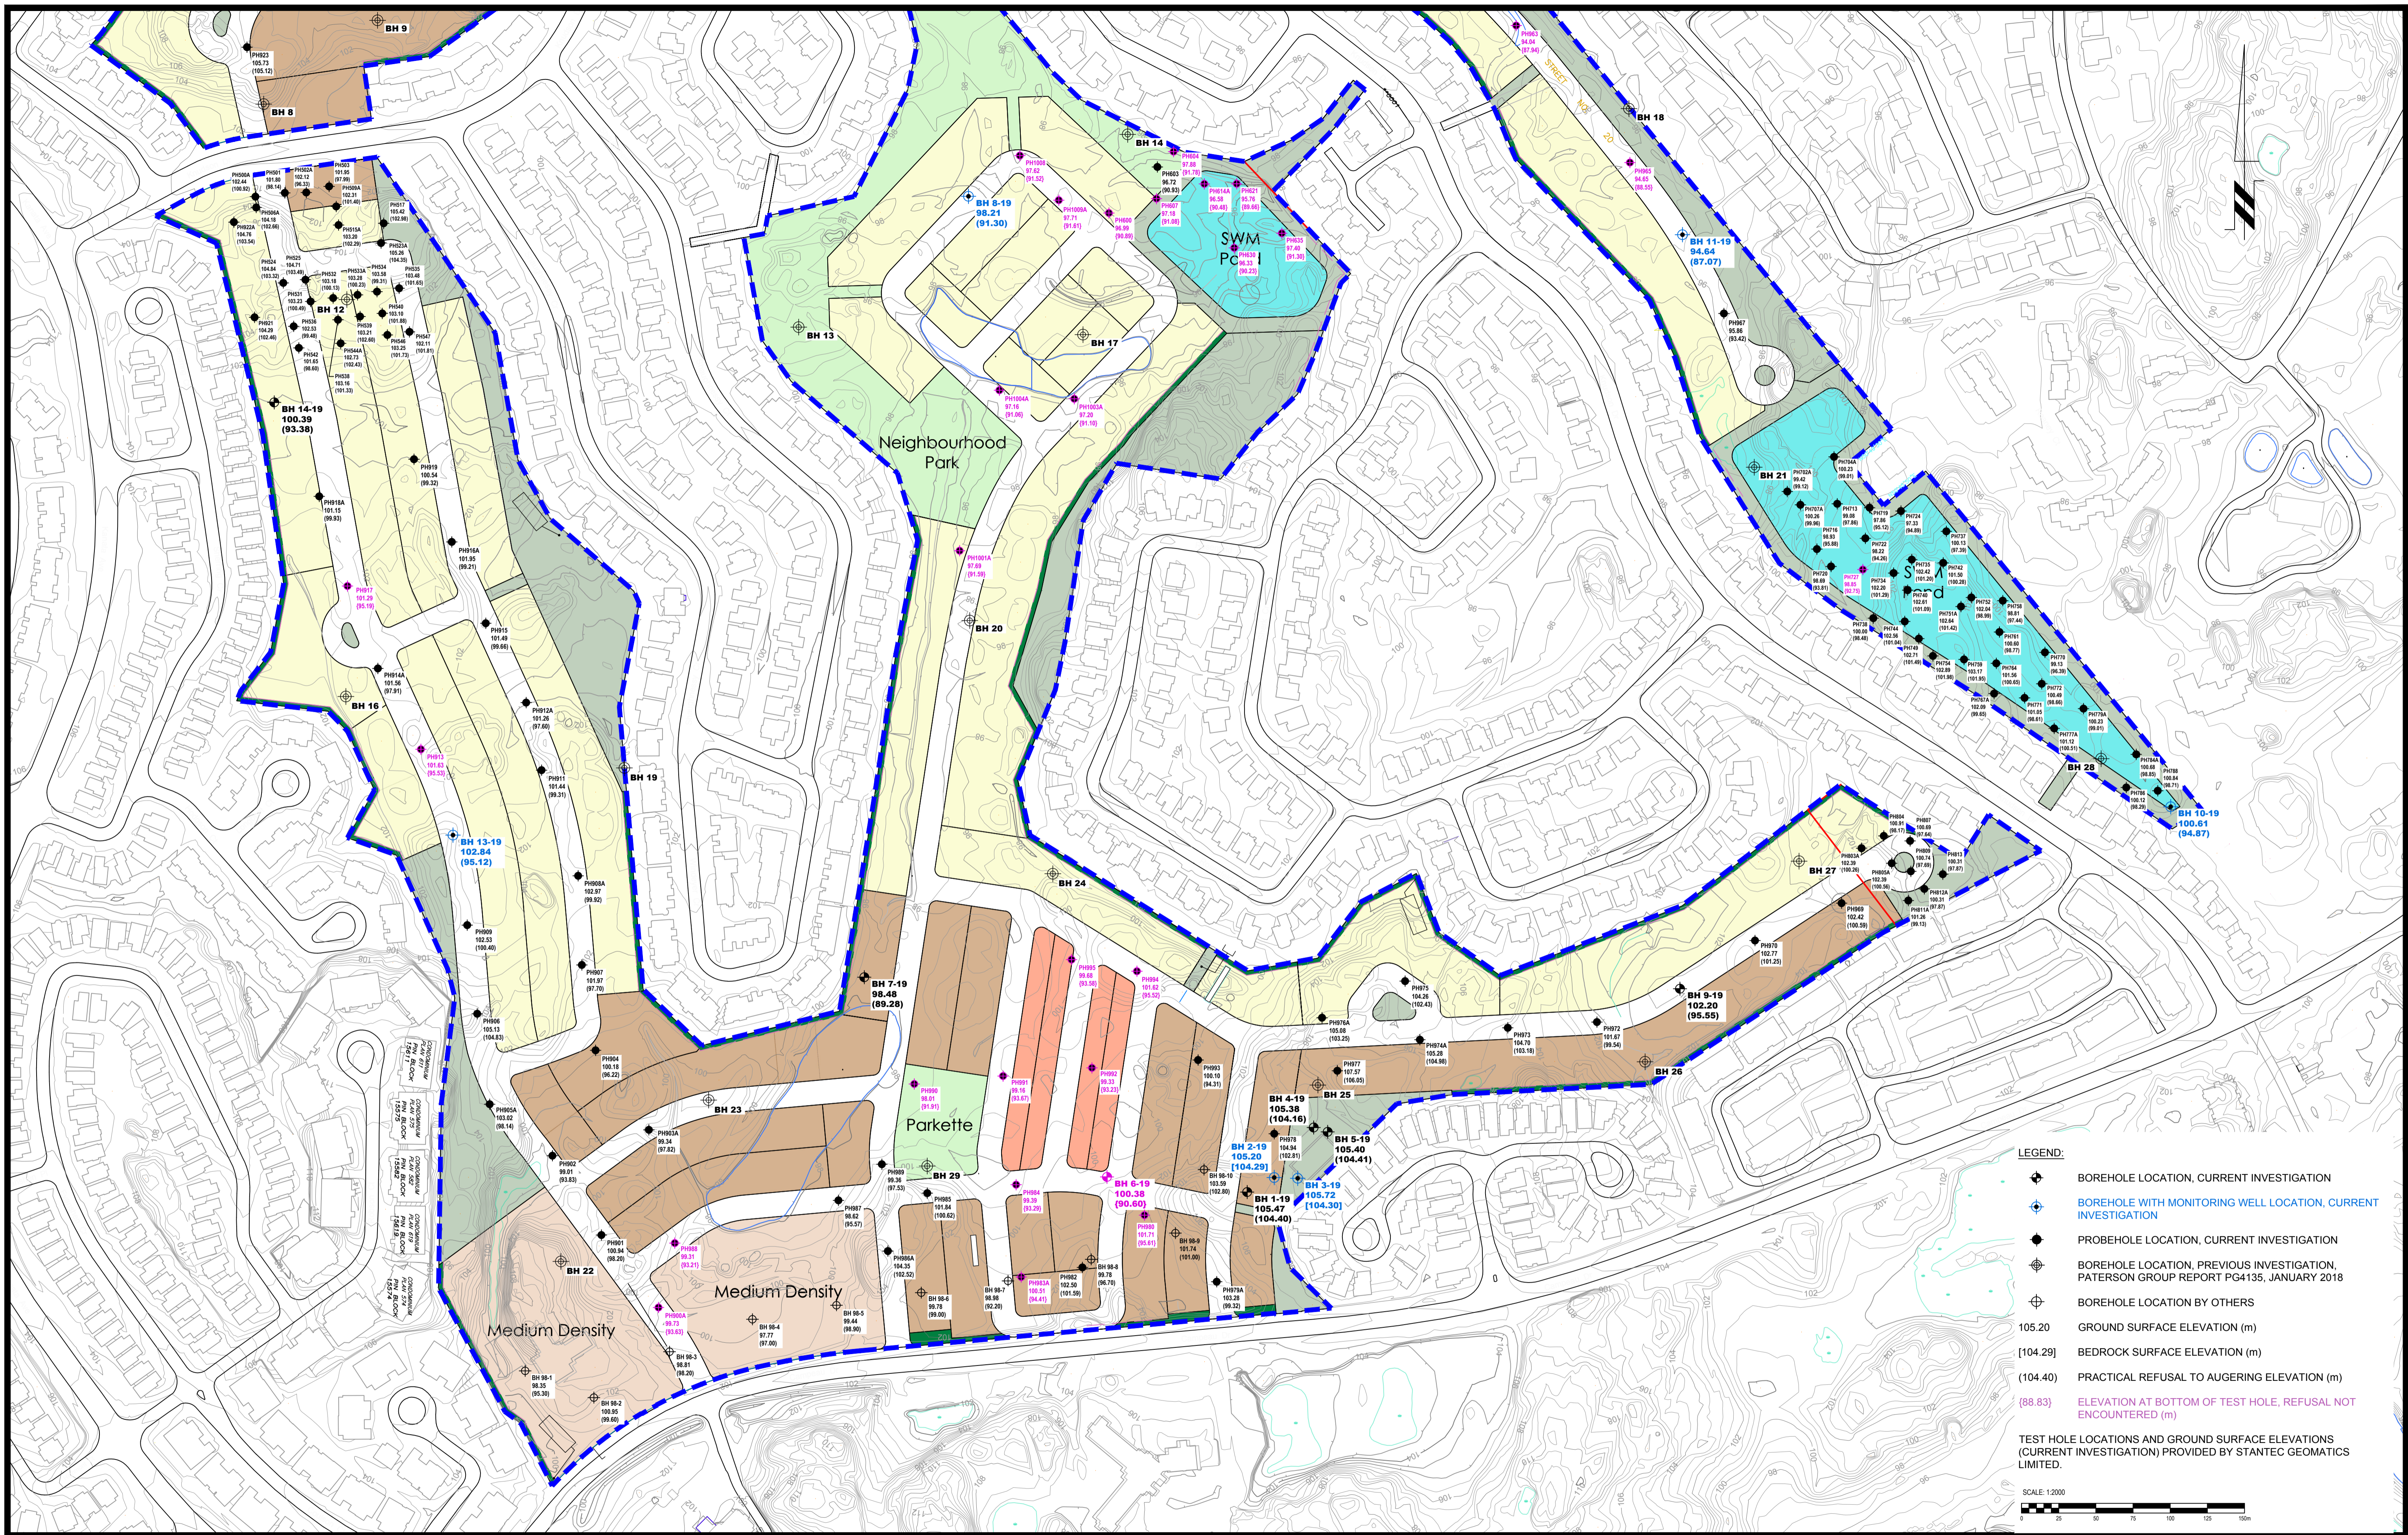
Scale:	1:2000	Report No.:	PG4135
Drawn by:	MPG	Drawing No.:	
Checked by:	RG		
Approved by:	DJG		PG4135-2
Date:	03/2019	Revision No.:	1

TEST HOLE LOCATIONS AND GROUND SURFACE ELEVATIONS (CURRENT INVESTIGATION) PROVIDED BY STANTEC GEOMATICS LIMITED.

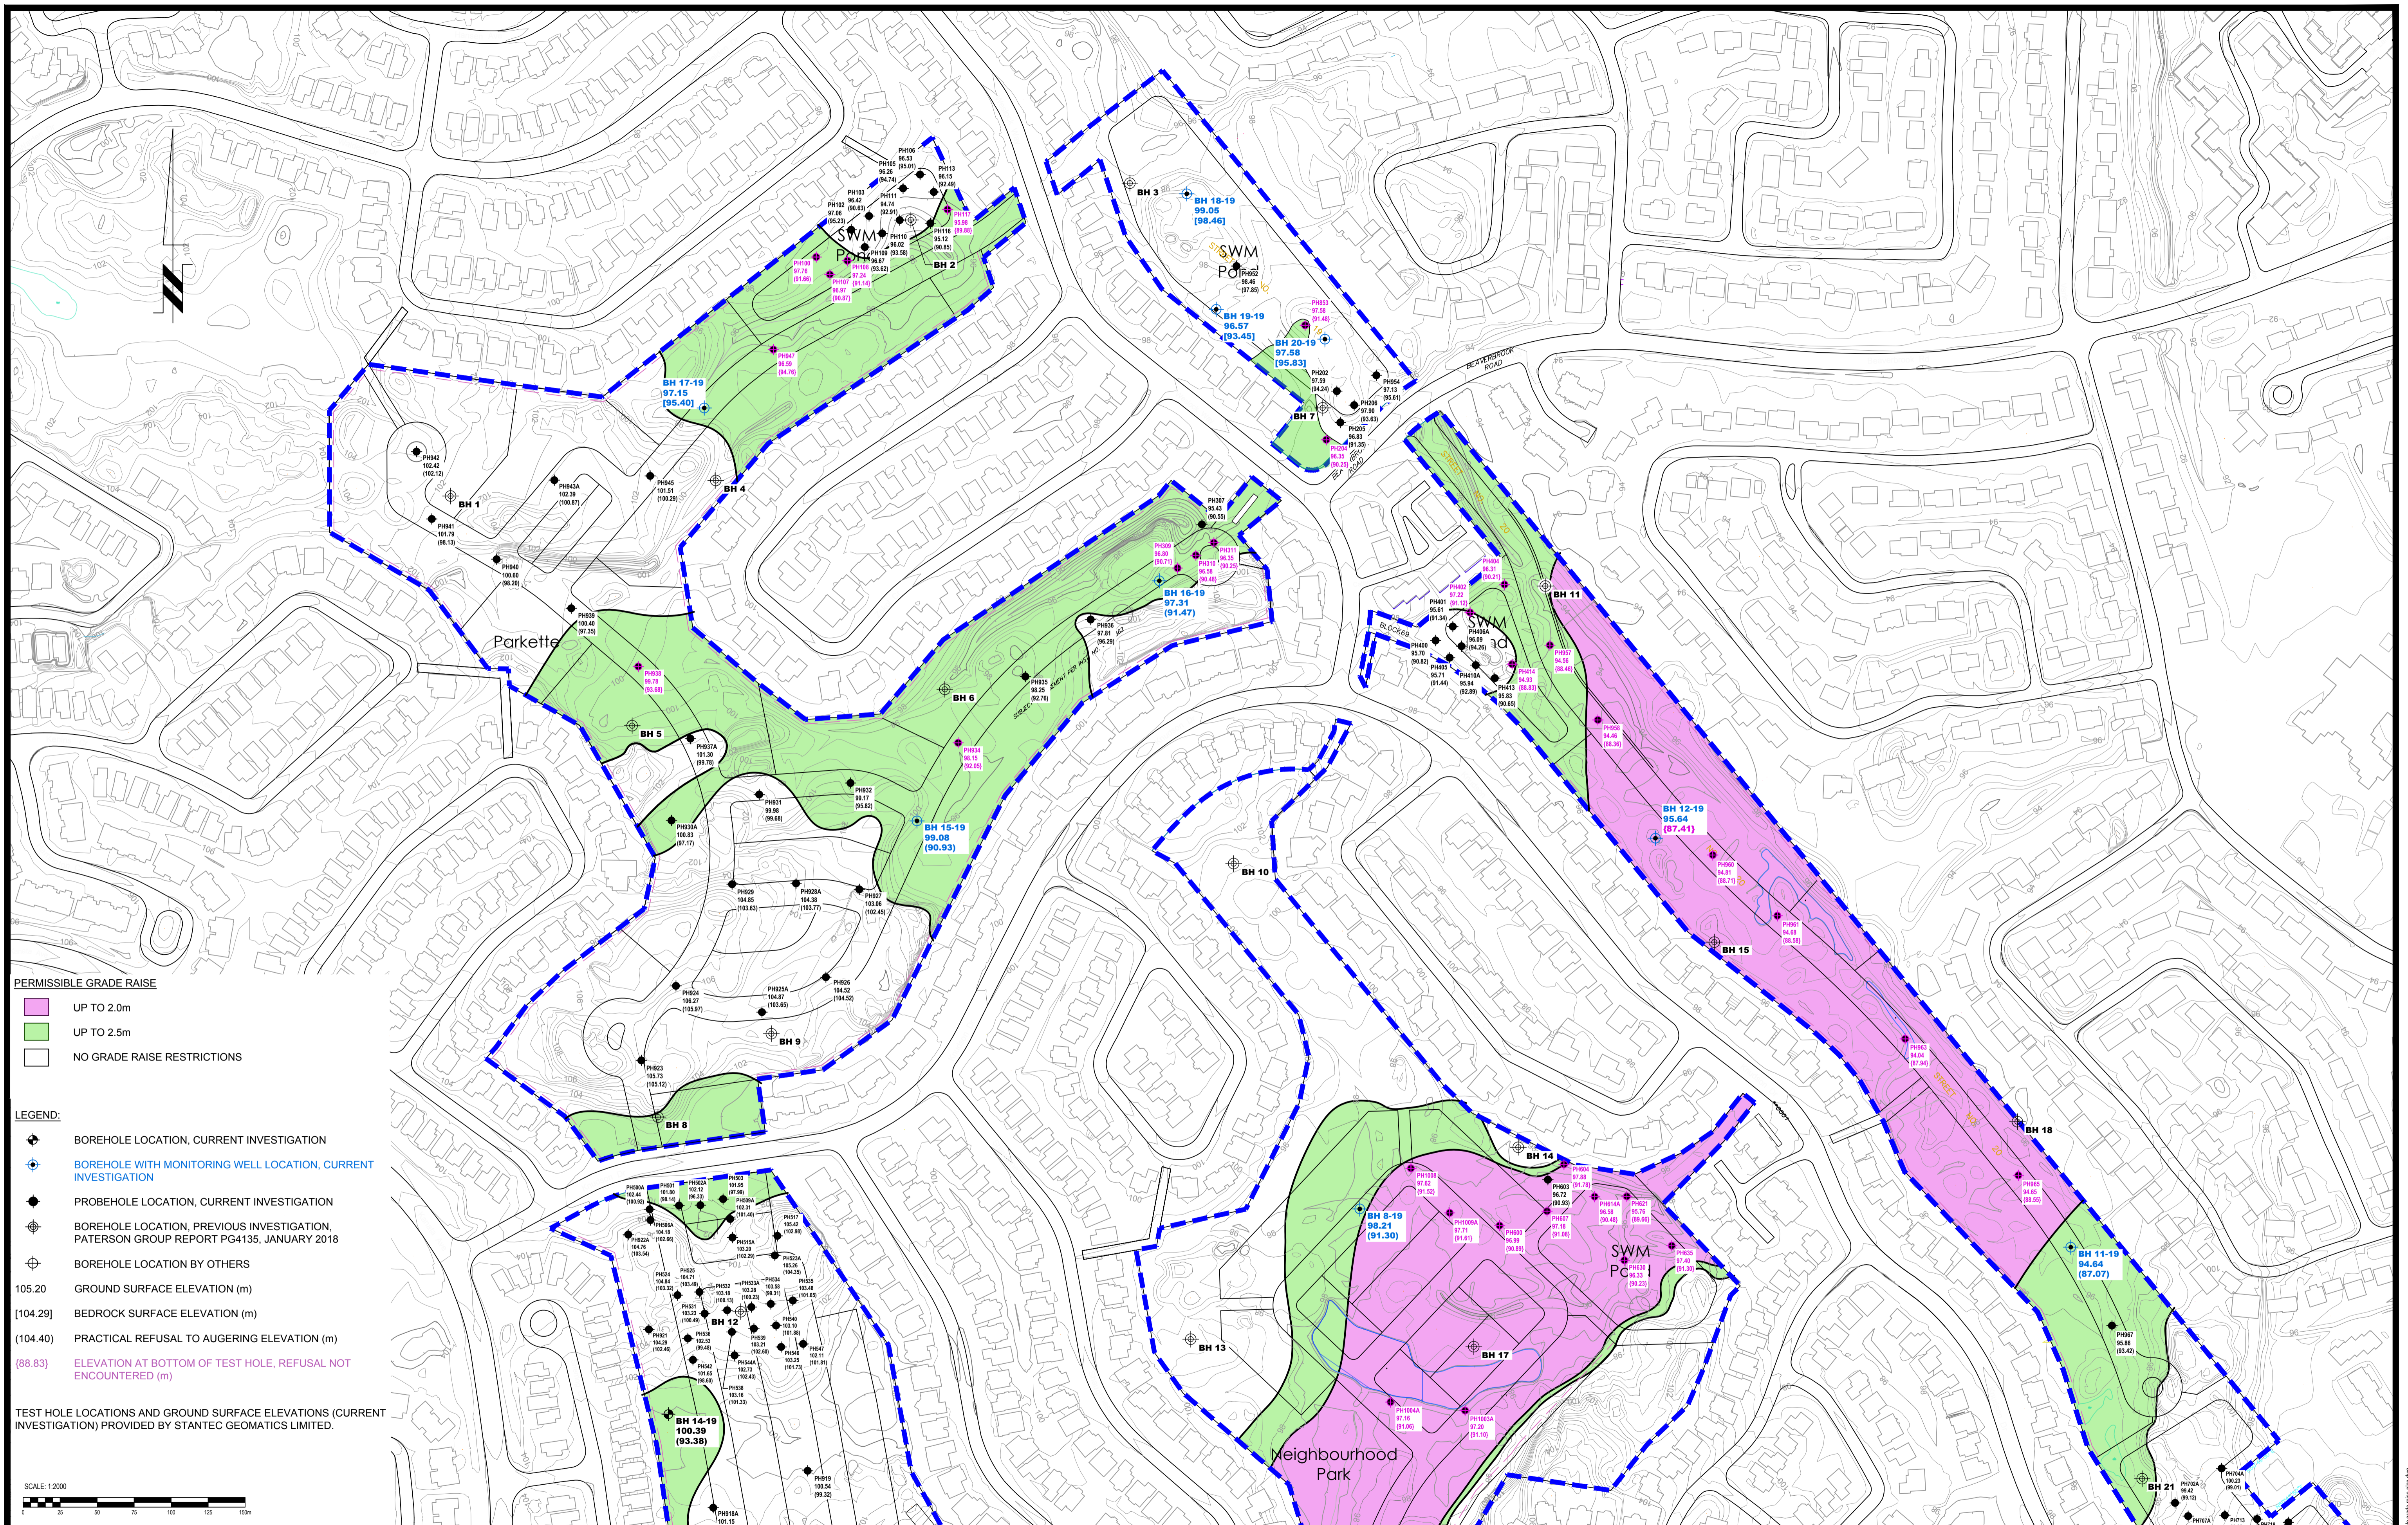
Scale: 1:2000	Report No.: PG4135
Drawn by: MPG	Drawing No.:
Checked by: RG	PG4135-3
Approved by: DJG	Revision No.: 0
Date: 03/2019

PERMISSIBLE GRADE RAISE

- UP TO 2.0m
- UP TO 2.5m
- NO GRADE RAISE RESTRICTIONS

From a geotechnical perspective, the subject site is considered suitable for the proposed residential development. However, due to the presence of a silty clay layer, portions of the proposed development will be subjected to grade raise restrictions. Permissible grade raise recommendations are discussed in Subsection 5.3 and permissible grade raise areas are presented in Drawings PG4135-3 and 4 - Permissible Grade Raise Plan in Appendix 2.

Based on the undrained shear strength values, our experience with Ottawa clays and consolidation testing results, permissible grade raise areas have been defined for the proposed development. The recommended permissible grade raise areas are presented in Drawings PG4135-3 and 4 - Permissible Grade Raise Plan in Appendix 2.

A low to medium sensitivity clay soil is present within the subject site. The following tree planting setbacks are recommended for areas identified on Drawings PG4135-3 and 4- Permissible Grade Raise Plan where permissible grade restrictions are provided. It should be noted that in areas where design finished grades and top of the silty clay layer is greater than 3.5 m, no tree planting setbacks will be required. This will be defined by the geotechnical consultant by a lot by lot basis upon review of the site grading plan.
