**Richmond Village Development Corporation –  
Green Lands  
Integrated Environmental Review**

**Updated Report**

**August 31, 2022**

**KILGOUR & ASSOCIATES LTD.**  
[www.kilgourassociates.com](http://www.kilgourassociates.com)  
Project Number: CAIV 1230

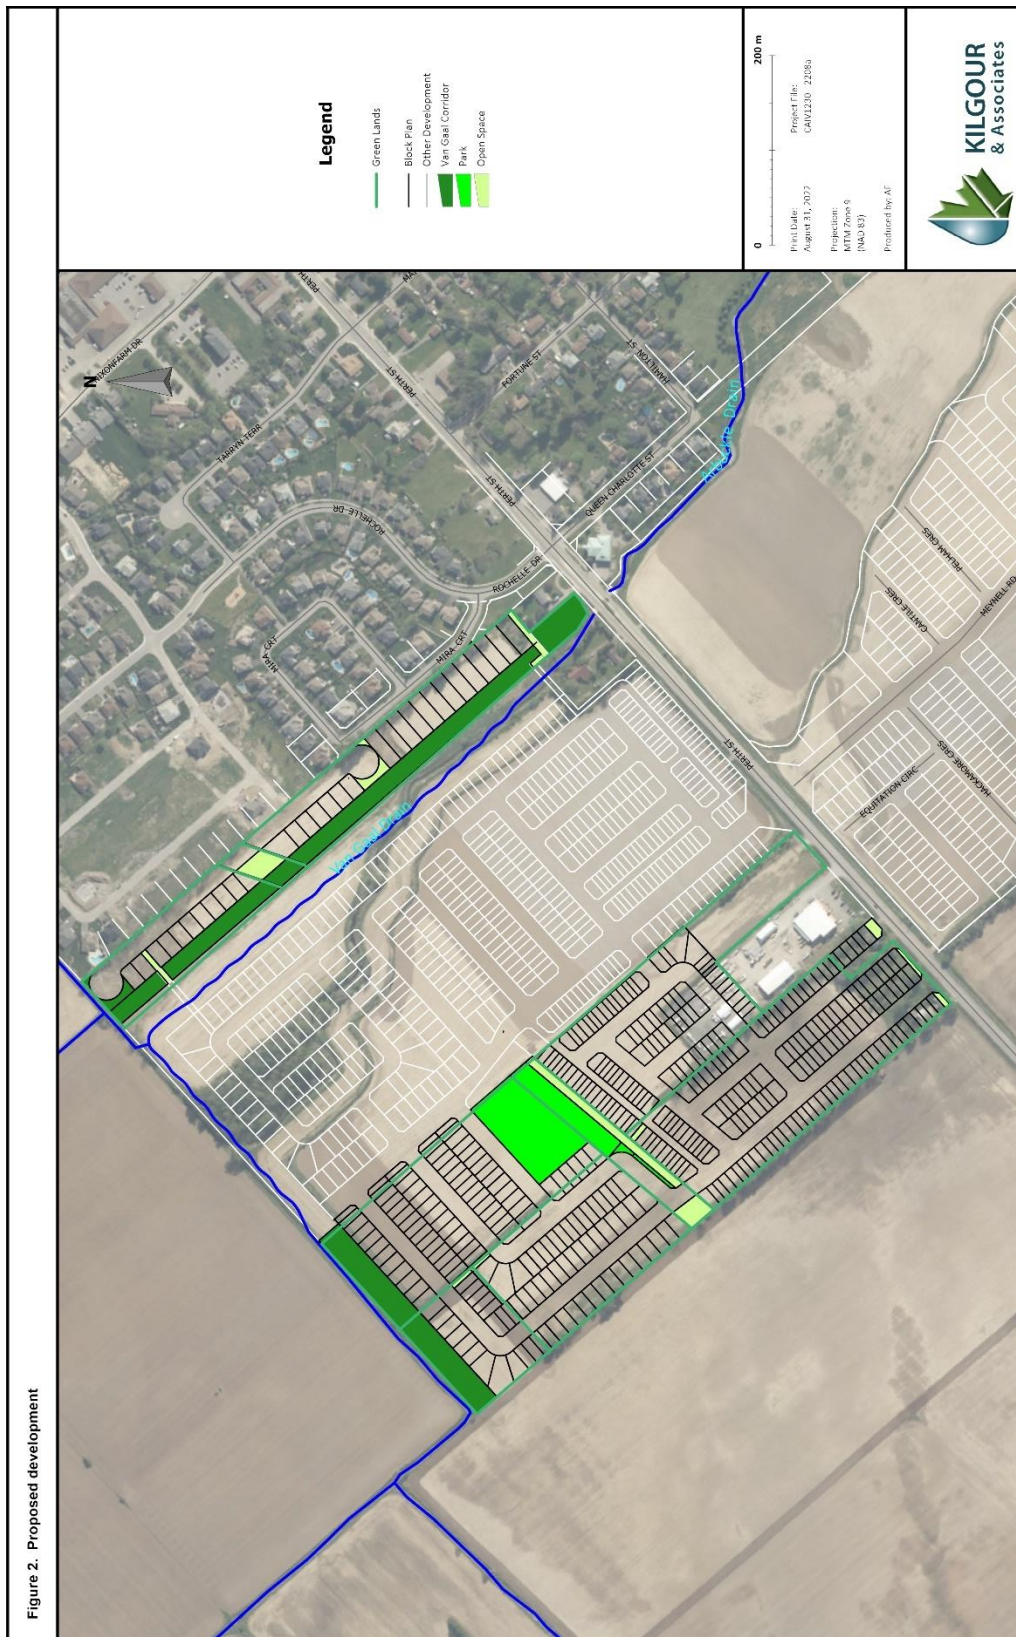
Figure 2. Proposed development

Figure 2. Proposed site development

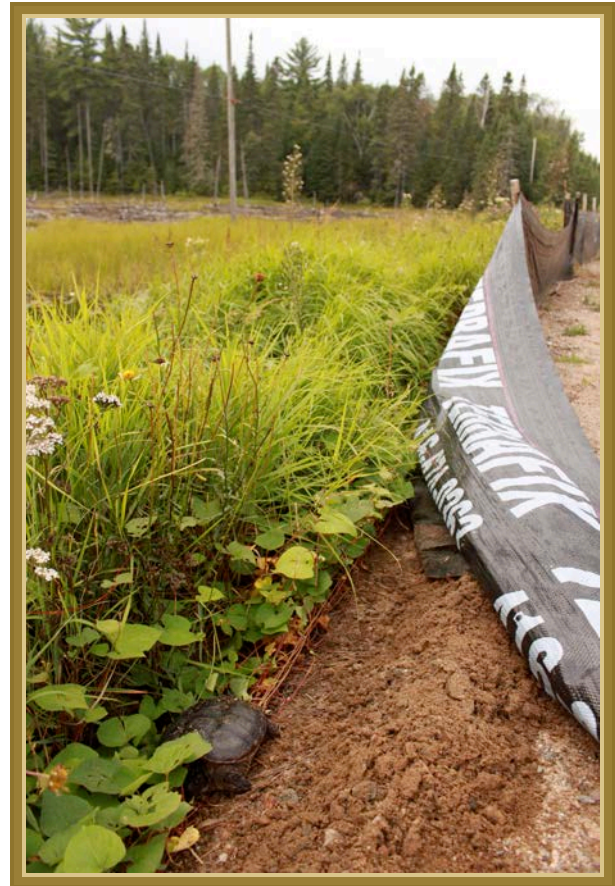
**Plate 1. Light-duty geotextile fencing with pre-attached wooden stakes used to exclude turtles from a road as seen on a regular maintenance check (photo credit: Brad Steinberg).**

Generally, light-duty geotextile fences are not effective if they exceed 1 metre in height unless purposely manufactured for greater height (e.g. stakes placed at closer intervals or cross braces). If greater height is required consider using heavy duty geotextile, hardware cloth or other fencing materials.

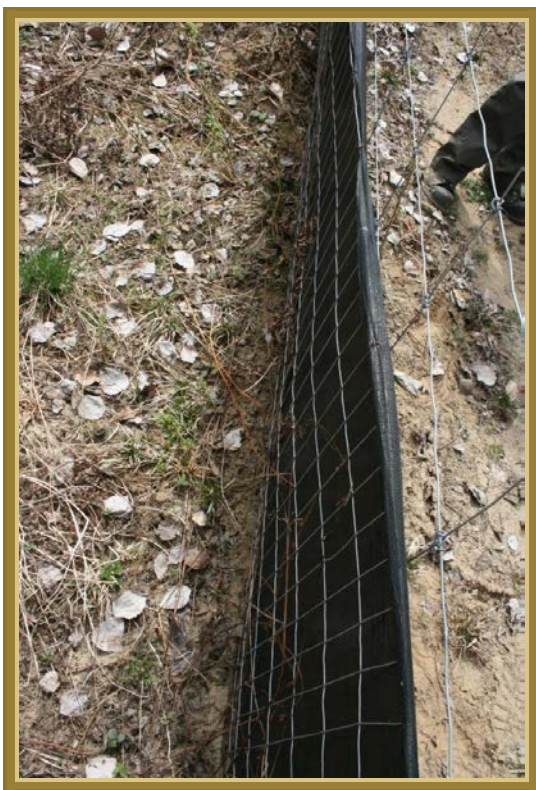
**Plate 2. Example of a heavy-duty geotextile fencing used to exclude snake species (photo credit: Jeremy Rouse).**

- The wire fence should be installed on the activity side to prevent animals from leveraging and climbing into the exclusion area while allowing the animal to escape if they find themselves on the wrong side (Figure 2).
- Geotextile fences across streams, ditches or waterways should have case-specific modifications.
- Contact your local MNR staff or experienced exclusion fencing contractor for advice.
- See light-duty geotextile section above and general best practices below for additional details.

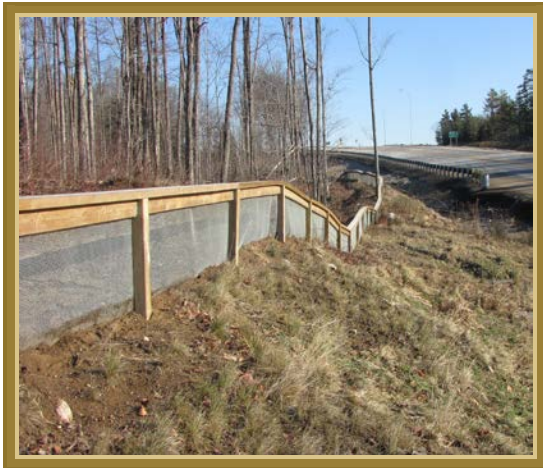
**Plate 3. Example of a galvanized mesh fencing used for the long-term exclusion of snakes and turtles from the adjacent highway (photo credit: Megan Bonenfant).**

- Secure the fence on posts placed a recommended 2.5 m apart with the stakes on the activity side (Figure 2).
- Pull the mesh taut and staple or secure with screws and a metal stripping to prevent the mesh from being ripped when pressure is applied.
- Installing a top rail or folding the mesh over a taut smooth wire reduces tearing (Plates 3 and 4).
- An outward facing lip installed on the species side ensures that snakes and amphibians are unable to climb or jump over the fence (Figure 2; Plate 4)
- Tears can be mended with 18-gauge galvanized wire.
- See general best practices section below for additional details.

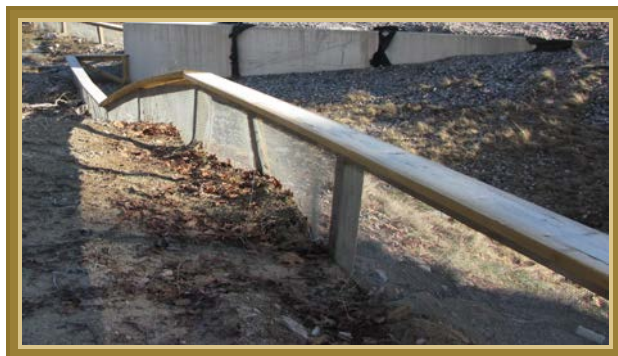
**Plate 4. Long-term to permanent exclusion fencing using galvanized mesh with over-hanging lip to prevent animals from climbing or jumping over (photo credit: Megan Bonenfant).**

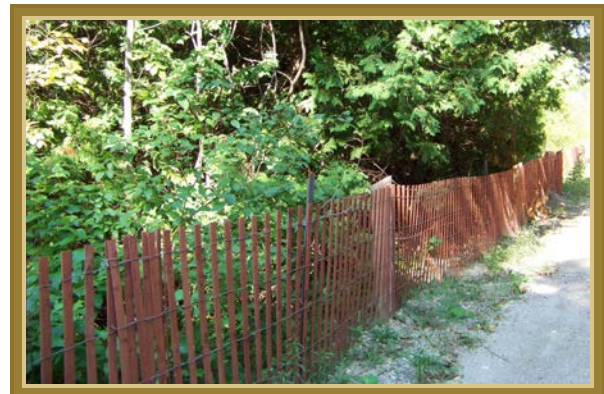
**Plate 5. Example of a wood lath snow fencing used to exclude turtles (photo credit: Karine Beriault).**

- The fencing should be attached to heavy plastic or metal stakes using heavy-duty wire staples or tie-wire.
- The stakes are recommended to be placed at 2 to 3 m intervals and securely driven into the ground 30 cm or more.
- Wood lath snow fencing across streams, ditches or waterways should have case-specific modifications.
- Wood lath snow fencing lends itself well to being combined with other types of material to ensure complete exclusion.
- See general best practices section below for additional details.

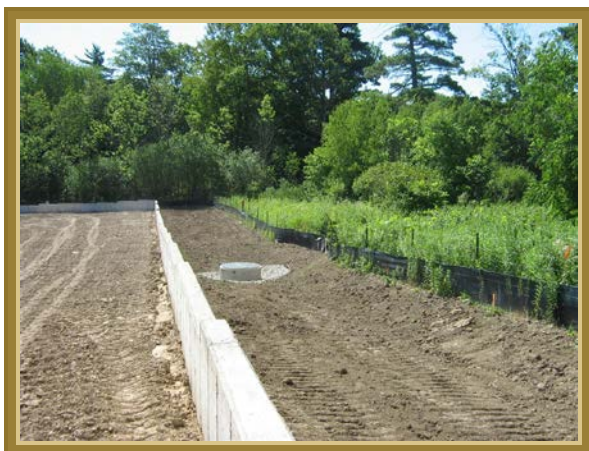
**Plate 6. Stand-alone continuous concrete wall used to exclude salamander species installed as pre-cast forms (photo credit: Steven Roorda).**

Concrete, metal or vinyl walls can stand alone or be combined with woven wire or chain link fences. They are durable, require minimal maintenance and are effective in excluding target species from high risk areas and guiding them to crossing structures or other desired locations (Plates 6 and 7). This fence type is comprised of a continuous vertical face of concrete, metal or vinyl sheeting with no gaps. Concrete walls can be installed as either pre-cast sections or pour directly in place.

The wall height depends upon the target species, but they are usually between 45 and 60 cm tall and buried 25 cm. Concrete, metal or vinyl exclusion fencing is most appropriate for salamanders, skinks, small snakes, and small turtles. For large turtle species, a chain link fence can be installed directly on top of the concrete wall for complete exclusion.

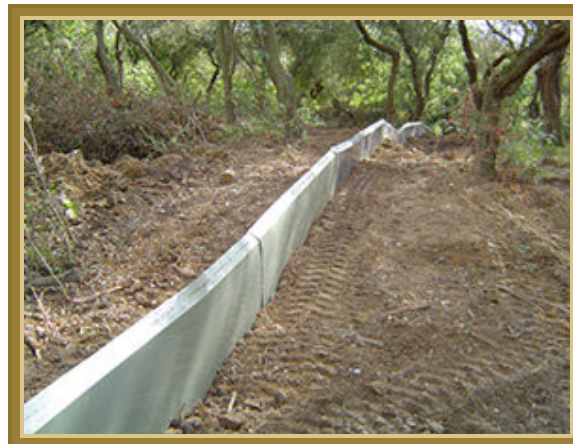
**Plate 7. Pre-formed vinyl sheeting fence intended to exclude salamanders for a construction site (photo credit: Herpetosure Ltd.)**

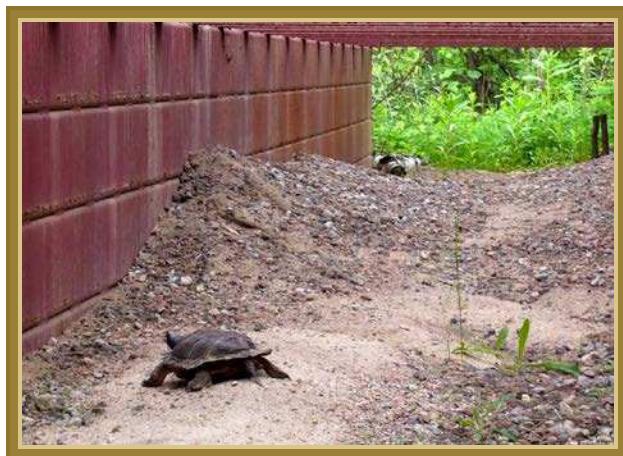
**Plate 7. A wood turtle travelling through a dry eco-passage. Ecopassages such as this help to ensure the long-term connectivity of seasonal habitat for this and other reptile and amphibian species (photo credit: Amy Mui).**

During the installation of fencing with an eco-passage, it is important that the fencing sits flush with the passage to ensure that

there are no gaps where animals can squeeze through.
