RE: Proposed New Multi-Story Building at 800 Montreal Road, Ottawa, ON
Geotechnical Investigation and Hydrogeological Investigation
For Site Plan Approval Application Only

RE: Review of Founding Elevation of Proposed Footings for New Multi-Story Building
(Phase I) located at 800 Montreal Road, Ottawa, ON

Report Title
**Geotechnical Letter
Review of Proposed Foundation Depth**

**Hydrogeological Investigation Report
800 Montreal Road, Ottawa, Ontario**

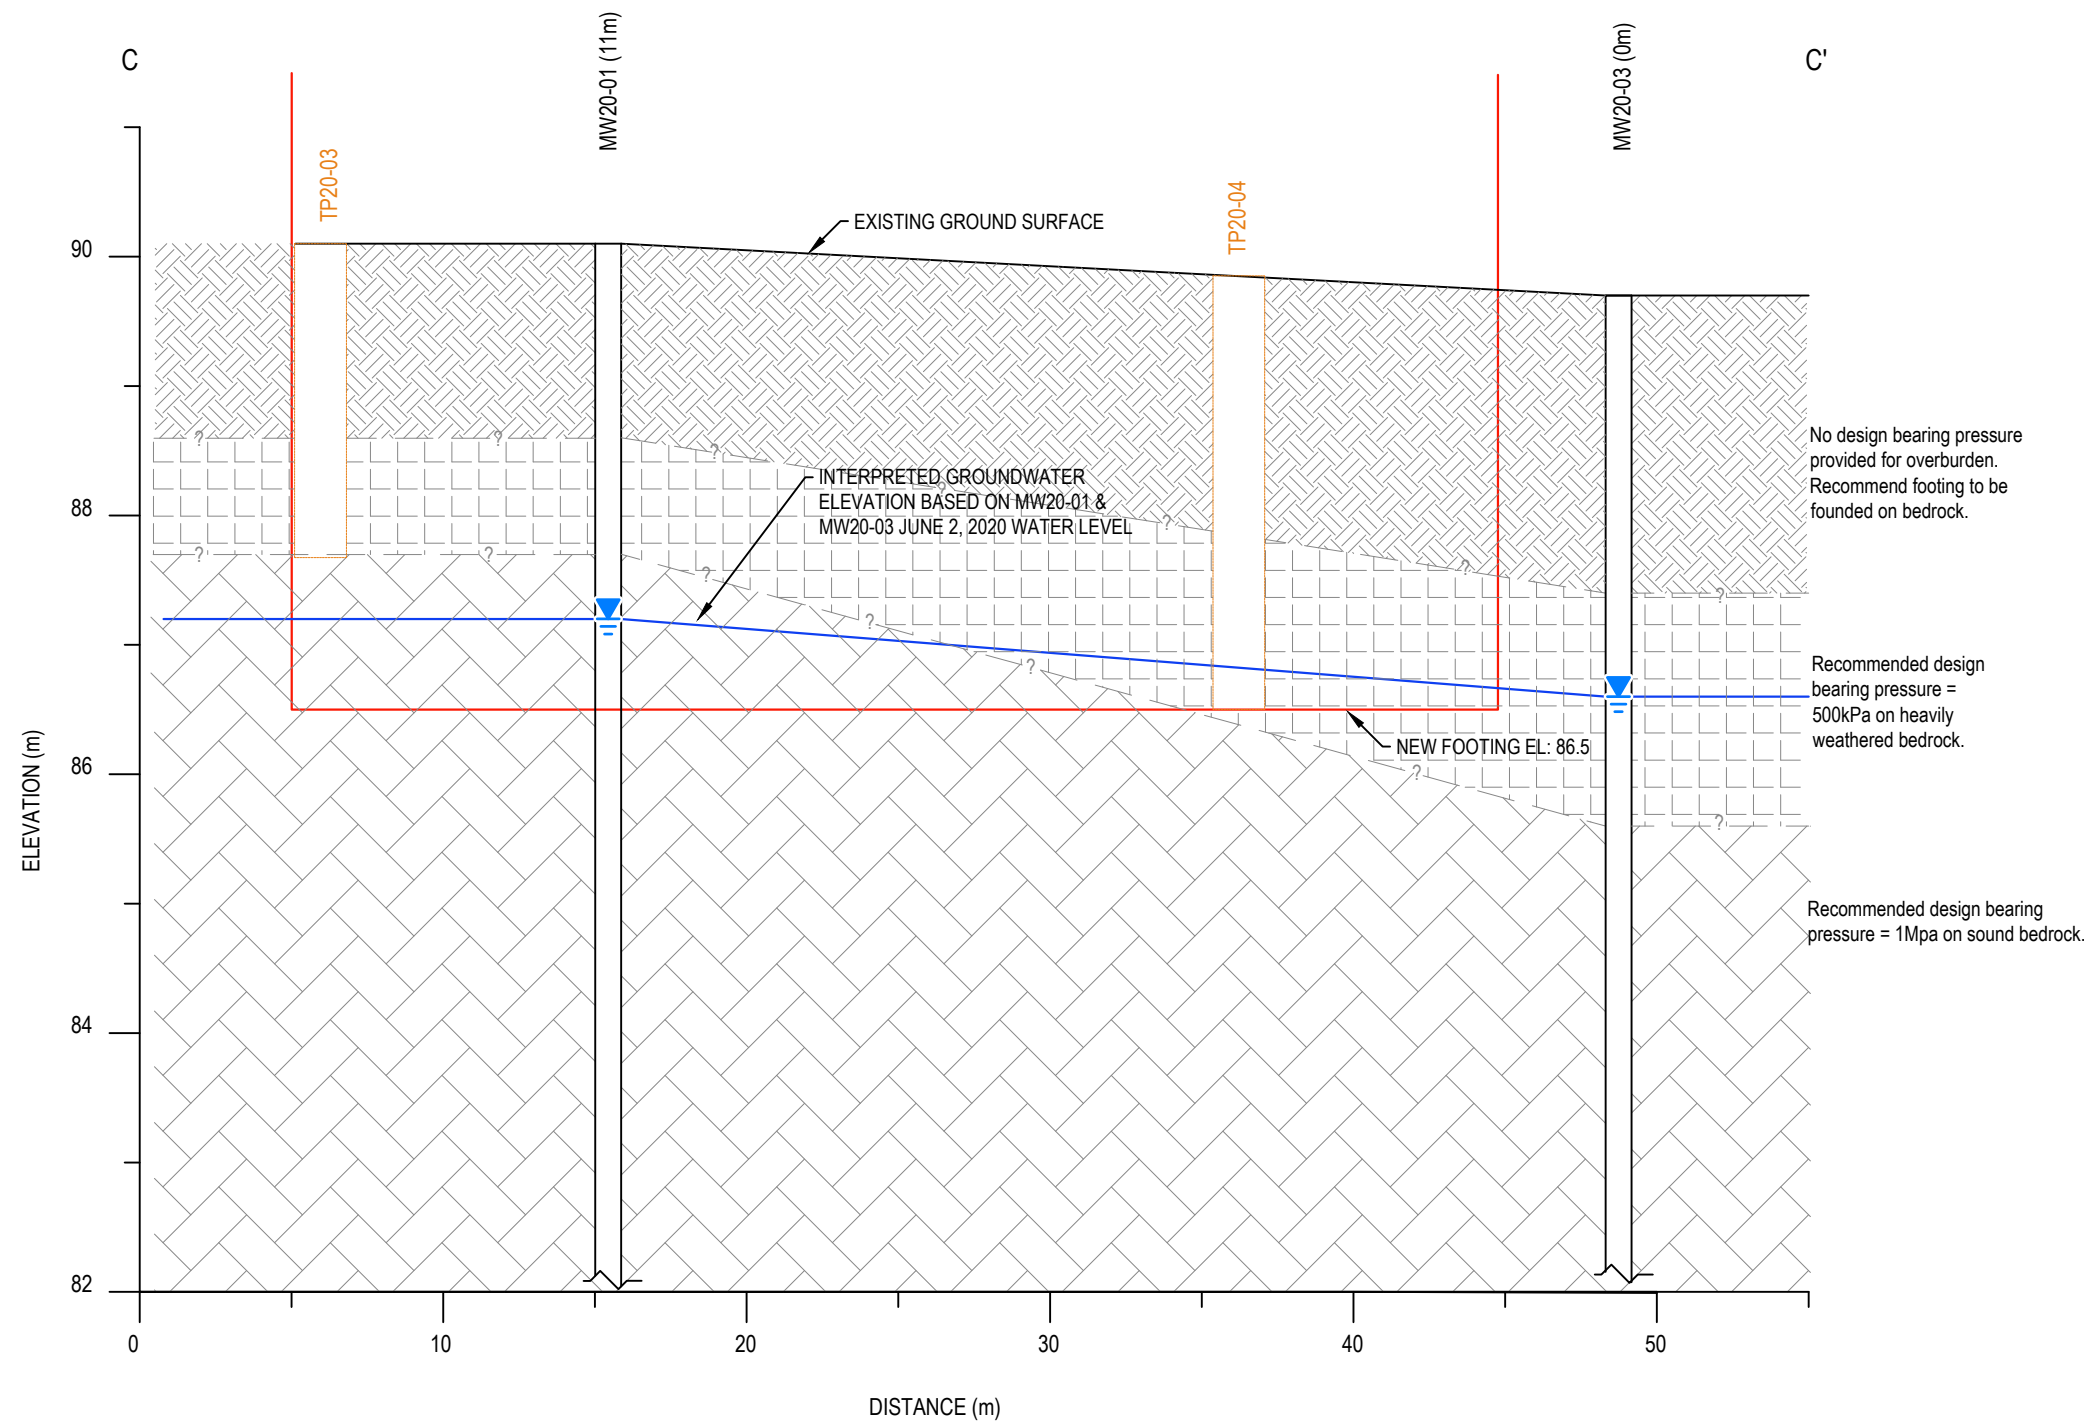
Designed By S.R.	Scale As shown
Drawn By K.M.	Date December 2020
Approved By	Project No. 02001055.000
Figure No.	4

1. This drawing shall be read in conjunction with the associated technical report.
2. No design bearing pressure provided for overburden. Recommend footing to be founded on bedrock.
3. Recommended design bearing pressure = 500kPa on heavily weathered bedrock. Recommended design bearing pressure = 1Mpa on sound bedrock.

According to the new foundation elevation provided by the Client, different foundation subsoil conditions at the perimeter footing elevations should be expected, as shown on Figures 1 to 6 attached depicting the cross sections of the proposed building. The following table summarizes the anticipated subsurface conditions at elevation 86.5 m at the location of the perimeter footings, based on the cross sections shown on Figure 2 to Figure 5 attached.

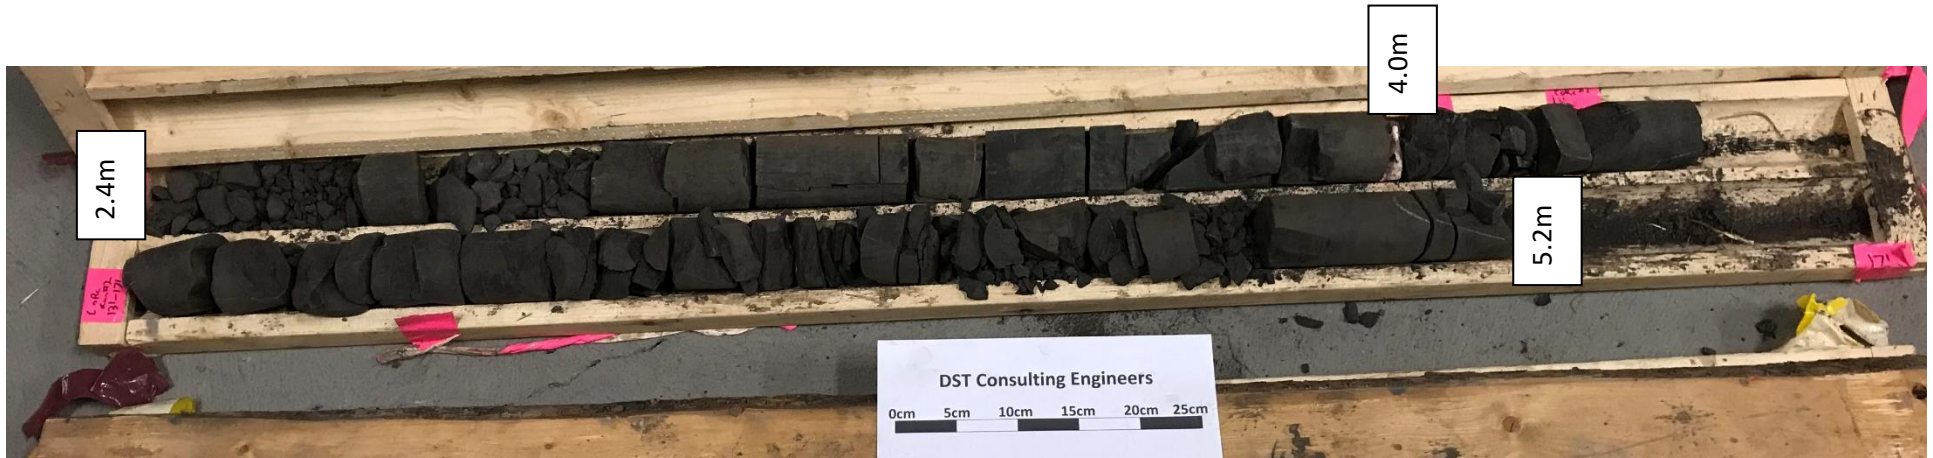
Rock Core Photo No.: 1

Borehole: BH 20-1

Depth: 2.4 to 5.2 m

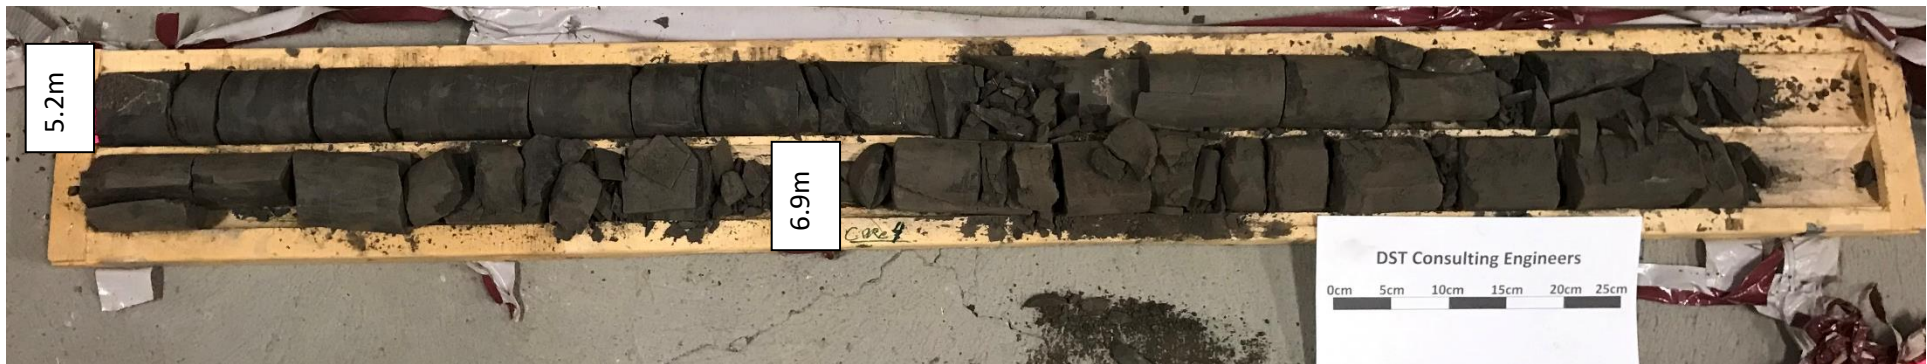
Rock Core Photo No.: 2

Borehole: BH 20-1

Depth: 5.2 to 7.7

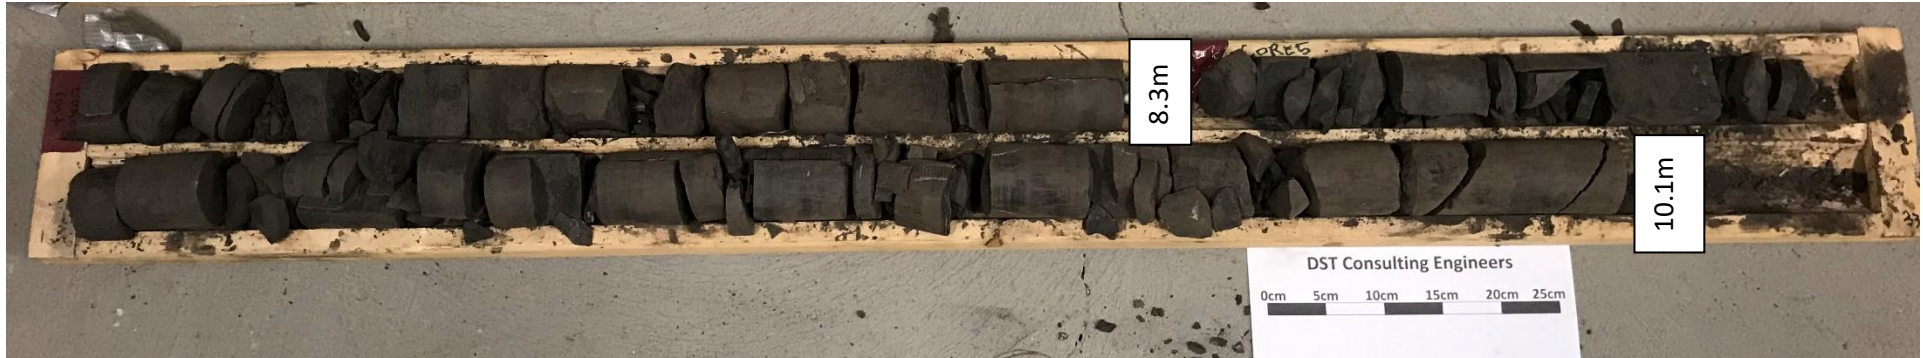
Rock Core Photo No.: 3

Borehole: BH 20-1

Depth: 7.7 to 10.1 m
