## Phase II – Environmental Site Assessment

Trail's Edge: Phase 5 (North)  
Ottawa, Ontario

Prepared For

Report: PE5000-1

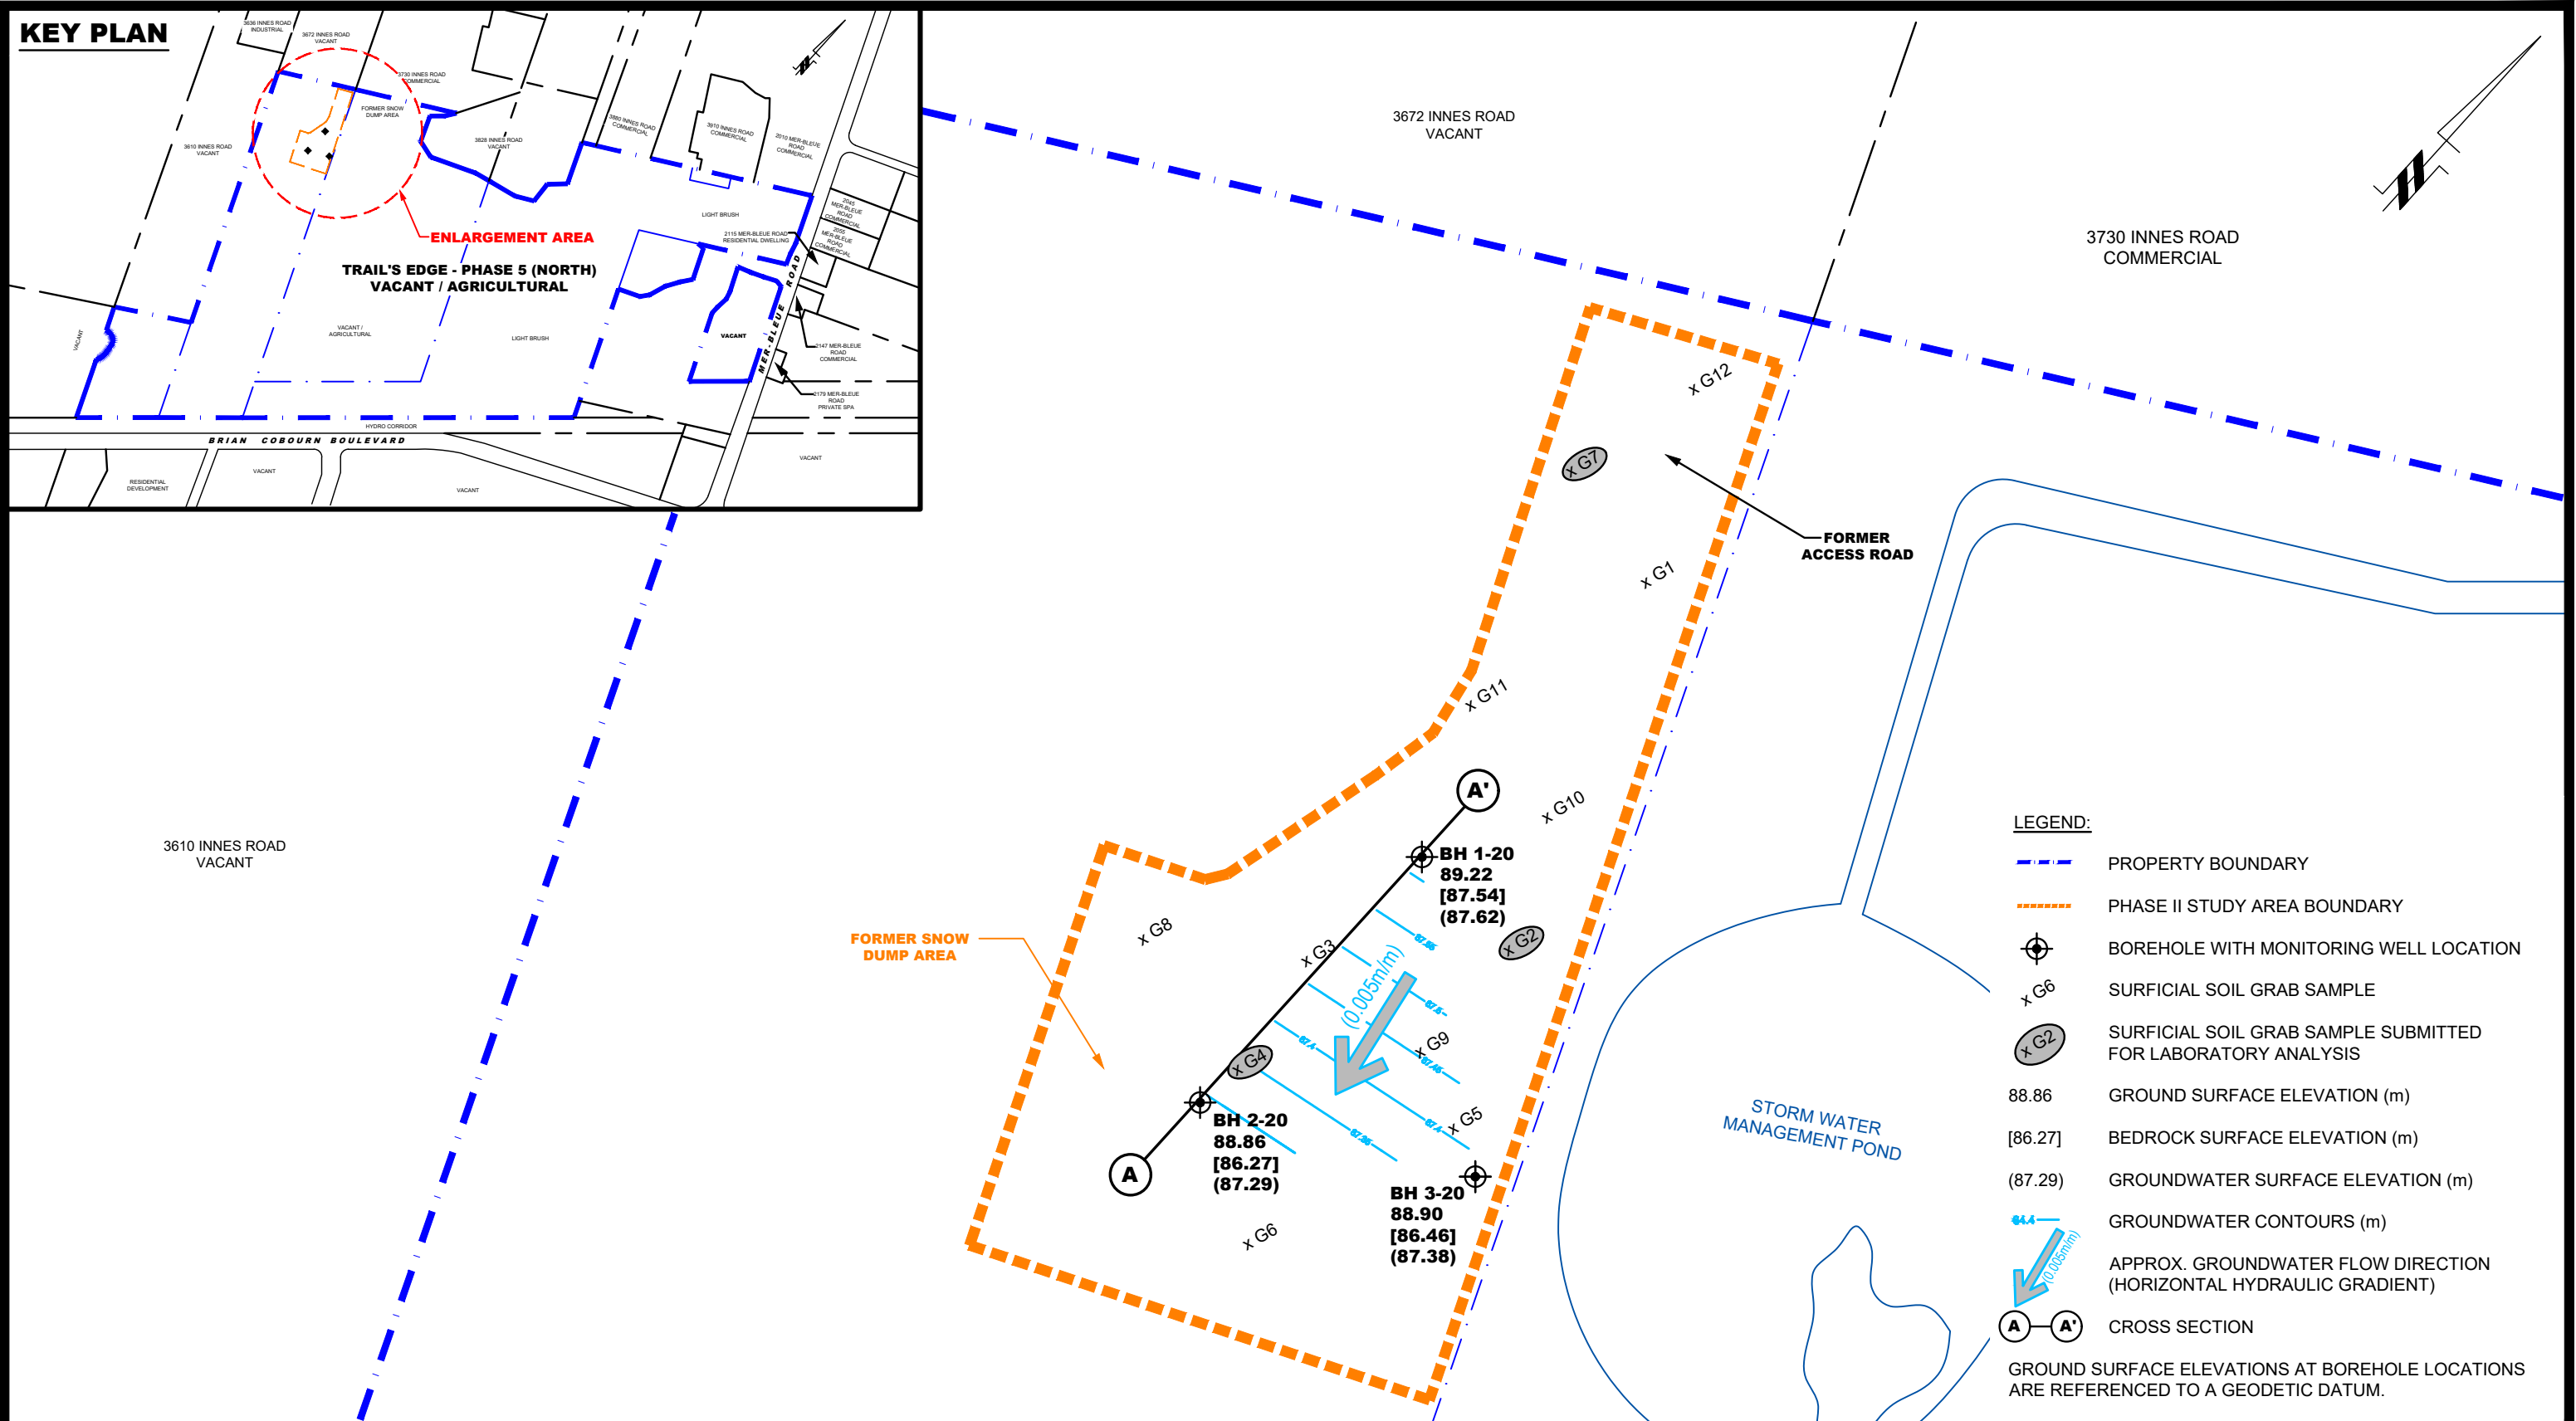
Scale:	1:1250	Date:	11/2020
Drawn by:	YA	Report No.:	PE5000-1
Checked by:	NS	Dwg. No.:	<b>PE5000-3</b>
Approved by:	MSD	Revision No.:

- LEGEND:**
- - - PROPERTY BOUNDARY
  - - - - - PHASE II STUDY AREA BOUNDARY
  - BOREHOLE WITH MONITORING WELL LOCATION
  - SURFICIAL SOIL GRAB SAMPLE
  - SURFICIAL SOIL GRAB SAMPLE SUBMITTED FOR LABORATORY ANALYSIS
  - 88.86 GROUND SURFACE ELEVATION (m)
  - [86.27] BEDROCK SURFACE ELEVATION (m)
  - (87.29) GROUNDWATER SURFACE ELEVATION (m)
  - GROUNDWATER CONTOURS (m)
  - APPROX. GROUNDWATER FLOW DIRECTION (HORIZONTAL HYDRAULIC GRADIENT)
  - CROSS SECTION
- GROUND SURFACE ELEVATIONS AT BOREHOLE LOCATIONS ARE REFERENCED TO A GEODETIC DATUM.

Refer to Drawing PE5000-3 Test Hole Location Plan for the location of all boreholes and surficial grab samples.

Under the full-time supervision of Paterson personnel, the boreholes were drilled using a track-mounted drill rig provided by George Downing Estate Drilling of Hawkesbury, Ontario. The locations of the boreholes are illustrated on Drawing PE5000-3 – Test Hole Location Plan, appended to this report.

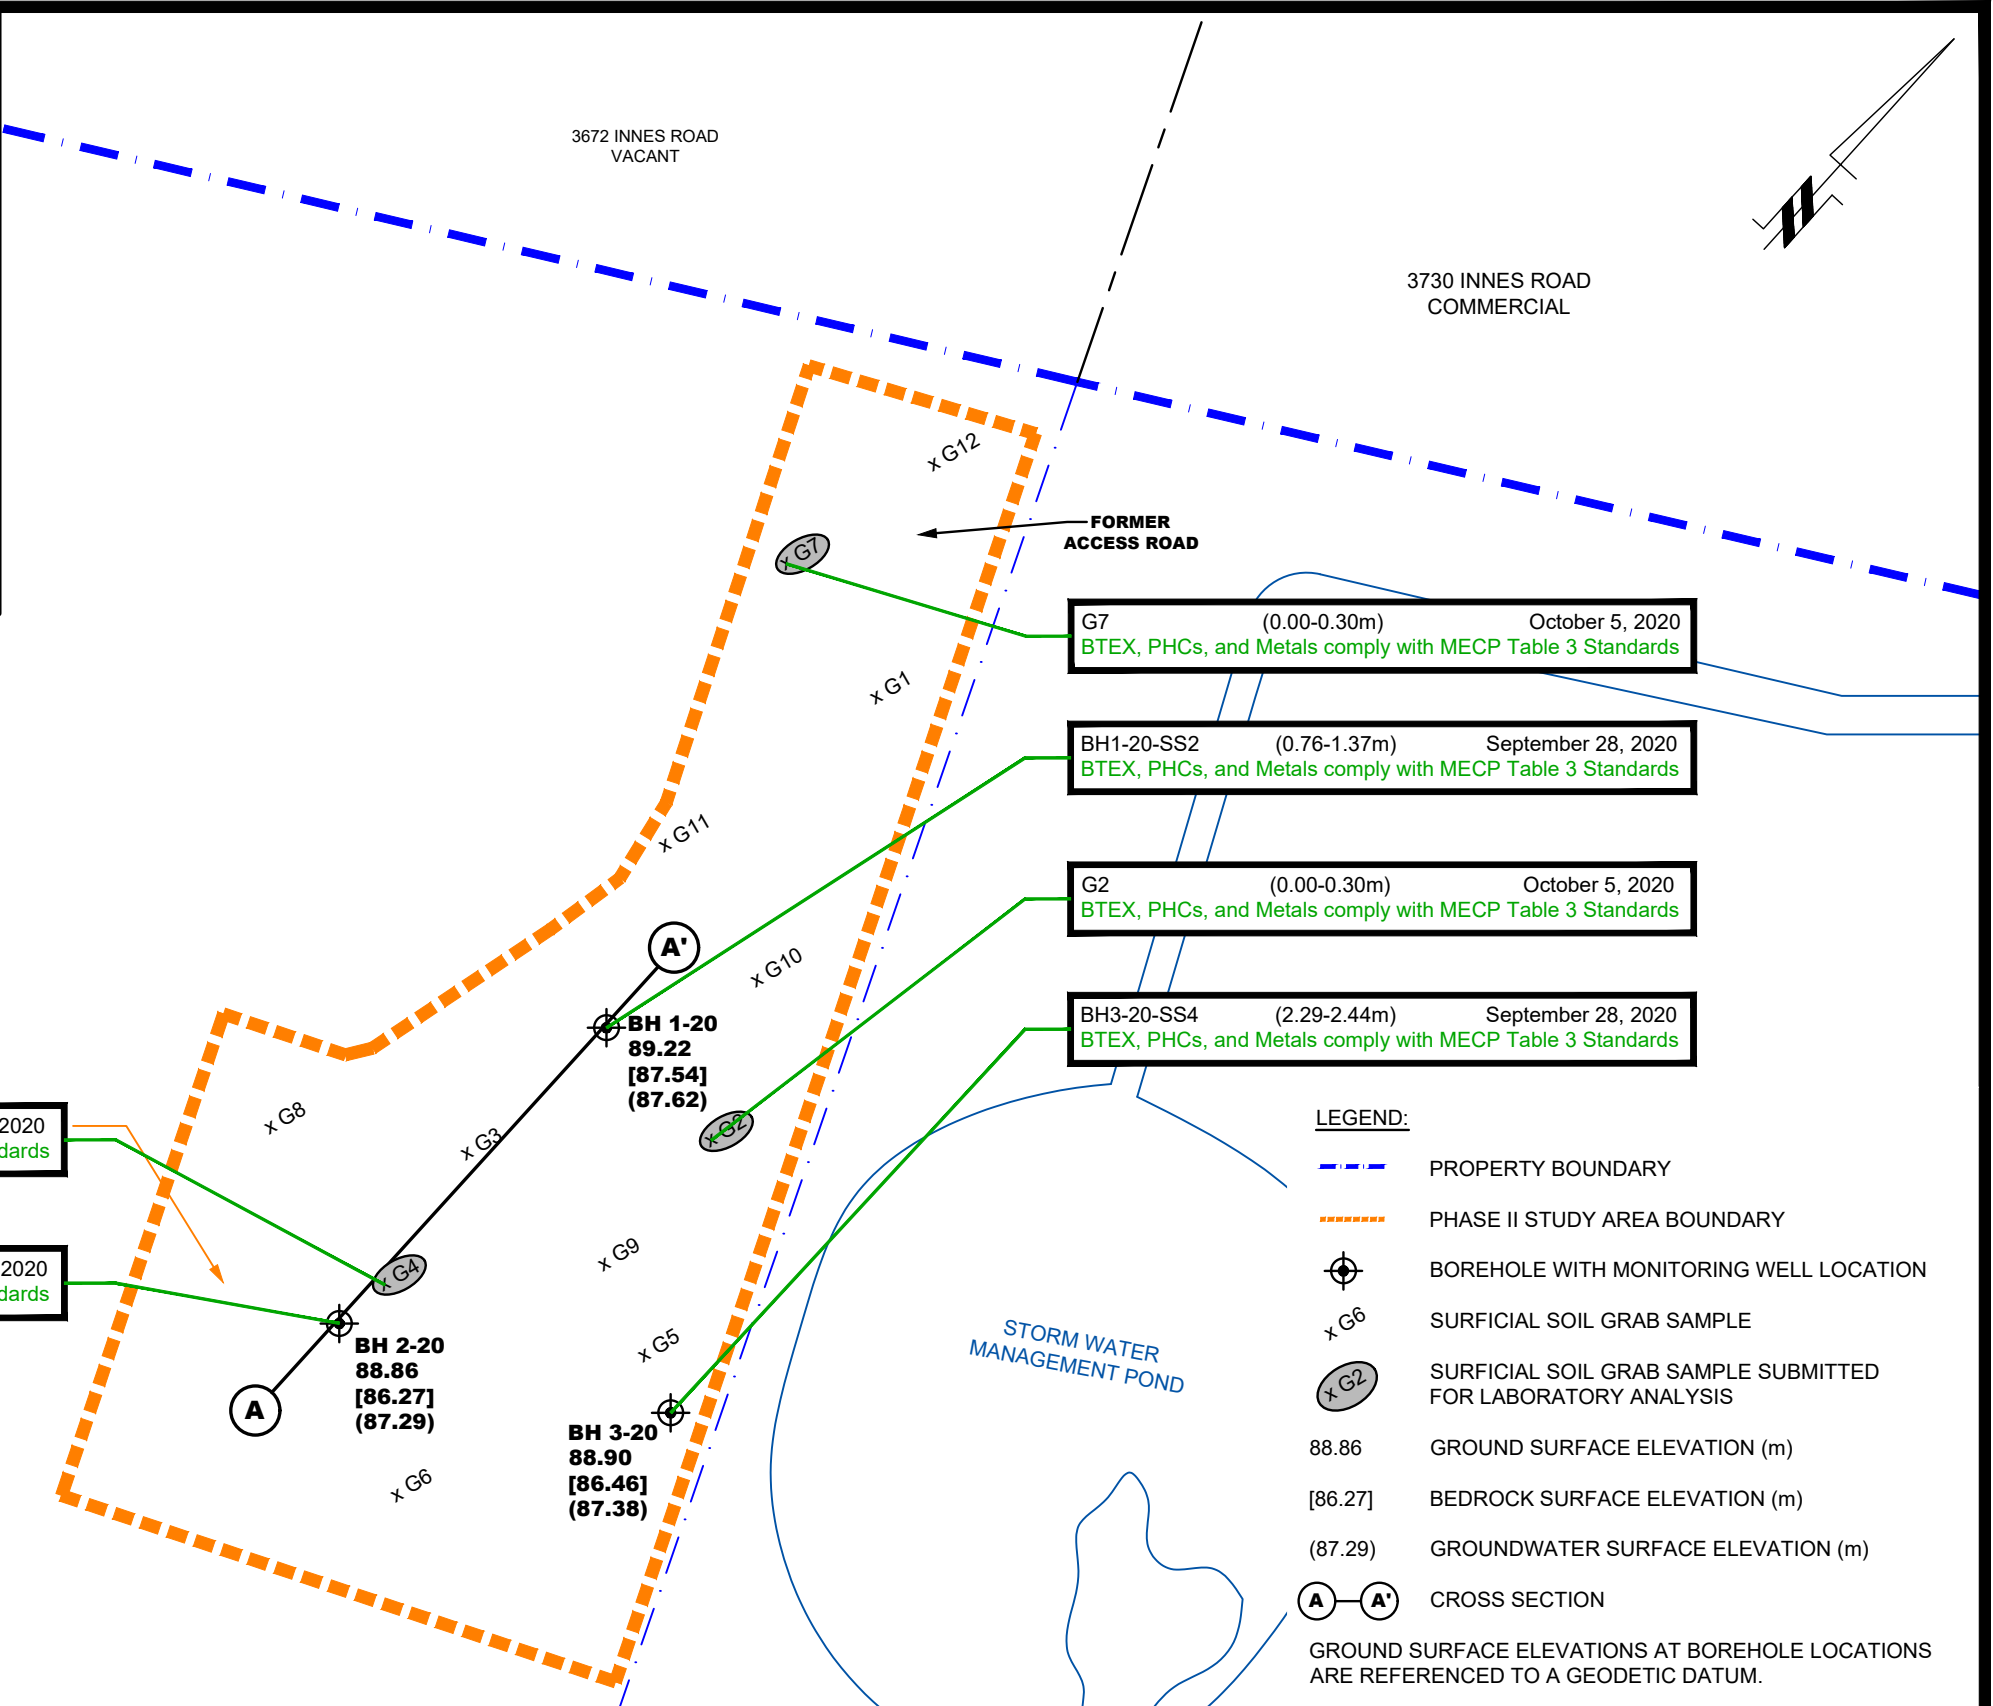
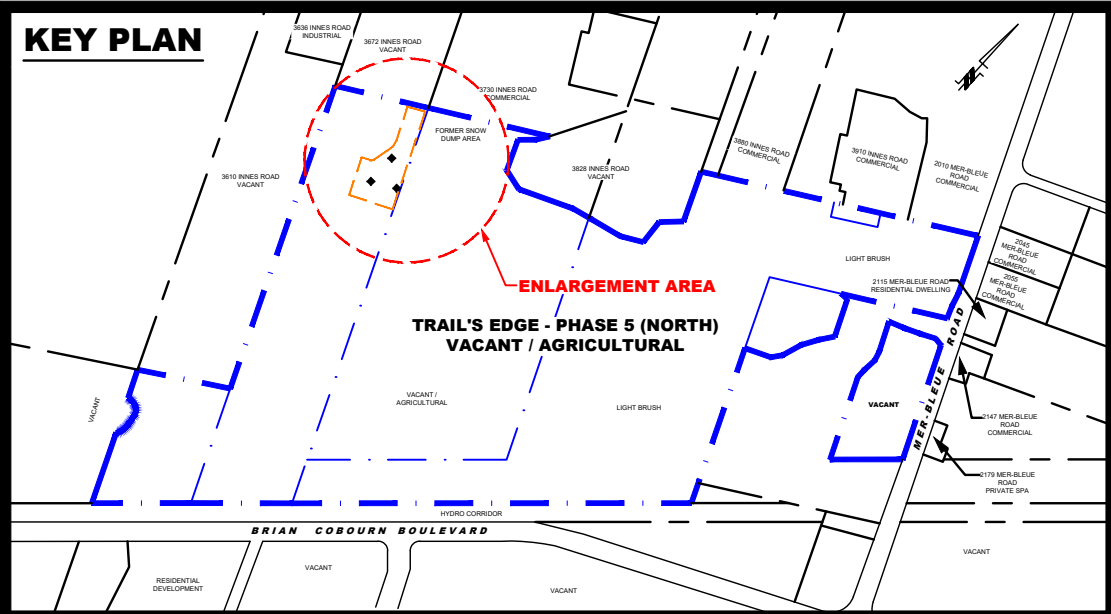
G4 (0.00-0.30m) October 5, 2020  
 BTEX, PHCs, and Metals comply with MECP Table 3 Standards

BH2-20-SS4 (2.29-2.90m) September 28, 2020  
 BTEX, PHCs, and Metals comply with MECP Table 3 Standards

BH1-20-SS2 (0.76-1.37m) September 28, 2020  
 BTEX, PHCs, and Metals comply with MECP Table 3 Standards

All detected metal concentrations in the soil samples analysed are in compliance with the selected MECP Table 3 standards, with the exception of the concentration of vanadium detected in sample BH1-20-SS4. Based on the native origins of the soil sample, as well as the relative consistency in detected metal parameters between soil samples obtained at similar depths from the other boreholes, this exceedance is considered to be a naturally occurring elevated level, commonly found in Ottawa Valley clays, and does not present a contaminant issue to the subject site.

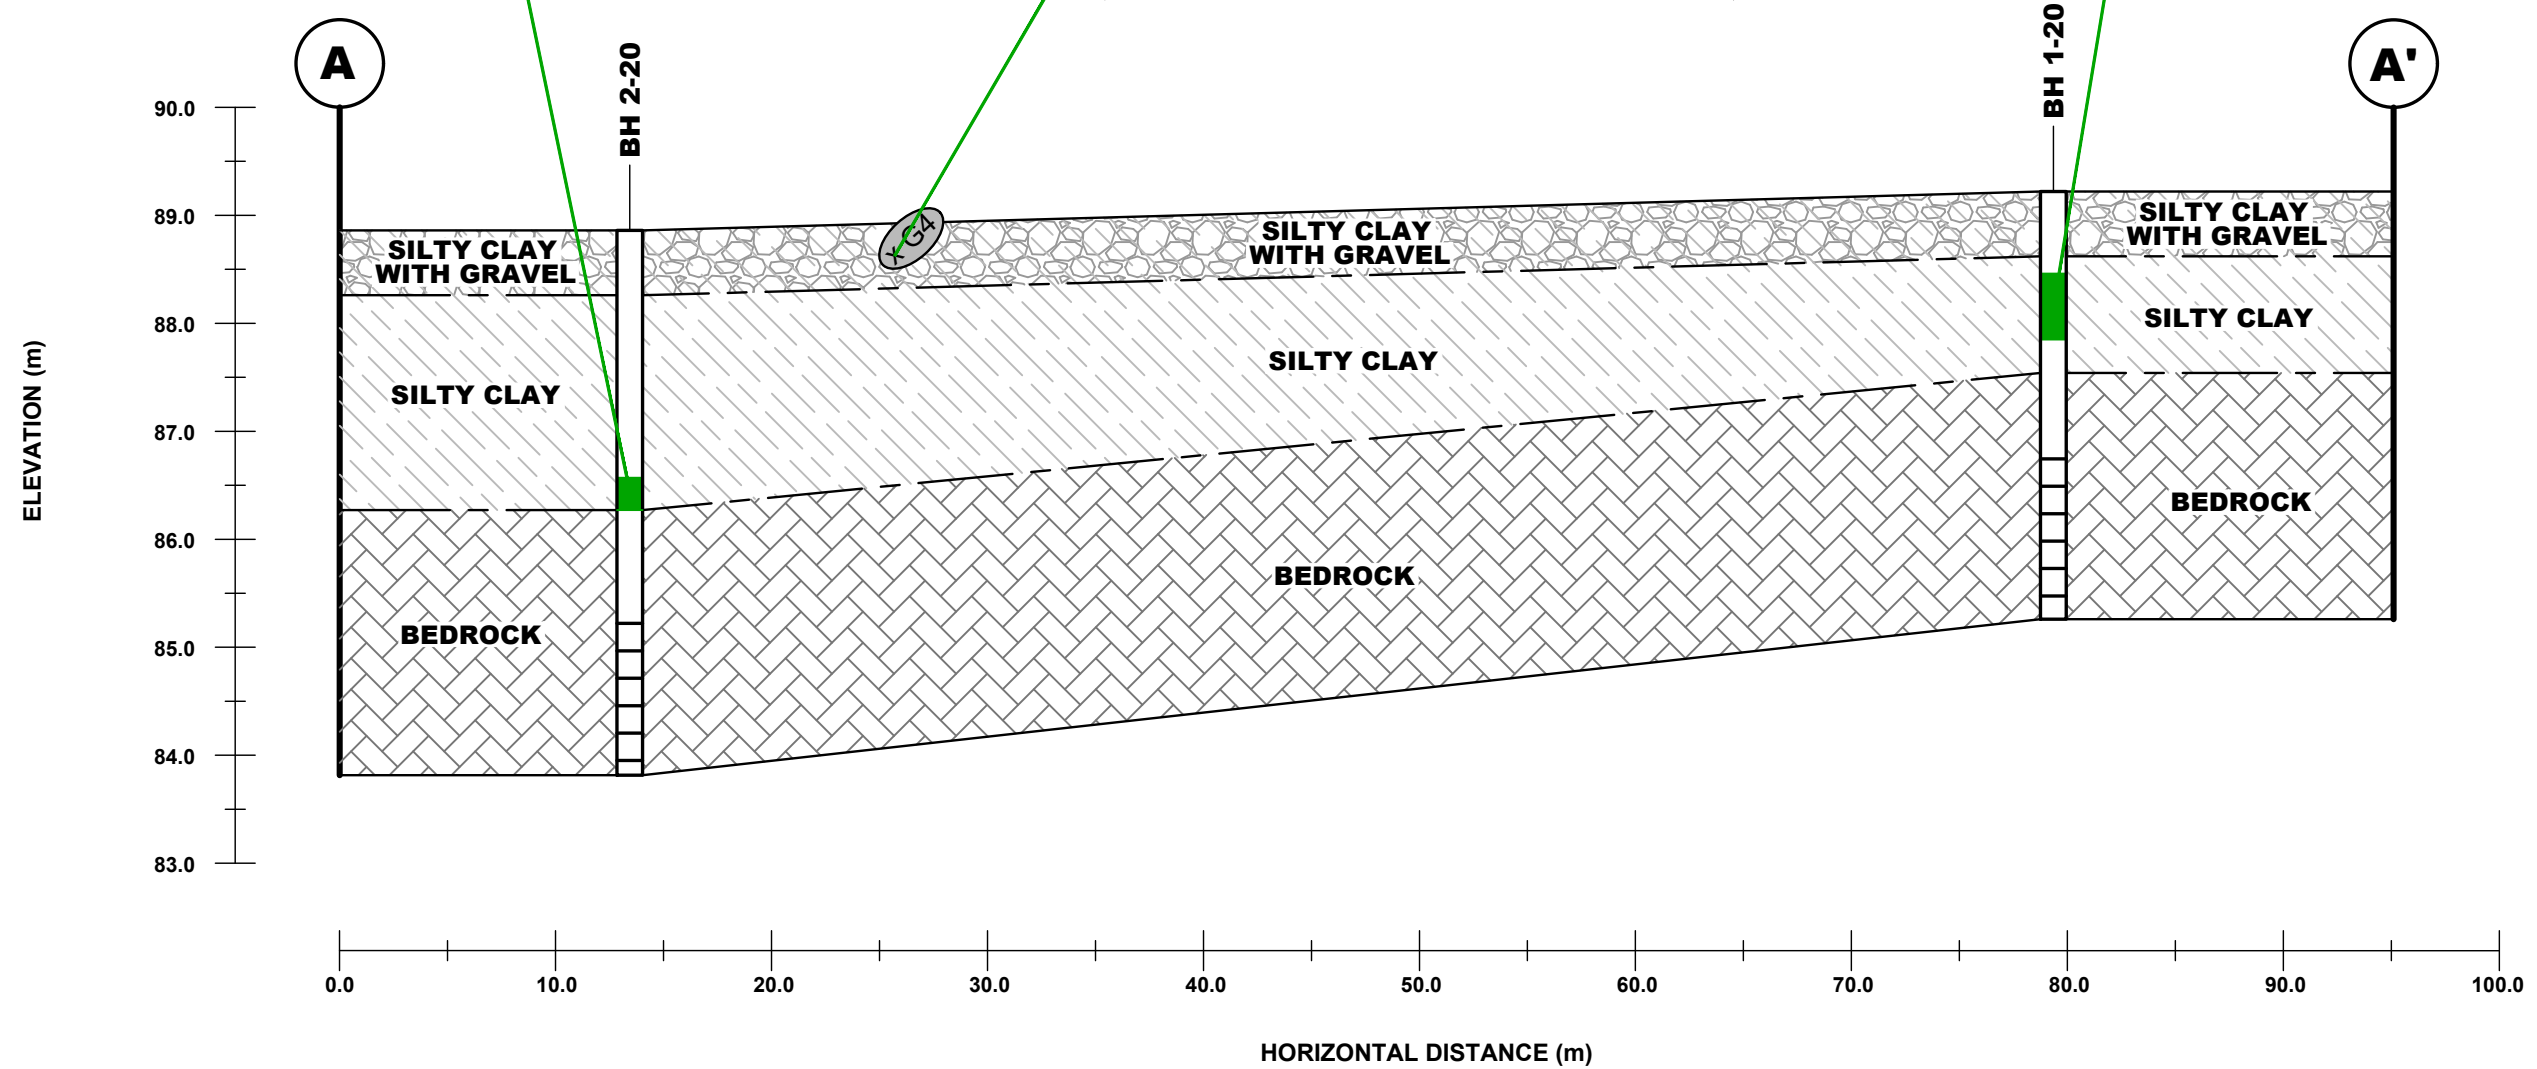
Scale: AS SHOWN	Date: 11/2020
Drawn by: YA	Report No.: PE5000-1
Checked by: NS	Dwg. No.: <b>PE5000-4A</b>
Approved by: MSD	Revision No.:

**SOIL RESULT COMPLIES WITH MECP TABLE 3 STANDARDS**

**SOIL RESULT EXCEEDS MECP TABLE 3 STANDARDS**

RICHCRAFT HOMES LTD.  
 PHASE II - ENVIRONMENTAL SITE ASSESSMENT  
 TRAILS EDGE - PHASE 5 (NORTH)  
 OTTAWA, ONTARIO  
 Title: **CROSS SECTION A-A' - SOIL (BTEX, PHCs, METALS)**

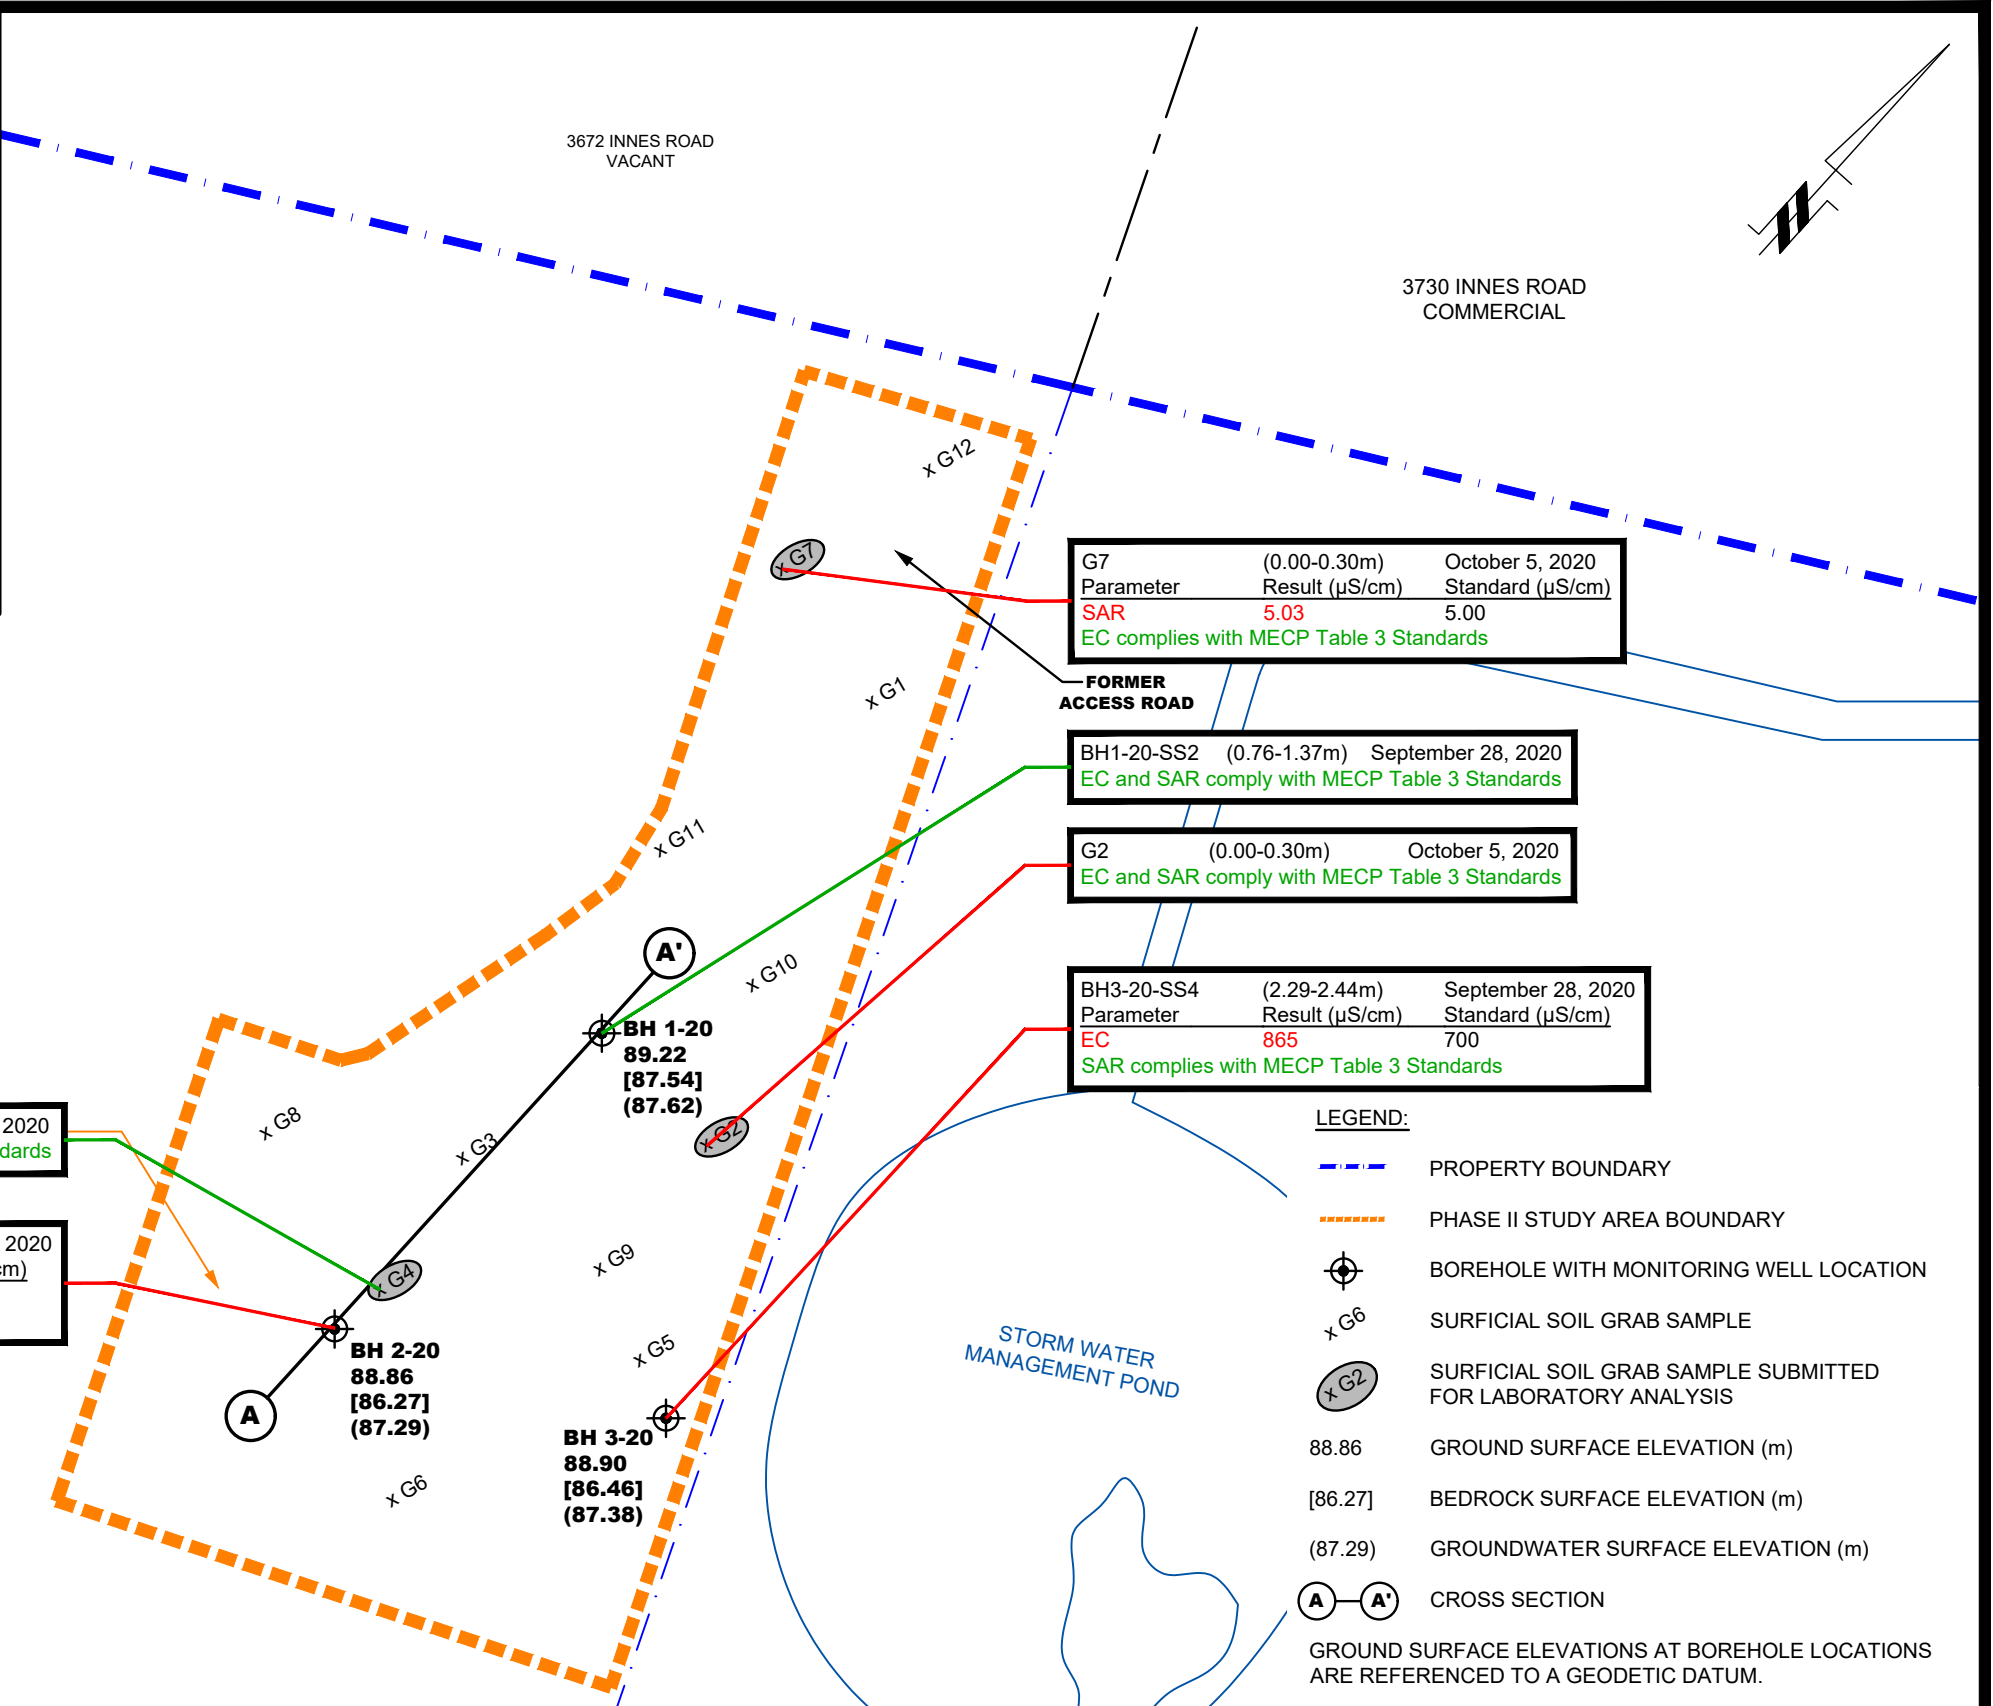
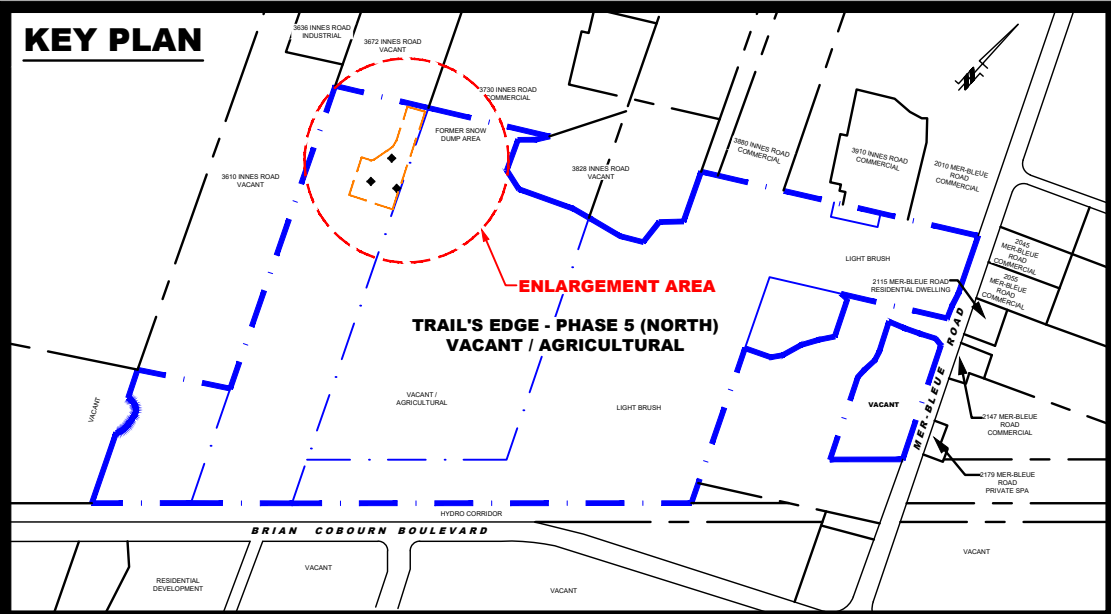
G4	(0.00-0.30m)	October 5, 2020
Parameter	Result (µS/cm)	Standard (µS/cm)
EC	1,690	700
SAR complies with MECP Table 3 Standards

BH2-20-SS4	(2.29-2.90m)	September 28, 2020
Parameter	Result (µS/cm)	Standard (µS/cm)
EC	1,690	700
SAR complies with MECP Table 3 Standards

BH1-20-SS2	(0.76-1.37m)	September 28, 2020
EC and SAR comply with MECP Table 3 Standards

Based on the findings of this Phase II ESA, elevated levels of EC and SAR were detected in the soil within the vicinity of BH1-20, BH2-20, and surficial sample G7. Despite exceeding the MECP Table 3 residential and/or commercial standards, this material is deemed suitable for use as subgrade material for future roadways within the proposed subdivision development where salt will be applied.

As previously noted, elevated levels of EC and SAR were identified in the soil at BH1, BH2, and/or the location of surficial sample G7. Based on the clean groundwater results, these exceedances are anticipated to be contained within the overburden soils at these locations.

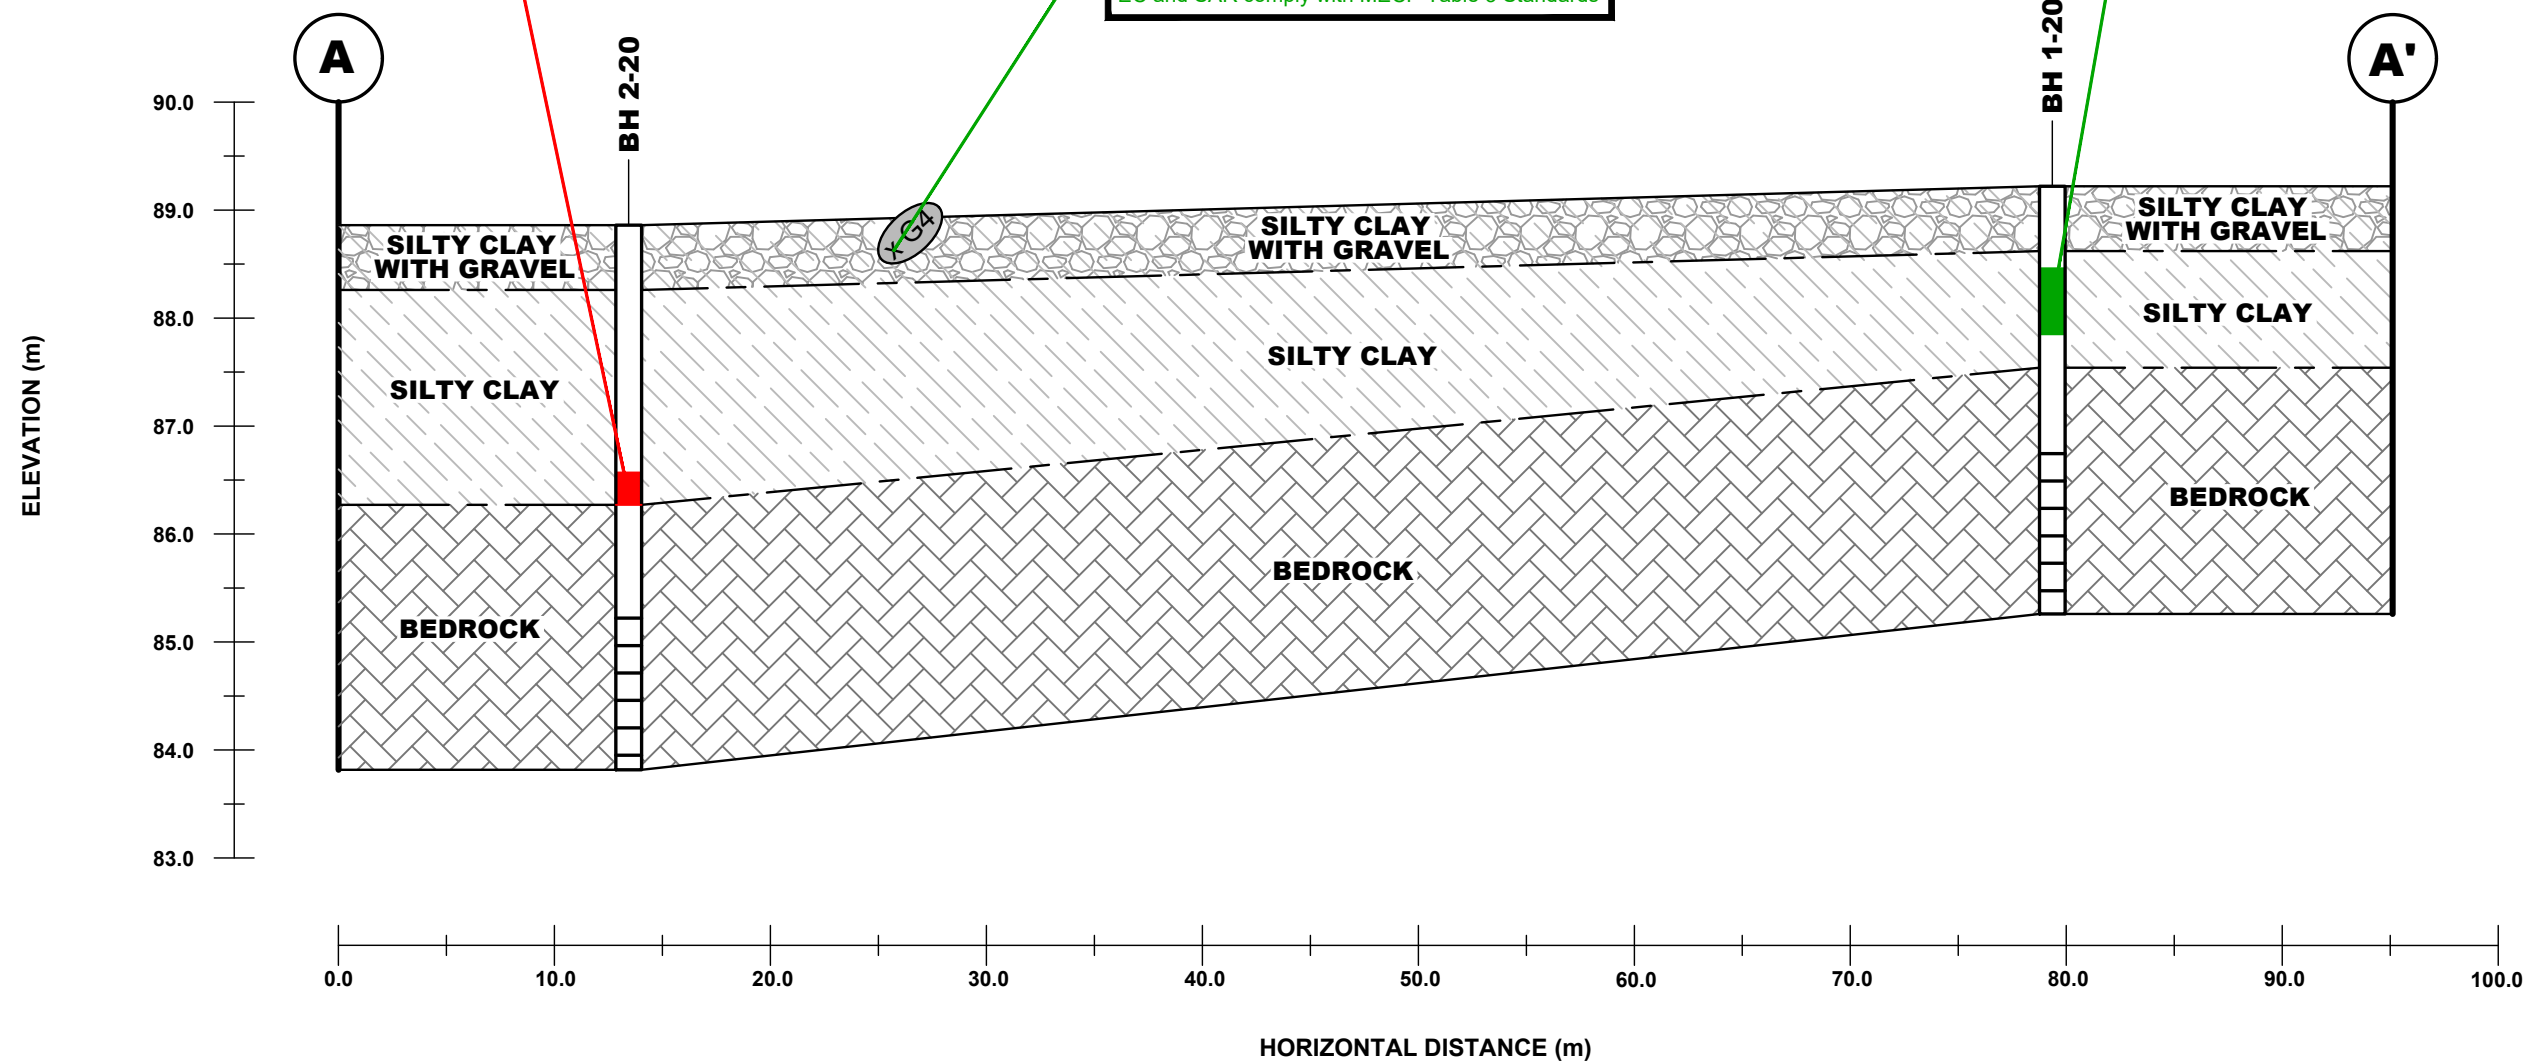
Scale:	AS SHOWN	Date:	11/2020
Drawn by:	YA	Report No.:	PE5000-1
Checked by:	NS	Dwg. No.:	<b>PE5000-5A</b>
Approved by:	MSD	Revision No.:

**SOIL RESULT COMPLIES WITH MECP TABLE 3 STANDARDS**

**SOIL RESULT EXCEEDS MECP TABLE 3 STANDARDS**

Title: **CROSS SECTION A-A' - SOIL (EC, SAR)**

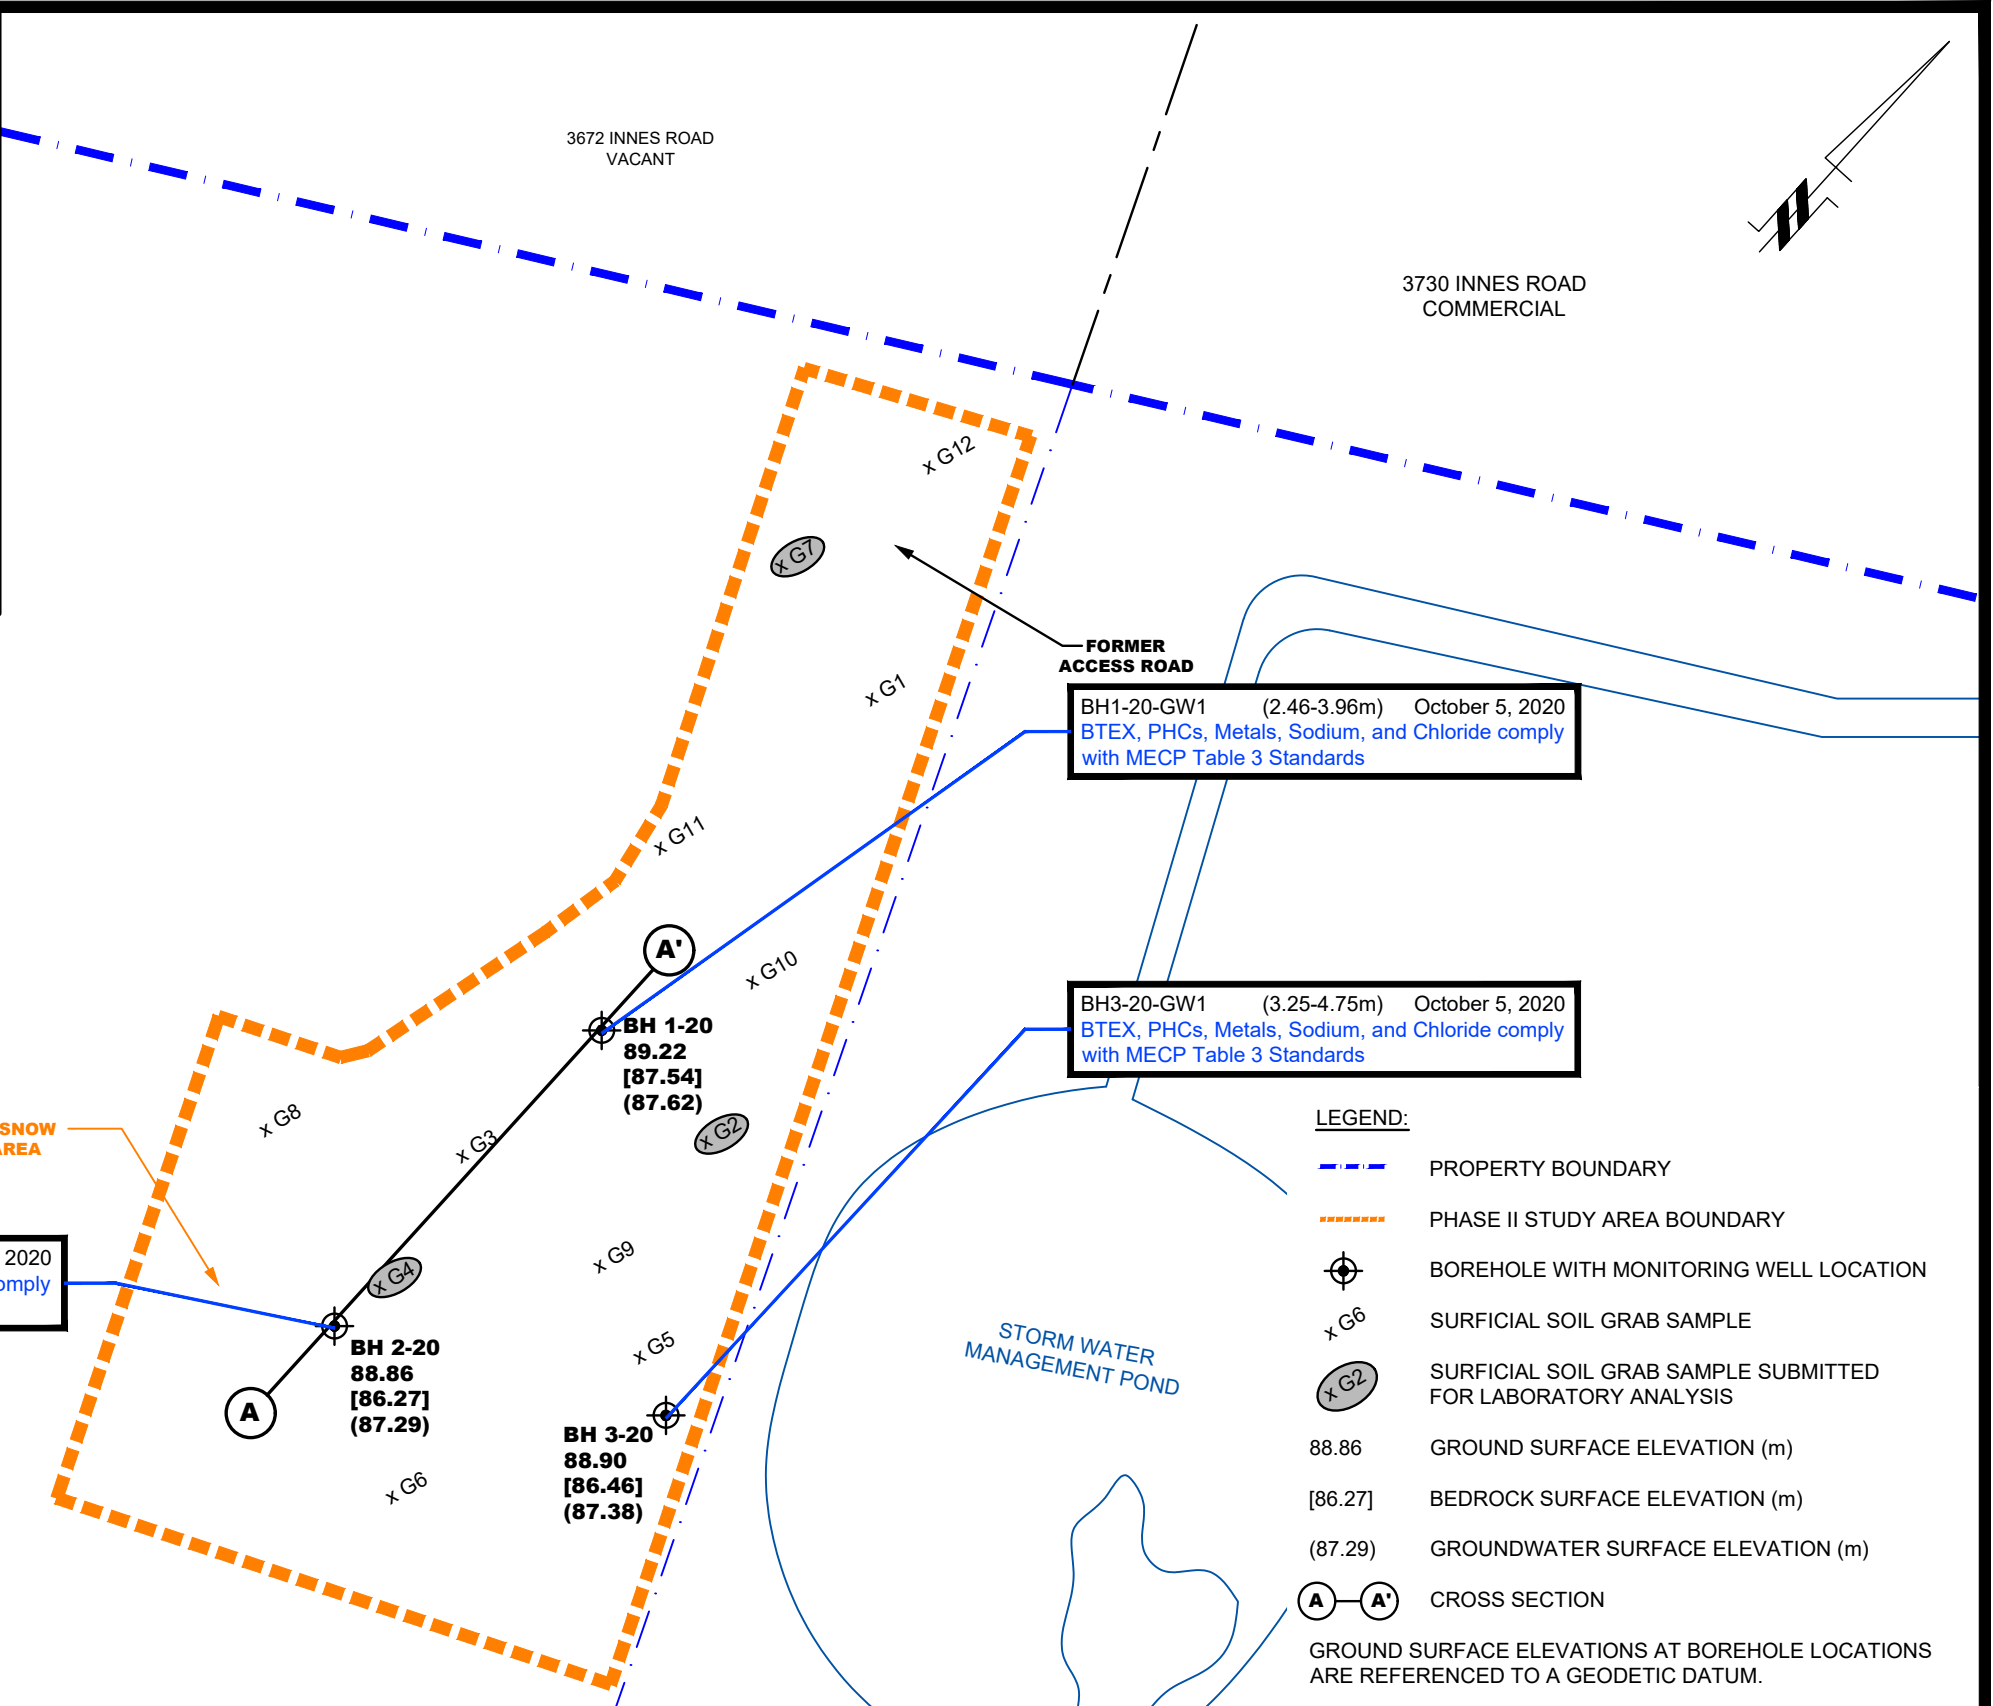
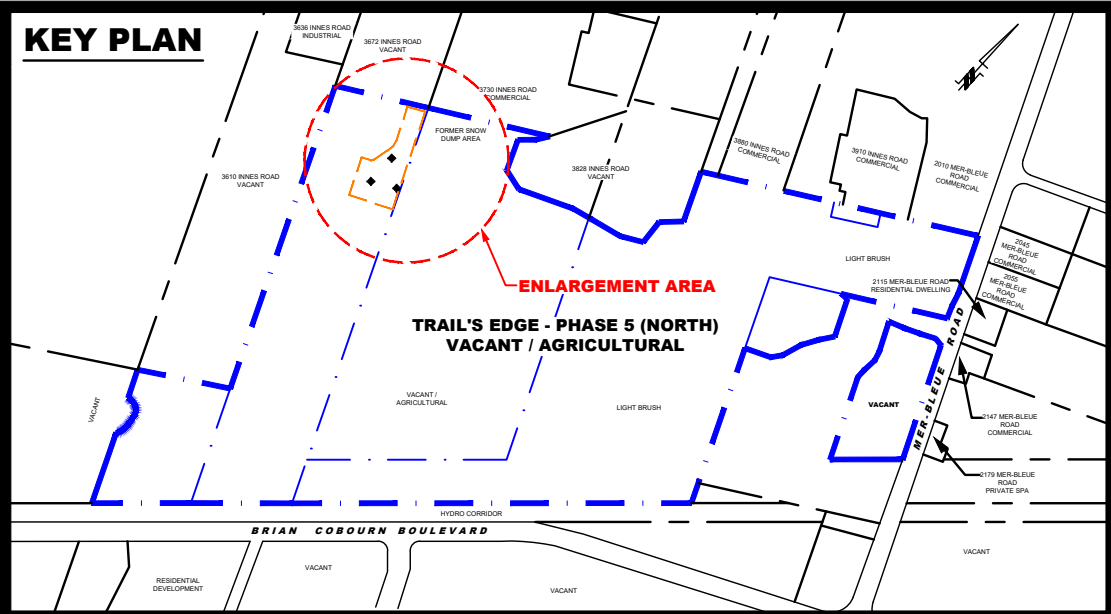
**DRAWING PE5000-6 – ANALYTICAL TESTING PLAN –  
GROUNDWATER**

**BH2-20-GW1** (3.56-5.06m) October 5, 2020  
 BTEX, PHCs, Metals, Sodium, and Chloride comply with MECP Table 3 Standards

**BH1-20-GW1** (2.46-3.96m) October 5, 2020  
 BTEX, PHCs, Metals, Sodium, and Chloride comply with MECP Table 3 Standards
