## Phase II – Environmental Site Assessment

Trail's Edge: Phase 5 (North)  
Ottawa, Ontario

Prepared For

Report: PE5000-1

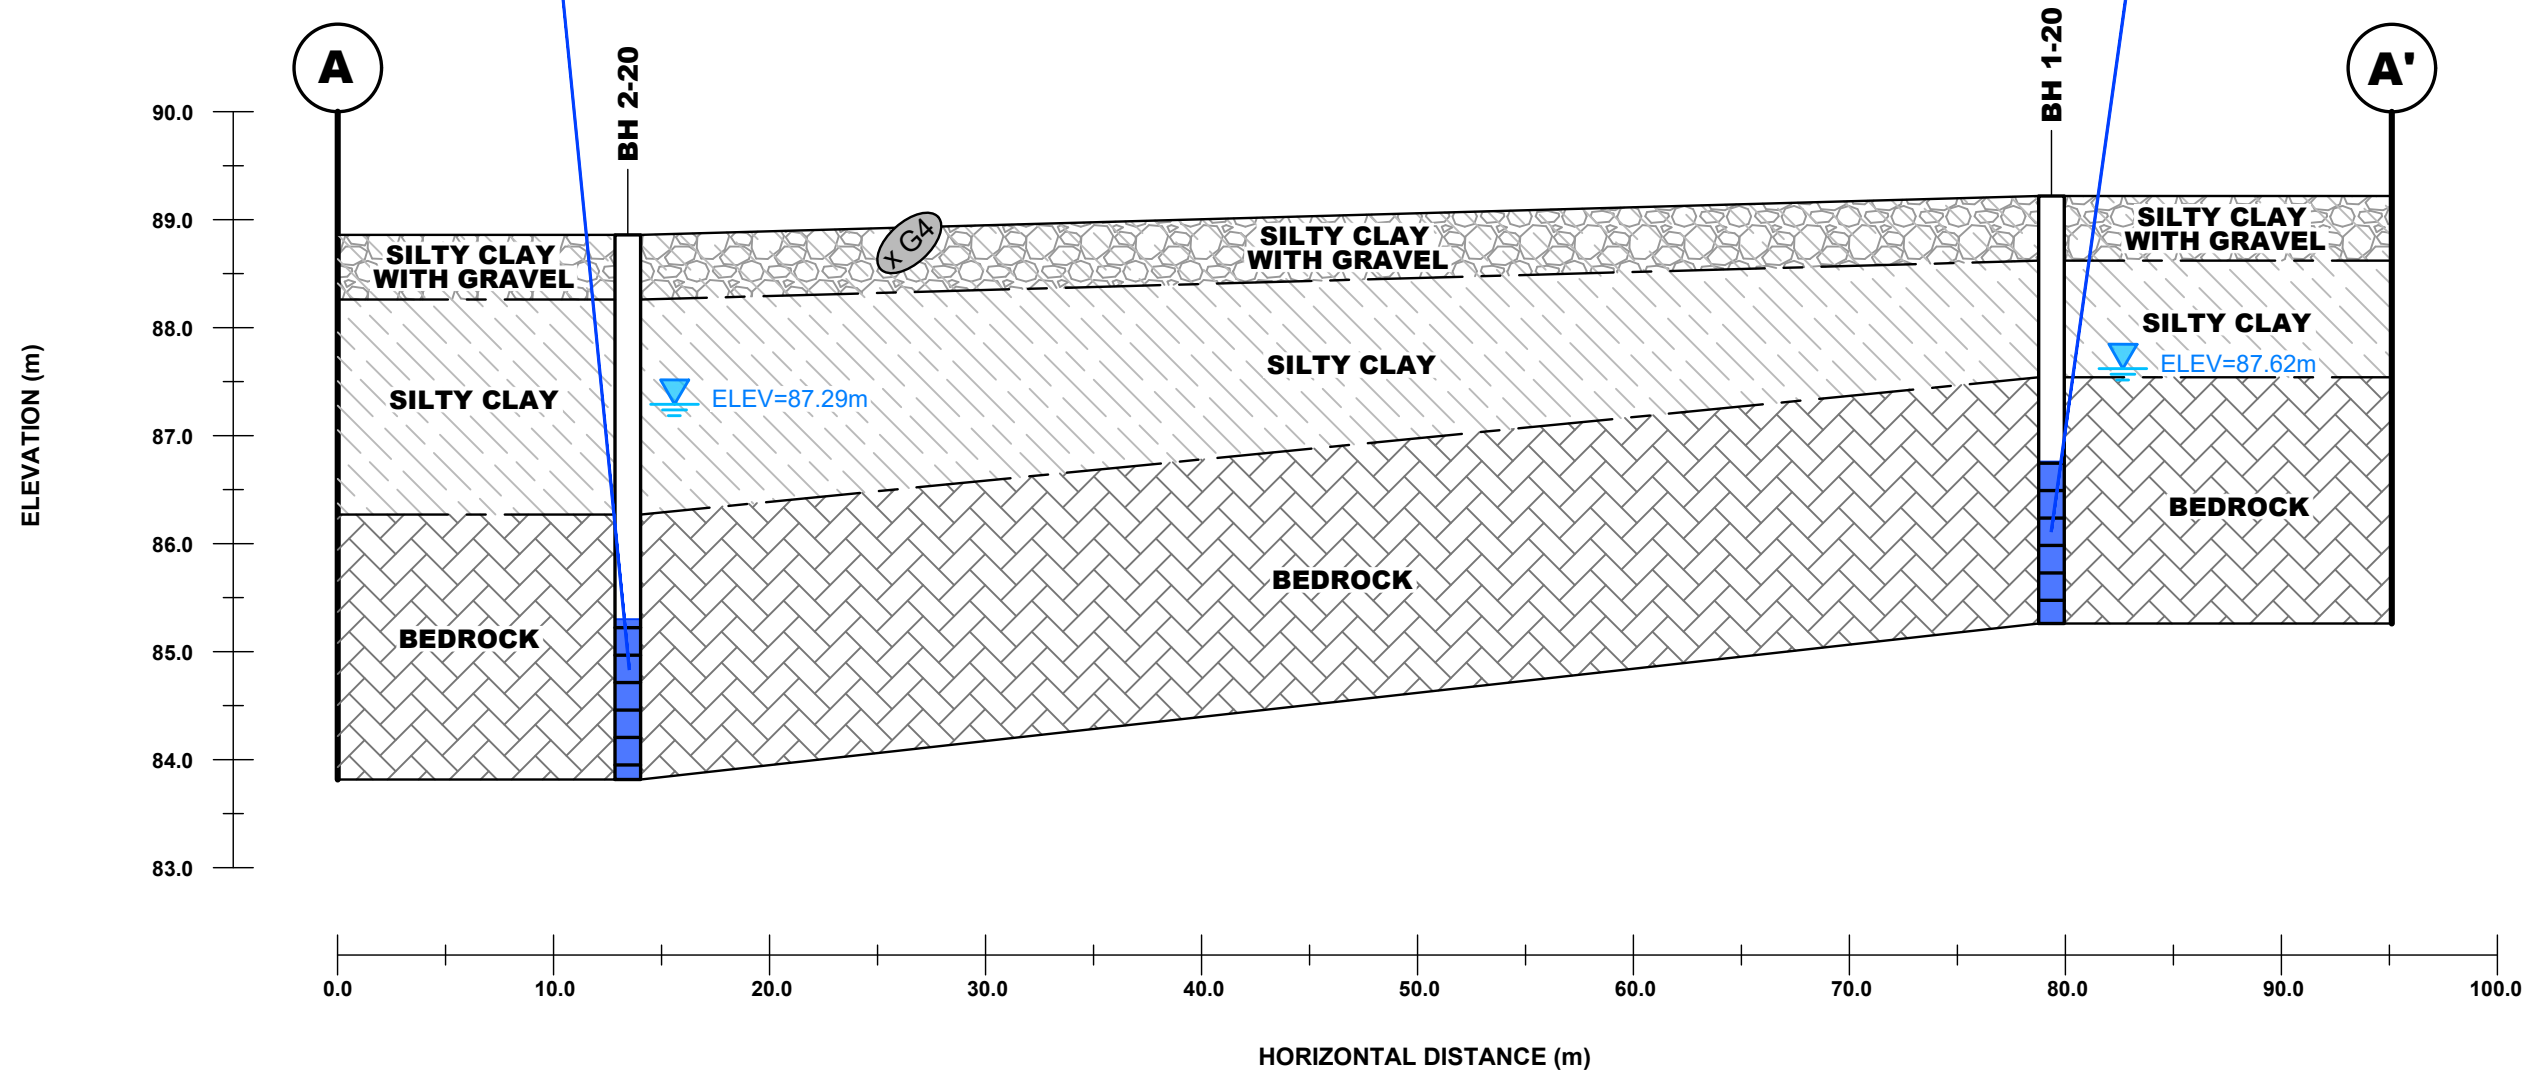
**DRAWING PE5000-6A – CROSS SECTION A-A' – GROUNDWATER**

BH2-20-GW1 (3.56-5.06m) October 5, 2020  
 BTEX, PHCs, Metals, Sodium, and Chloride comply  
 with MECP Table 3 Standards

BH1-20-GW1 (2.46-3.96m) October 5, 2020  
 BTEX, PHCs, Metals, Sodium, and Chloride comply  
 with MECP Table 3 Standards

**GROUNDWATER RESULT COMPLIES WITH MECP TABLE 3 STANDARDS**  
**GROUNDWATER RESULT EXCEEDS MECP TABLE 3 STANDARDS**
