Updated Geotechnical Investigation and Slope Stability Analysis. Proposed Residential Development 37 Wildpine Court Ottawa, Ontario

Project Number: OTT-00263154-A0

June 15, 2023 (supersede August 24, 2021 report)

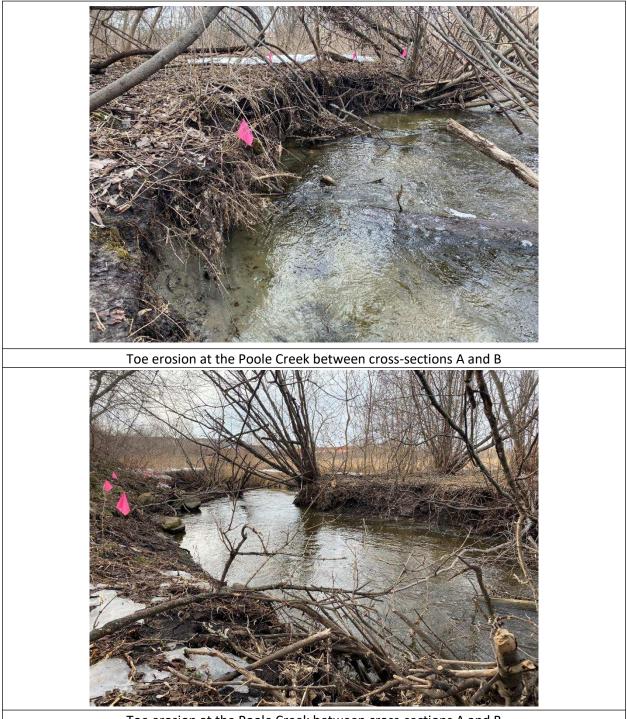
Toe erosion at the Poole Creek between cross-sections A and B

2. RVCA allows the provision of toe protection in lieu of toe erosion allowance. It is understood that due to site restrictions, this option was selected by the client to address the observed areas of toe erosion. Therefore, erosion allowance has not been taken into consideration when establishing the limit of hazardous lands which include the geotechnical set-back established plus the access allowance of 6 m as shown on Figure 2. EXP can provide further input on design and construction of the toe erosion protection.

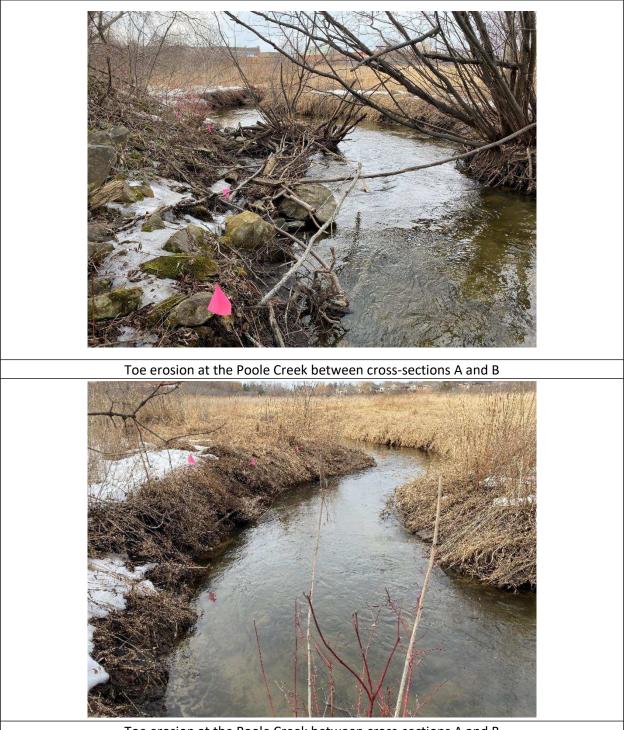
Toe erosion at the Poole Creek between cross-sections A and B
